[Kosse, Vladis](#) (2010) *Revealing design flaws at different stages of product development using anticipatory failure determination (AFD TM) technique*. In: Proceedings of the 6th Australasian Congress on Applied Mechanics, 12 - 15 December 2010, Perth, W.A.

Revealing Design Flaws at Different Stages of Product Development Using Anticipatory Failure Determination (AFD™) Technique

V. Kosse

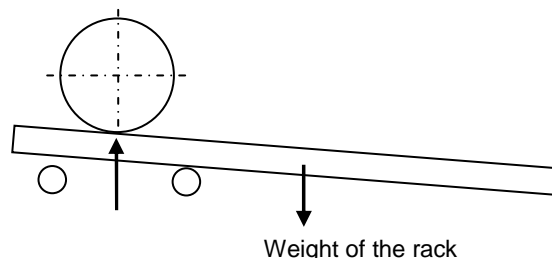
Figure 2: Leverage action of the rack.

Step 6. Search for the needed effect. It is apparent that when the rack is in the mid-position it is in equilibrium and is supported by two rollers. When it is shifted sideways, the gravitational forces tilt it, the rack is supported only by one roller. Clearances between components allow the rack to take inclined position. Due to the leverage action the rack applies large radial forces to the pinion (see Fig. 2). The limited torque clutch cannot prevent these forces being applied to the mechanism. Every time the mechanism is in operation it works under forces it was not designed for. Large radial forces create contact stresses significantly exceeding allowable contact stresses.

Step 7. Search for new solutions. There is no need to search for new solutions because the design flaw is obvious, and if the mechanism is built and installed it will be working under increased loads it was not designed for. This will cause accelerated wear of the rack and the pinion and premature failure.

Step 9. Development of means to prevent failures. One solution could be to put additional supporting rollers outside the flanges to minimise leverage action. An alternative solution could be to turn the mechanism 90°, so that the rack will travel in the vertical direction, and to put the chain on a sheave so that the rack will be suspended and its weight will not make any impact on forces in gear engagement. Moreover, the weight of the rack will work as a counterweight reducing forces applied to the rack and extending its operating life. These conceptual solutions are depicted in Fig. 3 below (the (a) option with additional supporting rollers, and (b) option with the vertical rack).

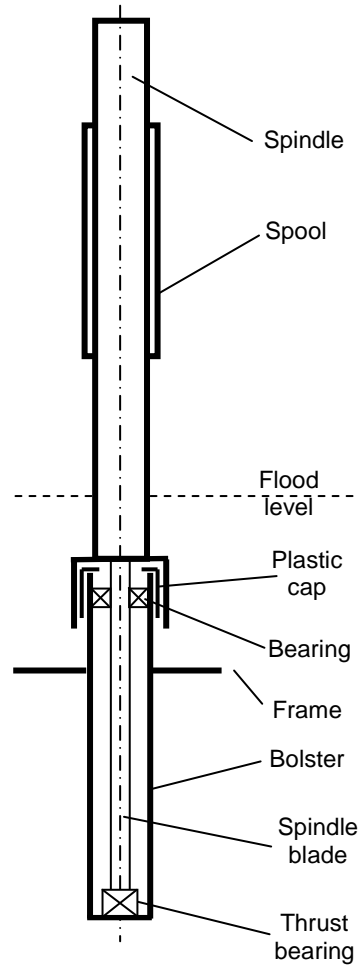
Figure 4: Bolster assembly

As it was mentioned earlier, lubricant was repeatedly replaced. So it looks like water was removed from the bolster. However, bearings had indication of abrasive wear, which can take place only in the presence of highly abrasive particles. Abrasive particles can initially form as a result of chemical reaction of water with iron, which produce Ferro-oxides, highly abrasive particles. Debris of worn out surfaces can also contribute to excessive wear of bearings. Thus, we have to search for another possibility of water entrapment in a bolster despite of lubricant replacement. Let's have a close look what happens when floodwater rises. Since floodwater level was above the entry opening between the spindle and the bolster, hydrostatic pressure pushed water in the clearance between the spindle skirt and the plastic cap, and under the plastic cap. Due to small clearances, surface tension and capillary action contributed to water entrapment.

When floodwater was gone, maintenance staff disassembled flooded bolsters, wiped open surfaces with a cloth, sacked the lubricant with a syringe, dried bolster inner surfaces with compressed air, and refilled them with fresh oil. Most likely the plastic cap was not removed and was not inspected, so the water entrapped under the plastic cap remained there. When after maintenance bolster units were assembled and switched on, water entrapped under the plastic cap evaporated due to the operating machine warming up. When the bolsters were switched off overnight, water vapours condensed on inner surfaces including the bearings. Water drops interacting with iron produced highly abrasive particles of Ferro-oxide. When equipment was switched on again the next morning, the bolster bearings were running with 'sand'. Since quite substantial amount of water was entrapped under the plastic cap, evaporation and condensation process took place repeatedly over several days or possibly weeks, causing extensive bearing damage. The peculiarity of bolster bearing is that they do not have an inner ring. Rollers are running over the shoulder on the spindle blade. So, when rollers wear out, they cause extensive wear of the shoulder as well. In this case, replacement of the bolster bearing without spindle replacement is of little or no help, because new rollers are running over the worn-out shoulder. This is how the long-term damage had occurred.

Inspection of the flooded bolsters by the author proved that bolster surfaces under the plastic cap were rusty, and the bearing shoulders on the spindle blades were worn out, which was possible to feel even with a finger tip. This validates the hypotheses expressed above.

After the flood it was necessary to inspect all flooded bolster assemblies, remove plastic caps from the bolster tubes, and dry them up before putting fresh oil.

Unfortunately the maintenance staff removed water only from accessible surfaces and did not dismantle the plastic cap from bolster tubes. Water entrapped under the plastic cap remained there and caused initially damage to the bearings and then to the shoulder on the needle blade. However at this stage only careful inspection of bearing shoulders on spindle blades and replacement of faulty spindles can help, which is costly.

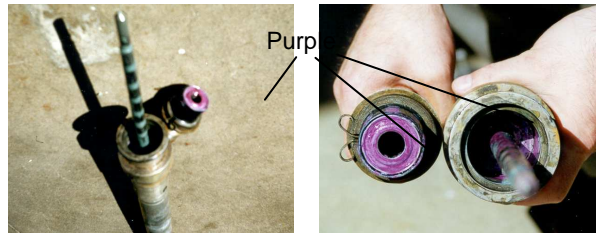
The problem is how to prove and document that the water was entrapped. The Ideal Final Result analysis suggests it would happen by itself. In other words, if water is entrapped, it will make itself visible. The question is “how?” Let’s employ the Substance Field analysis [3]. When water (substance S_2) penetrates the bolster, it interacts with inner surfaces of the bolster (substance S_1) through a surface tension field F_1 (see Fig. 5 below). The result is useful but insufficient action (depicted with dashed arrow) – it is difficult to detect water especially if the amount of water entrapped is small. What if to add another substance S_3 that will chemically interact with the water through a field F_2 . As a result, substance S_3 will change its colour. Information search showed that such a substance is available on the market. It is called “water finding paste” and is widely used at petrol stations to detect water in petrol tanks. In these experiments the paste from Gilbarco Australia Pty Ltd was used, which initially has a turquoise colour, but in contact with water turns purple. In this study the bolster was disassembled, and its inner surfaces were smeared with the water finding paste. Then flood conditions were modelled in a laboratory. When the bolster was disassembled, plastic cap was purple (see Fig. 6 below), and in some experiments, the spindle blade was also purple. This explicitly proves that flooded bolsters had entrapped water.

Figure 6: Water-finding paste changed its colour to purple in contact with water
