1. Report No.		2.		3. Recipient's Accession No.	
4. Title and Subtitle Florida's East Coast Inlets Shoreline Effects and Recommended Action				5. Report Date December, 1987

6.	
7. Author(s) R. G. Dean M. P. O'Brien				8. Performing Organization Report No. UFL/COEL-87/017	
9. Performing Organization Name and Address Coastal and Oceanographic Engineering Department University of Florida 336 Weil Hall Gainesville, FL 32611				10. Project/Task/Work Unit No.

FLORIDA'S EAST COAST INLETS
SHORELINE EFFECTS AND RECOMMENDED ACTION

December, 1987

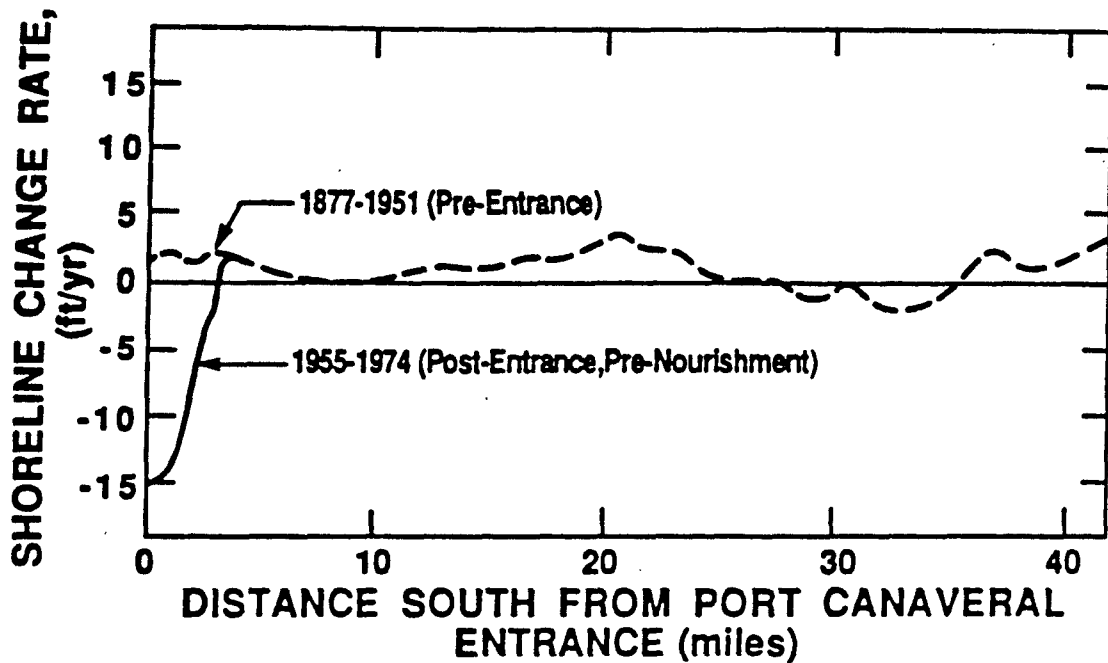
a) Effects of Channel Entrance on Downdrift Beach Stability, Compared to Pre-Entrance Condition.

It is enlightening to examine pre- and post-entrance downdrift shoreline changes. Figure 3a presents the shoreline changes from 1877 to 1951, prior to entrance construction for the 41 mile segment downdrift of Port Canaveral Entrance. It is clear that in its natural condition, although there were areas of erosion and accretion, on the average this 41 mile shoreline segment was accreting at a rate of approximately 1 ft per year. Figure 3a also documents the erosion over the 23 year period 1951 to 1974. Immediately downdrift (south) of the entrance, erosion rates were up to 16 ft per year with a maximum localized erosion extent of nearly 400 ft in the 23 year period. Interpretation of these data indicated that the volumetric rate of erosion is approximately 200,000 cubic yards per year rather than the 350,000 cubic yards per year originally estimated.

By the early 1970's, the downdrift erosion had become so acute that local interests initiated legal action to remedy the erosion conditions caused by the entrance. The legal settlement included the placement, in 1974, of approximately 2.5 million cubic yards of sand on the 2.1 mile segment immediately south of the south jetty. The shoreline over this segment was advanced seaward an approximate distance of 400 ft which more-or-less reestablished the pre-entrance shoreline. Figure 3b presents the shoreline changes between 1974 and 1986. Several features are noteworthy. First by 1986, the erosion that was formerly located within 4 miles south of the south jetty had by 1986 spread out to a distance of 14 miles south of the entrance. Secondly by 1986, the nourishment placed within 2.1 miles of the south jetty had benefitted the beach system up to 4 miles south. Finally, even though the 12 year period (1974-1986) is not long compared to shoreline changes, it is of interest to note that by-and-large the shoreline changes outside the limit of influence of the entrance exhibit strong similarities to those based on the longer term changes (1877-1951).

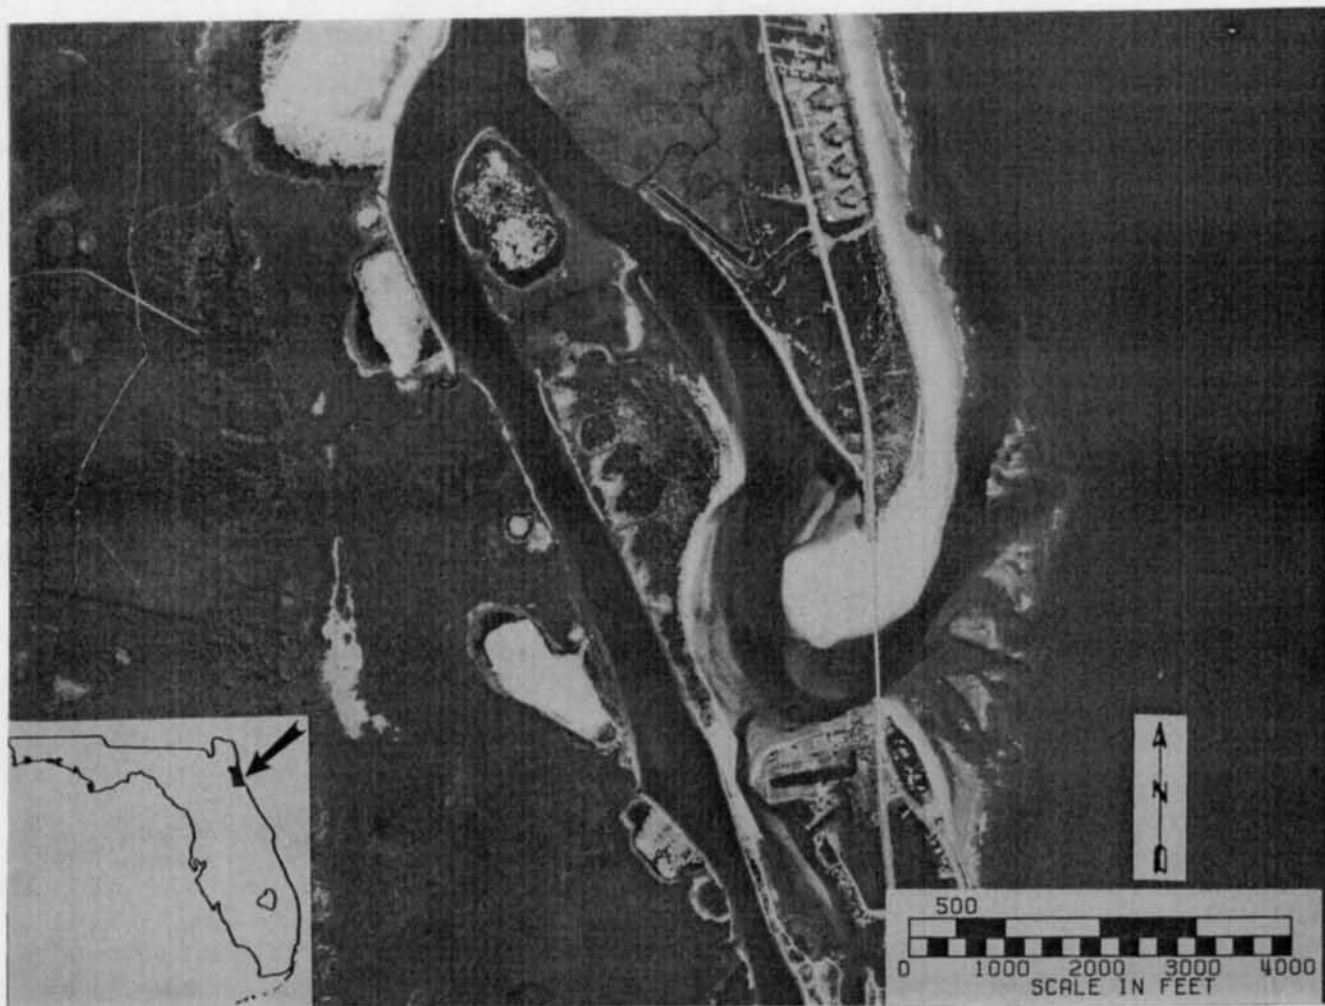
MATANZAS INLET

- A natural inlet without dredging or jetties, Matanzas Inlet has been affected by bridge and abutment construction.
- In 1925, highway bridge constructed parallel to the shore and near the throat of this inlet. Replaced in 1956.
- In 1972, breakthrough in Rattlesnake Island from Intracoastal Waterway to Matanzas tidal area.
- Breakthrough was closed by dike construction in 1976.

- Bypass sand so that there is no additional storage inside the flood tidal shoal.

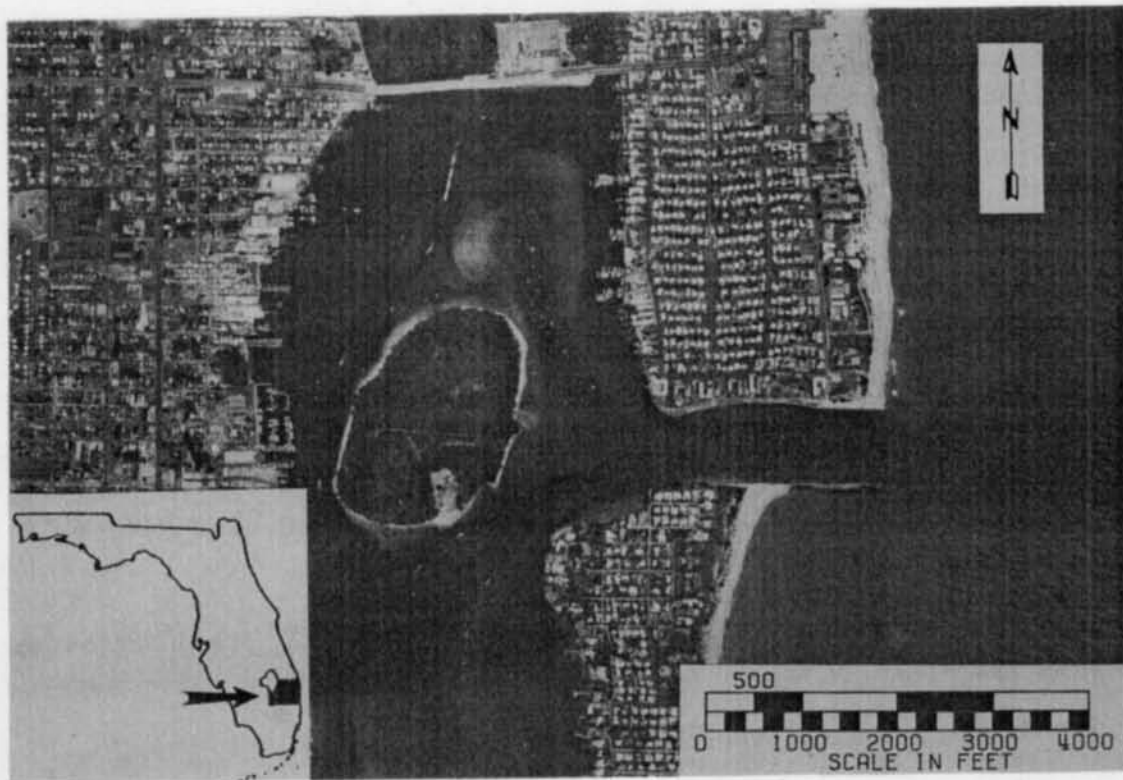
LAKE WORTH INLET (PORT OF PALM BEACH ENTRANCE)

"coffer dam" around the sand intake point to limit the amount of sand which can flow to the bypassing plant. The limited effectiveness of the bypassing plant is reinforced by the annual dredging to maintain the channel depth of 35 ft. Records available over the six year period, 1980-1985, indicate that an average annual amount of 42,370 cubic yards was dredged from the channel and placed offshore.

Over the history of this entrance, 2.8 million cubic yards of dredged material have been lost due to deep water disposal. In addition to placing large quantities of sand offshore, earlier disposal practices included placement in an interior shoal called "Peanut Island" which has been built to approximately 25 ft in elevation and contains an estimated 1.2 million cubic yards. Much of the 20 mile segment forming Palm Beach Island is in an advanced degree of erosion.

- Eliminate restrictions on by-passing plant operation imposed by coffer dam around pumping plant intake.
- Attempt to increase bypassing to estimated net longshore transport rate (approximately 200,000 cubic yards per year).

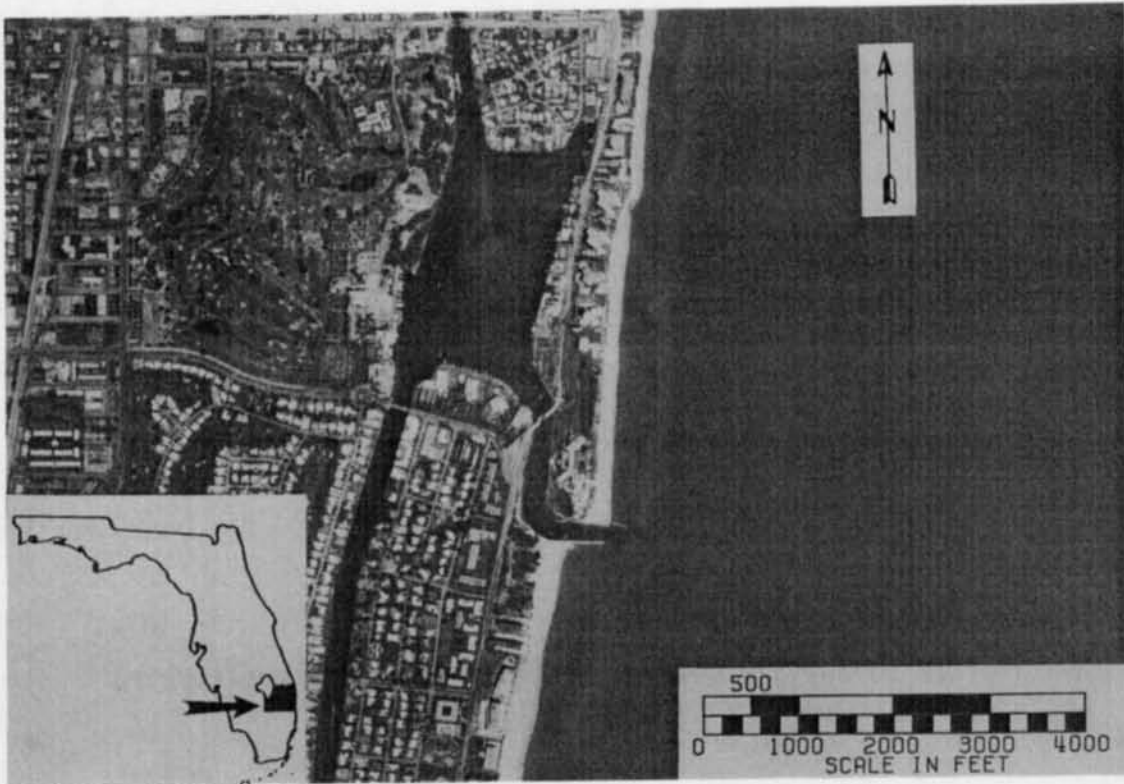
BOCA RATON INLET

750,000 cubic yards were removed from the ebb tidal shoal in 1985 and placed on the downdrift beaches. This placement widened these beaches substantially; however a visit in November 1987 showed that these beaches were returning to an eroded condition.

- Encourage City of Boca Raton to continue by-passing sand to beach south.
- Attempt to increase bypassing rates to approximately 200,000 cubic yards per year.

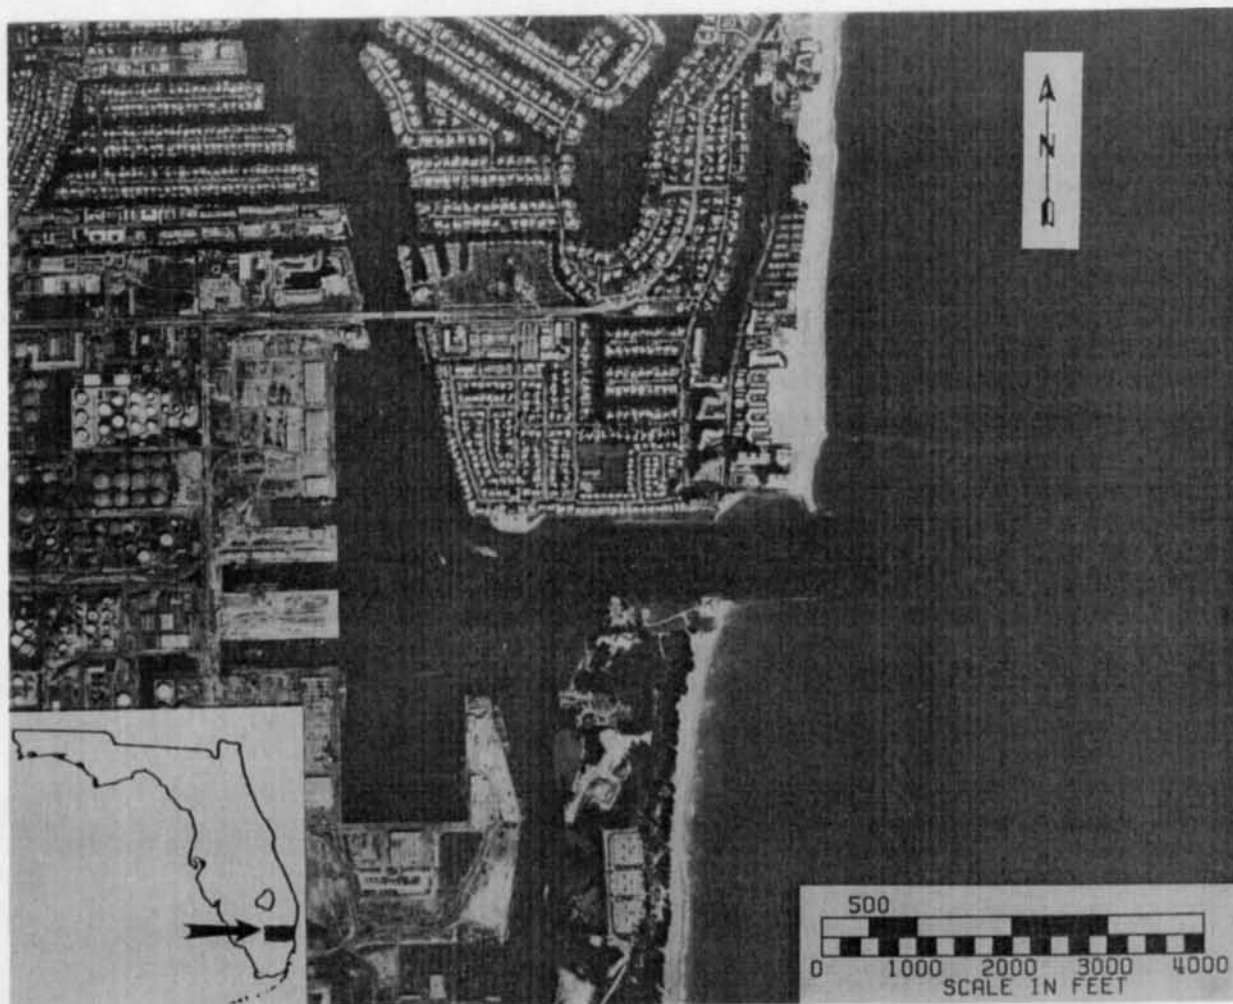
PORT EVERGLADES ENTRANCE

- This entrance has caused substantial downdrift (south) erosion.
- There does not appear to be as much maintenance dredging required as the downdrift erosion experienced.
- Shore northward is highly developed.
- No ebb shoal.

- Implement a program of placing on the south beach on an average annual basis, the net longshore sediment transport (50,000 to 270,000 yd³/yr). A minimum of 100,000 yd³/yr is recommended.
- The source of this material could be bypassing from the north beach or elsewhere.
