UFL/COEL-90/002

**WATER AND EROSION DAMAGE TO COASTAL  
STRUCTURES – SOUTH CAROLINA COAST,  
HURRICANE HUGO, 1989**

**Hsiang Wang**

**March 1990**

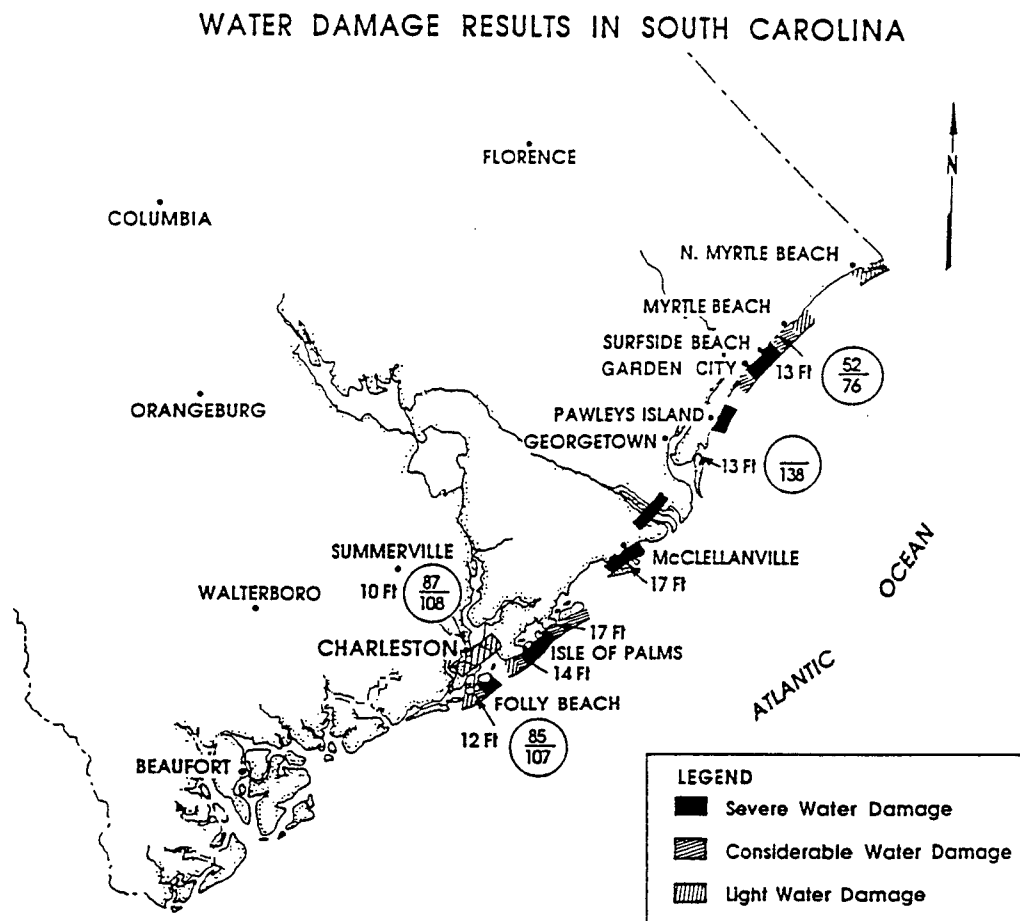
Based upon visual inspection, the severity of water damages was subjectively determined, shown graphically in Figure 1.

Figure 1: A General Assessment of Water Damages Along Coastal Region Under the Influence of Hugo (Surge and Wind Information From Federal Insurance Administration, 1989).

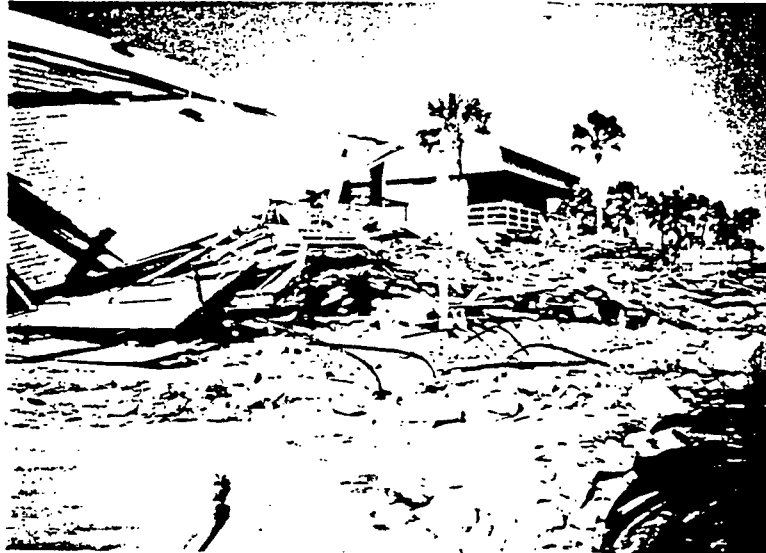
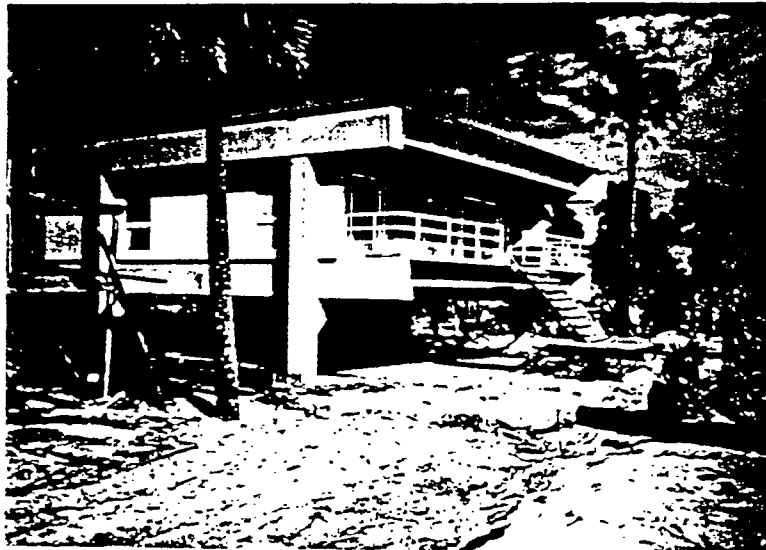
Figure 2: A Concrete Residential Structure on Folly Island Survived With No Damage Amongst Heavy Destructions.

It is a frame structure with four concrete columns seated on four 14" square piles. By discussing with the design architect and the County building inspector, it is concluded that this structure fared so well for a number of reasons:

1. Sufficient elevation (bottom of support beam at elv.15 feet MWL).
2. Deep and strong pilings (22 feet plus 5 feet tip).
3. Simple and strong connections.
4. Low profile and low roof line.
5. Very rigid main columns.

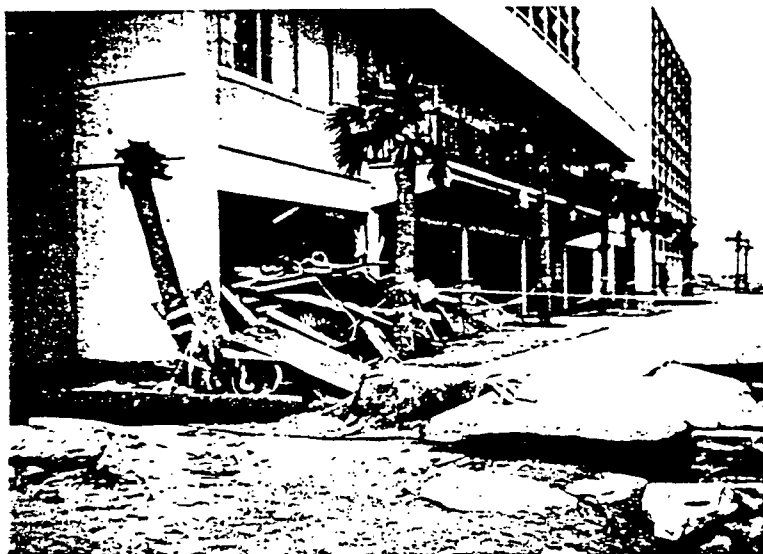
The Holiday Inn is the only substantial commercial building along the open coast. It is a relatively new construction, built about 5 years ago. The building is at an exposed location with receding shorelines on both sides. The front is protected by a retaining wall and heavy revetment. The building, nevertheless, sustained heavy water damage. Practically all the ground floor facilities were destroyed (Figure 3).

Erosion behind the retaining wall was significant, causing concrete deck to collapse and undermining the swimming pool. The seawall cap was partially destroyed due to wave impact. The water damage was certainly heavier than one would expect for structures of this type built in such a recent date. A number of contributing factors are listed here:

1. The elevations of the structure as well as the protective seawall are inadequate for the surge level.
2. There is no fronting beach to dissipate wave energy, causing heavy wave runup and overtopping.
3. The structure protrudes beyond the adjacent shorelines and there is no return wall to protect its flanks.

Figure 3: Photo Shown Water Damages to the Ground Level Units and Water Front Amenity Facilities at Holiday Inn, Folly Island, a Typical Damage Mode Among High Rise Hotels and Condominiums.

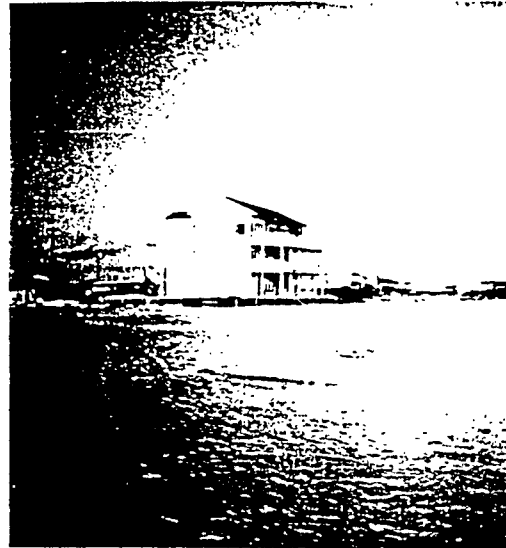
The Sea Cabin Condominiums at Ocean Blvd. and 14th Avenue sustained heavy water damage. The entire complex was prefabricated modular units seated on pile foundation. The ground units and the end unit were completely damaged. Inadequate elevation and poor structural member connections were the main reasons of failure. Two structures on the exposed Ocean Blvd. (#126 and #912) stood out with little visible damage, wind or water (Figure 4 shows the post storm condition of #912).

Figure 4: A Well  
Constructed Pile Supported  
(Wooden) Frame Residential  
Structure On Isle of Palm  
Fared Very Well Even In An  
Exposed Location.

Both structures were built by the same builder and the constructions appeared to exceed the current building code requirement. Class "B" piles (12" Dia. from butt in and 14" Dia. above ground) with 3/4" steel diagonal bracings were used. Frames were connected throughout with 1/2" and 3/4" plywood using #16 Galvanized penny nails at 4" intervals around corners to insure shear rigidity. Hurricane clips were properly installed at critical connection points around roof frame and at pile-beam junctions. Roof tiles were nailed properly to 5/8" roof plywood. Ridge vent was installed to relief pressure difference. As a consequence, only a minimal number of roof tiles were missing, uncharacteristic to the general extensive roof damages in this region. Members that are subject to lift force were connected by galvanized screws instead of nails.

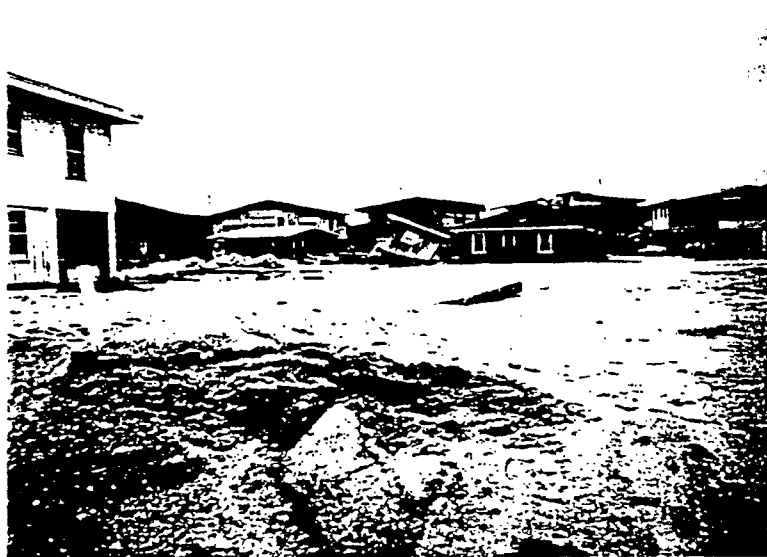
The water damage and the sand washover were among the worst of all the areas inspected. Water damages due to flooding can be traced as far back as 1500 feet, or four or five rows deep from the first street; the sand washover was measured to top 1 foot on the second row of houses (north of Waccamaw Avenue see Figure 5). Right after the hurricane, debris were piled 20 feet high at intersections, made passage to the second row impossible from either side.

Figure 5: Sand Washover on Second Row of Houses (North of Waccamaw Avenue, Garden City).

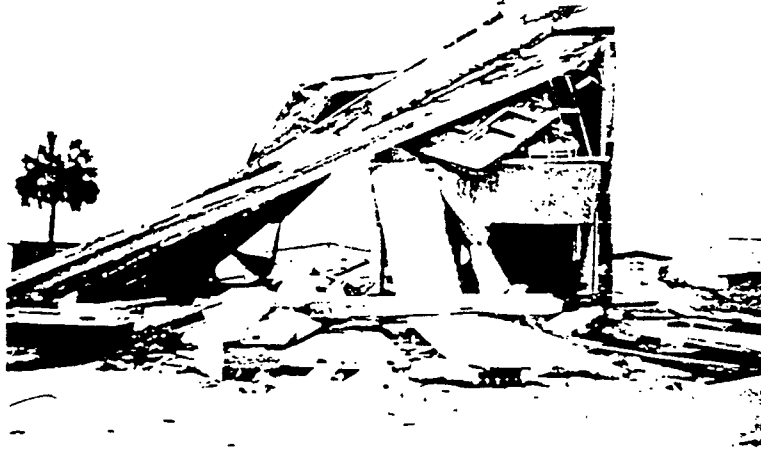
Figure 6: A Two Story Concrete Residential Structure Collapsed Under Its Own Weight Due to Weak Foundation (Garden City).

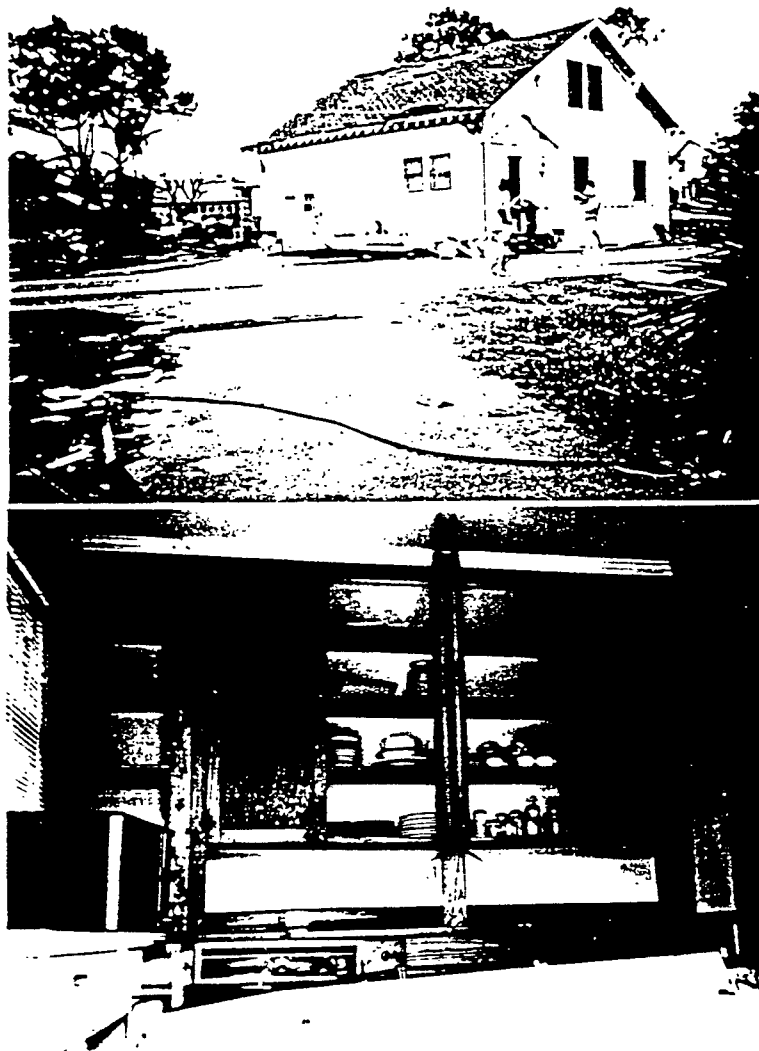
Figure 8: (a) Structure Built On Slab Floated Away From Foundation And Deposited 100 Feet Away Across the Street. (b) The Arrangement Inside the Kitchen Remained Undisturbed in the House.

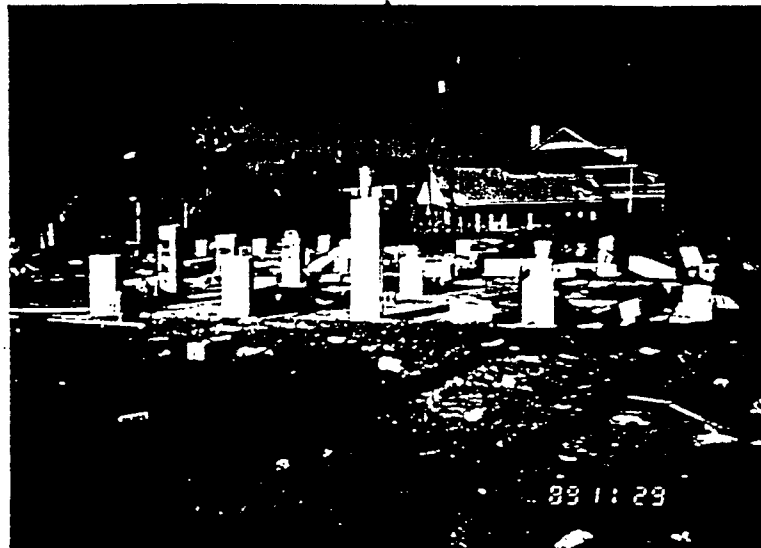
In the above ground section, masonry pier is inferior to wood or poured concrete piers. Masonry pier often failed due to inadequate reinforcement, sloppy job on masonry fills and weak joints between blocks (Figure 11).

Figure 11: Masonry Pier Made of Concrete Blocks Failed Due to Weak Joint and Inadequate Fill.

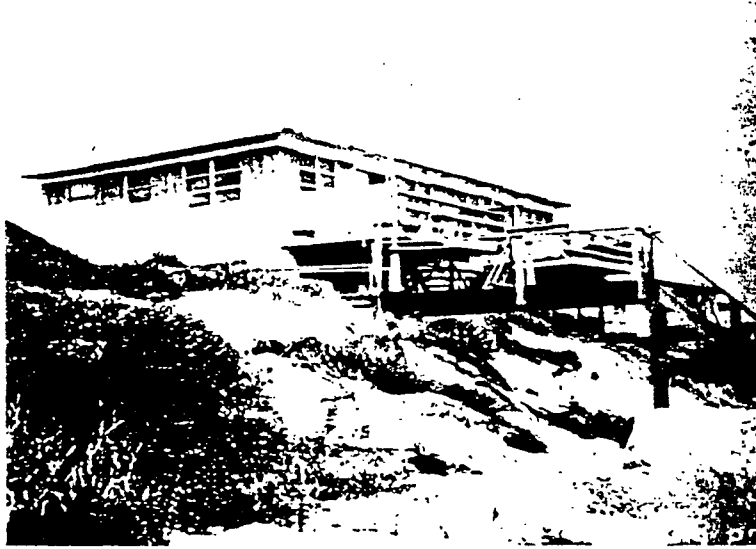
Figure 14: (a) House With Access Ramp to Beach (Prior to Hugo).

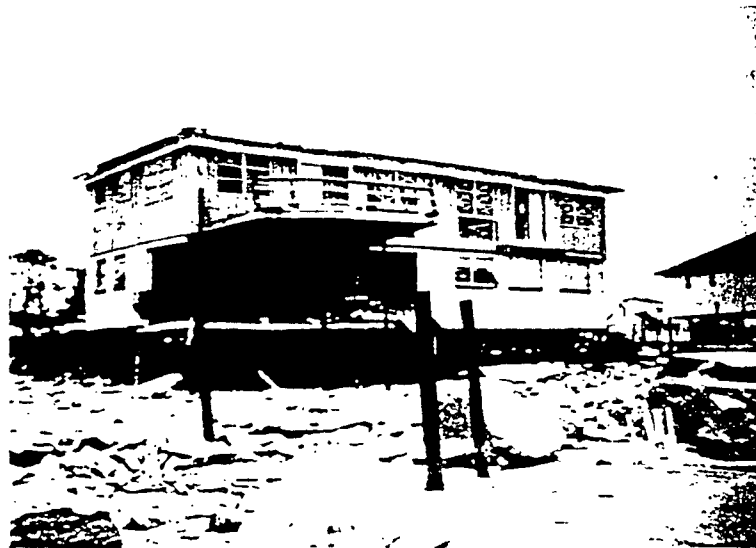
A surprising amount of damage was caused by failures of appurtenant structures. Deck structures with access ladders or ramps to the beach were a main source of problem. They were not designed to resist water forces,

yet, most of them were secured to the main structures. Water forces would most certainly destruct them which in turn would puncture or tear apart that portion of the main structure connected to them (Figure 14). Ground floor garage doors, air conditioners, water tanks, non-break-away walls, etc., all contributed to additional damages to the main structures. Revetment armor units sometimes behaved like missiles powered by waves as discussed earlier.

Figure 14: (b) The Access Ramp Washed Into the House Due to Wave Force.

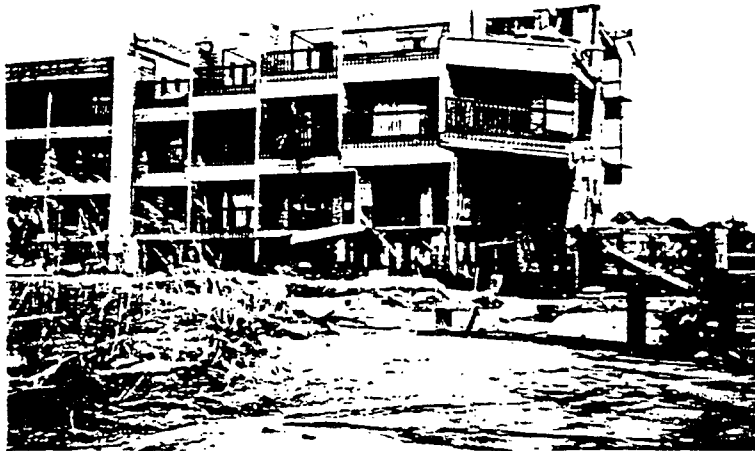
Figure 15: (a) Modular Unit Constructions With Poor Connections

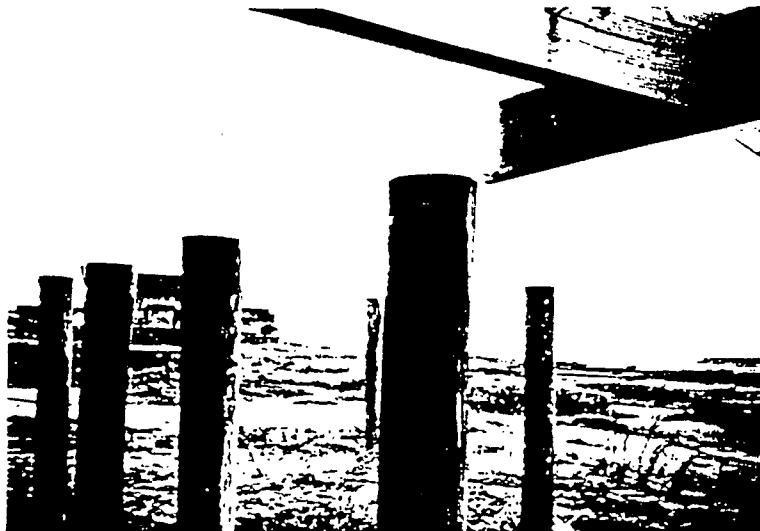
Connections play a major role in wind damage but a lesser one in water damage. Improper connections between floor beams and foundations caused the structures to float away, to collapse and to lean or shift. Figure 15 shows an example of a modular unit completely separated from the foundation piles. Improper nailing practice and inadequate sizes of nails were a prevailing practice causing member separations under minor shift (Figure 16). Missing and inadequate hurricane clips were also prevalent. Mobile home tie downs were found to be common. Very few mobile home units were found near the coast. One small mobile home park south of Myrtle Beach did incur heavy damage, but was mainly due to inadequate elevation as opposed to inadequate tie downs.

Figure 15: (b) The End Unit of the Modular Structure Simply Disconnected From the Piles.

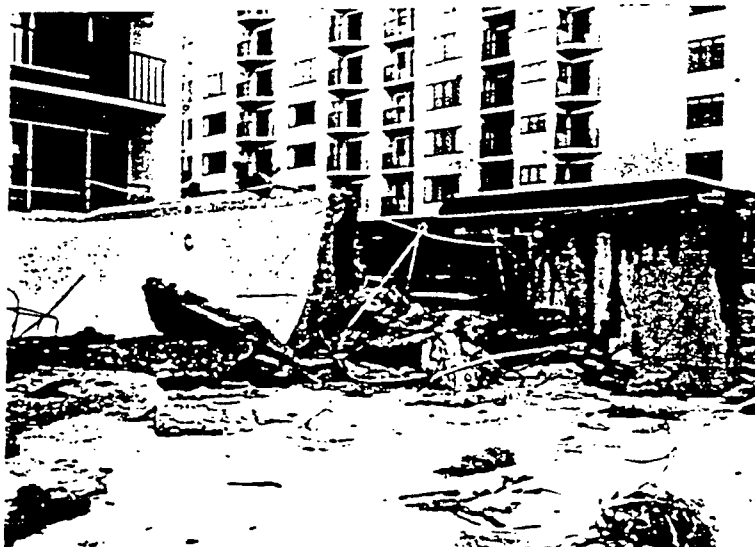
1. Seawalls: Sea walls are numerous in the affected region. Most of them are actually just retaining walls built for the primary purpose of supporting amenity facilities or lawns. And, most of them are grossly inadequate in height to protect the upland structures from water damage. Scouring behind seawalls due to overtopping was the most prevalent damage mode observed which then led to failures of decks and pools or collapsing of seawalls themselves (Figure 17). In addition, most of the return walls were underdesigned resulting in numerous failures (Figure 18). Once the return walls failed, water quickly rushed in from behind like a breached dam causing rapid losses of material.

Figure 17: Overtopping Induced Seawall Failure.

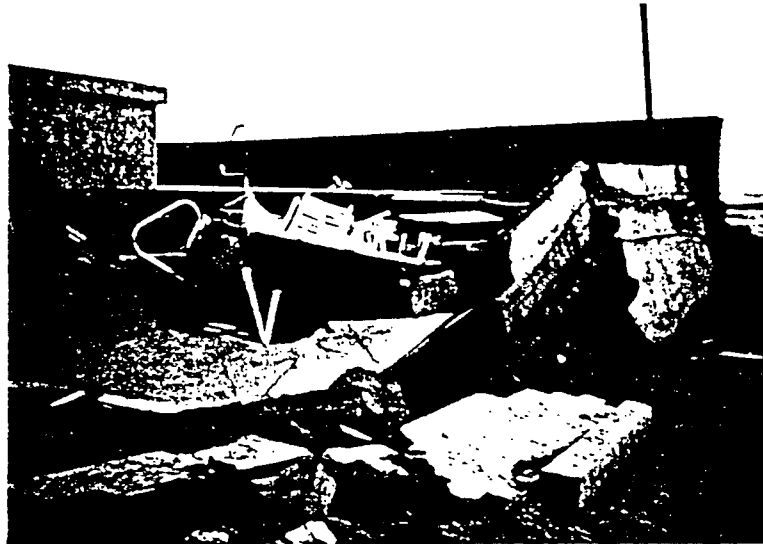
Figure 18: Underdesigned Return Wall Was Common Occurrences.

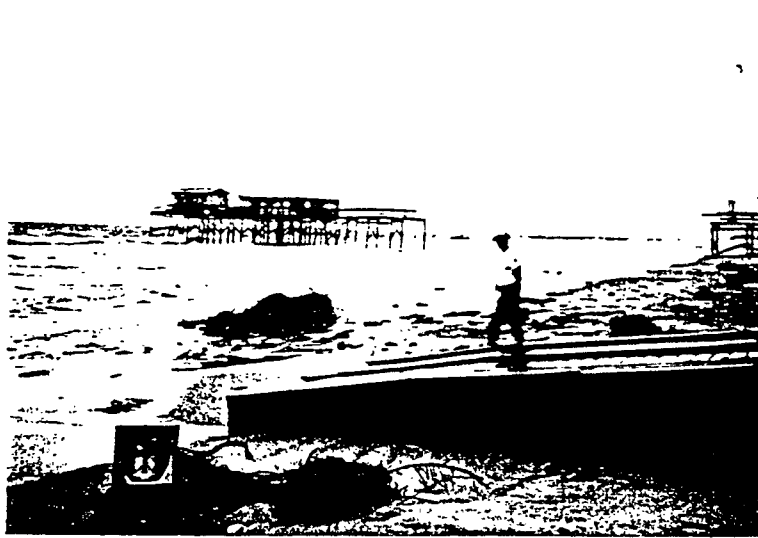
3. Piers: Practically all the piers along this coast sustained severe damage, if not totally destroyed. The few surviving ones had their mid sections across the surf zone missing (Figure 19), which seemed to indicate where the most destructive water force had occurred. These piers, though, might not have savage value.

Figure 19: Piers With Mid-Section Missing Revealed the Location of Maximum Dynamic Force to be in Surf Zone.

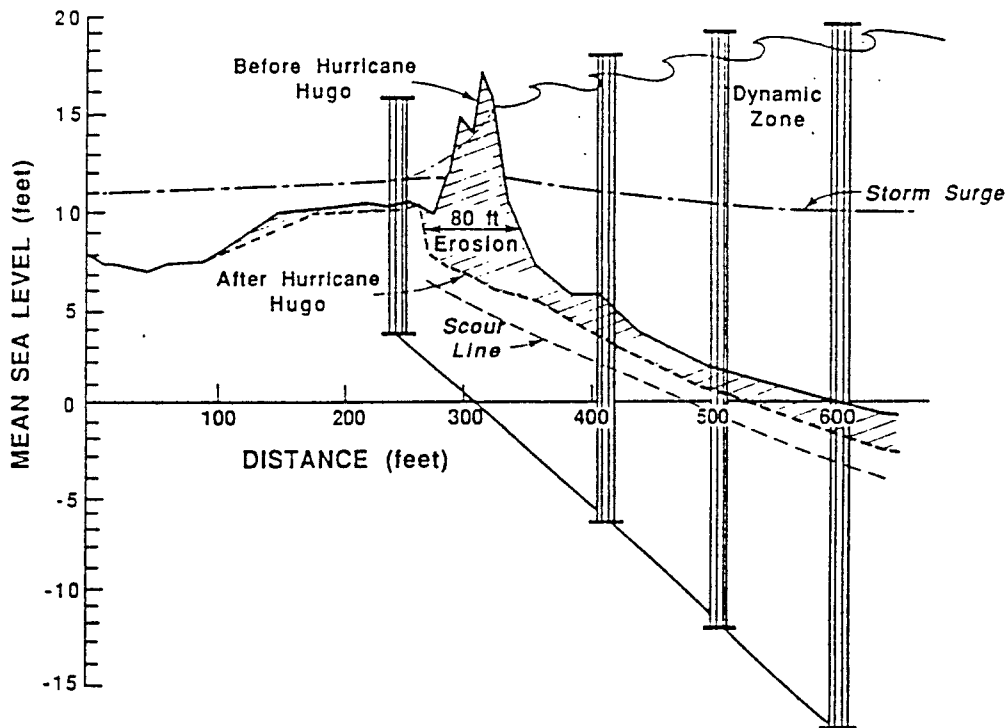
Figure 20: Sketch Shows the Beneficial Effect of Setback on Structural Foundation.

Structures built on open coast should be designed to avoid water force rather than resisting it. Deep pile is the only structural element that could be used, within reasonable cost, to resist hurricane induced water force. Other structural elements, if have to be exposed in this water force zone, should be designed to break away under loading. Structural set back is important for a number of reasons; it reduces the cost of construction; it reduces the vulnerability of being exposed to dynamic water forces and it reduces damage. Figure illustrates the importance of elevation and setback. Clearly, the closer to the water line the higher the structure, the deeper the foundation and the stronger the foundation are required. Both the water crest line and the scouring line shown in Figure 20 should be respected in coastal construction.
