FLORIDA'S WEST COAST INLETS  
SHORELINE EFFECTS AND RECOMMENDED ACTION

December, 1987

Coastal and Oceanographic Engineering Department  
University of Florida  
Gainesville, Florida 32611

7. Author(s) R. G. Dean M. P. O'Brien				8. Performing Organization Report No. UFL/COEL-87-018	
9. Performing Organization Name and Address Coastal and Oceanographic Engineering Department University of Florida 336 Weil Hall Gainesville, FL 32611				10. Project/Task/Work Unit No.

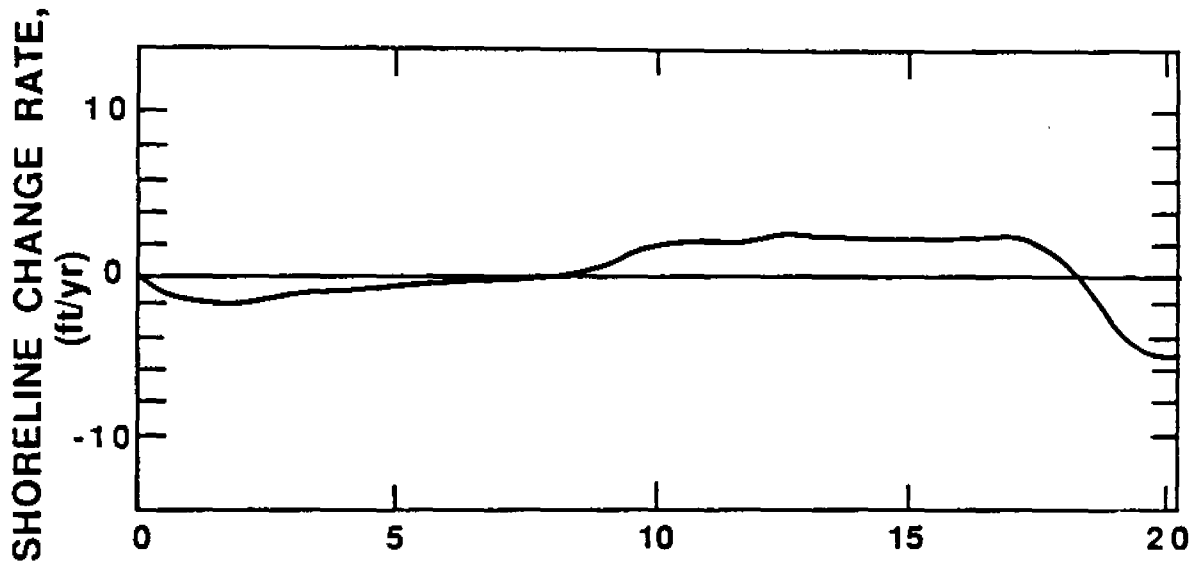
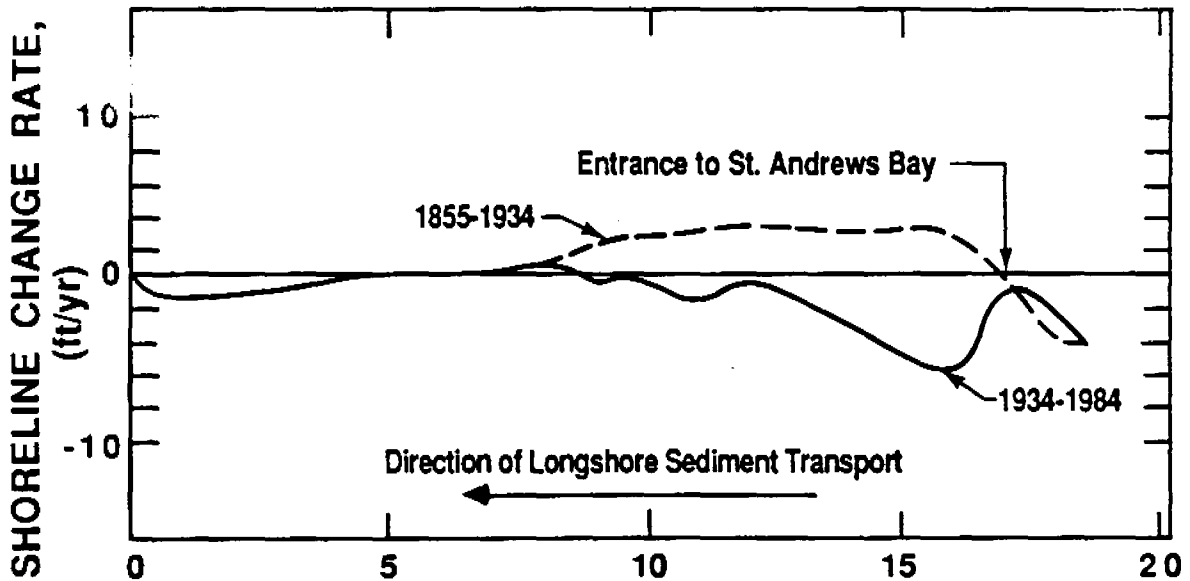
Figure 2. Effect of Cutting Entrance to St. Andrews Bay in 1934 on Downdrift Shoreline (Shoreline Change Results Provided by J. H. Balsillie).

This entrance is an example of very severe effects to the downdrift shoreline. Additionally the entrance is relatively young (constructed in 1934) and the shoreline impact has been documented rather completely.

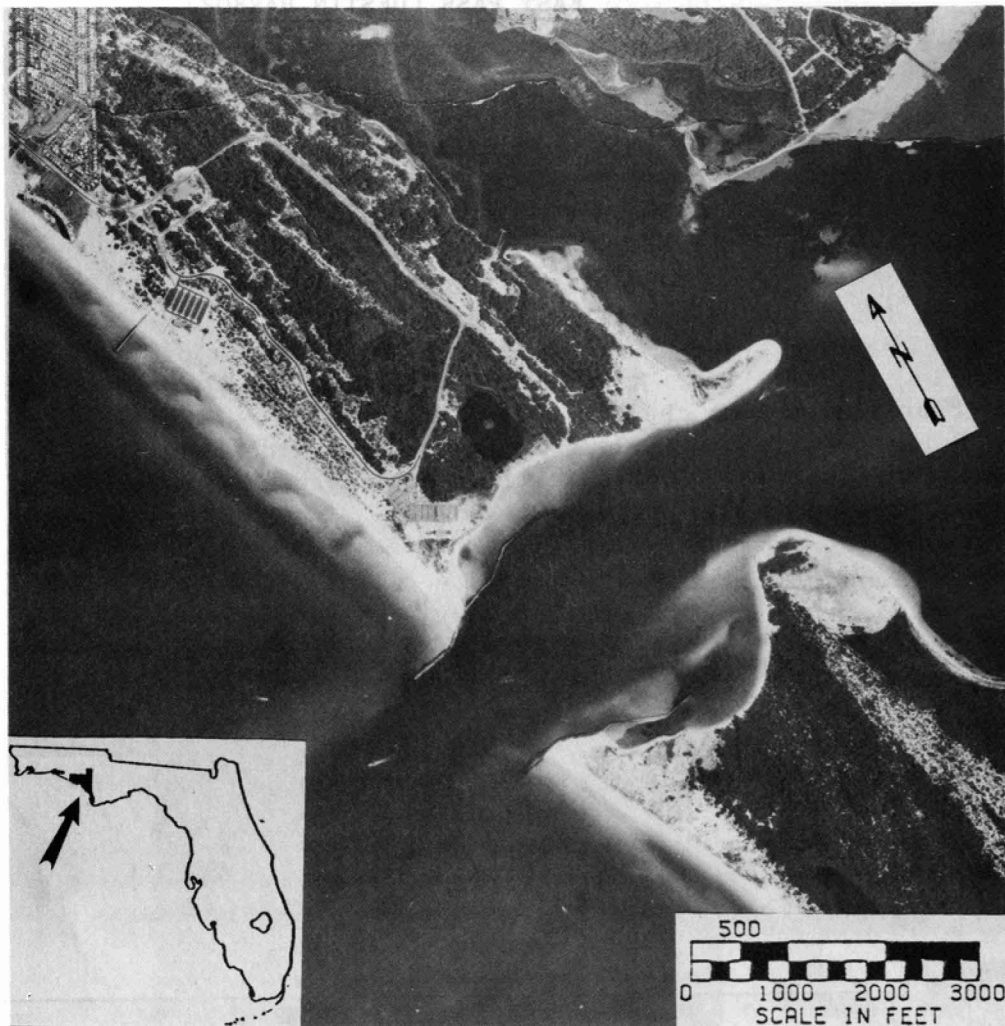
ST. ANDREWS BAY ENTRANCE CHANNEL (PANAMA CITY)

- This entrance has caused an erosion of the downdrift (west) shoreline of approximately 13 million cubic yards, extending some eleven miles to the west.
- Starting in 1972, some of the maintenance dredging has been placed on the downdrift shoreline. In the period 1976-1986, 128,000 cubic yards per year was dredged and all was placed on the beach.
- The available information suggests that the jetties at this entrance may be quite permeable allowing sand to enter the channel at rates greater than the net longshore sediment transport.

- Evaluate whether the permeability of the jetties is detrimental to the stability of the adjacent beaches. If so, sand tighten jetties.
- Continue to place all maintenance dredging on the downdrift shoreline. The placement area should serve as a feeder beach to the downdrift shoreline.
- To partially compensate for the net loss of approximately 13 million cubic yards since inlet construction, develop plans to place at least 7 million cubic yards of sand at selected locations within the downdrift segment of approximately seven miles.

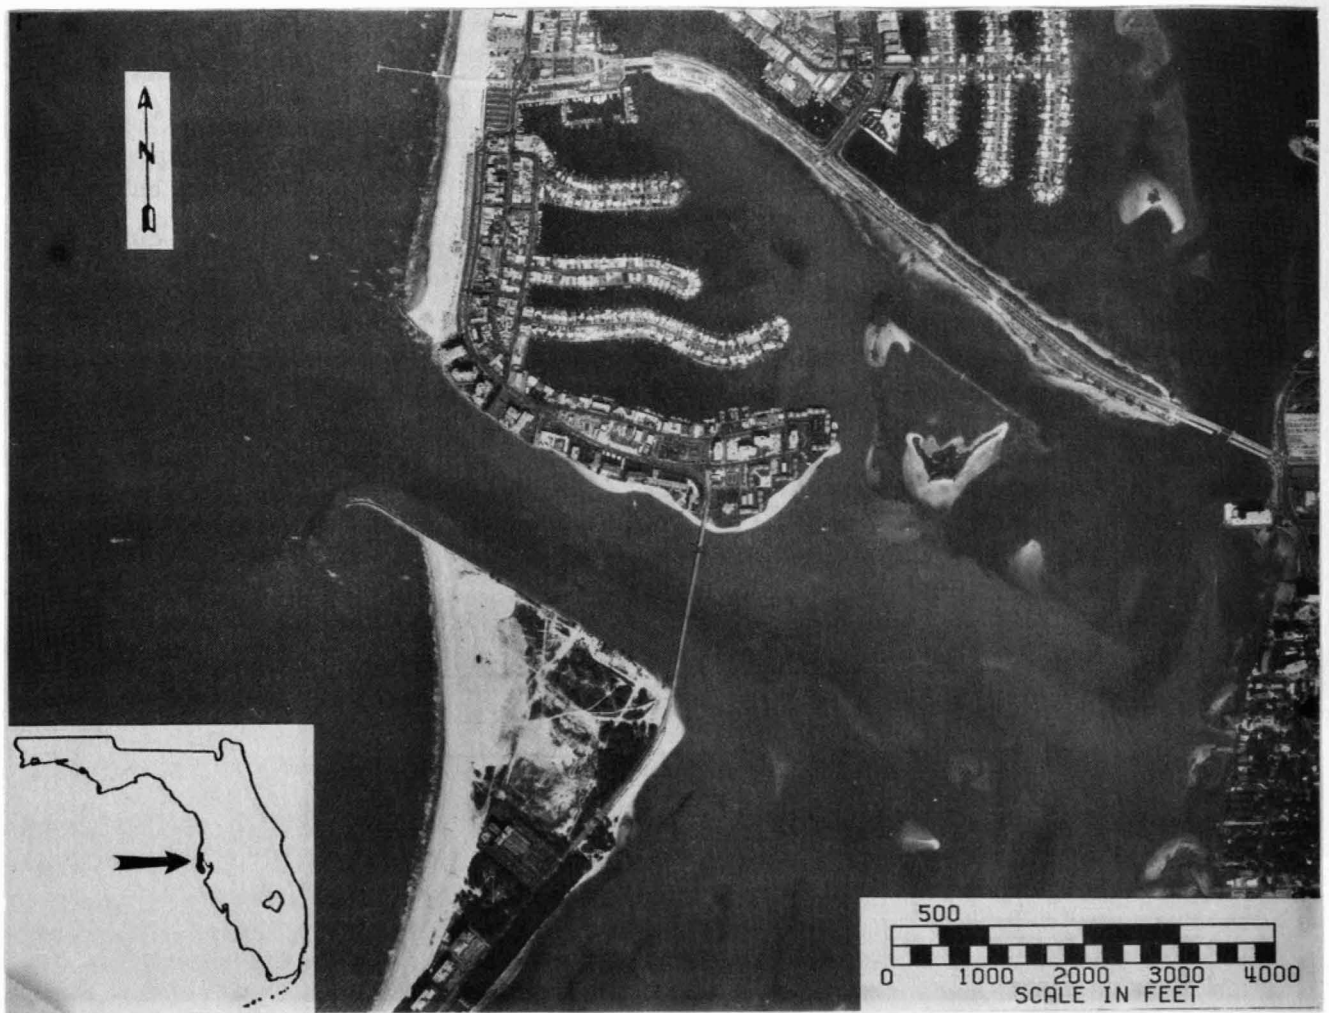
## CLEARWATER PASS

Causeways may have altered the effective tidal prism and the sedimentary regime

- Continue placing dredged sand on the beach to the north and to eroding areas on Sand Key to the South.

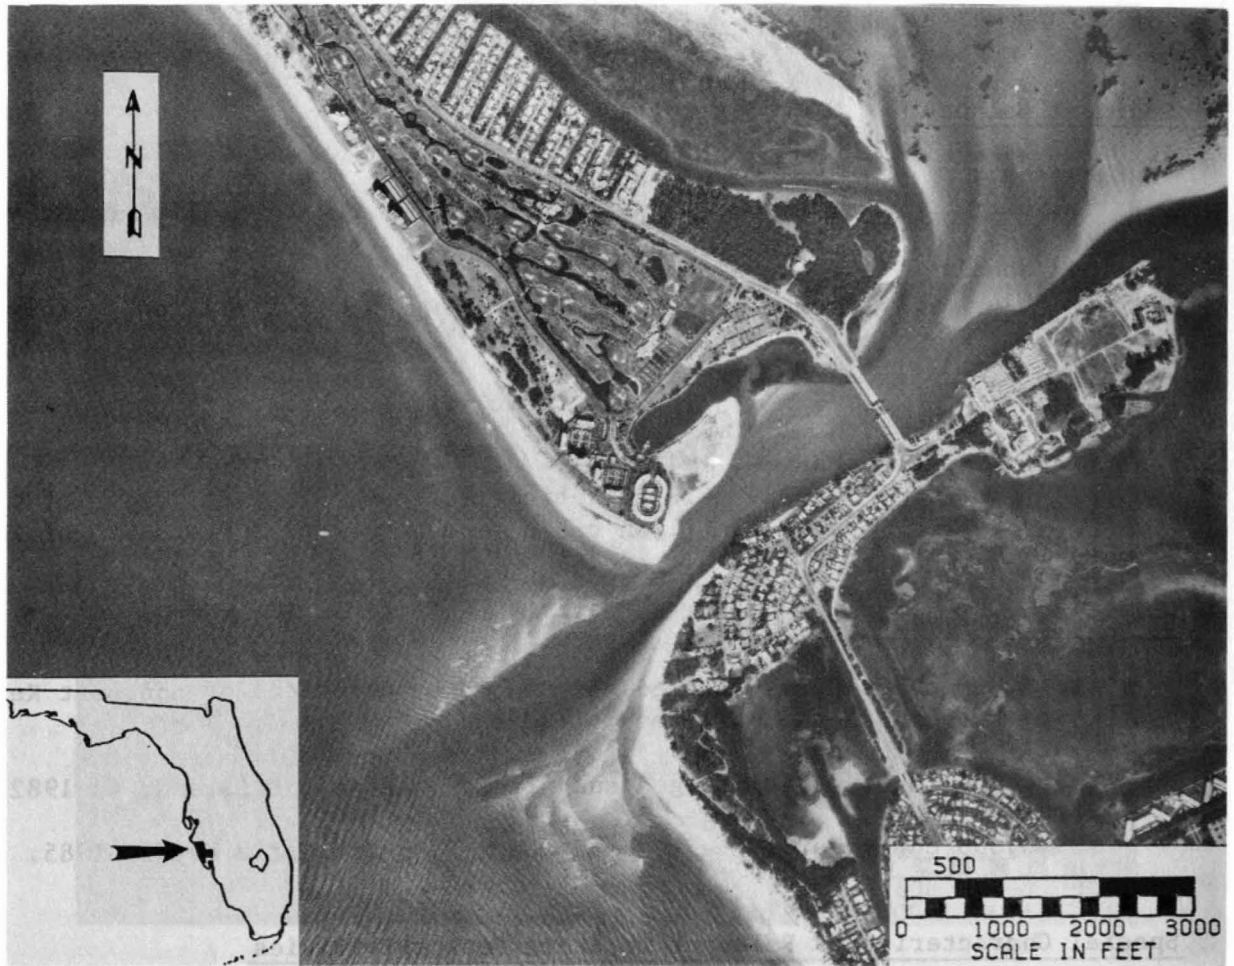
NEW PASS (SARASOTA)

- The placement of sand on Longboat Key in 1982 in combination with a relocation of the outer end of the channel by 300 feet southward appear to have caused severe erosion of the south bank of New Pass.

- Continue practice of placing dredged material on the south beach.
- Develop a plan for placement of dredged material that will enhance stability of channel and adjacent beaches.

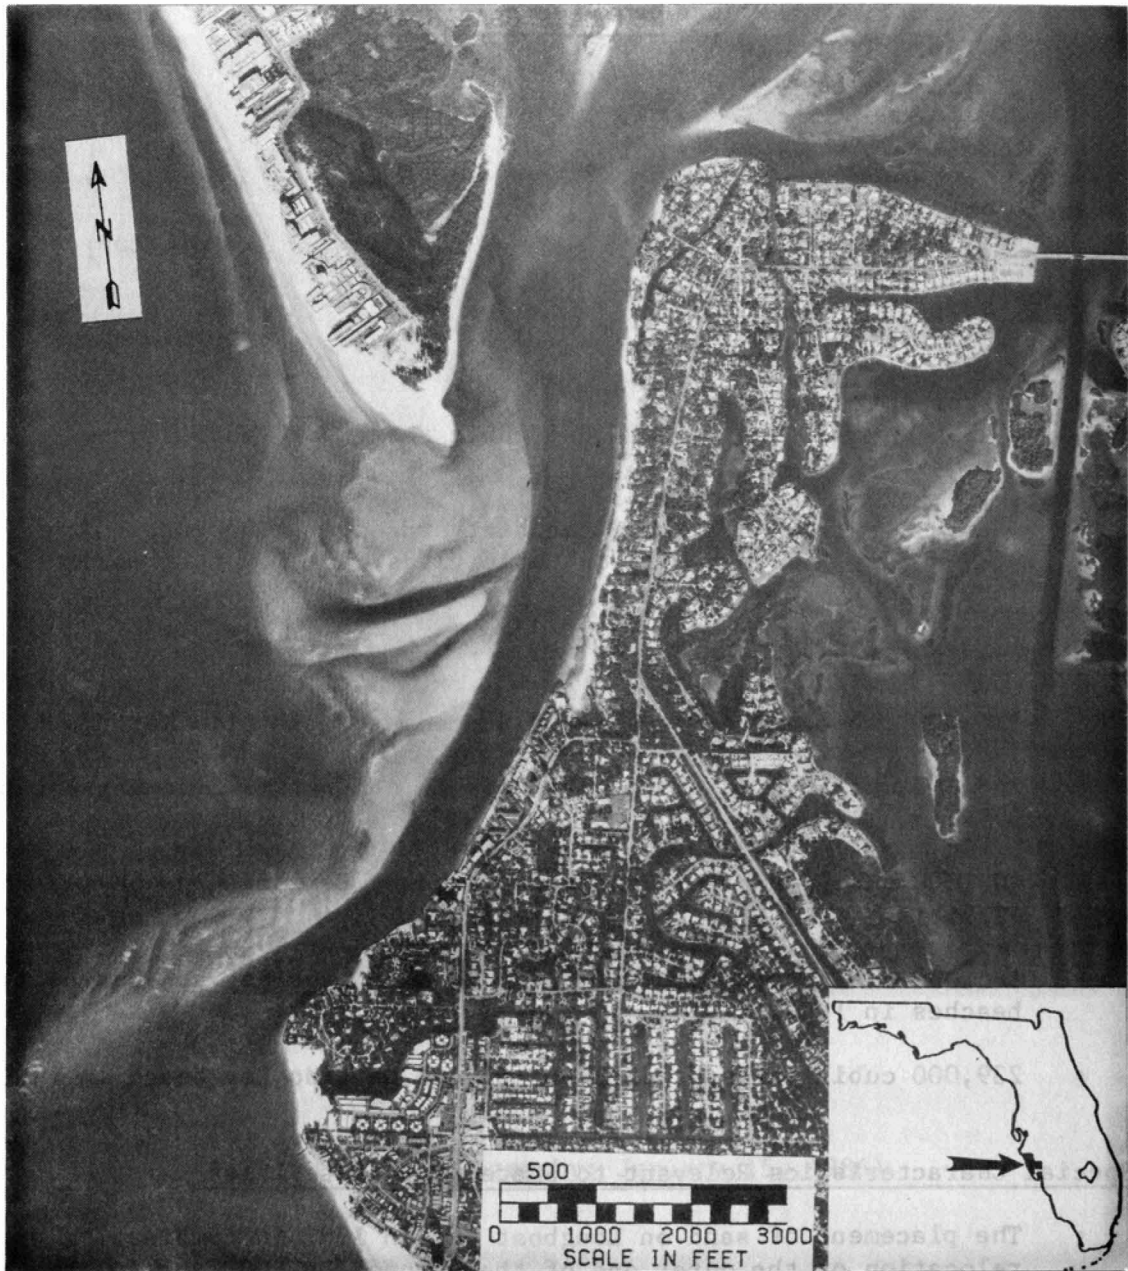
BIG SARASOTA PASS

- Sand transport southward has caused a large shoal to grow from Lido Key toward Siesta Key. This shoal has resulted in a deep channel adjacent to and an erosional tendency on the north end of Siesta Key.

- Monitor adjacent beaches by surveys. If pass is dredged, place material on Siesta Key.

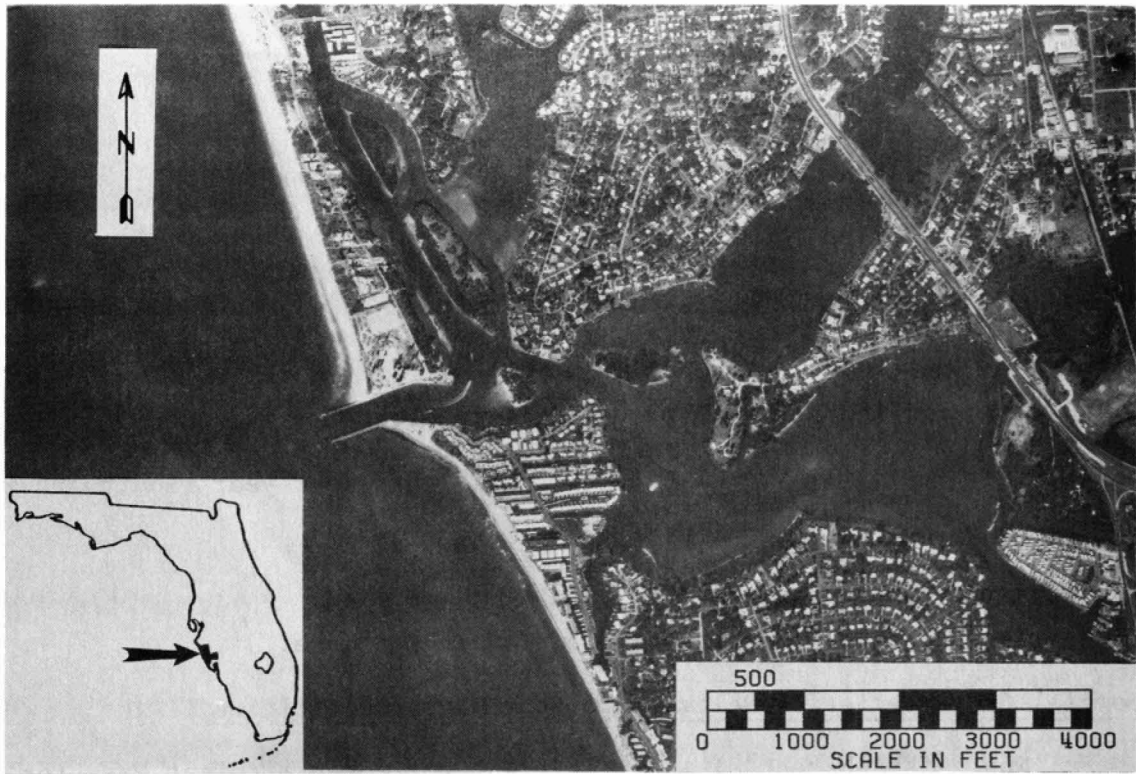
## VENICE INLET

Commencing about one-half mile south, the inlet has caused severe erosion.

- Venice Inlet has caused severe erosion to the beaches to the south. A road has been abandoned and portions of a sewage treatment facility are jeopardized.

- Monitor adjacent beaches in surveys.
- Develop a concerted effort to implement some sand transfer at Venice Inlet.
