A Method for Siting and Prioritizing the Removal of Derelict Vessels in Florida Coastal Waters:

Test Applications in the Florida Keys

Cover Photograph: Fishing vessel, half submerged, partially broken-up, obstructing navigation, threatening environment and health, and polluting Key Colony Beach.

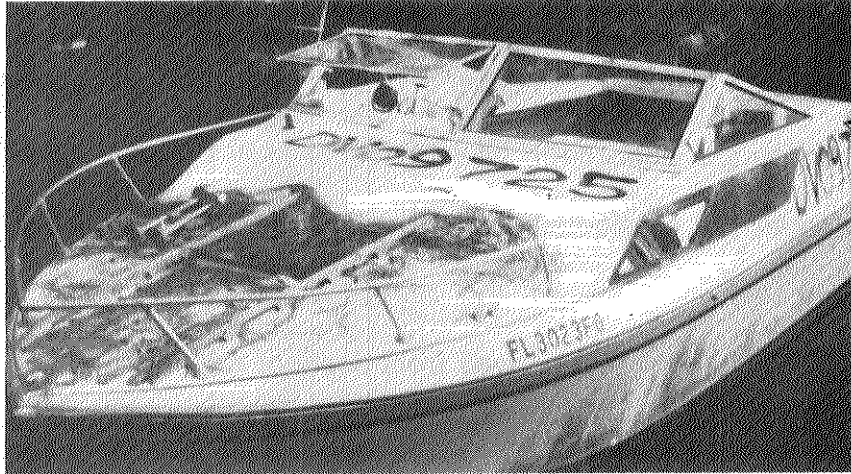
Photo 1. Recreation power DV, intact, obstructing navigable canal, considered health hazard since children may be injured playing on vessel, at Big Pine Key bayside.

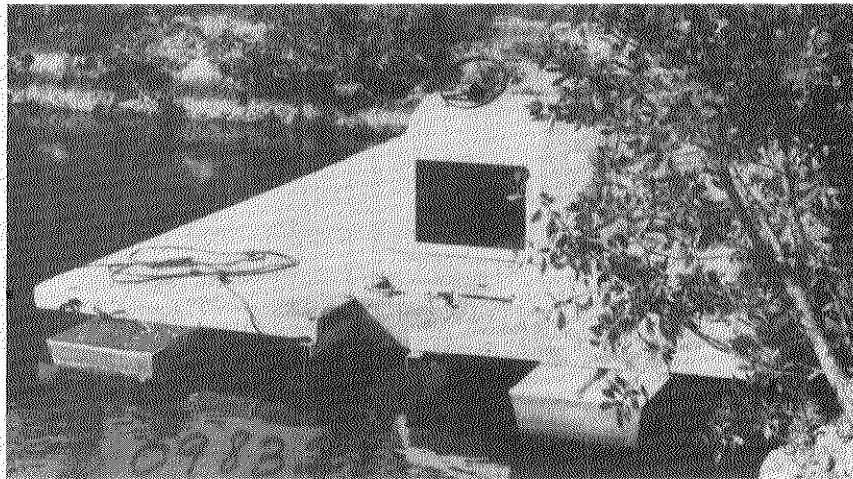
Photo 2. Float DV, intact, afloat, used as dock which may result in injuries, at Big Pine Key bayside.

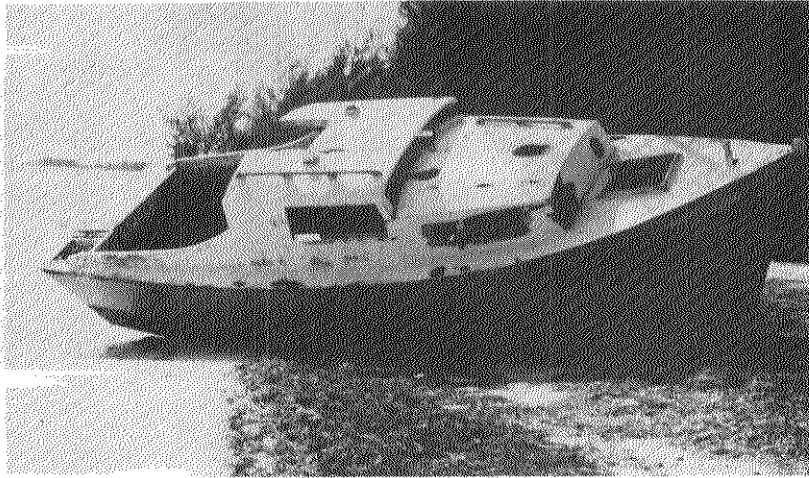
Photo 3. Sail DV, wood, beached, partially broken-up, at Coco Plum Beach.

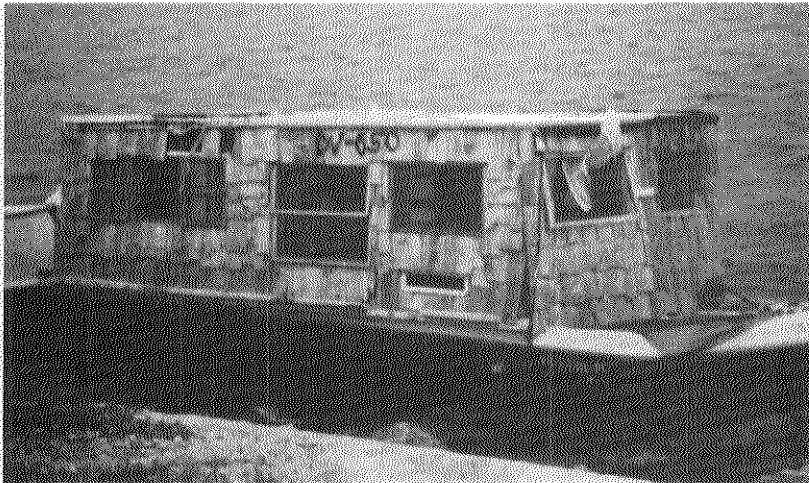
Photo 4. Houseboat DV, intact, accessible by land, creating flotsam, polluter, at Conch Keys bayside.

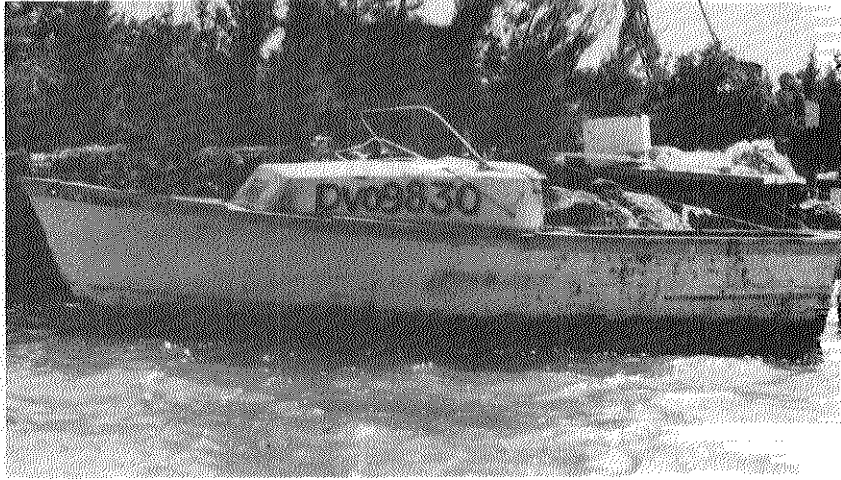
Photo 5. Fishing DV, afloat, navigation threat as may break adrift in channel, at Marathon bayside.

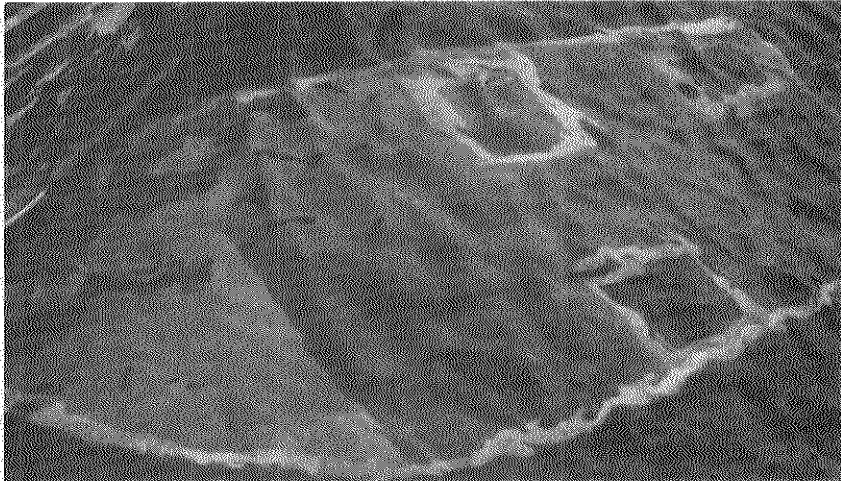
Photo 6. Completely submerged DV, 16' length, fiberglass, at Boot Key Harbor.

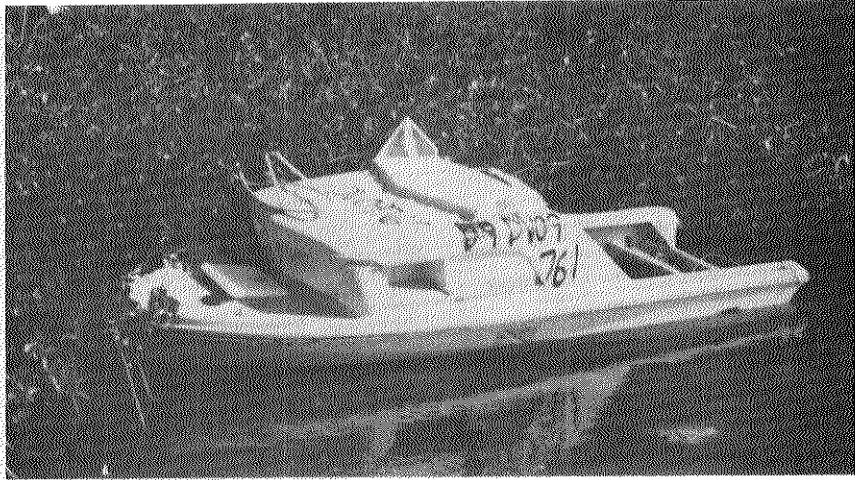
Photo 7. Fishing DV, on bay bottom damaging mangroves, threat to environment, at Sugarloaf Key oceanside.

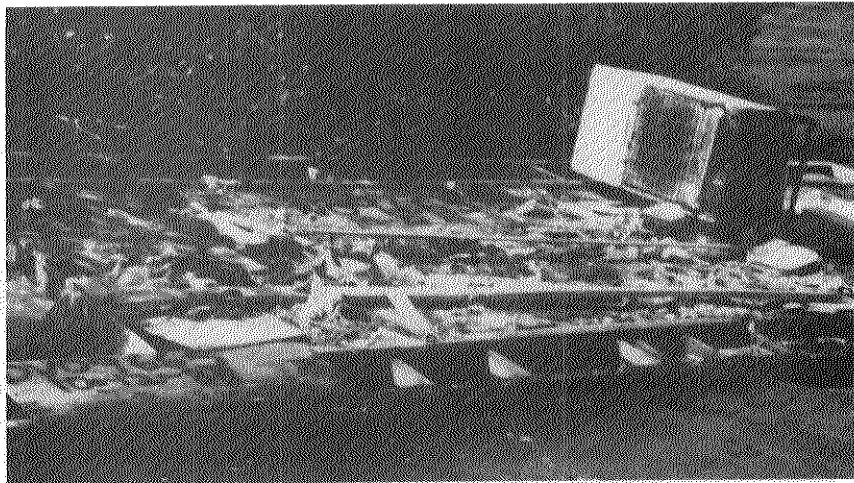
Photo 8. Barge DV, beached, polluter, potential threat to environment, at Islamorada bayside.

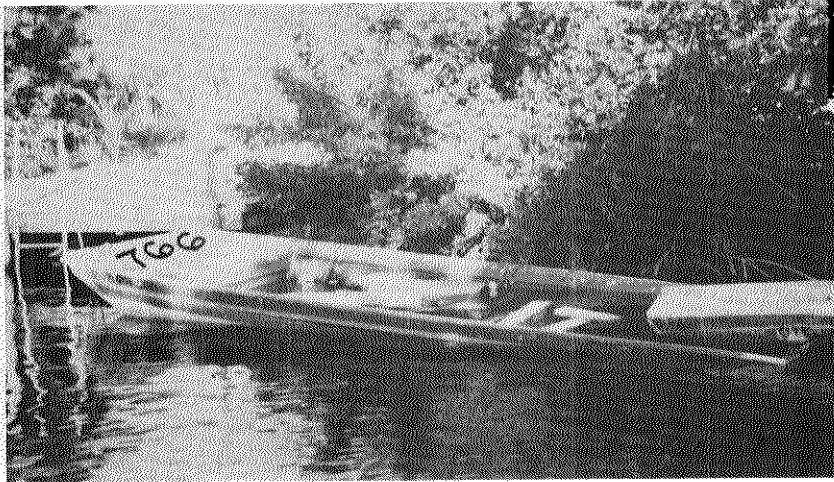
Photo 9. Fishing DV, afloat, aluminum shards constitute health hazard, canal obstruction creates navigation threat, at Little Torch Key bayside.

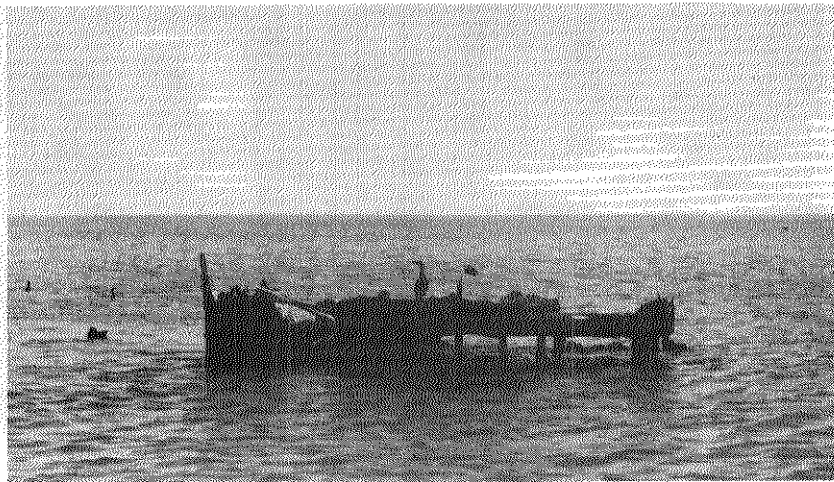
Photo 10. Steel DV, wrecked, at Boot Key Harbor.
