M/V CONNECTED
Coral Reef Restoration Monitoring Report
Monitoring Events 2004-2005
Florida Keys National Marine Sanctuary
Monroe County, Florida

December 2006

Joe Schittone
Erik C. Franklin
J. Harold Hudson
Jeff Anderson

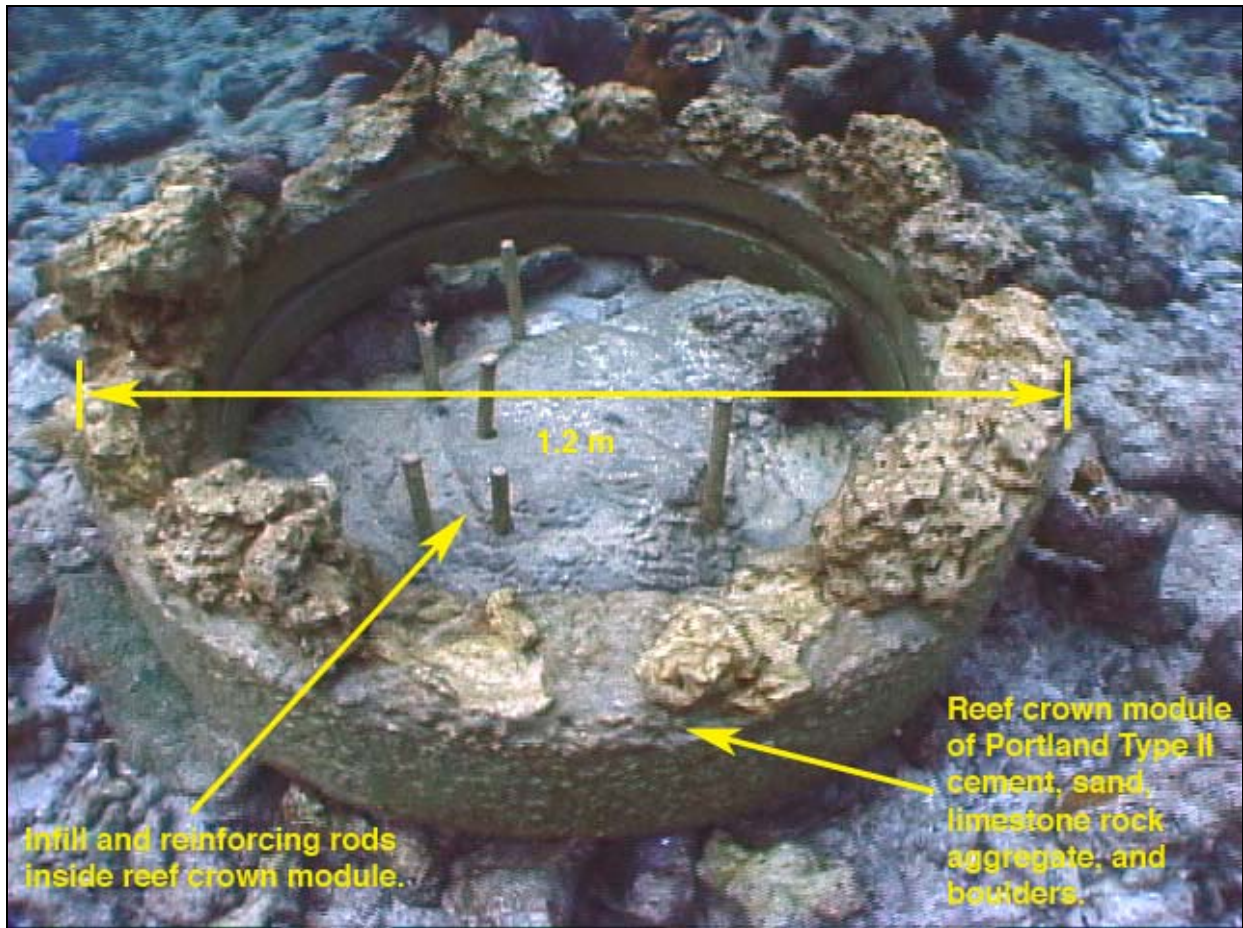
Figure 6. A “king crown” restoration module installed on seafloor prior to addition of coral fragments to center of the module.
