A SIMULATION STUDY OF SLOPE STABILITY AFFECTED BY CONSTRUCTION OF NEW BUILDINGS AT UNIVERSITI TEKNOLOGI MALAYSIA, SKUDAI.

Abstract: Landslide occurrences had caused failure of sheet pile wall located about 6 m from Bangunan Tambahan, Fakulti Kejuruteraan Mekanikal (FKM), Universiti Teknologi Malaysia in Skudai, Johor. With the aim of investigating cause(s) of the failure, the slope stability conditions prior and after construction were simulated using SLOPE/W Version 3.03. The results showed that effects of load of a newly filled water tank sited on the top of slope contributed to subsident of the slope surface within the vicinity by creating tension cracks near its raft footing. The slope became more unstable as the soil moisture or pore-water pressure increased due to infiltration of rainwater. This has reduced the shear strength, in particular the cohesion value, c . The simulation also confirmed the hypothesis that the global soil mass movement started from the hill top where the water tank was located toward the installed sheet pile. The combined mobilized shear force and lateral pressure of the global slope was about 8 times the strength of the sheet pile. The associated str

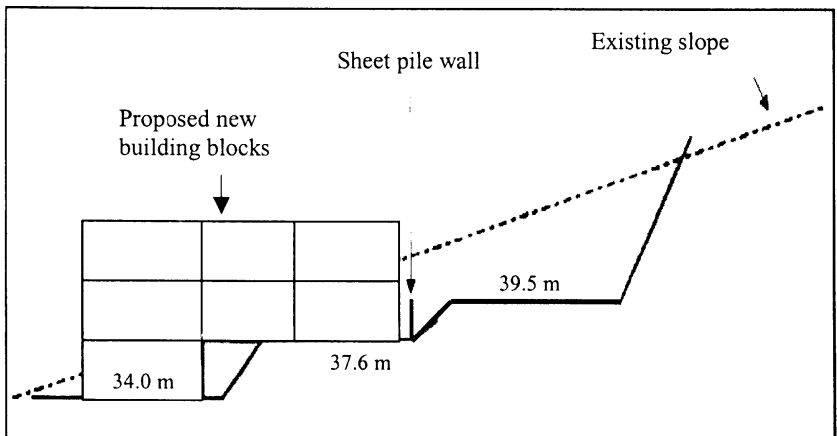
By June 2000, the tension cracks and slope movement had reached more than 250 m beyond the boundary of the proposed site and approached the existing water supply tank (at elevation of about 90 m). In an attempt to counter the slope instability or soil movement down the slope towards the proposed buildings, a row of sheet piles were installed at the toe of the slope between platforms at 37.6 m and 39.5 m (Figure 1). However, after three quarter of the piles had been installed, lateral movement of the piles was observed. The downhill force of global soil mass was so big that caused the pile wall shifted towards the road with end of pile as a center of tilt.

Figure 1: Installation of sheet piles between platforms at 37.6 m and 39.5 m.

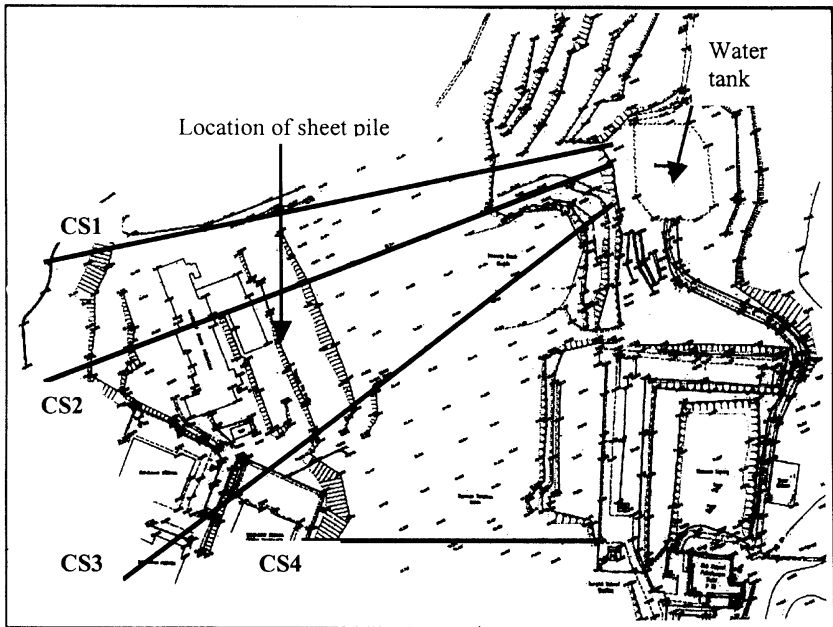
Figure 2: Layout of cross sections CS1, CS2, CS3 and CS4.

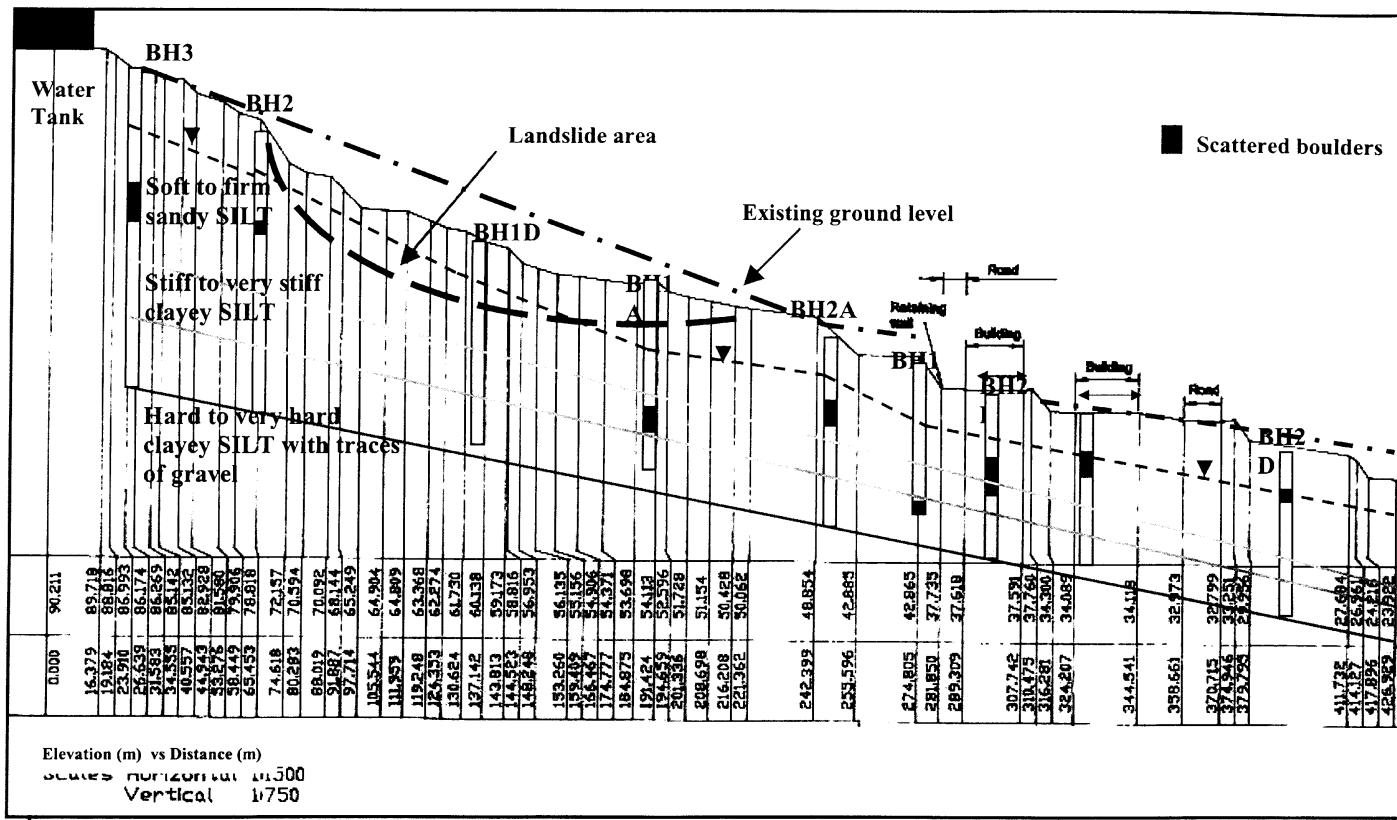
Figure 3 shows the general geotechnical profile interpreted from the site investigation carried out earlier (Kassim, 2002). Based on available report (Universiti Teknologi Malaysia, 2001) on the landslide occurrence between 1999 and 2001, the summary of the simulation inputs for four cross sections are shown in Tables 1 and 2.

Figure 3: Cross sectional topography and geotechnical properties at the landslide area.
