SYSTEMATIC INVESTIGATION OF FAILURE ANALYSIS ON  
A STEAM TRAP BYPASS TUBE IN A  
COALFIRED POWER PLANT

A project report submitted in partial fulfillment of the requirements for the award of  
Masters Degree in Mechanical Engineering

Faculty of Mechanical and Manufacturing  
Tun Hussein Onn University of Malaysia

NOVEMBER 2007

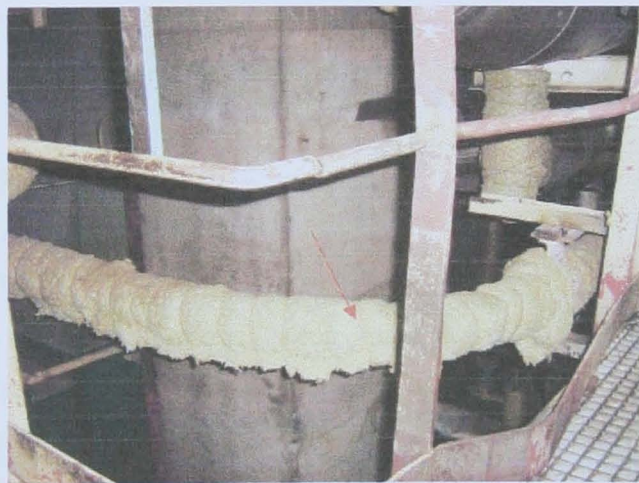
**Figure 1.1:** Insulated steam trap bypass tube in actual process.
