FAILURE MODE FROM BACK ANALYSIS OF DEFORMED CANTILEVER SHEET PILE WALL

Abstract: The soil mass movement on failed slope had substantially deformed a sheet pile wall positioned at 6m from the new laboratory of Faculty of Mechanical Engineering (FKM Lab), Universiti Teknologi Malaysia, Skudai, Johor. To facilitate investigating the causes of the wall deformation, a computer modeling of slope stability is applied to simulate slope conditions before and after construction of the study area. The results of simulation analysis establish the fact that global soil mass movement started from the elevation of the newly filled water tank to downhill direction towards the installed sheet pile. Consequently, the mass movement generates a combination of mobilized shear force and lateral pressure larger than strength capacity of the sheet pile. In addition, the finite element analysis shows that the sheet pile might successfully intercept the slip plane of failure slope but the wall moves significantly forward because of inadequate passive resistance and required minimum penetration depth in order to achieve stability.

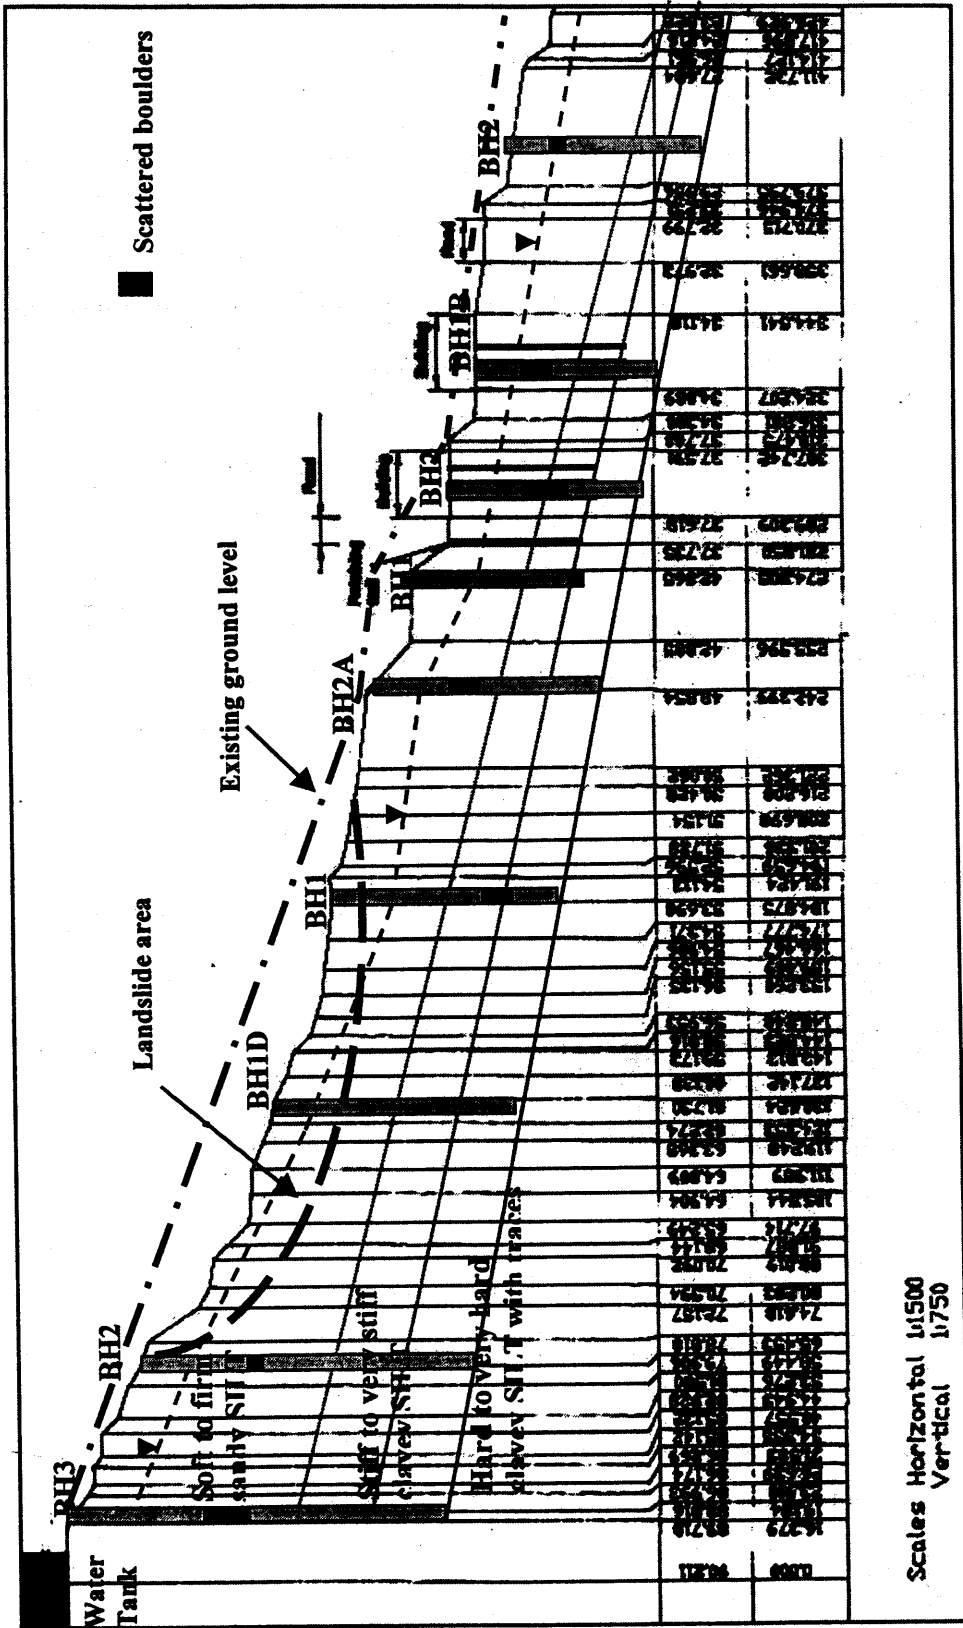
Figure 2: Cross sectional topography and geotechnical properties at the landslide area (after Kassim, 2002)

An additional remote possibility that the sheet pile could have bulged during the driving since the pile might have encountered bedrock stratum as shown in **Figure 2**. **Figure 2** shows granite or very hard layer ($N > 50$) was encountered at depth of 9m to 20m which required the minimum wall modulus of $3000\text{cm}^3/\text{m}$ ($N > 50$) of sheet pile to be driven in ground that exceeding the wall modulus of Section ESC-B8, Grade S275.

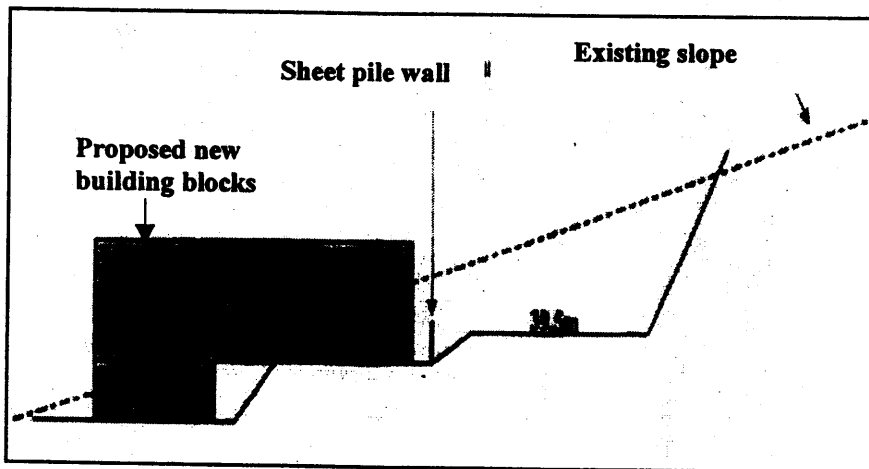
Figure 3: Installation of sheet piles at the toe of the slope between platforms at 37.6m and 39.5m.

Heaving at platform level of 39.5m has extended to platform 37.6m after the completion of the piling works of new building at platform level of 34.0m. Tension cracks have now reached more than 250m beyond the site boundary and earth subsided to about 3.0m closing to the existing water supply reservoir. In an attempt to counter the

slope instability or soil movement down the slope towards the proposed new FKM Lab., sheet piles were installed at the toe of the slope between platforms at 36m and 39.5m. However, after three quarter of piles had been installed, lateral movement of the piles was noticed and it indicates movement of the soil mass has yet to stabilize and give concerned over the overall stability and safety of the building structure and also the reservoir.

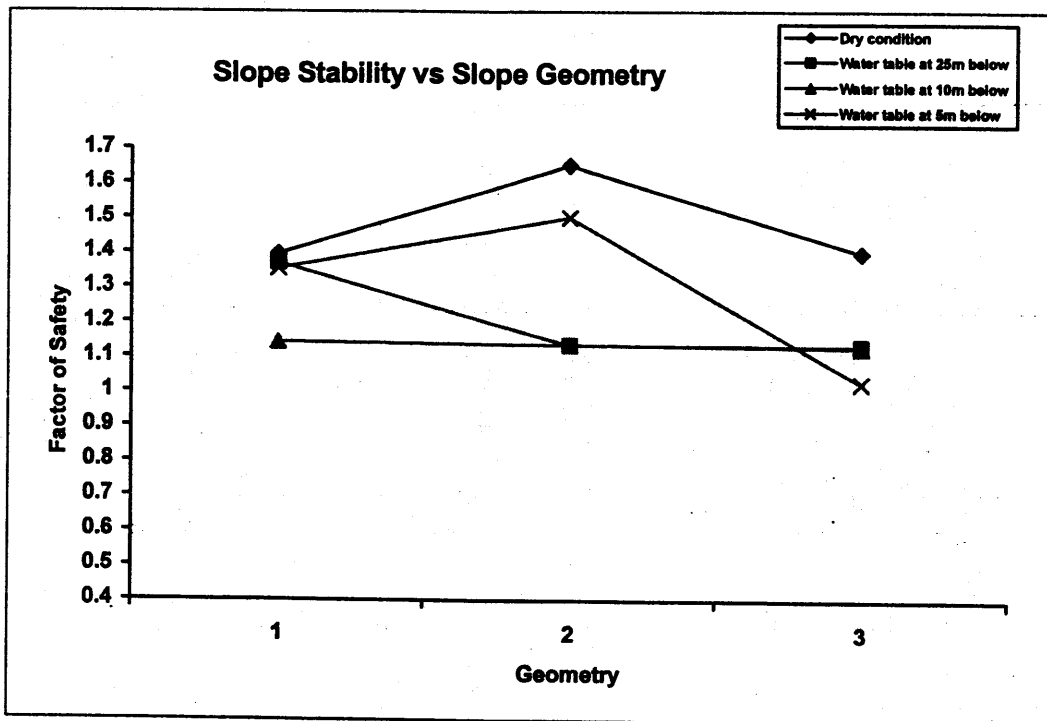
Figure 6: Slope stability for various conditions

The analysis of the slope shows locations of the critical failure plane on slope depending on the geometry and situation being analyzed. The significant changes of critical slip surface are experienced for the original/natural slope, and the slope after cut to platform level. Initially, the location of the failure plane emerges at the toe of the slope which is near river at x-elevation of 400m to 460m. However, after the slope is cut to platform level, the failure plane is shifted towards the crest (at x-elevation of 10 to 100m) of the slope adjacent to the newly filled water tank.

Generally, the slip surfaces go deeper with the increase of groundwater table. Initially, the slip surfaces are considered shallow and parallel to the slope surface, but do not go beyond the vicinity of soil layer 1. However, the mode of failure changes to circular rotational slides as the groundwater table increases, particularly when groundwater table is assumed 5m below ground level. The results show that the stability of the cut slopes is directly governed by the existence of water. This observation is generally accepted as landslides on hill-site in Malaysia are always triggered by water.

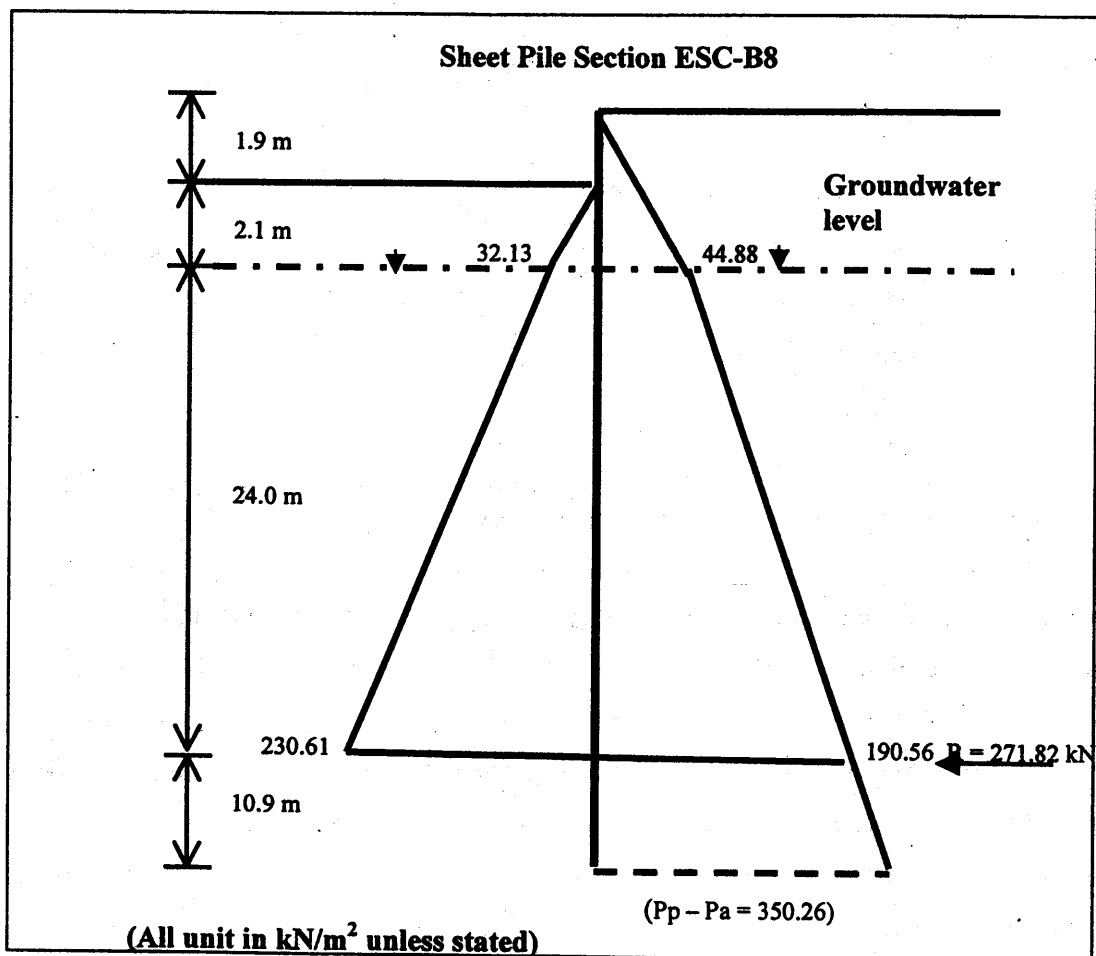
Figure 7: Analyzed pressure distribution at depth of penetration, D'

Figure 7 shows the results of the analyzed pressure distribution of the cantilever sheet pile wall. In summary, the depth of embedded, D_e is found to be 37 m and minimum

depth of penetration, $D' = 26.1$ m with net passive resistance value, $R = 271.82$ kN. The net total pressure, shear and moment calculated from pressure distribution diagrams in Figure 7 yield the magnitude of maximum moment = 430.25 kNm. The allowable section modulus is found to be $1,564 \text{ cm}^3/\text{m}$ which it is not exceeding $2,518 \text{ cm}^3/\text{m}$ of section modulus of driven sheet pile on site. The results confirm that the developed pressures do not exceed the section properties. A conclusion can be derived from the analysis is that the sheet pile can be considered a good and safe material to perform as a retaining structure if it is driven at minimum depth of penetration, $D' = 26.1$ m.

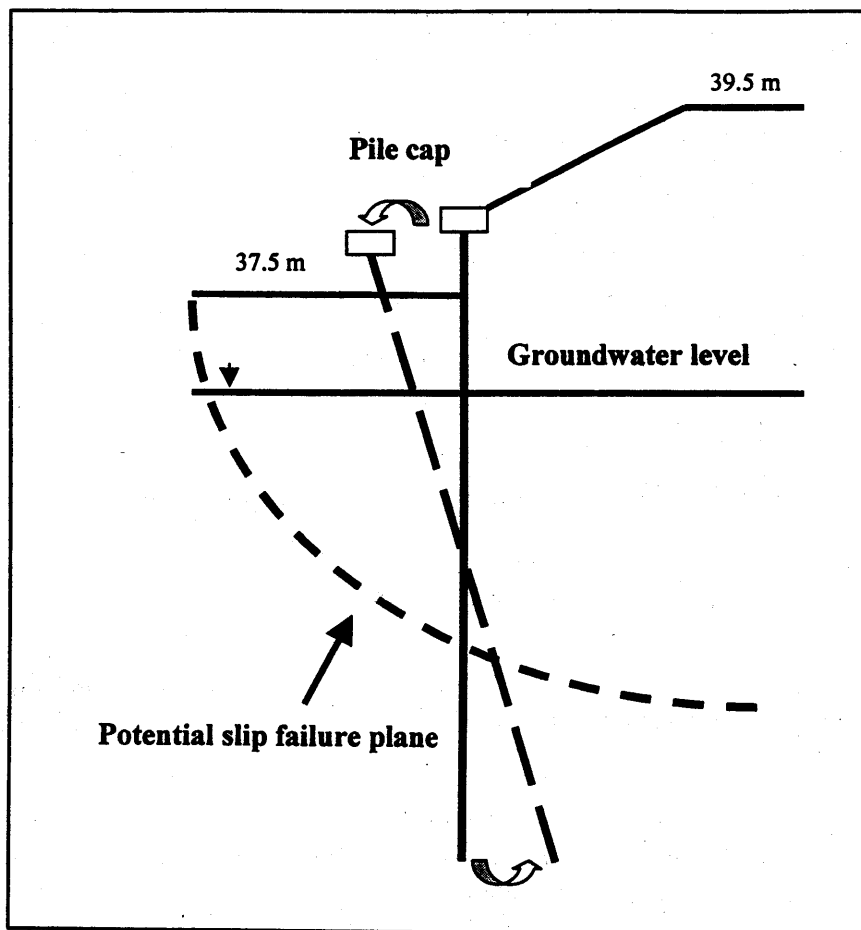
Figure 8: Probable mode of failure of the sheet pile wall

The results of the analysis of sheet pile establish the fact that though the sheet pile on site might successfully intercepted any potential slip plane of the failure slope, the minimum penetration depth, D' of 26.1 m however has never been achieved. The embedded pile of 18m depths on site is not sufficient to resist the forward movement due to insufficient of net passive resistance behind the pile. Although the sheet pile on site might successfully intercept the slip plane of failure slope, but the sheet pile wall on site has failed as it moved forward due to inadequate passive resistance at the bottom of sheet pile that required minimum penetration depth in order to achieve stability as illustrated in Figure 8.

Furthermore, non-uniform filling or non-uniform consolidation and ineffective drainage of the soil behind the wall may result in the line of capping becoming irregular and the sheet pile to bulge. It is recommended that ample penetration (e.g. at minimum penetration depth, D') and good drainage of the backfill are better investments than conservative design of sheet piles for bending stresses. If the pressures on sheet piles are

such that an excessively thick pile or the depth of required penetration is required, the provision of a tie at the level of capping beam can be used. With the provision of one or more ties or props, the required depth is reduced as is the lateral deflection and bending moment in the pile.
