Conservation: Training, Reports (1966-1973): Article 05

SHELDON KECK and ROBERT L. FELLER

Detection of an Epoxy-Resin Coating on a Seventeenth-Century Painting

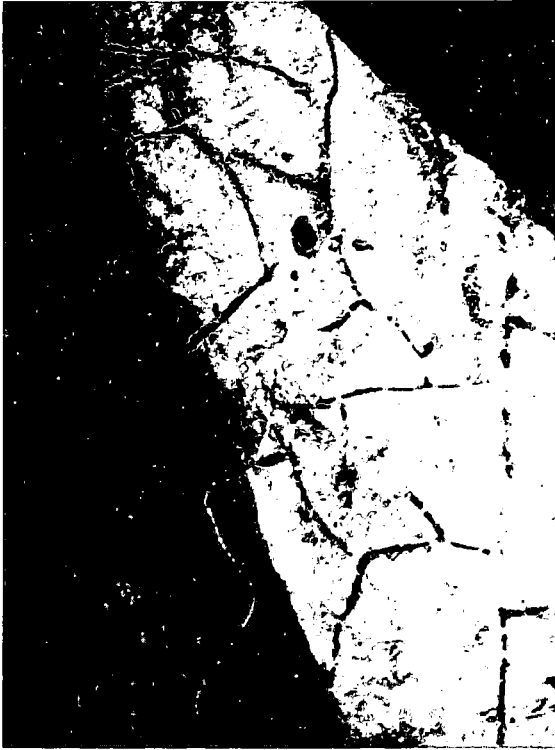
was not until the cracks on the surface were compared under low magnification with those in the radiograph that certain areas were found where the incised cracks did not precisely follow those in the painting beneath (Figs. 2A and B). (4) The original subject was probably extensively abraded, if one may judge from what was left of the unrepainted background. (5) A tough, insoluble protective coating had been placed over the repainting, apparently to prevent the readily-softened repaint from detection. On top of this coating had been placed a thin film of readily-soluble material.

FIG. 2A. *At left* photomicrograph $8\times$. Repaint with false cracks completely covers paint with a different crackle system as revealed by radiograph $8\times$ *at right*.

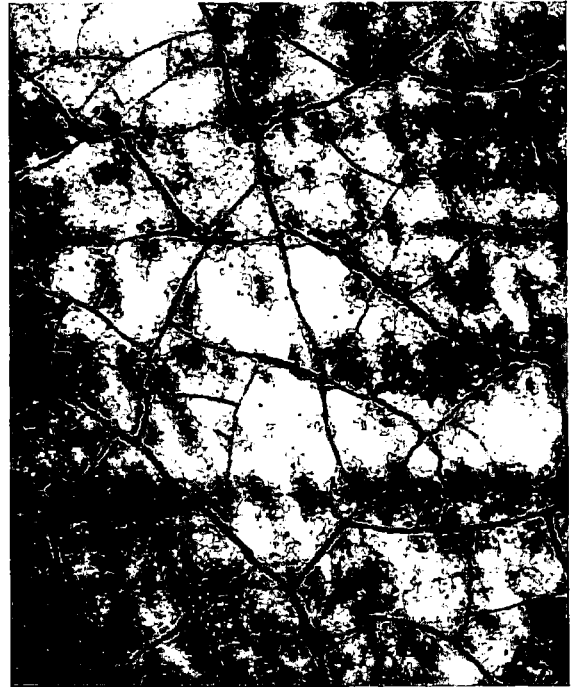
FIG. 2B. *At left* photomicrograph $8\times$. Another area of paint with radiograph of same area *at right*. Crackle in surface of painting corresponding closely to that in radiograph shows variations and reinforcements which do not quite match the cracks themselves. Note particularly changes in upper left.

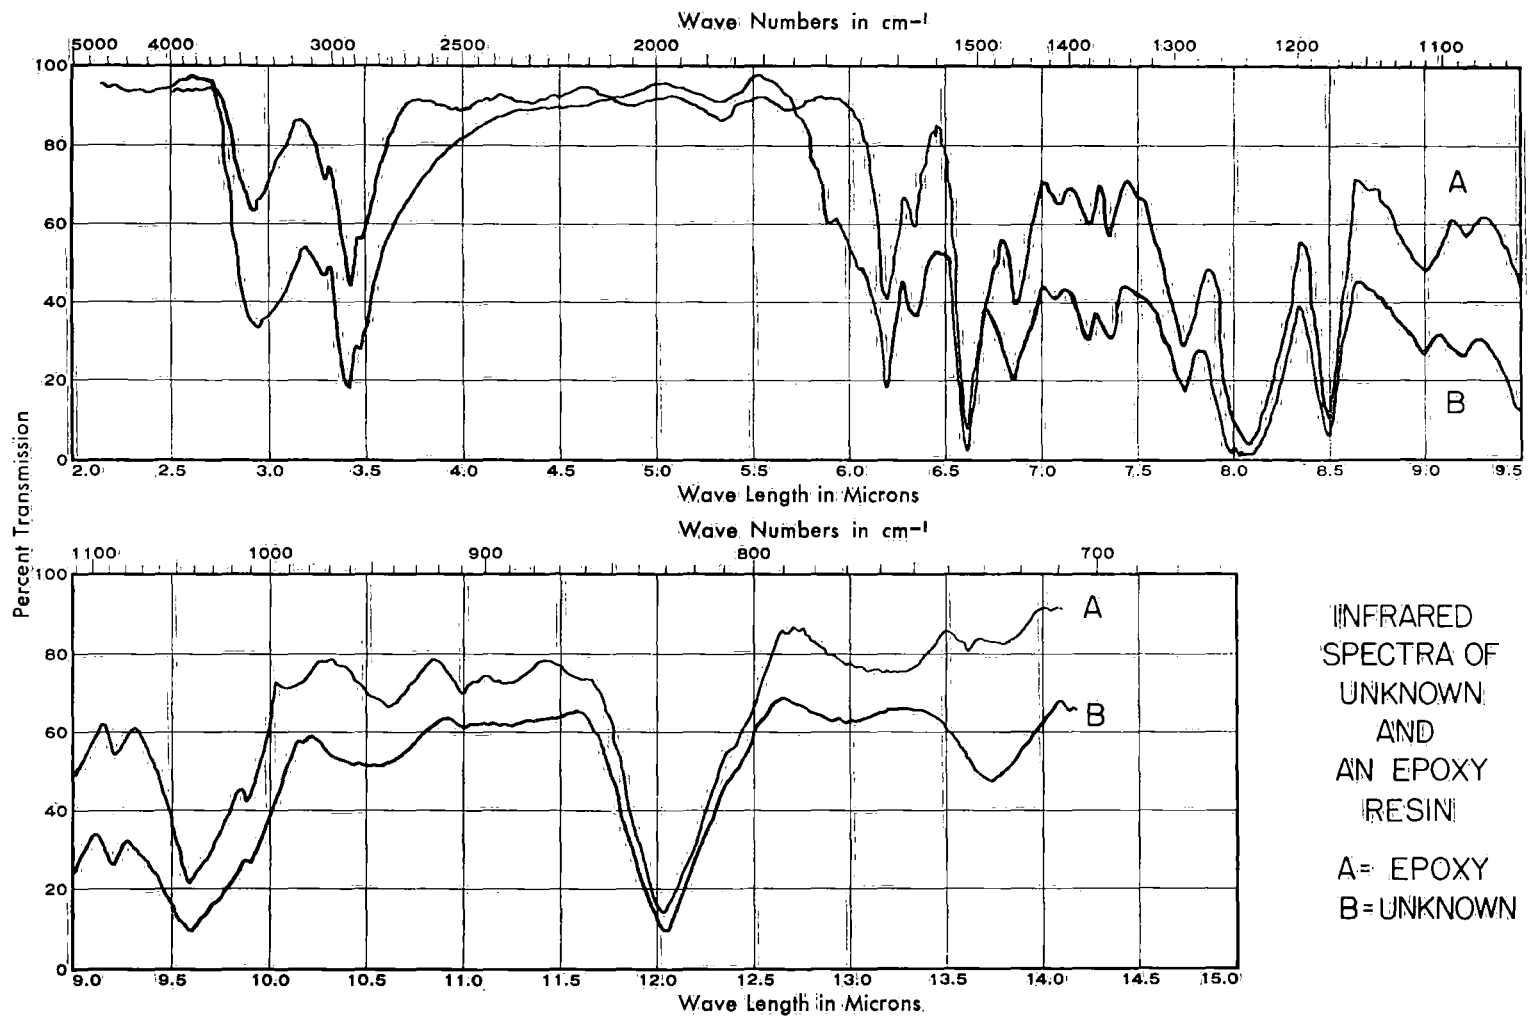
FIG. 3

A sample was prepared and analyzed by infrared spectroscopy. The resulting spectrum corresponded almost identically to spectra reported for high molecular-weight, bisphenol-type epoxy resins [2]. A comparison of the spectra of the unknown and an epoxy resin of this type is shown in Fig. 3 [3]. There is no doubt of the identity of the material. Its spectrum corresponds to that of the known in about twenty absorption bands, and the material itself gave a typical spot test for a bisphenol-type epoxy resin [4].

The only significant difference in the infrared spectra was in the appearance of absorption at 5.9 and 6.05 microns in the unknown. The absorption at 5.9 was thought to be due to carbonyl groups, perhaps in oil, dammar [5],

The absorption at 6.05 microns remained after the extraction. It is suspected this band was due to an imino or amide group arising from a curing agent in the polymer. The spectrum in this region most closely resembles that of an epoxy cured with a polyamide: Epon Curing Agent V-15 (Shell Chemical Company) [7].
