## Avary-Fulton House

# AVARY-FULTON HOUSE

## HISTORIC STRUCTURE REPORT

CLASS OF FALL 2015  
GEORGIA STATE UNIVERSITY  
CONSERVATION OF HISTORIC BUILDING MATERIALS

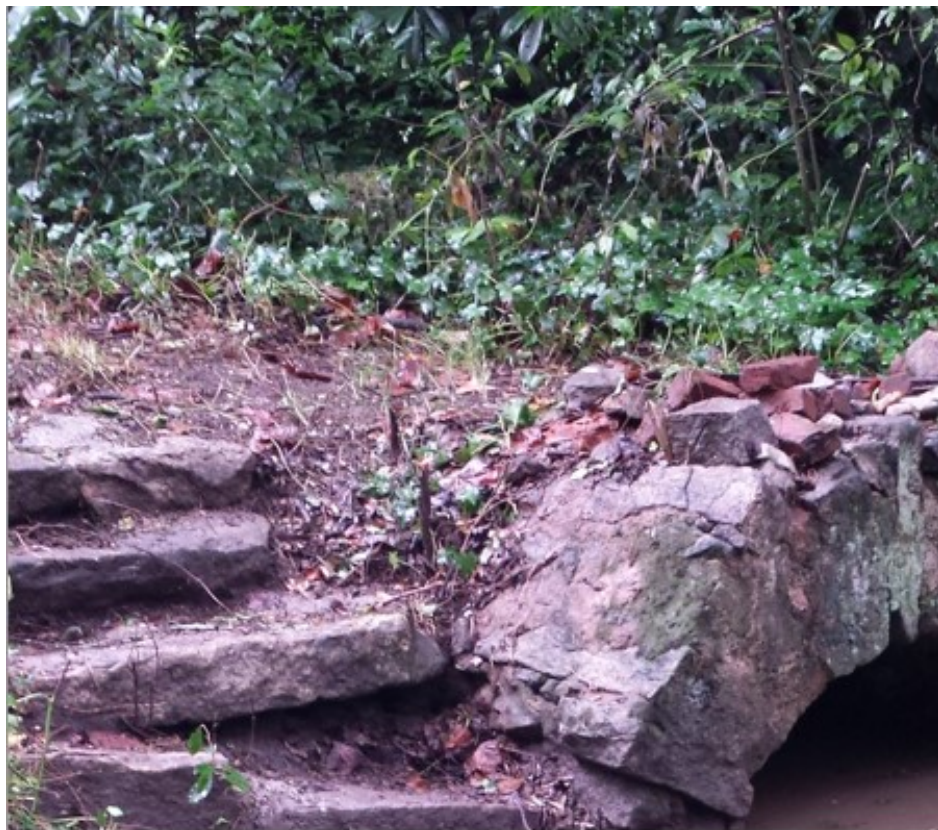
**Figure 68.** *Vegetation grows unchecked over the masonry spring house.*

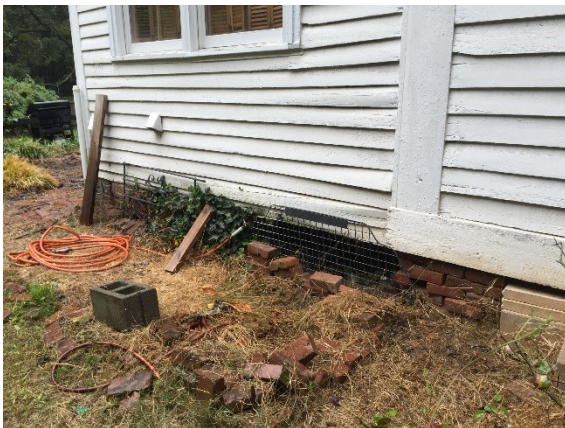
The foundation is composed of brick piers along with either terraced brick infill, bricks or concrete masonry units stacked at random between the piers. While the brick piers contain historic mortar, many of them, such as the one located at the southwest corner of the original house, have eroded mortar joints (Figure 69). Some of the infill between the brick piers is missing, creating space for small animals to gain access to the crawlspace (Figure 70). Some of the brick piers have vegetation growing out from them or up against them (Figure 71).

**Figure 69. Brick foundation pier with deteriorated mortar**

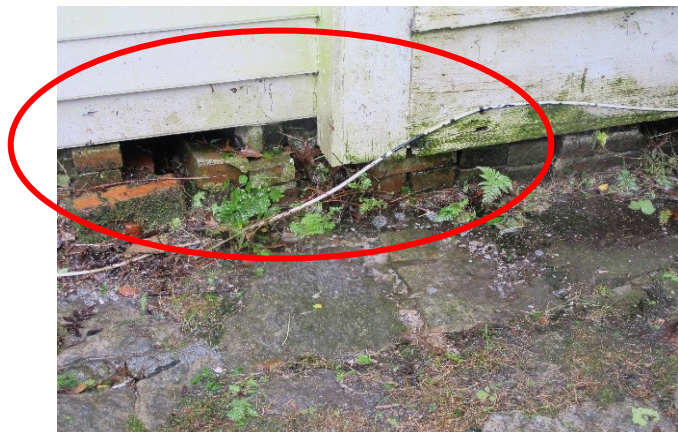
**Figure 70. Open space in foundation.**

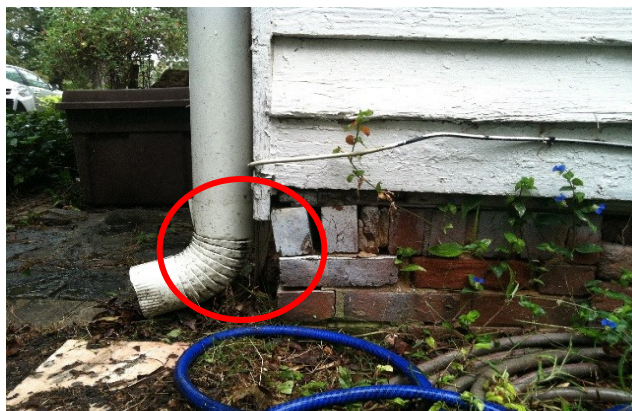
**Figure 71. Foundation pier with deteriorated mortar, vegetation along foundation bricks, and gutter with no downspout extender.**

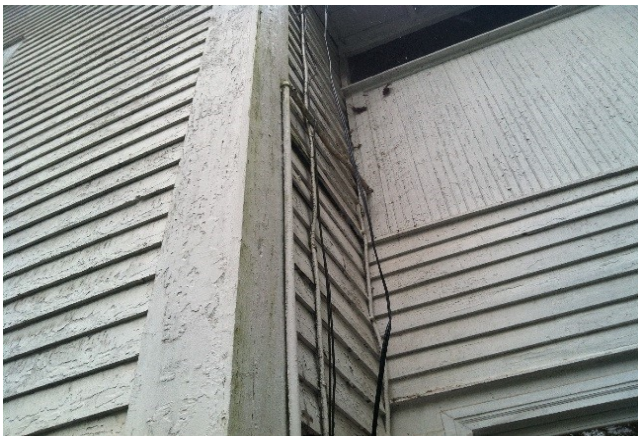
**Figure 72. Paint cracking on north facade.**

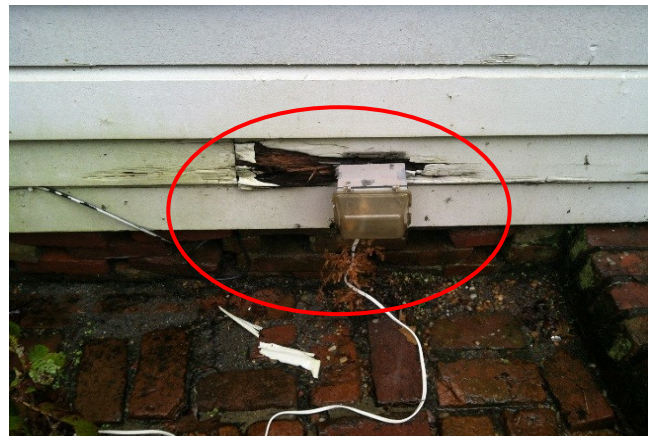
There is a piece of clapboard that has rotted around an electric outlet on the west façade of the addition that is due to damp conditions (Figure 73). This can allow additional moisture to enter behind the outlet and is a fire hazard. In addition, there is a large tree in the loop of the driveway leaning toward the northwest corner of the historic kitchen (Figure 74). This vegetation is holding moisture against the house causing the siding to deteriorate.

**Figure 73. Rotted clapboard on west facade.**

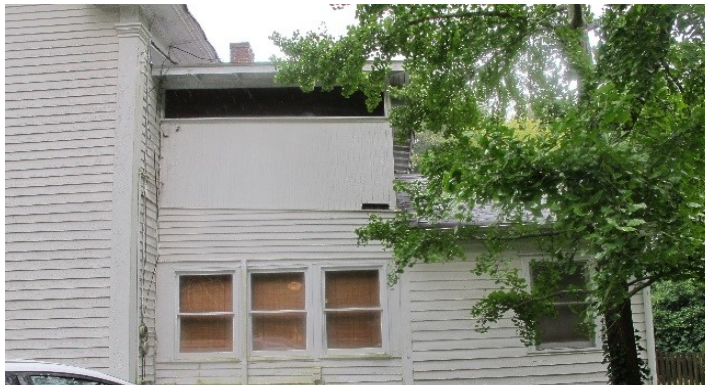
**Figure 74. Vegetation too close to house and leaking gutter have formed a moisture rich "microclimate" which is causing the siding to deteriorate.**

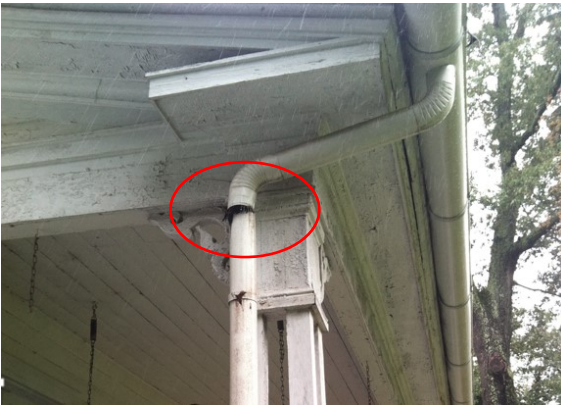
The downspout on the southeast corner of the front porch has come loose and is not secure (Figure 75). Water falls down beside the porch and accumulates. The gutter on the north side of the historic kitchen (Room 107) is not flush with the roofline. The gutter sags and allows water to fall and accumulate near the foundation, causing deterioration of the wood siding (Figure 76). Some of the downspouts do not have downspout extenders, which are necessary to move stormwater away from the foundation of the house. Also, improper grading at the northeast, northwest and southeast corners of the original house is allowing water to collect along and under the foundation of the house.

**Figure 75. Downspout not connected and leaking.**

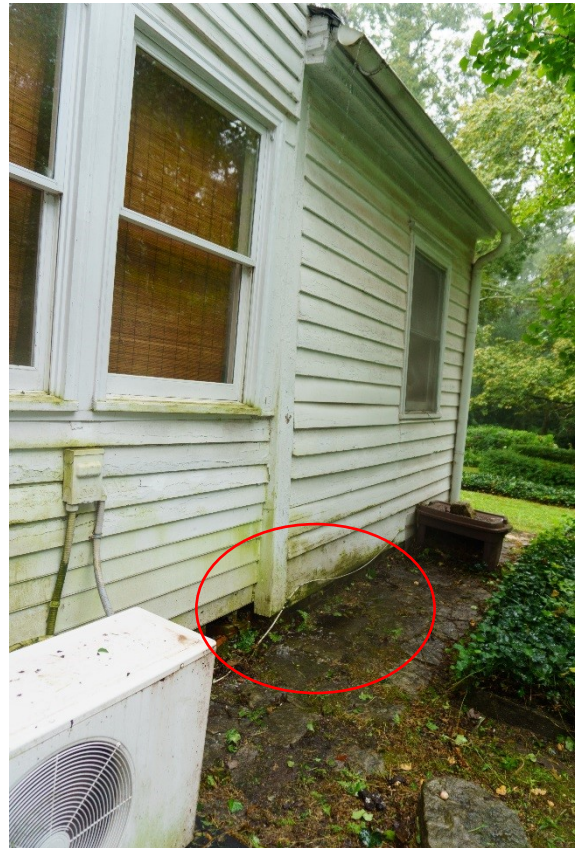
**Figure 76. Gutter sagging and leaking. Note accumulation of mildew on the siding due to the water leaking from the gutter.**

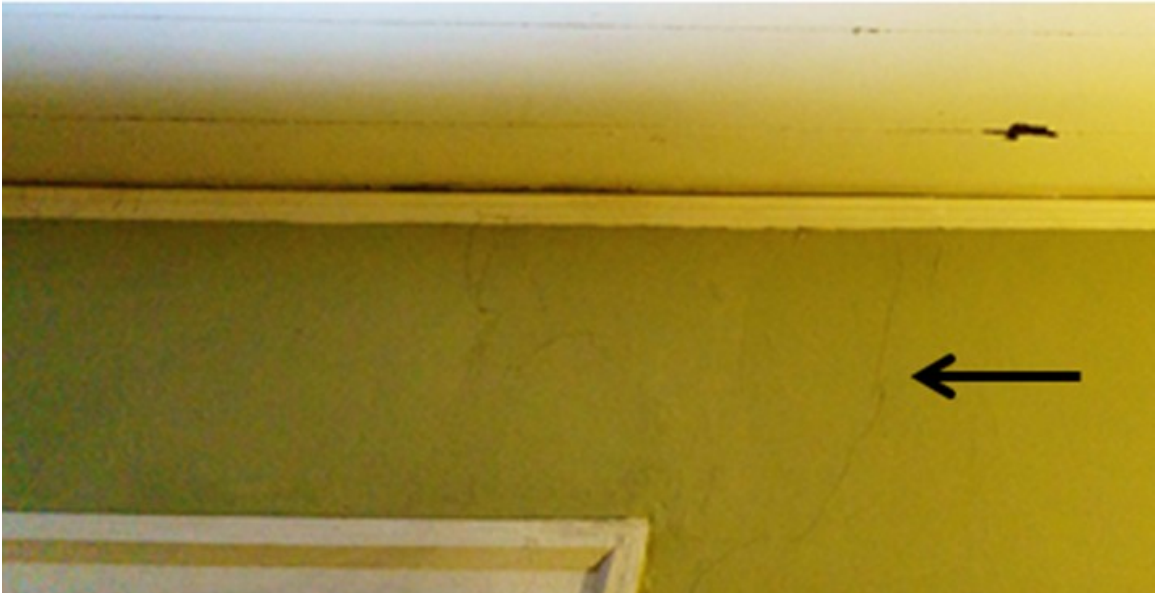
- The floor has a weak spot 3'7" west of the north side of the fireplace hearth.
- The plaster is cracking above the right corner of the south window (Figure 78) and on the west wall on the north side of the window. The cracks, as well as those in the other rooms, are a result of the house settling.

**Figure 78. Room 102. Upper right corner of the south window.**

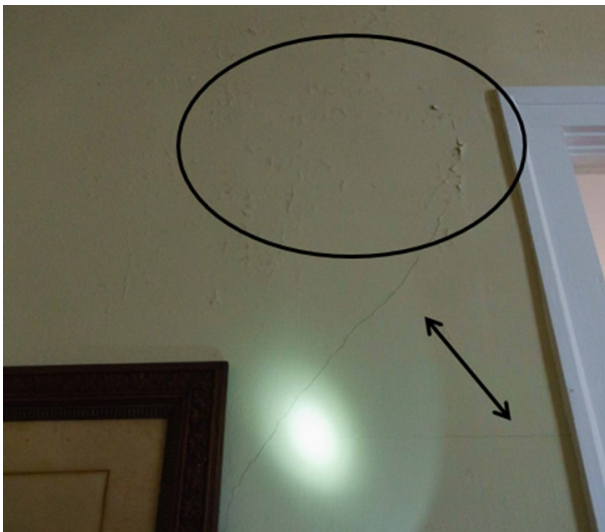
**Figure 80: West wall in Room 103. Note the crazing in the circled area and the arrow pointing to the cracks in the plaster.**

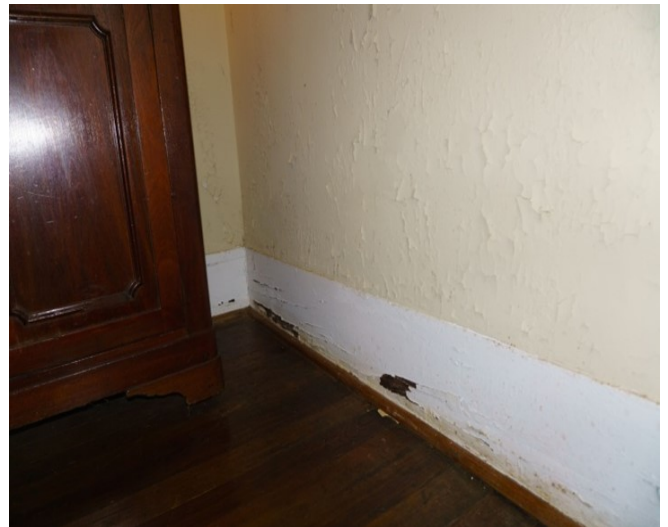
**Figure 81: North wall of Room 103. Crazing above the baseboard, left of the window.**

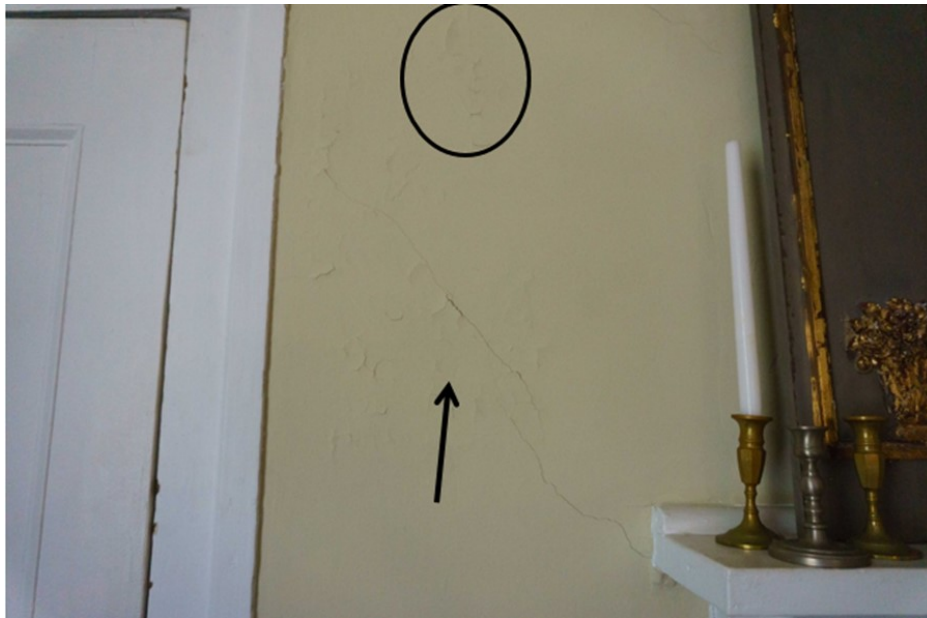
- ◇ **East wall:** next to the left corner of the mantel (Figure 82).
- There are several cracks in the plaster. One runs diagonally downward from the south corner of the door on the west wall. From the same wall, a shorter crack runs horizontally from the left side of the door. The remaining cracks are located on the east wall above and to the right of the closet door,

Figure 82: East wall in room 103. Note the crazing in the circle and the arrow pointing to the cracks in the plaster.

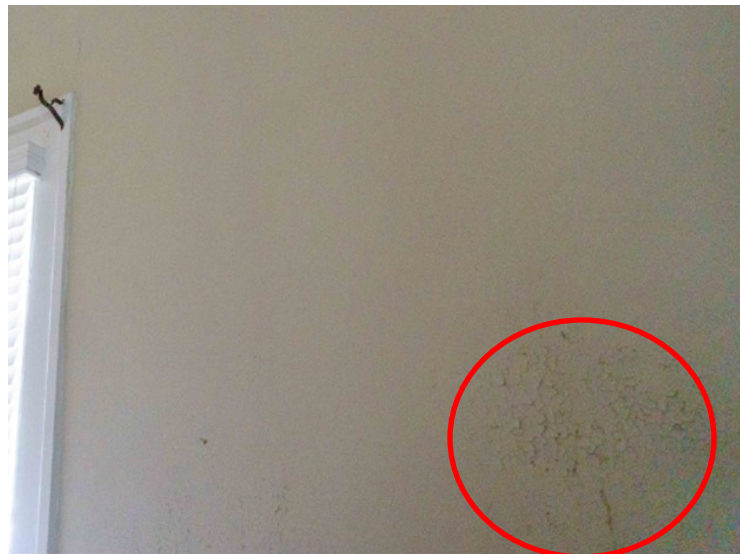
Figure 83. North wall of room 104. Notice the crazing in the lower right hand corner.

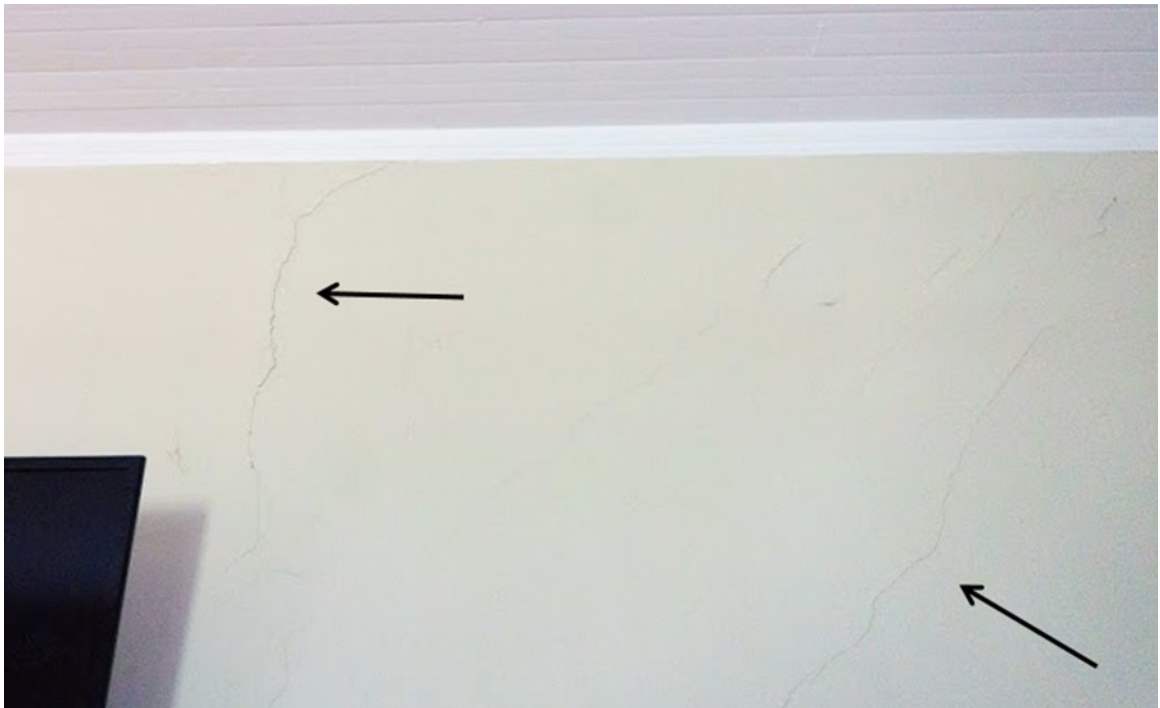
**Figure 85. Cracks in the plaster of the west wall in room 104.**

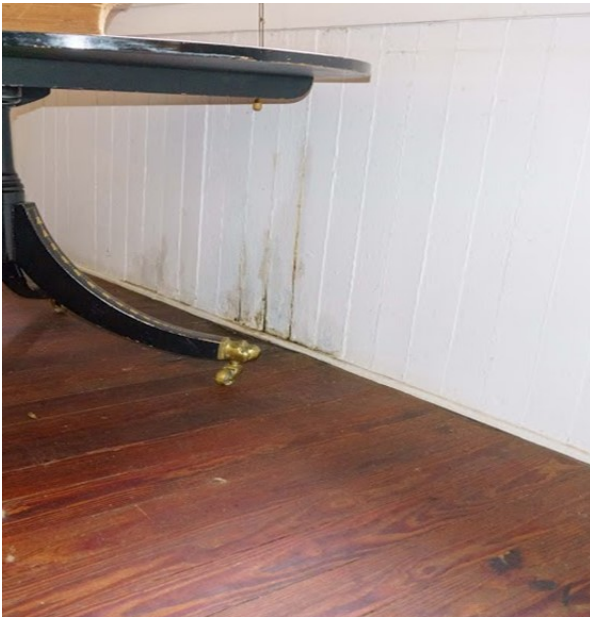
- Wood paneling on the west wall near the floor between the center and north window is rotting. It may be related to the rot that is occurring between the same windows on the exterior (Figure 86). The rot was caused by water infiltration due to a lack of a gutter on the roof of the addition. The issue was repaired between the second house visit on October 24, 2015 and November 14, 2015 (Figure 87).
- Paint is flaking off along the door on the west wall from the door knob down (Figure 88).

**Figure 86. Rot beneath the triple windows on the west wall of Room 106.**

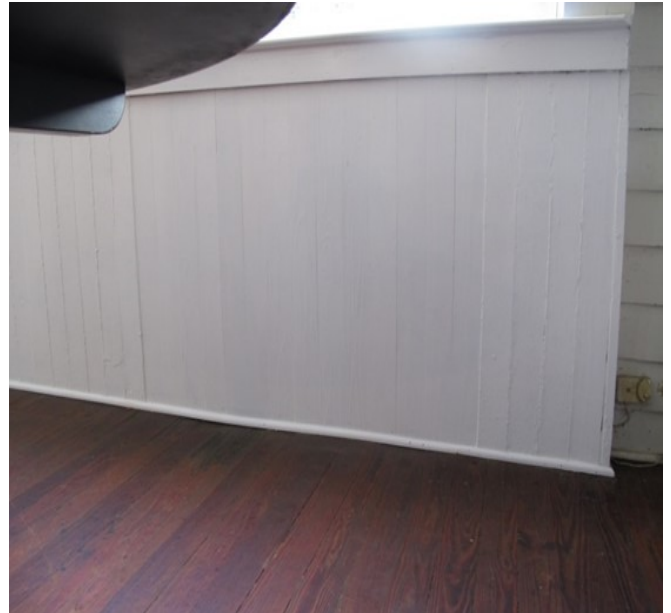
**Figure 87. Repair made on the west wall.**

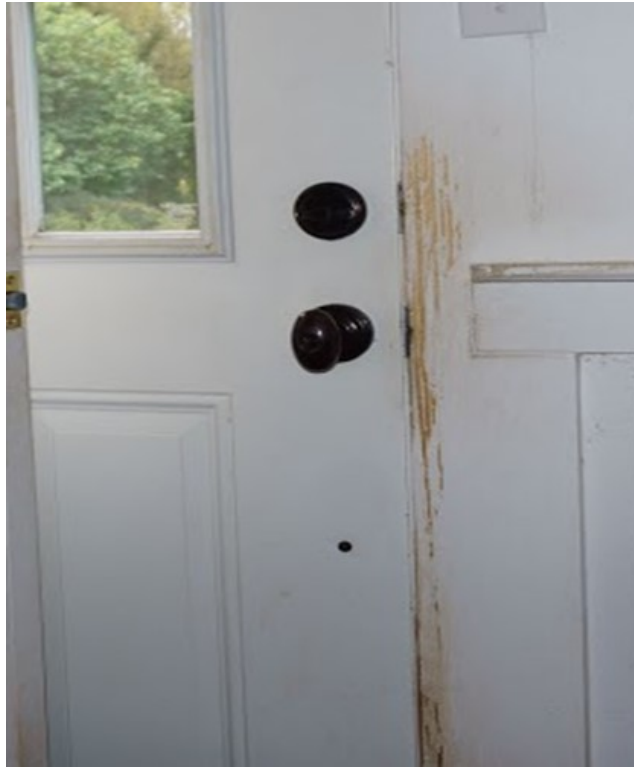
**Figure 88. Missing paint along the jamb of the back door on the west wall.**

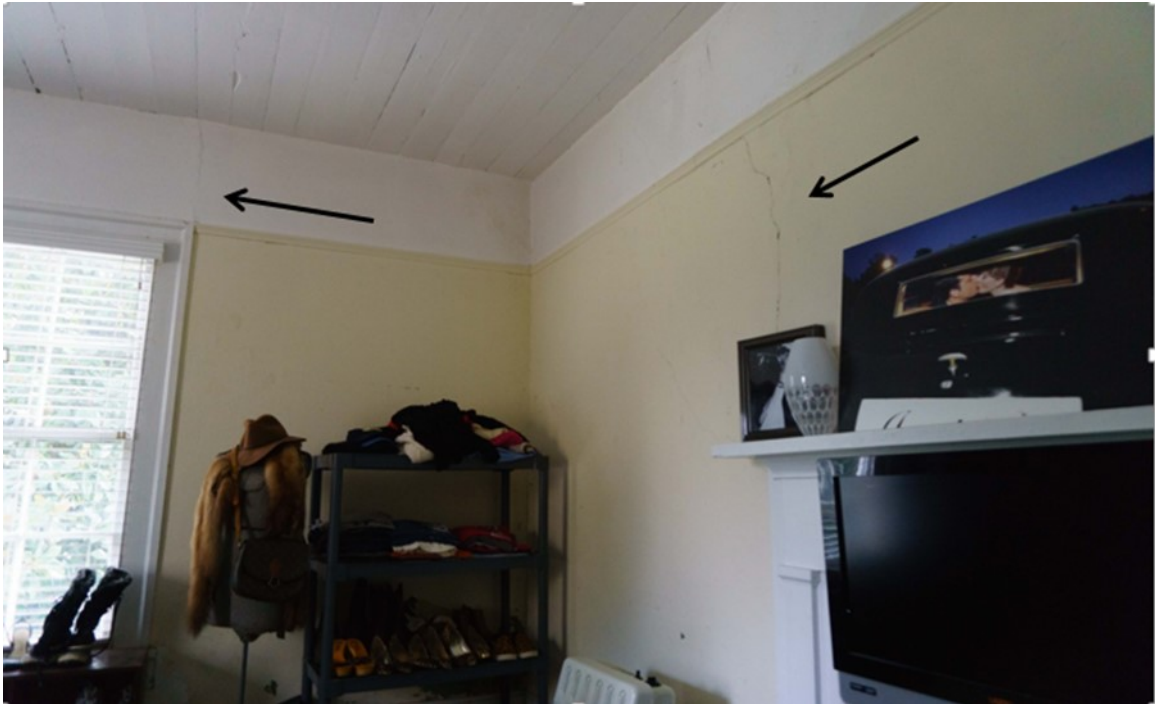
- Plaster is cracked in multiple areas but primarily on the south and west walls (Figure 89).
- Layers of paint are flaking off, mostly on the lower portion of the south wall (Figure 90).

**Figure 89** South and west walls of room 201. Note the cracks in the plaster.

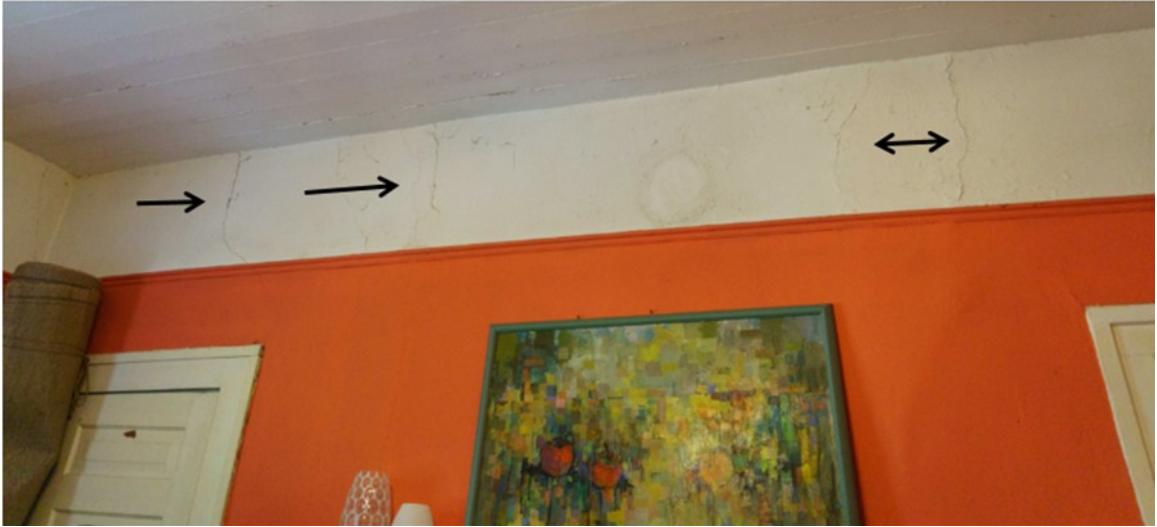
- Vertical cracks in the plaster of the cornice. Most of which are located on the east wall (Figure 203).

**Figure 91.** East wall of Room 203. Notice the cracks in the cornice.

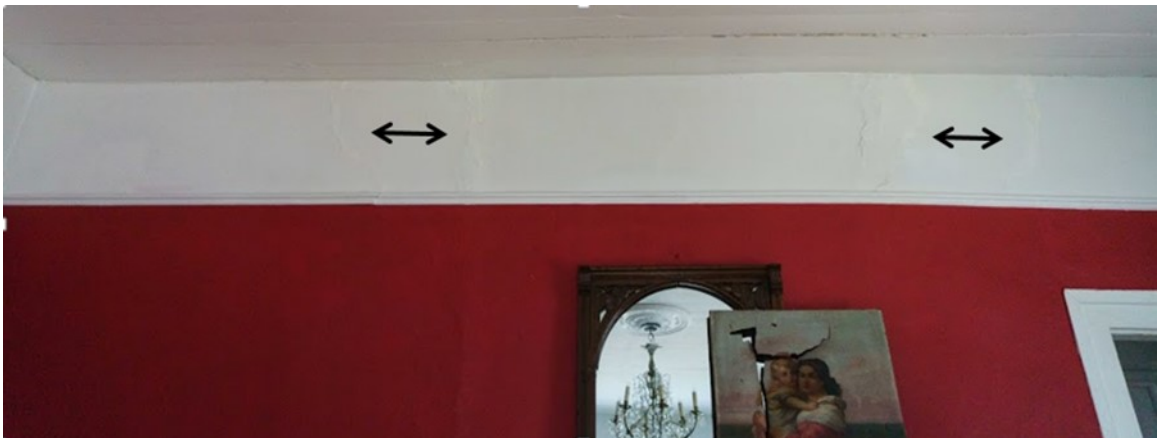
**Figure 92.**

- Vertical cracks in the plaster of the cornice, most of which are located on the west wall.

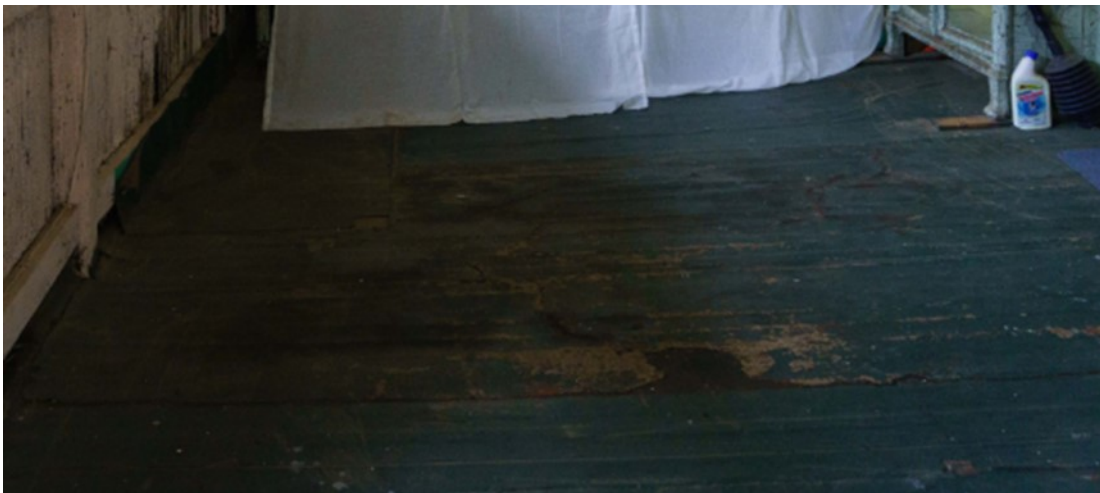
- Vinyl floor covering is worn off in various places. A large section is missing from the area in front of the north door (Figure 93).
- A lower section of the west wall on the northern side is rotting. It is caused by excess water due to the lack of a gutter (Figure 94).
- There are nails protruding through the beadboard above the rotting section (Figure 95).
- The paint is alligating on the beadboard of the north and west walls (Figures 95 and 96).
- A rafter is rotted by water infiltration. The source of this water needs to be found in order to prevent the problems from reoccurring (Figure 97).
- Paint on the south door is alligating and is worn off on the bottom sill.

**Figure 93. Damaged floor of Room 206.**

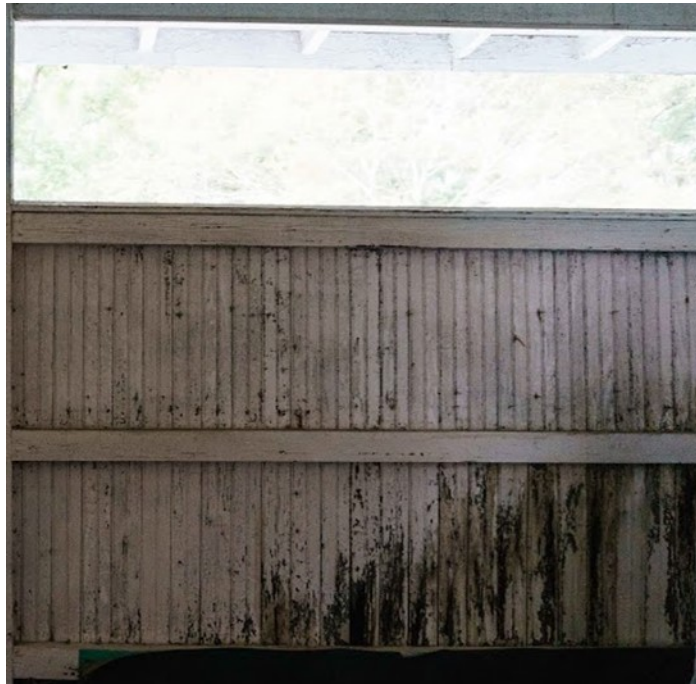
*Figure 94. Rot on lower section of the west wall of Room 207.*

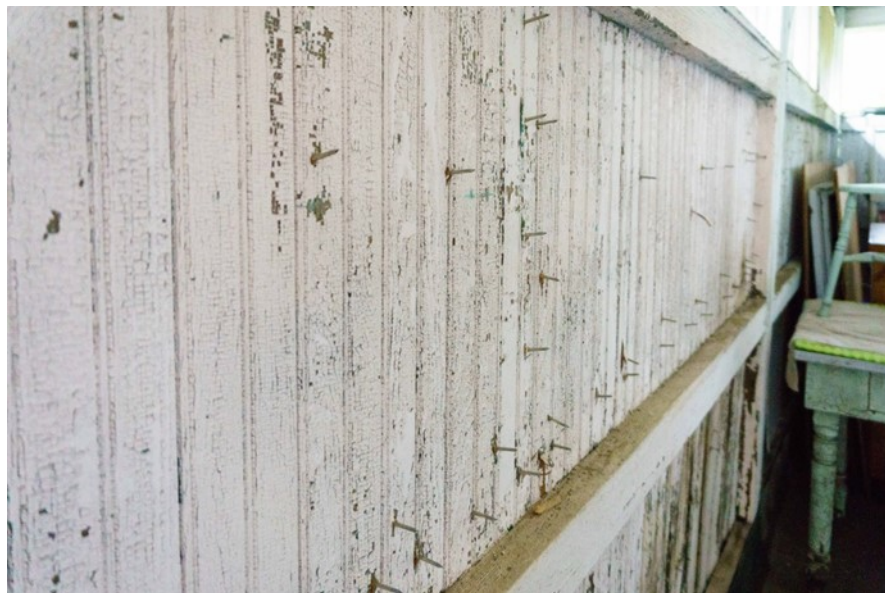
*Figure 95. Nails protruding through the bead board on the west wall in room 207. Some alligatoring is also evident.*

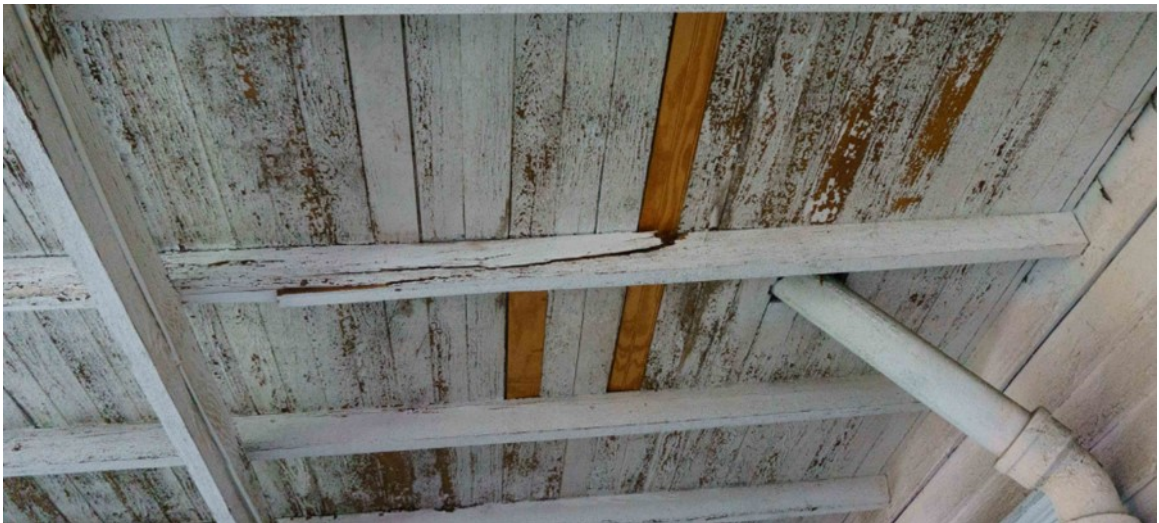
**Figure 97 Cracked rafter in Room 206.**

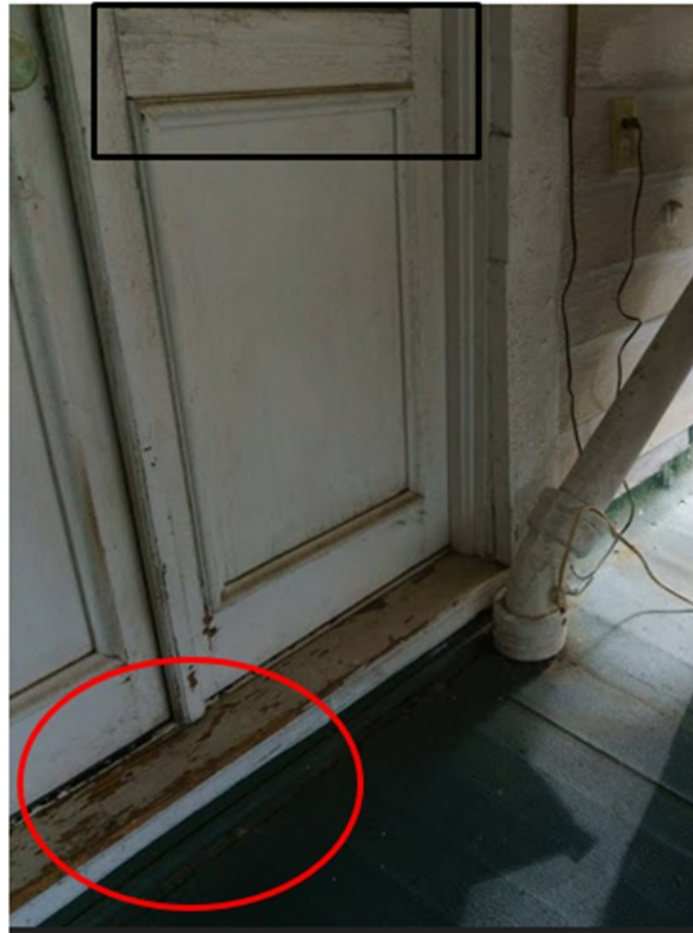
**Figure 98. The double doors on the east wall of Room 206. The red circle highlights the paint alligating and the circle shows where the paint is wearing away.**

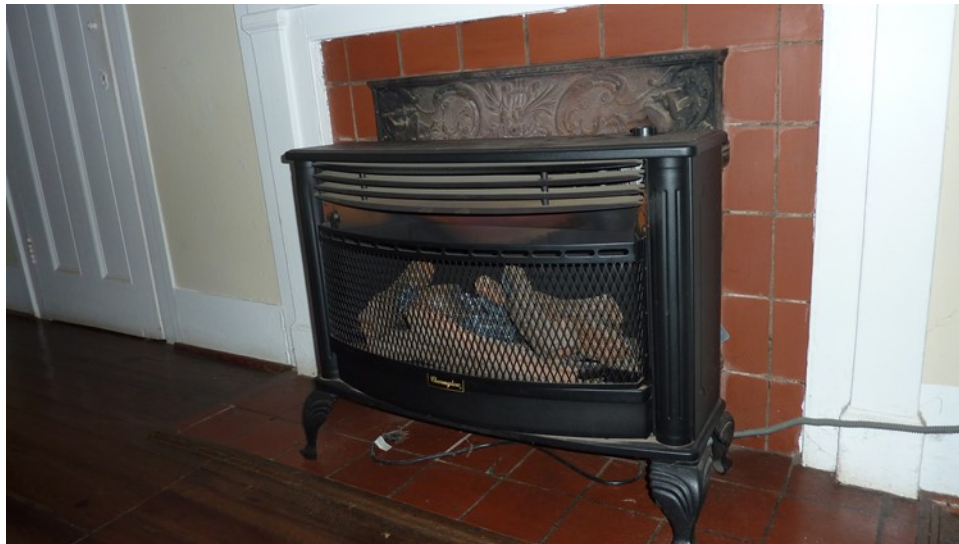
***Figure 99. Current gas-powered heaters, like this one in Room 103, block historic hearths from view and can be dangerous if touched.***

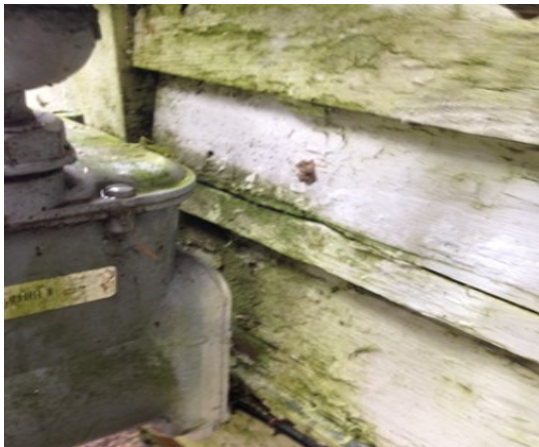
**Figure 103.** Mildew/rot behind gas meter on northwest end of the main house.

1. Install an external gutter to allow the flow of water to run away from the surface of the house.
  - a. For the rot behind the meter (and biological staining under the windows of the central addition), build an external gutter system on the central addition to direct flow down and onto the kitchen addition and then down and out through the downspout on the northwest corner of the kitchen addition which directs away from the house.
  - b. For the biological (mildew) staining on the west facade, install an external gutter on the second story of the sleeping porch addition.
2. If gutters are not installed, extend roofing material to direct run-off away from sills and onto the ground.
3. Repair rotted wood as needed and replace what is not stable.
  - a. To help with positive drainage, the hexagonal pathway can be regraded or the stones can be reset.

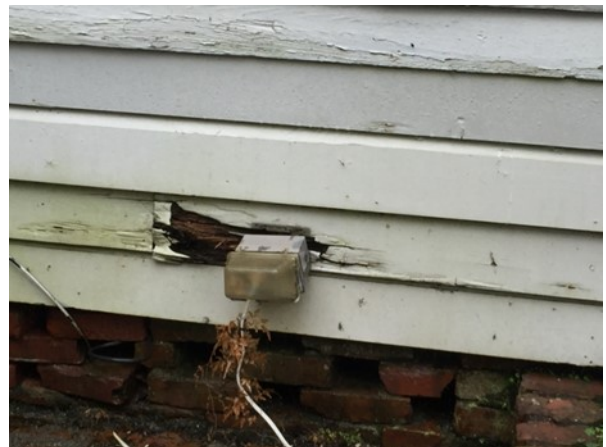
**Figure 104.** Wood rot on the west façade of the house, south of the back door. (This has been repaired since the initial conditions assessment site visit was conducted.)

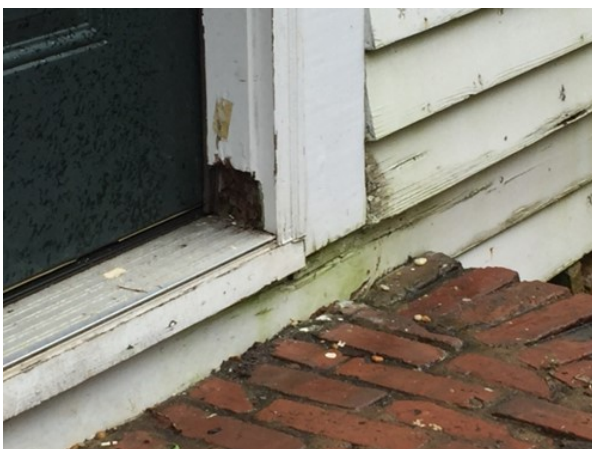
**Figure 105.** Wood rot on lower right corner of the back door.

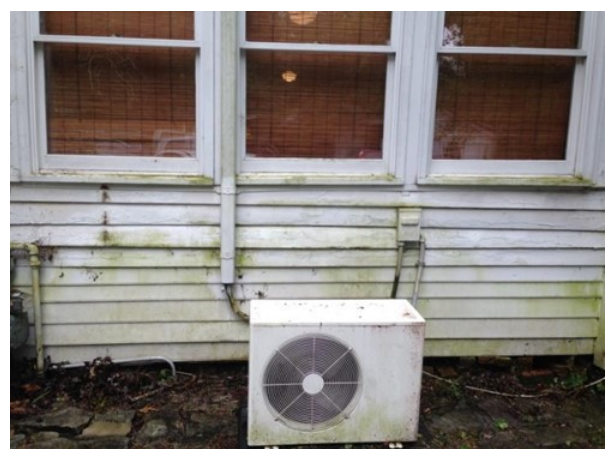
**Figure 106.** Moisture causing algae staining on the east side of the central addition.

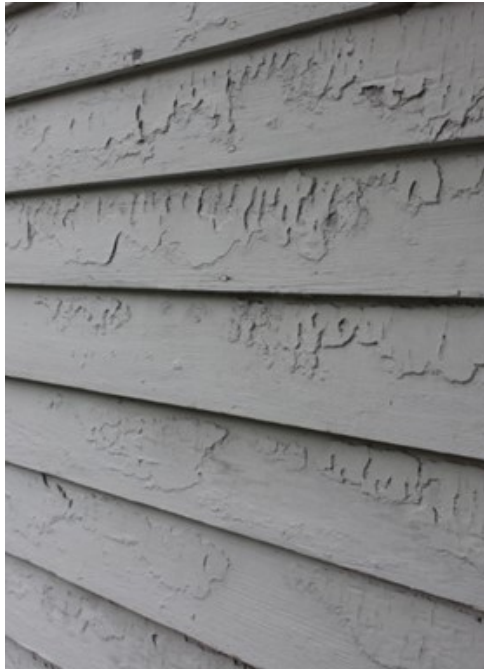
**Figure 107.** Alligatoring of paint on the east façade of the main house.

1. If only in the top layers, the layers can be scraped by hand or mechanically sanded to the next sound layer, then repainted.
2. If progressed to bare wood and the paint has begun to flake, it will need to be totally removed.
3. Removal includes scraping or chemical strippers, whichever is the gentlest means to the historic material.

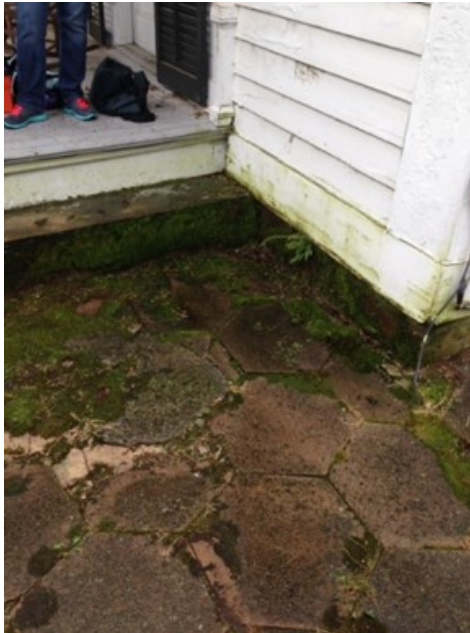
- Problem with mildew staining on the west facade seems to be there is no main gutter system on the second story of the sleeping porch addition.
  - Install an external gutter system
2. Repair or replace (in kind) damaged siding or other historic material.
  3. Clean the different biological staining with respect to the different materials.

**Figure 108** East façade on northeast corner microclimate visible due to excessive water.

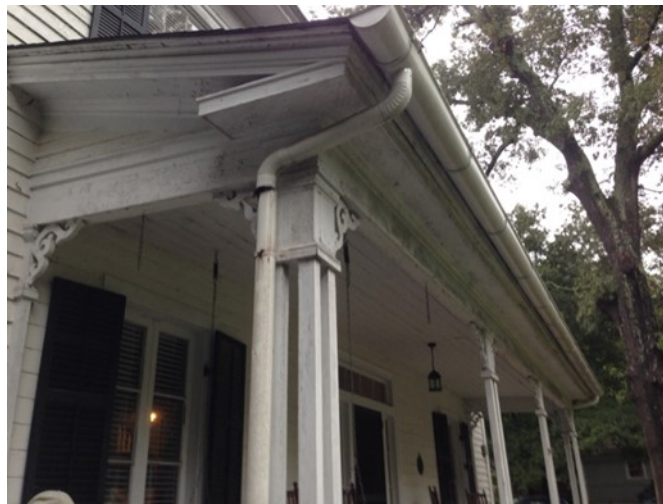
**Figure 112. East Façade on the southeast corner downspout and gutter system**

1. Clean out the gutter system
2. Repair the system by sealing the disconnection (this has been resolved since last site visit)
  - a. The microclimates on both corners of the east facade are caused by water not being drained away from the structure properly. To fix this:
    - Regrade (also needs to be defined somewhere) the hexagonal pathway on both the northeast corner and southeast corner to have the water running away from the building.
    - In terms of the downspout on the northeast corner of the east facade, it can be brought out to the edge of the driveway and run away from the building.

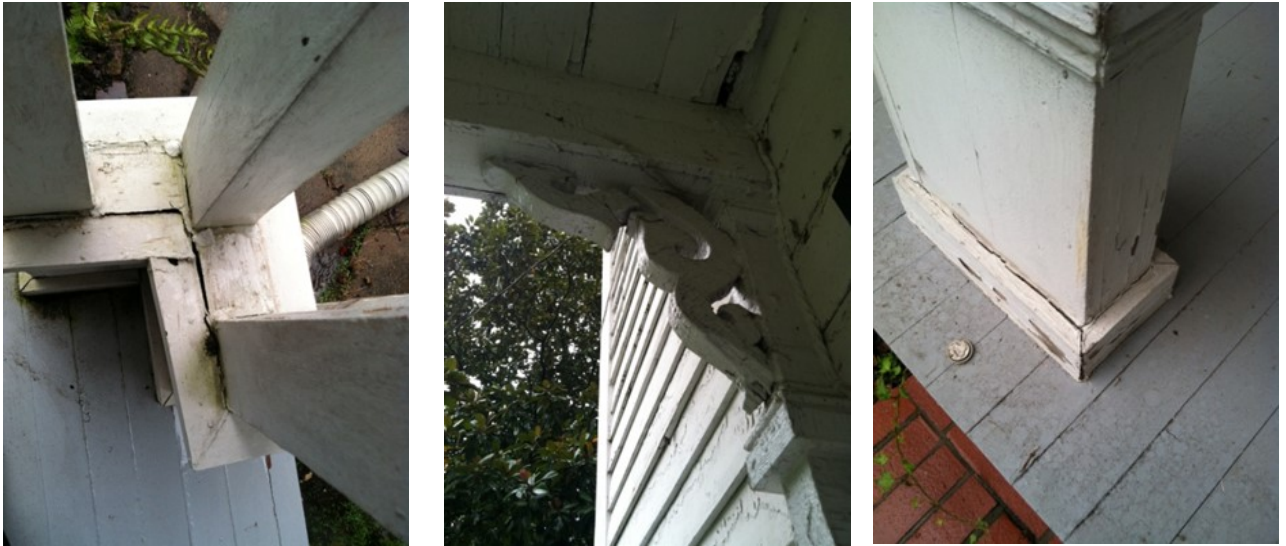
**Figures 113-115: East Façade porch columns and brackets are broken**

1. Rebuild the base of the columns and some brackets according to the Secretary's Standards.
2. Caulking of base.

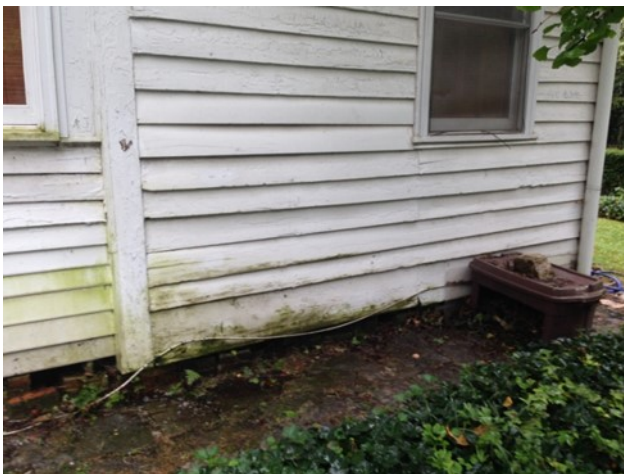
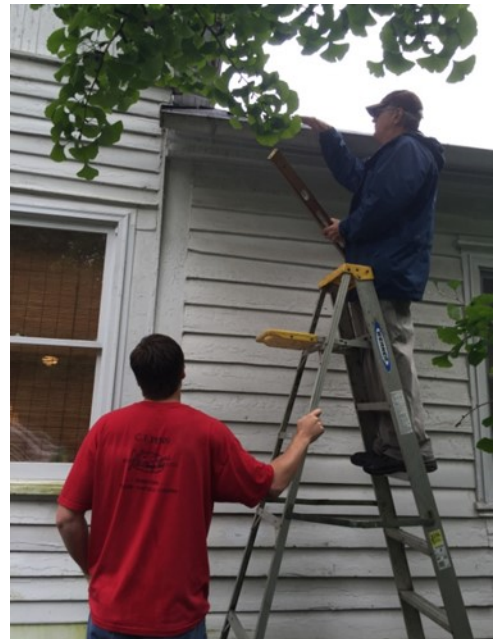
**Figures 116-117: North Façade gutter system failure on the kitchen addition**

1. Clean out the gutter system.
2. Re-hang and re-align gutter system so it flows positively.
3. If needed, trim the tree to allow two feet of separation between the house and the limbs.

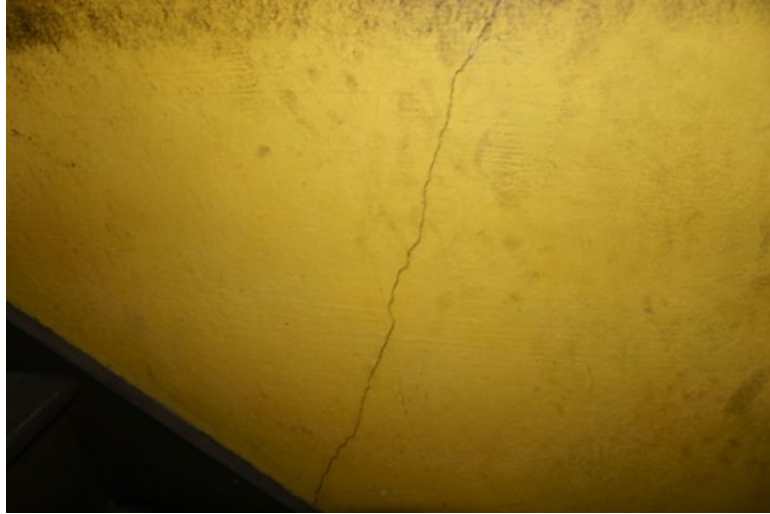
**Figure 134:** Attic – Vertical crack in the plaster of the stairwell leading from Room 205 into the attic.

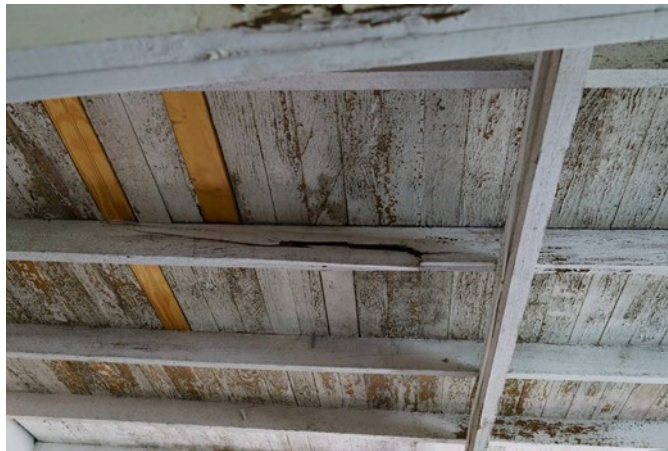
**Figure 138: Room 206 roof rafter cracked.**
