Lyon House

Amanda Brown

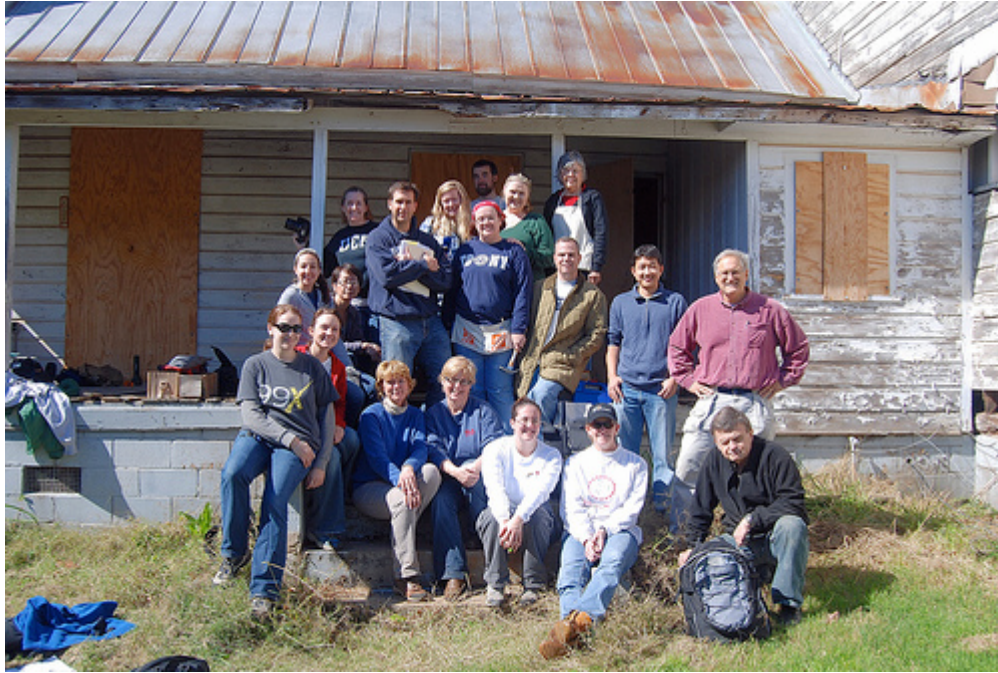
Fig. I-1. Lyon House project team.

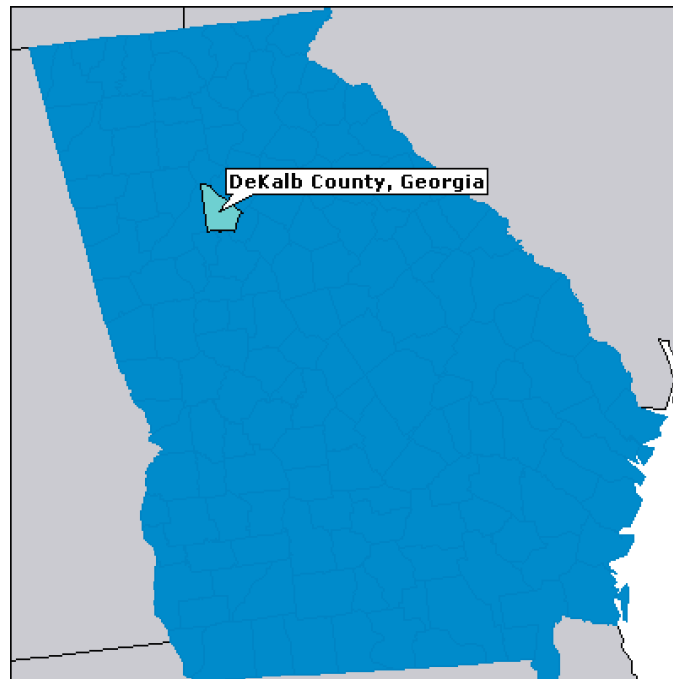
Fig. I-2. Map of Georgia with DeKalb County highlighted.
<http://www.epodunk.com/cgi-bin/genInfo.php?locIndex=7908>.
Accessed November 3, 2008.

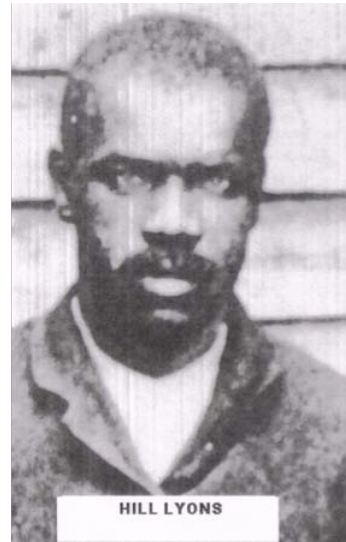
Fig. II-4. Hill Lyons.
Former Lyon family slave.
Date unknown.

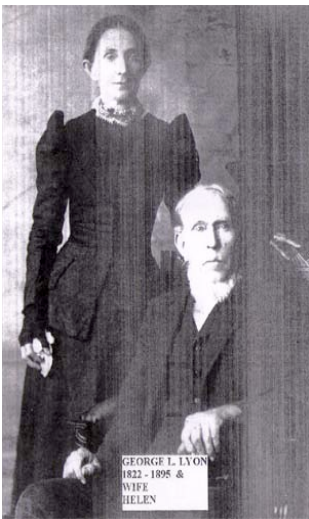
Fig. II-5. George L. Lyon, Jr., grandson of Joseph Emmanuel Lyon. and his wife

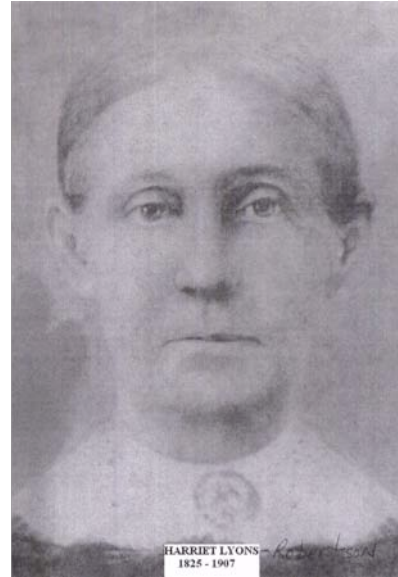
Fig. II-6. Harriet Lyon, aunt of Wallace Kirk Lyon and sister of George Lyon, Jr.

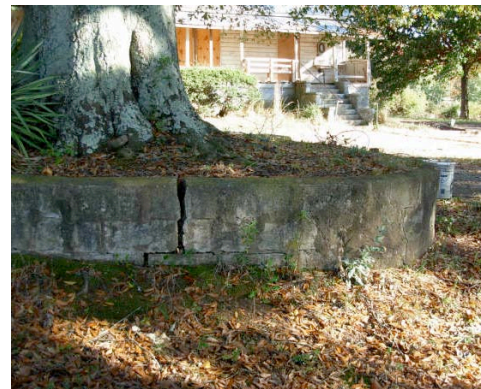
Fig. III-7. Looking east. CMU area of retaining wall; tree roots causing cracking.

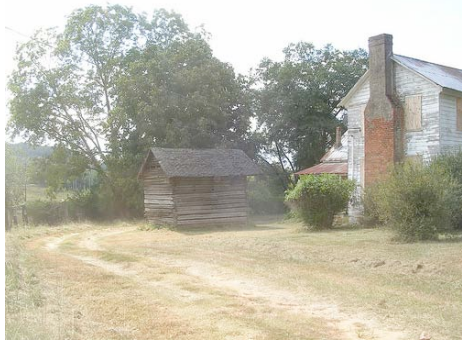
Fig. III-8. Smokehouse, located east of the Lyon house.

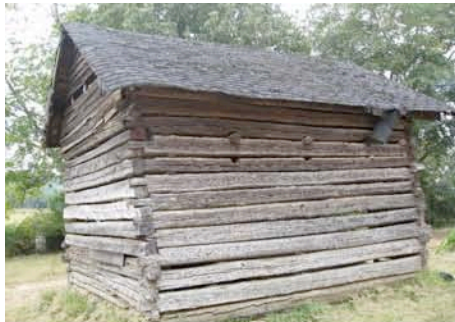
Fig. III-9. East gable end and north facade of the smokehouse. Notice the ends of the two logs projecting from the north facade as well as the loose asphalt shingles and the

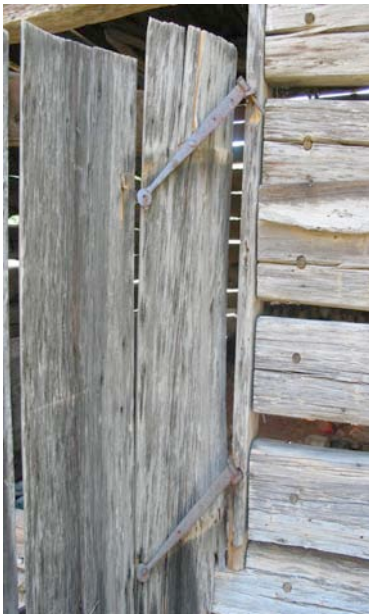
Fig. III-10. Close up of the smokehouse door when it was attached to the smokehouse. The metal hinges featured here were stolen between July and September of 2008. (Photo by J. Brinkman 2004)

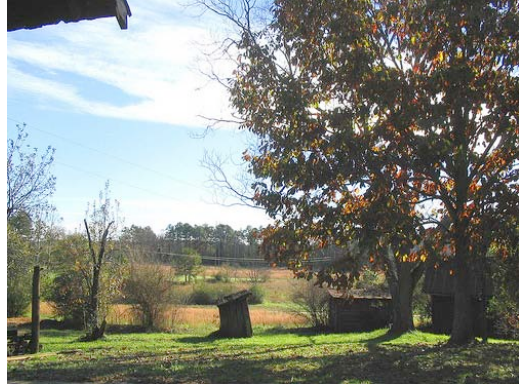
Fig. III-16: Looking southeast from the Lyon House. The privy (center) and single pen (right) can be seen-Photo by J. Brinkman 2004

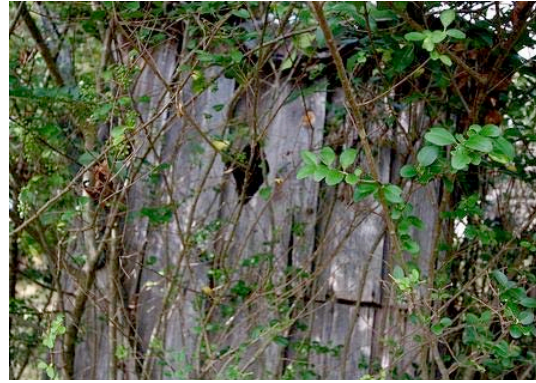
Fig. III-22. Close up of diamond cut window on north façade of privy.

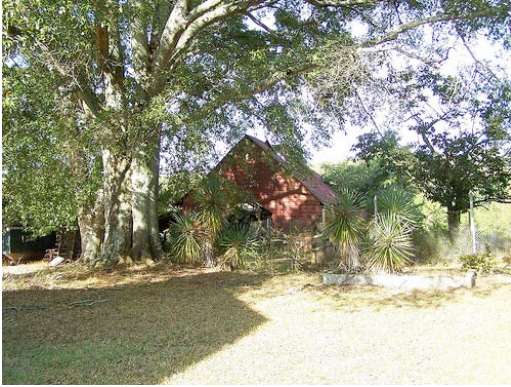
Fig. III-25. South façade of the barn—several pieces of clapboard siding are missing as well as elements from the roof.

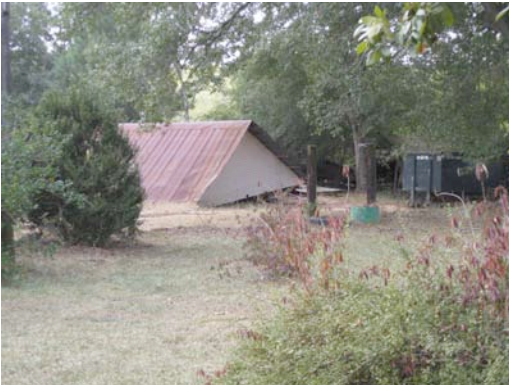
Fig. III-26. Looking southwest from the Lyon house. The collapsed garage is visible (center).

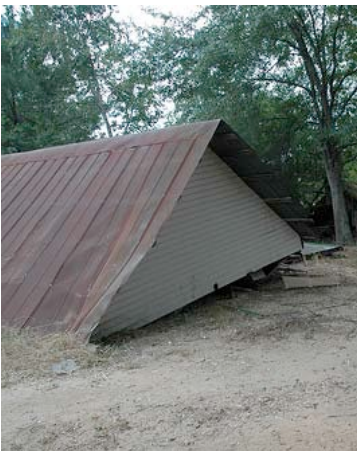
Fig. III-27. Close up of the collapsed garage.

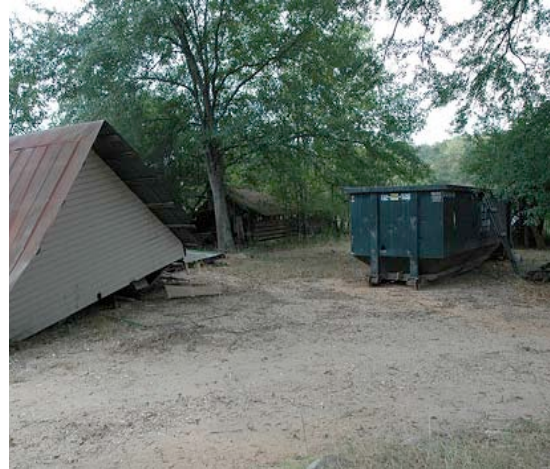
Fig. III-28. Looking southwest from the Lyon house, the small barn is visible between the collapsed garage and the dumpster.

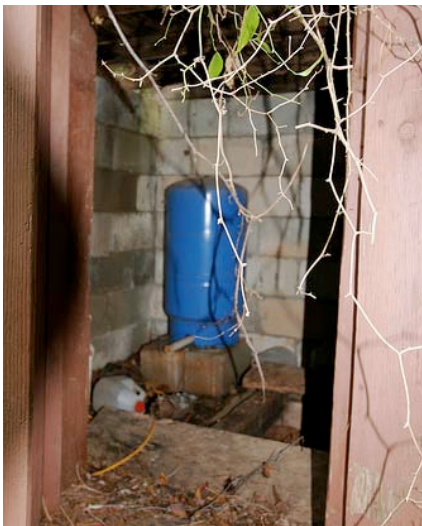
Fig. III-33: Interior of well house

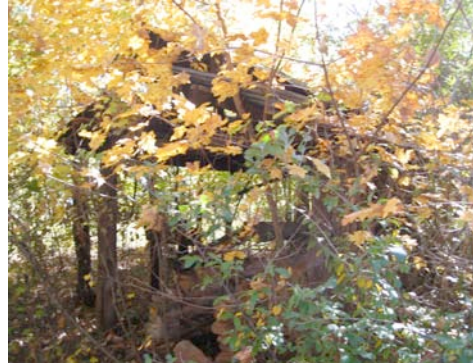
Fig. III-34. Sorghum boiler.

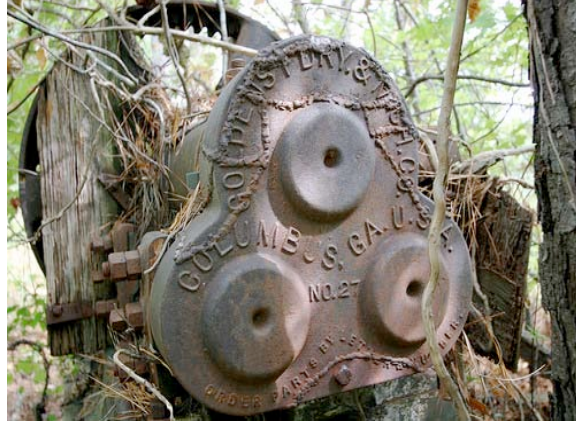
Fig. III-37. Close up cane mill; model No. 27 Goldens Foundry and Machine Co, Columbus, GA.

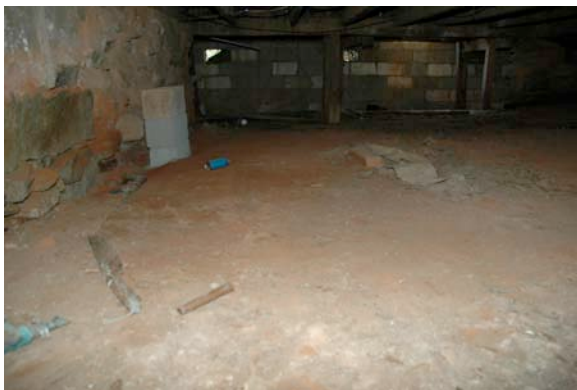
Fig. III-38. Overview of the foundation looking to the west. To the south is the granite wall of the basement (Room 001). To the west is the CMU foundation of the west porch.

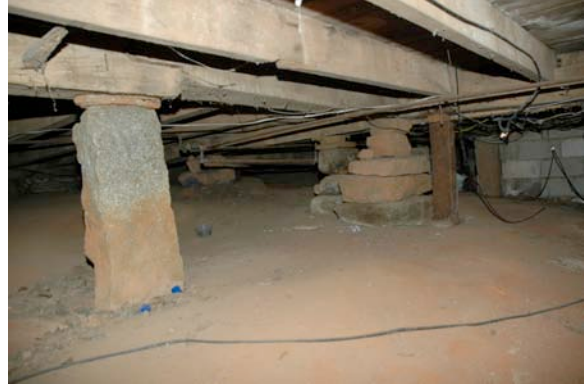
Fig. III-39. Overview of the foundation, looking northeast. To the west is a large granite block pier. To the east is a stacked granite pier that has been reinforced with a wooden block. At the far, east side is the CMU foundation of the eastern porch.

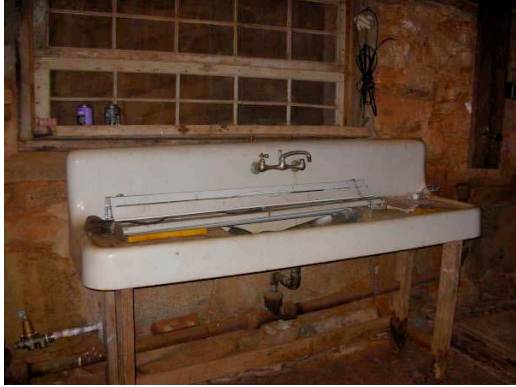
Fig. III-40. Looking west in Room 001 at window W3, which predates the porches.

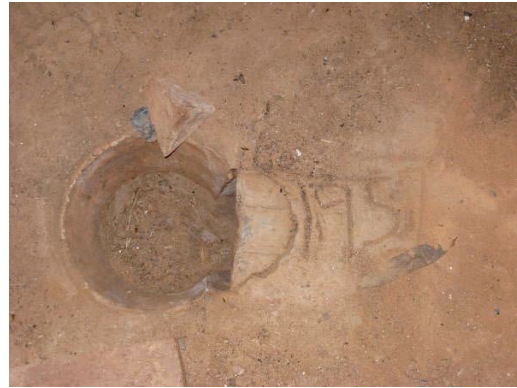
Fig. III-43. Close-up of the floor of Room 001, showing drain with the date "1957" inscribed on it.

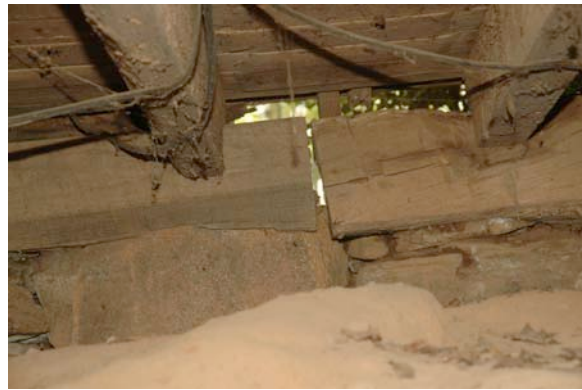
Fig. III-44. View of the central north foundation showing abutment of sill pieces. The sill on the left is circular sawn; the sill on the right is hand-hewn, indicating that the left sill is a replacement.

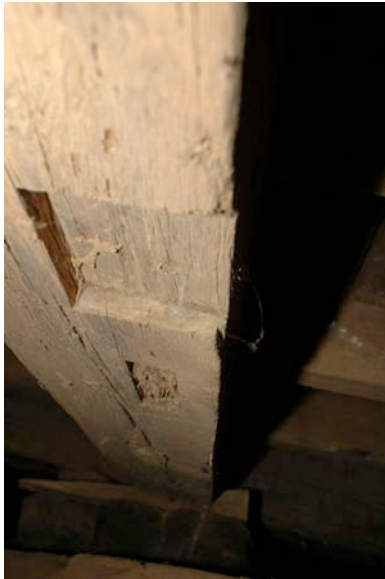
Fig. III-45. Looking west at the additional beam perpendicular to the summer beam. Mortise joint notches from prior use are visible.

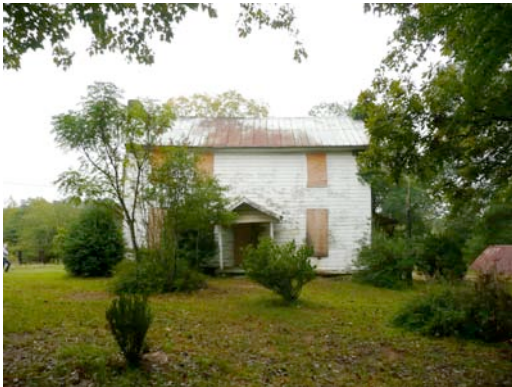
Fig. III-46. View of north façade, looking south.

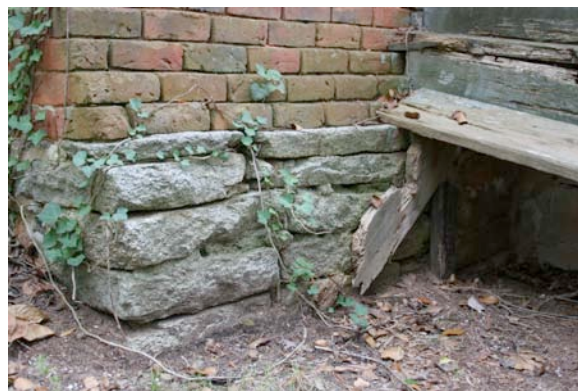
Fig. III-50. Foundation of the west chimney and the steps at the north end of the west porch.

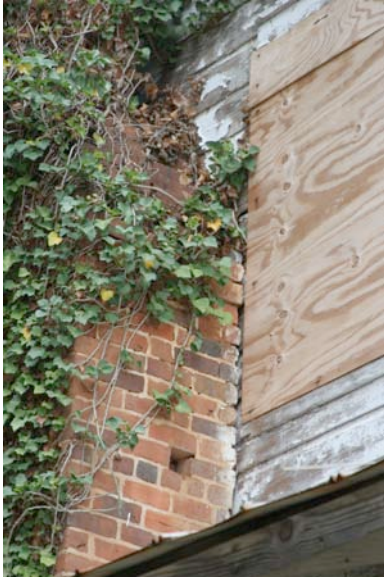
Fig. III-51. One of the missing bricks on the west chimney, south side of the chimney next to window W21.

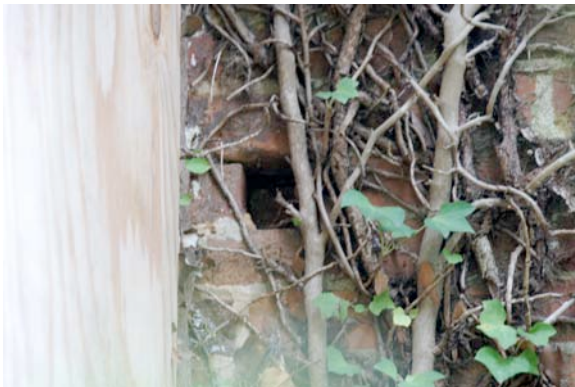
Fig. III-52. Another of the missing bricks on the west chimney, north side of the chimney, note the lack of mortar in the space.

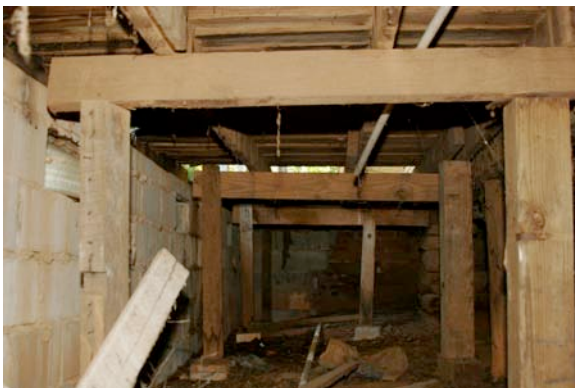
Fig. III-53. Porch foundation (to the left) and the porch supports in the center – view facing north.

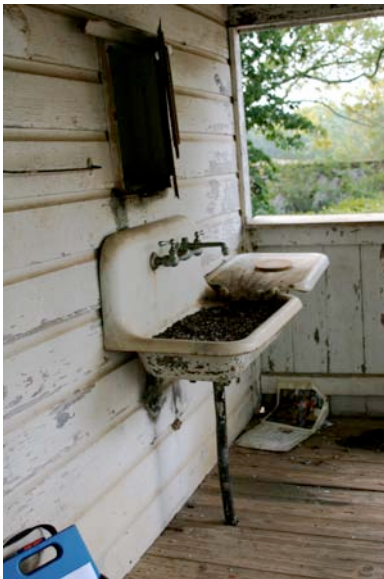
Fig. III-55. Sink on the west porch, south end of the porch.

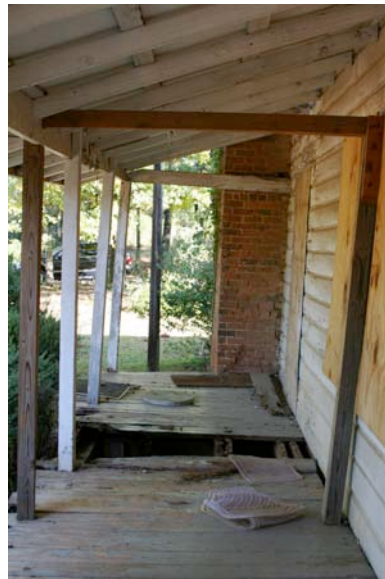
Fig. III-56. Support for a swing. Notice the difference in the coloring of the wood and the lack of paint, indicating a newer construction.

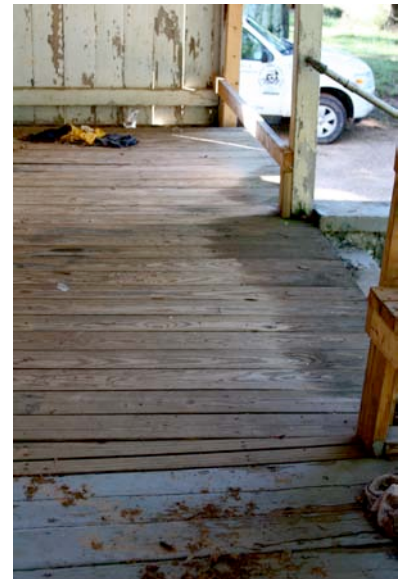
Fig. III-57. Floor of the west porch. This is the south end of the porch where the floor appears to have been recently replaced.

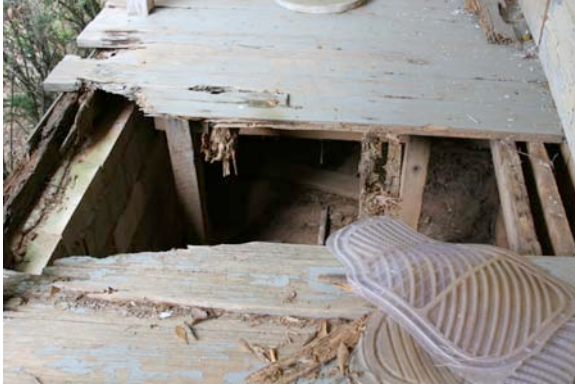
Fig. III-58. Hole in the west porch. Notice the damage to the supporting structures.

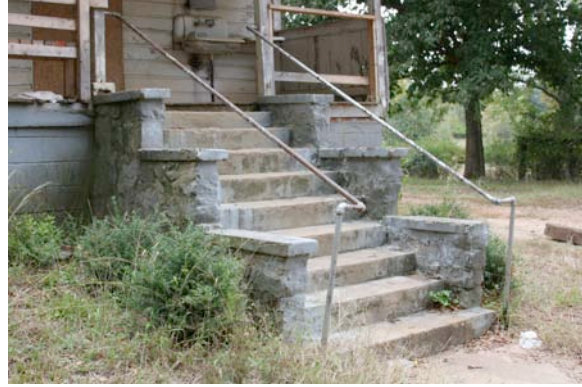
Fig. III-59. Main steps up to the west porch.

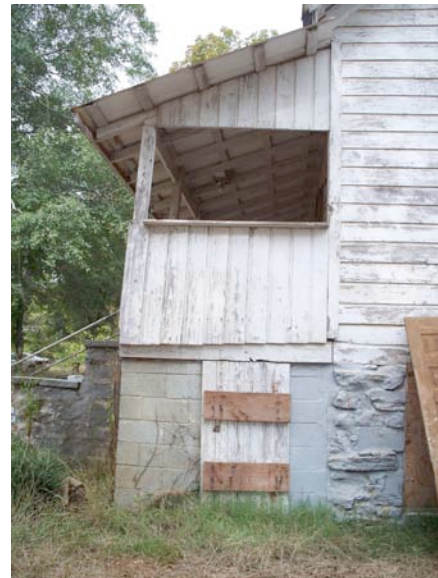
Fig. III-66. Detail of western section of south foundation, showing CMU and granite foundation.

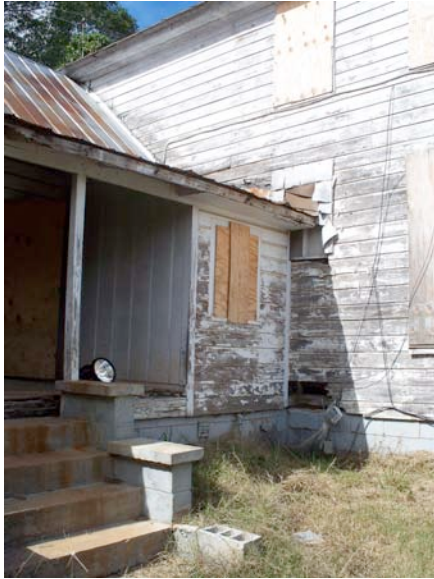
Fig. III-67. Junction of main house and ell, showing hole in wall cladding.

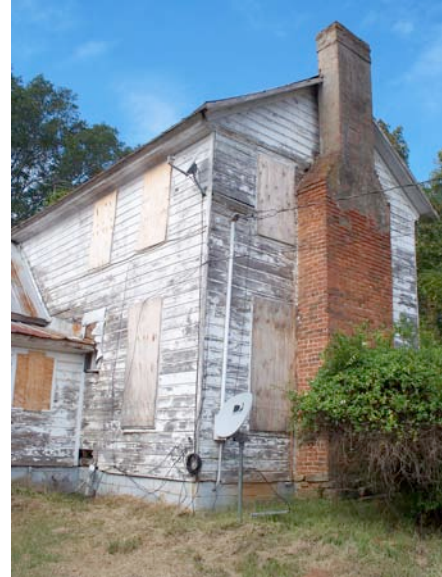
Fig. III-70. Intersection of the east and south façades of the main house.

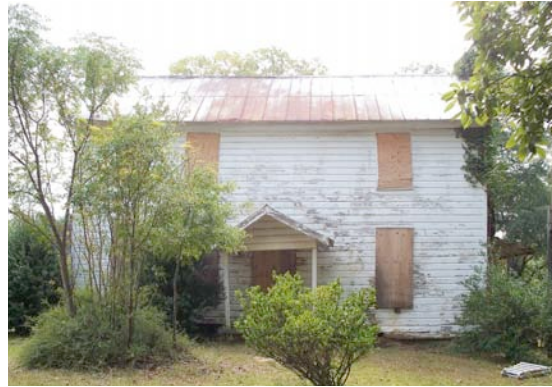
Fig. III-75. North façade of the main house with side-gabled roof with standing-seam, galvanized steel roofing. Note the metal corrosion.

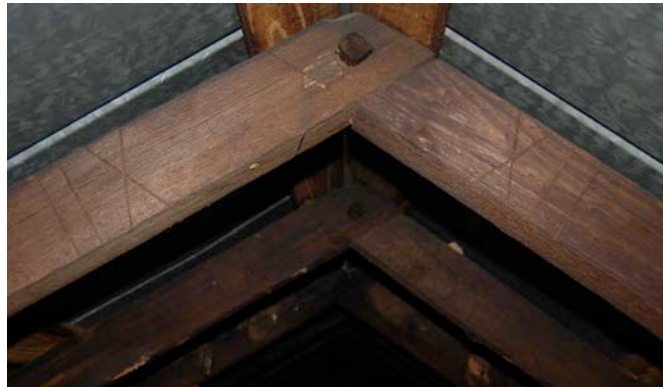
Fig. III-76. Rafters in the main house attic are connected at the ridgeline through mortise-and-tenon with a wooden peg. Each set of rafters is marked with a Roman numeral.

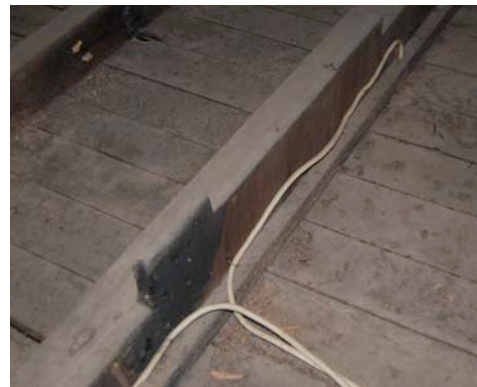
Fig. III-77. East wall of stairwell extends into the main house attic at the eighth ceiling joist from the access panel (going west to east). The wall is constructed of tongue-and-groove vertical panels. There appears to be some fire damage.

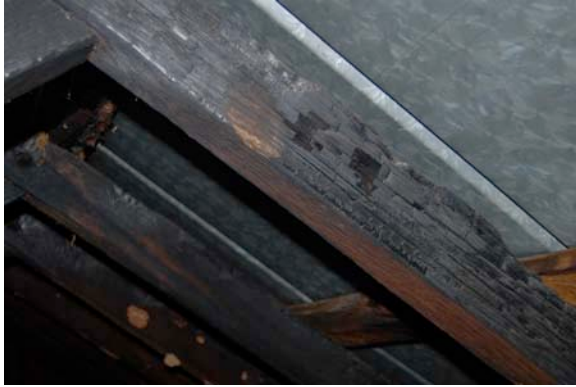
Fig. III-78. Fire damage to rafters in main house attic.

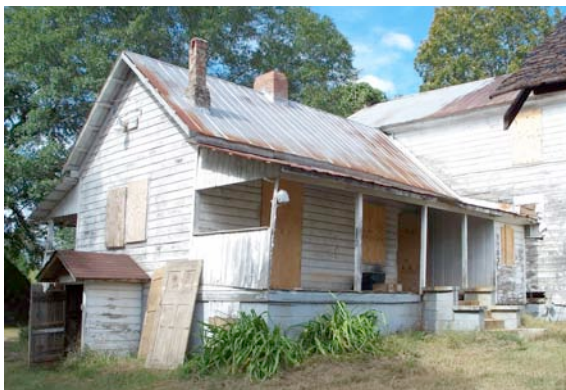
Fig. III-79. East and south facades. Rear ell has a rear-gabled roof with two interior chimneys. Shed roofs extend from just below the eaves to cover full-length porches on the east and west facades.

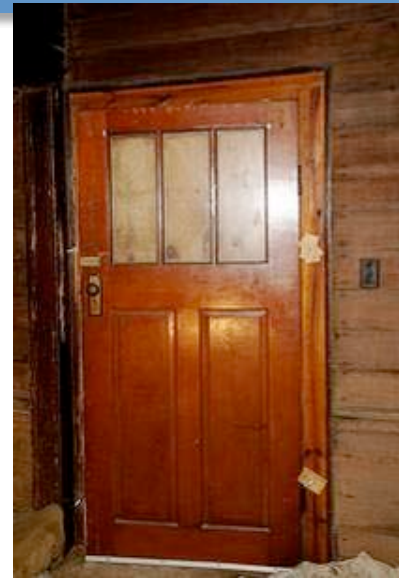
Fig III-88. Door D5, note varnished finish.

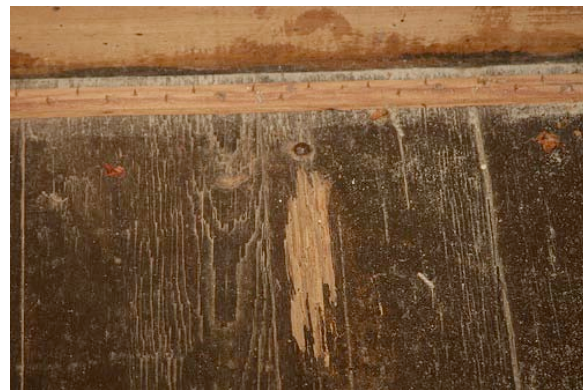
Fig. III-89. Dark paint or stain on wood flooring, Room 102.

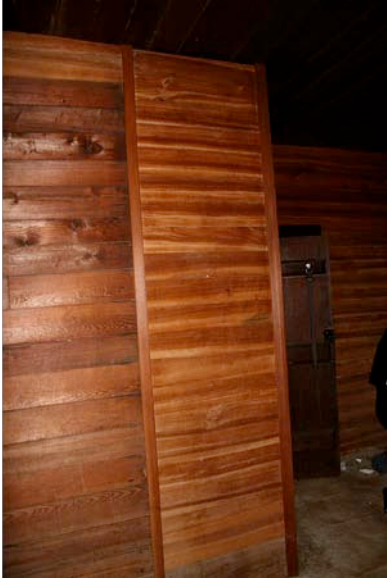
Fig. III-90. New paneling in closet (Room 102).

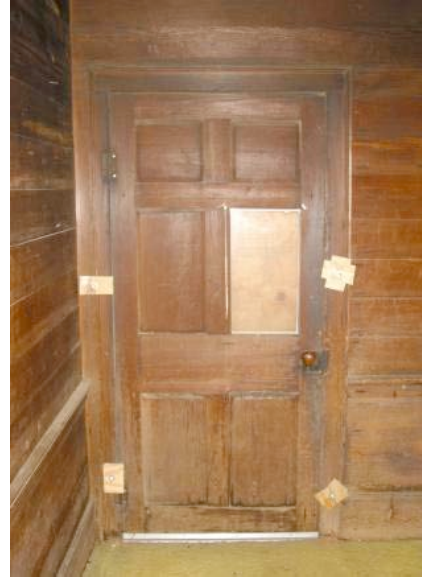
Fig. III-104. Door D11, note Cross-and-Bible configuration.

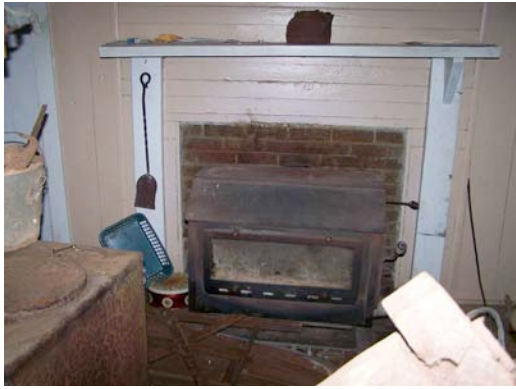
Fig. III-110. Room 106 fireplace.

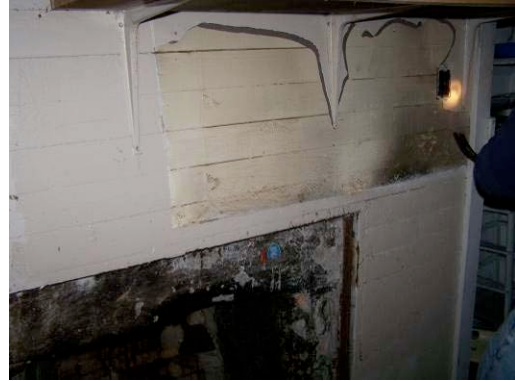
Fig. III-115. Room 107, patch pulled away to reveal original board siding.

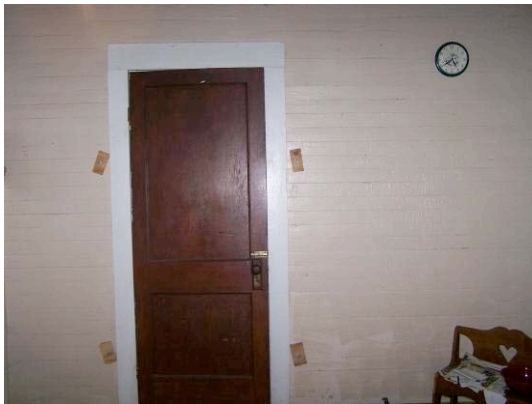
Fig. III-119. Room 107 Door (D16) on the east side.

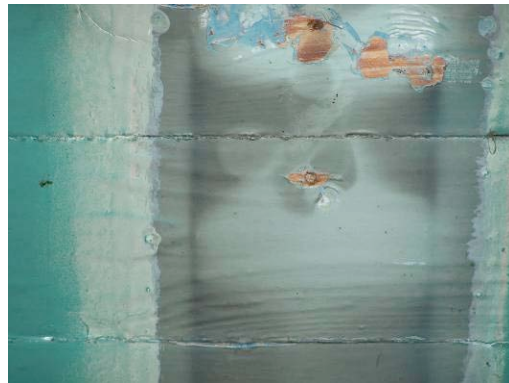
Fig. III-121. Room 107, ceiling.

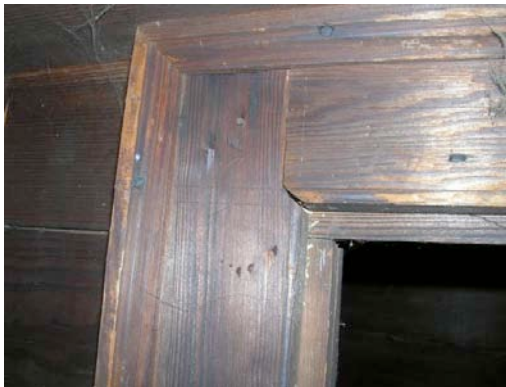
Fig. III-131 Door frame to Room 201. Door is missing therefore not numbered.

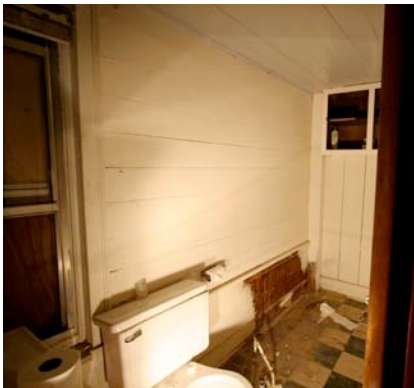
Fig. III-134. Room 204: West wall with shelves. The window and chair rail are on the south wall.

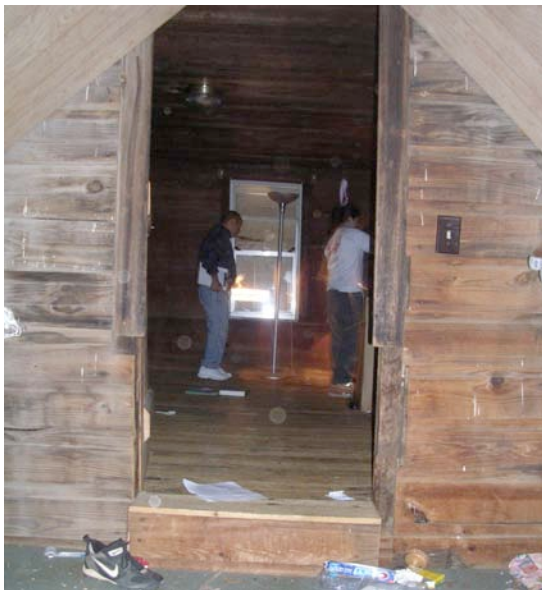
Fig. III-139. Unpainted exterior sheathing boards of the south wall, as shown from inside Room 206 looking north to Room 205.

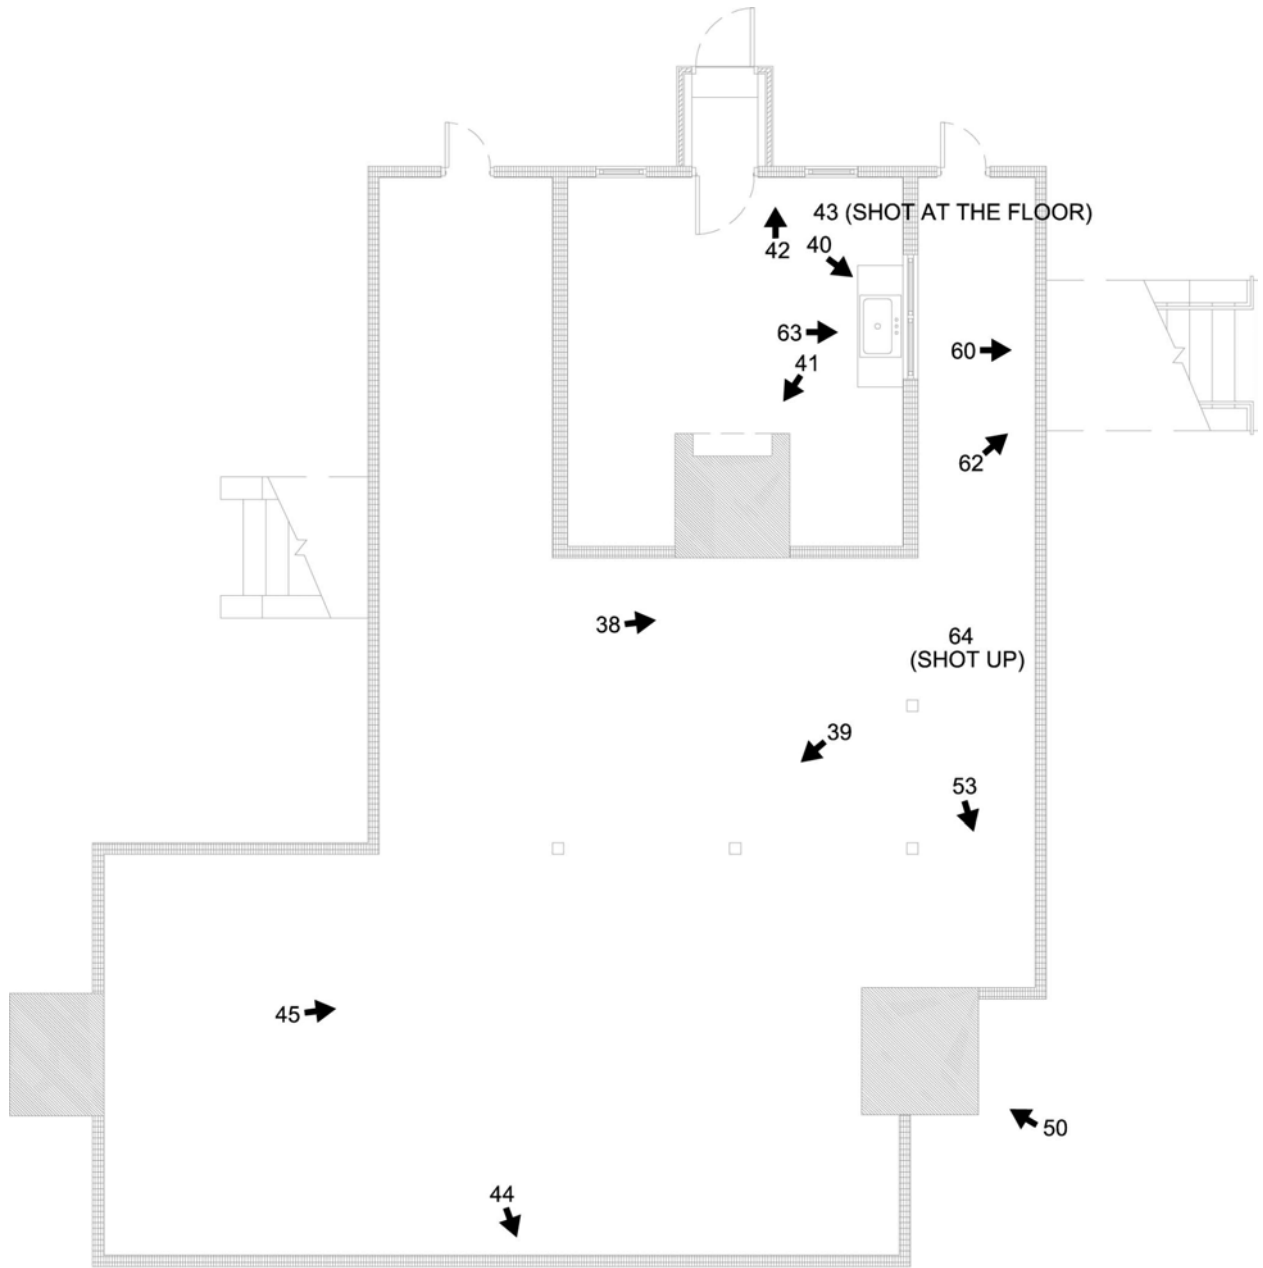
PART III: BASEMENT FLOOR AND FOUNDATION PHOTO KEY

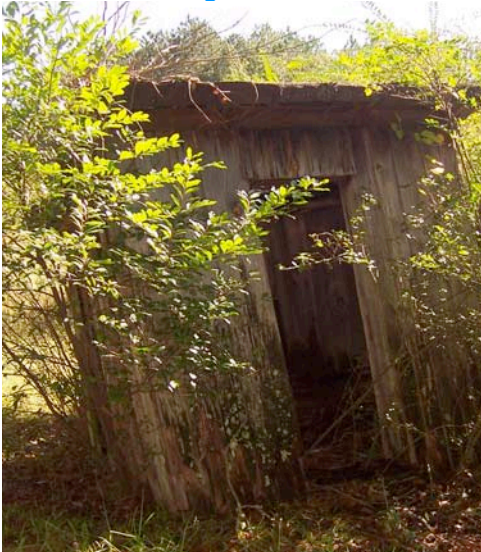
Fig. IV-2. Vegetation encroaching on privy.

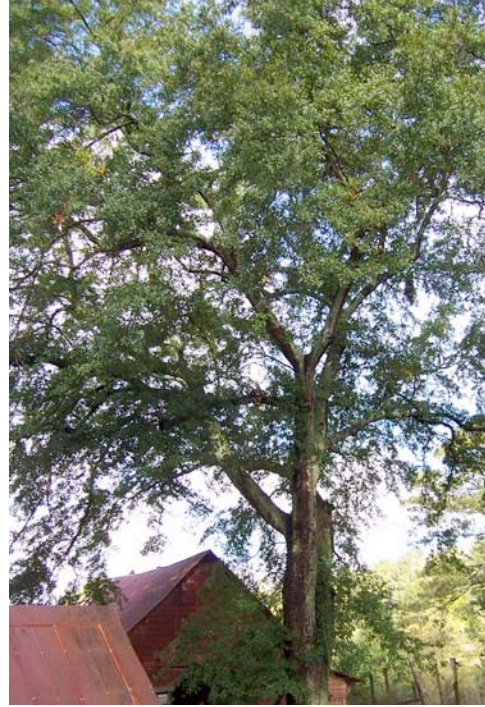
Fig. IV-3. Looking west. Historic oak tree growing over barn.

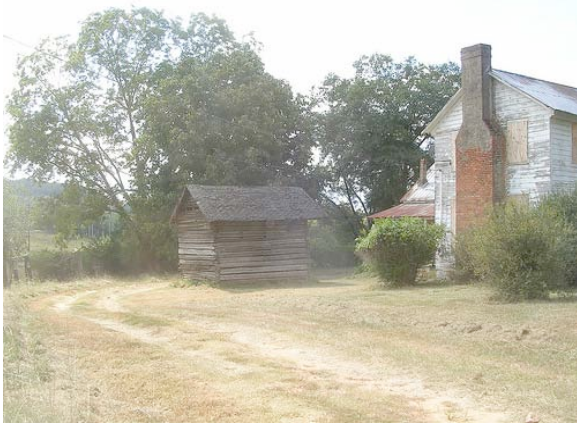
Fig. IV-5. Smokehouse located southeast of the Lyon House.

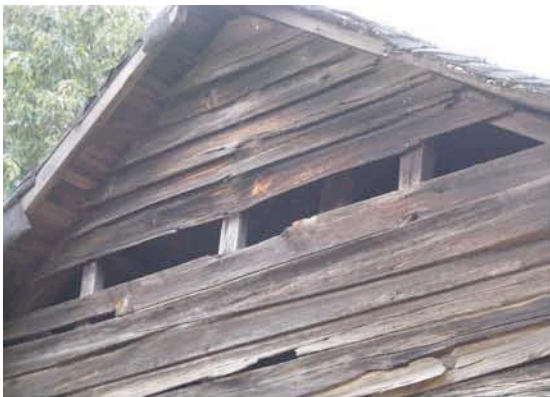
Fig. IV-6. Ultraviolet damage to the east gable end of the smokehouse. Notice that some of the boards have started to buckle and that others are missing.

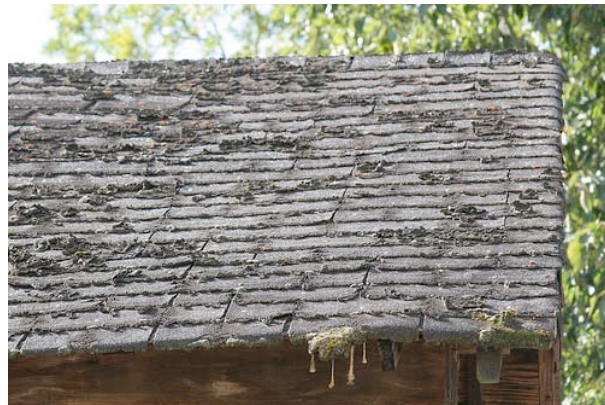
Fig. IV-7. Deteriorating asphalt shingles on the north plane of the smokehouse roof

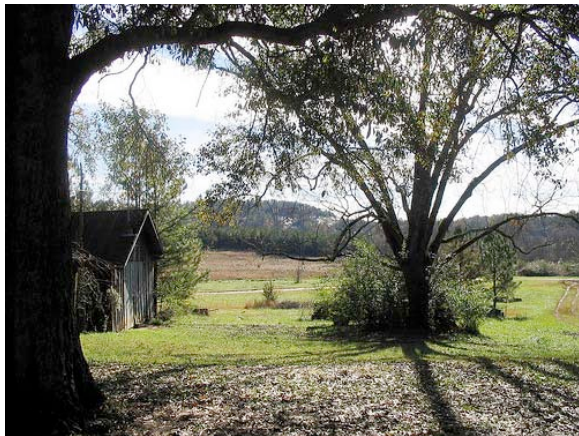
Fig. IV-9. Looking south from the Lyon House. The north and west facades of the workshop are visible.

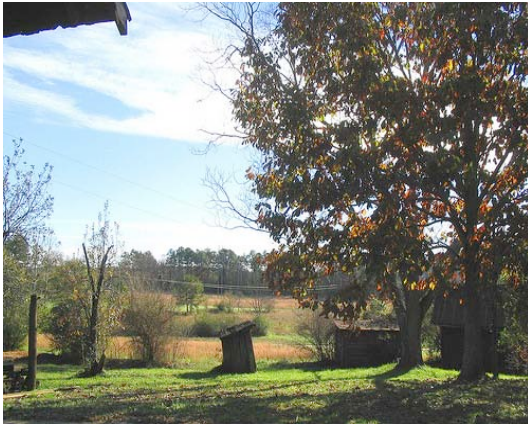
Fig. IV-11. Looking southeast from the Lyon House, with the privy at center and single pen on the right. (Photo by J. Brinkman 2004)

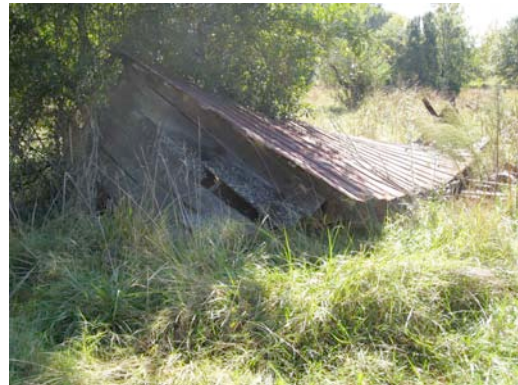
Fig. IV-14. Unknown structure located east of the Lyon House, which collapsed prior to the commencement of the HSR.

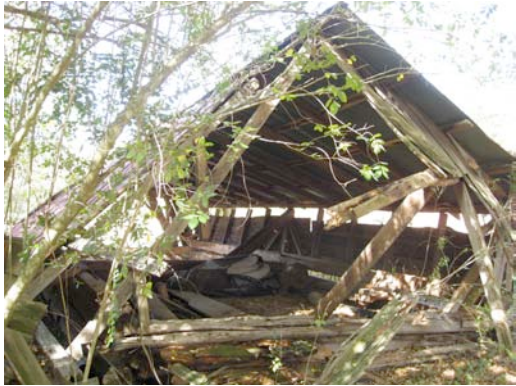
Fig. IV-18. What remains of the east facade of the small barn.

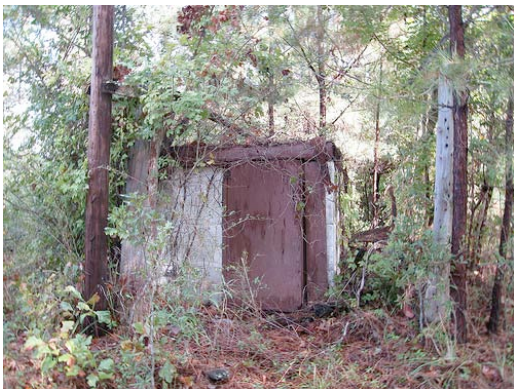
Fig. IV-19. Well structure surrounded by overgrown vegetation.

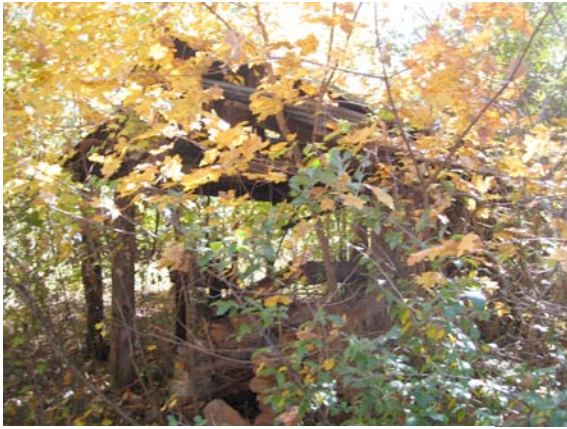
Fig. IV-20. Sorghum boiler.

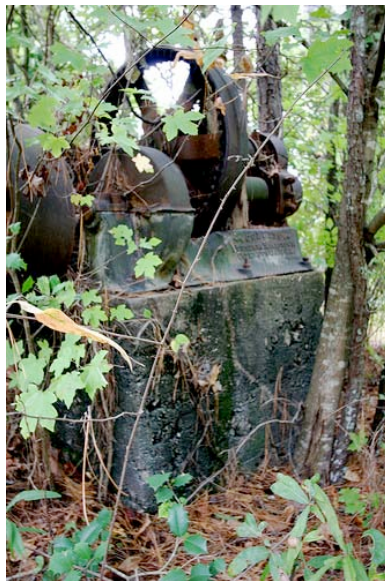
Fig. IV-22. Cane mill surrounded by vegetation.

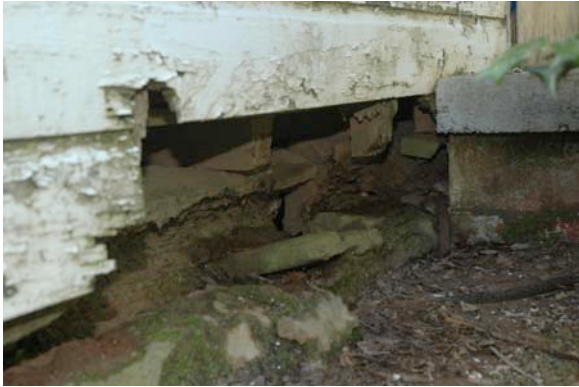
Fig. IV-23. Termite damage to sill on north facade.

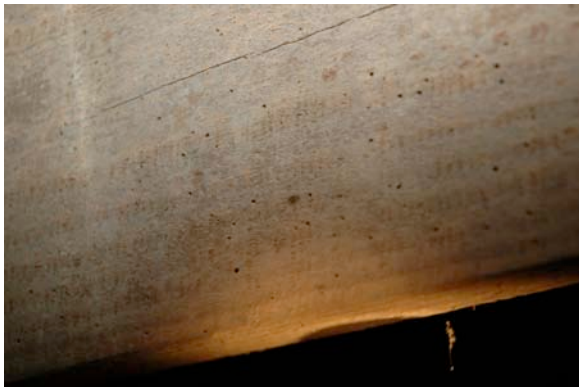
Fig. IV-24. Powderpost beetle damage to south sill.

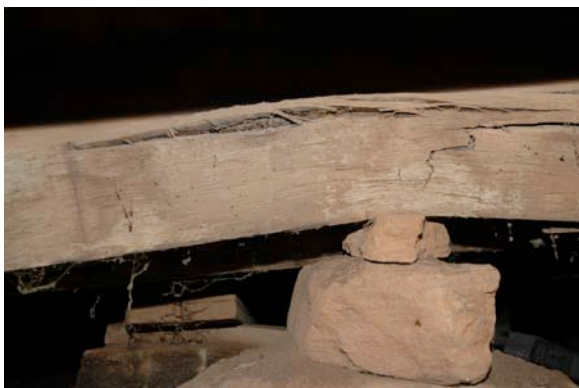
Fig. IV-25. Looking east, showing damage to the summer beam.

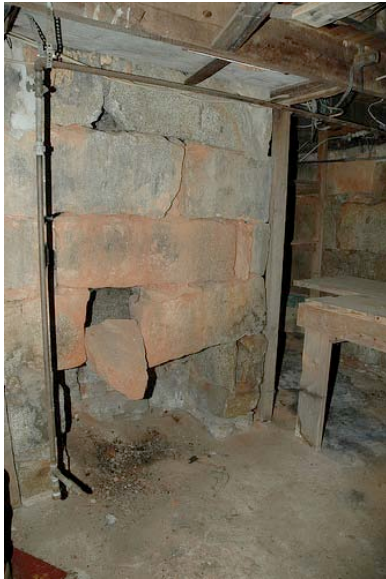
Fig. IV-26. Looking north in Room 001 at the granite fireplace.

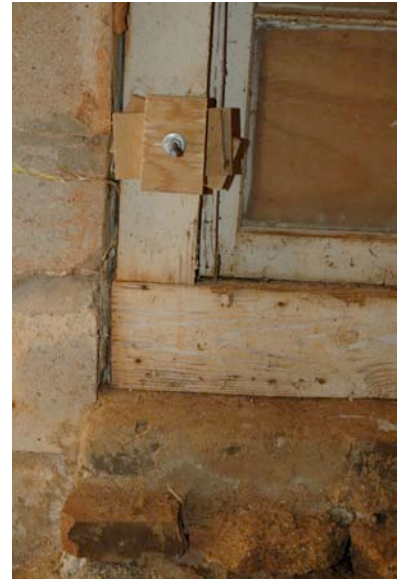
Fig. IV-27. Close-up of window W2 showing damage to frame due to bolted-on plywood.

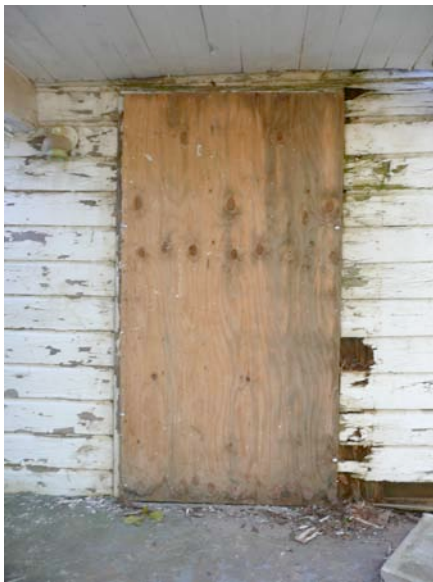
Figure IV-28 Door (D5) covered with plywood.

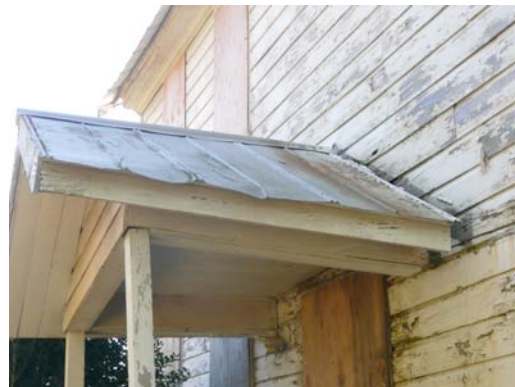
Figure IV-30 Portico (North facade). Notice detachment from house.

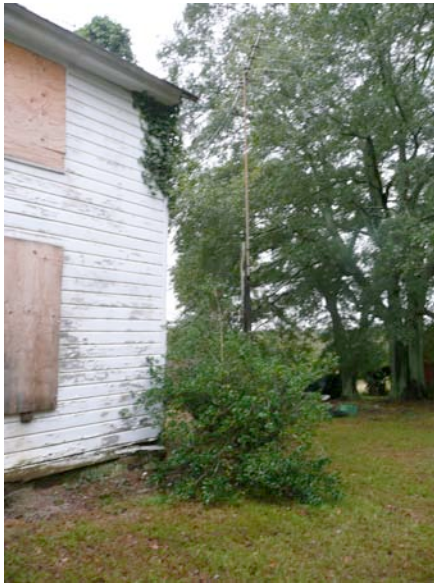
Figure IV-31 Northwest corner. Notice damage to boards above foundation, vines growing on wall, and overgrown shrub adjacent to house.

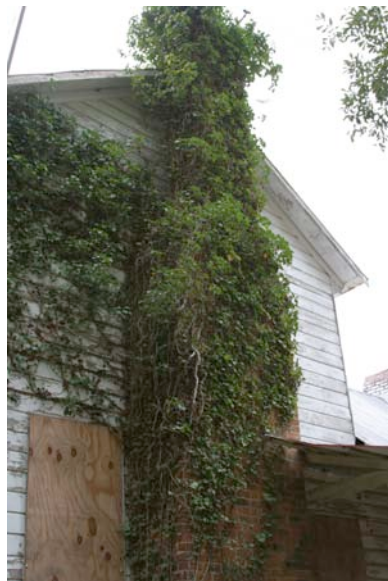
Fig. IV-32. West chimney covered in vines.

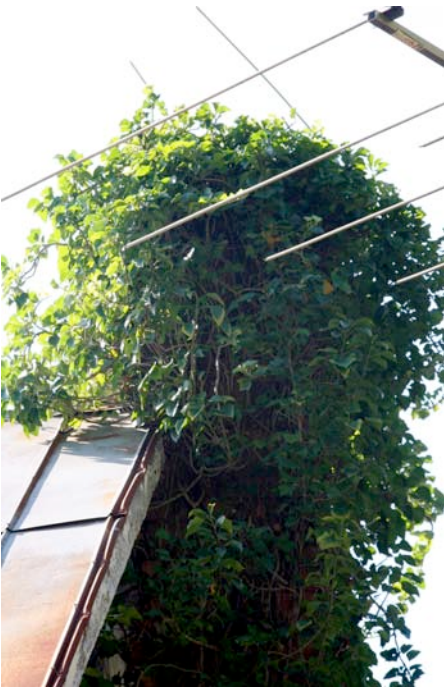
Fig. IV-33. Top of the west chimney, note the television antenna.

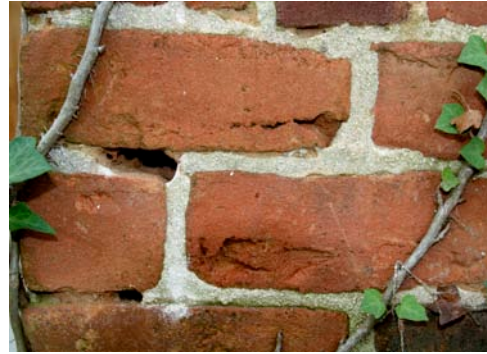
Figs. IV-34 and IV-35. Deteriorated mortar on the west chimney.

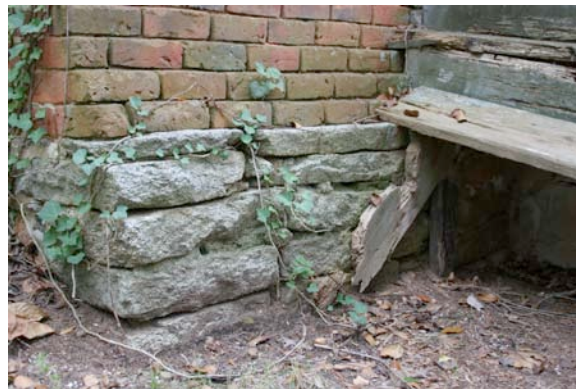
Fig. IV-36. Foundation of west chimney. Notice the missing mortar on the foundation and the bricks above. Also seen are the damaged north steps.

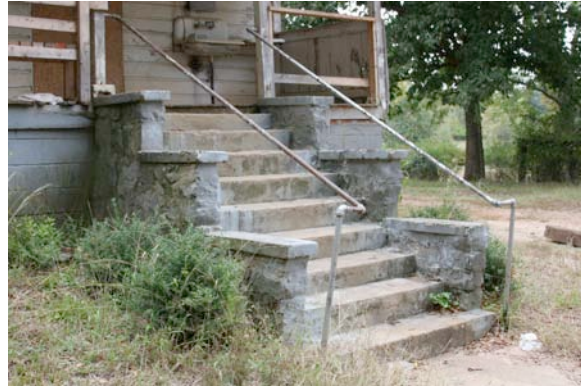
Fig. IV-37. Main stairs to the west porch.

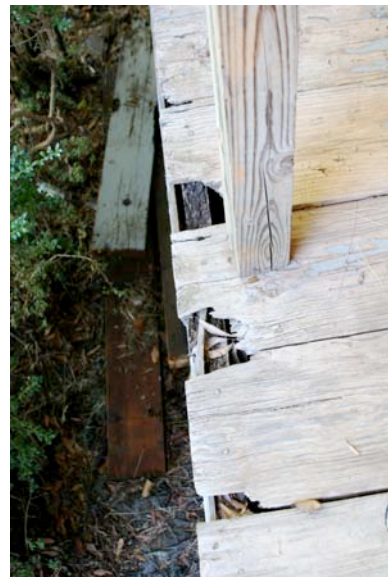
Fig. IV-39. Deterioration at the edges of the porch due to water.

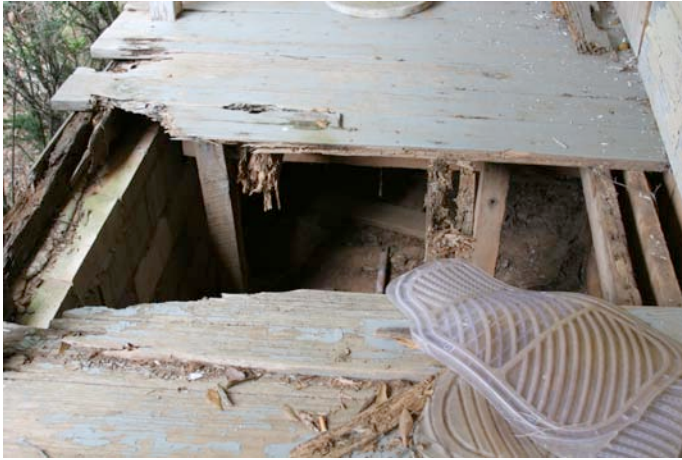
Fig. IV-40. Hole in the west porch due to water and termites.

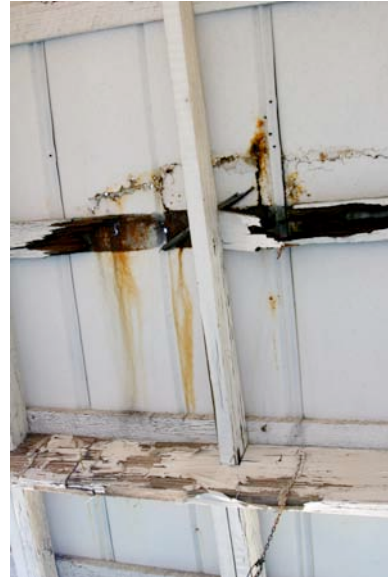
Fig. IV-41. Roofing above the hole in the west porch. Note the rust and damaged wood supports. There are also several small holes in the material.

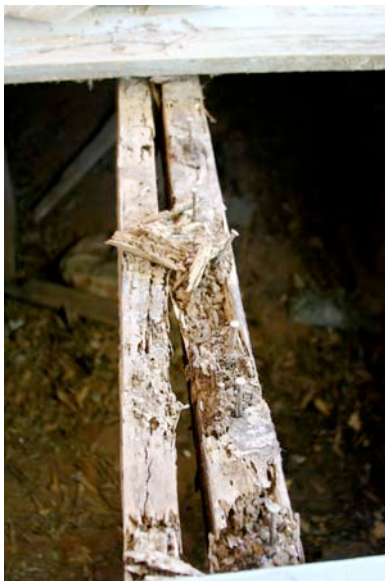
Fig. IV-42. Damaged porch support due to termites.

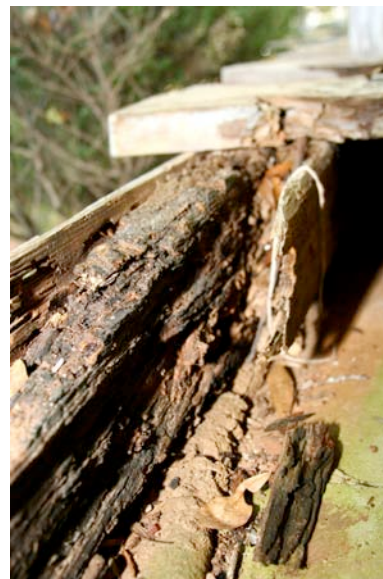
Fig. IV-43. Outside sill of the west porch damaged by water and possibly termites.

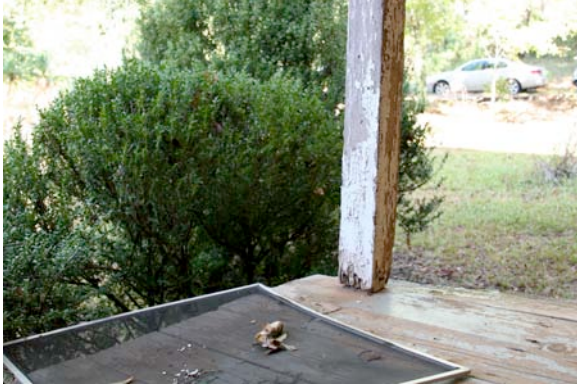
Fig. IV-44. Support on the north end of the west porch. Not the wear on the end of the post.
