Lyon House

Amanda Brown

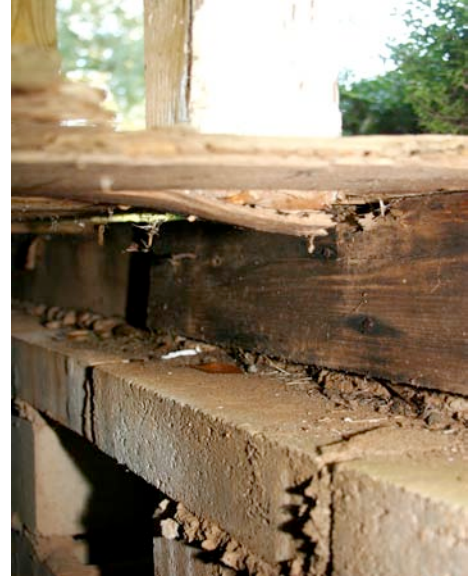
Fig. IV-45. Close up of one of the supports next to the hole in the west porch. Note the deterioration under the floor where the post is not supported.

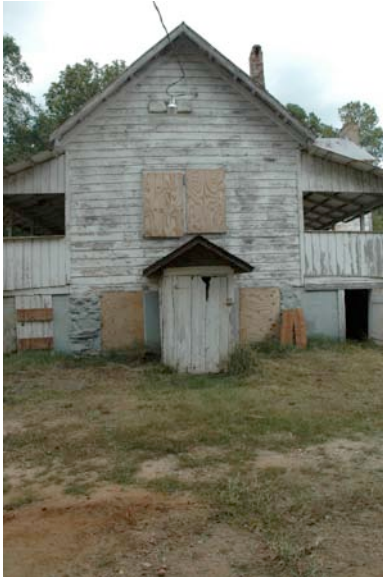
Fig. IV-46. The south façade of the rear ell.

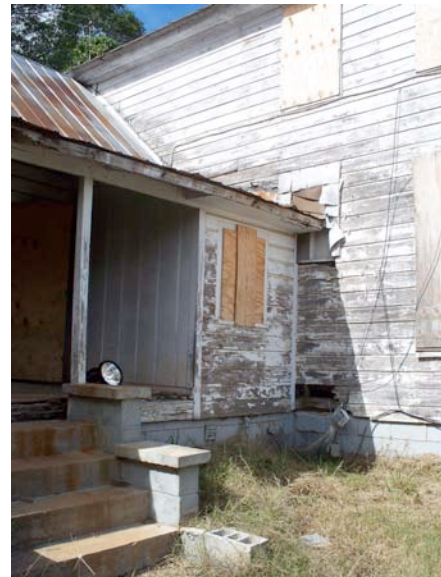
Fig. IV-47. The junction of the east façade with the south façade of the I-house, showing damage to the siding.

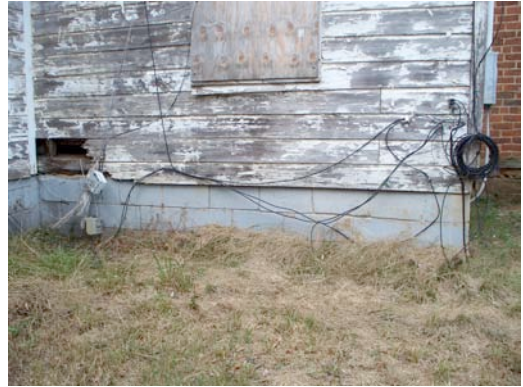
Fig. IV-48. CMU foundation on the east façade.

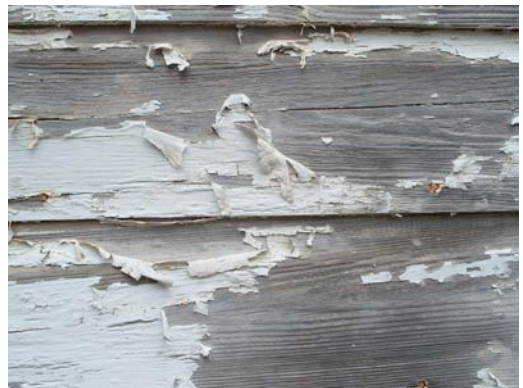
Fig. IV-49. Paint deterioration on the east façade

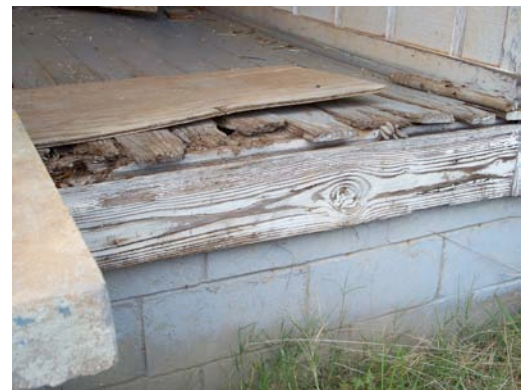
Fig. IV-50. Deterioration of wood floorboards on East Porch.

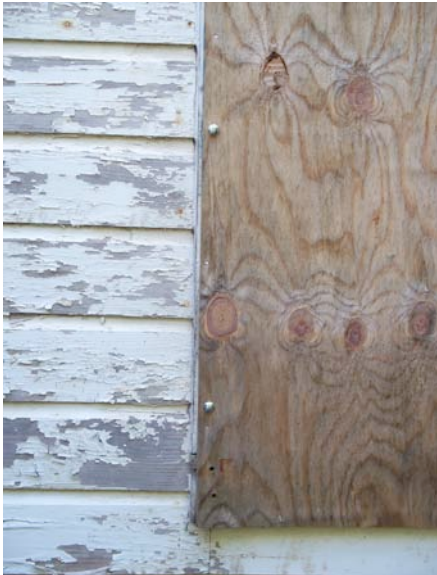
Fig. IV-51. Protective plywood panels that were mounted to window frames for security.

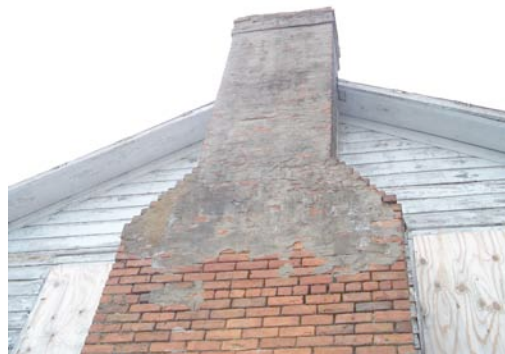
Fig. IV-54. Repair work at top of east façade chimney.

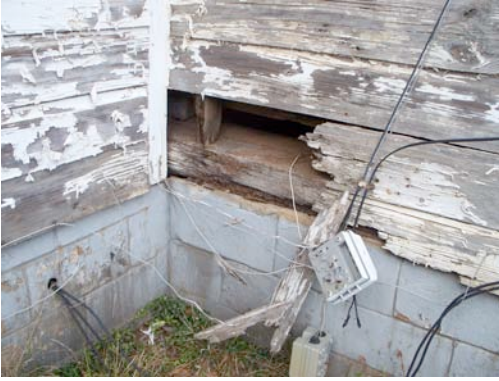
Fig. IV-55. Hole in siding just above foundation.

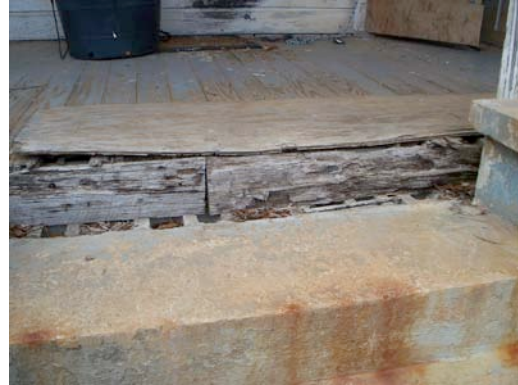
Fig. IV-56. Rust stains caused by runoff from metal roof.

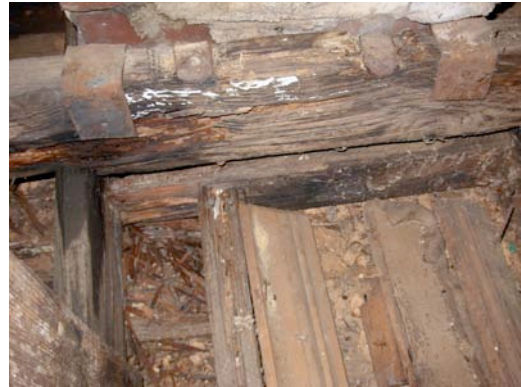
Fig. IV-57. Attic (Room 207). Lack of chimney crickets around the south interior chimney has caused the wood around the chimney to rot. The two metal bars and the joist are used to defer the weight of the chimney from the ceiling to the joist. However, the rot has caused this system to fail and the weight of the chimney now rests on the ceiling.

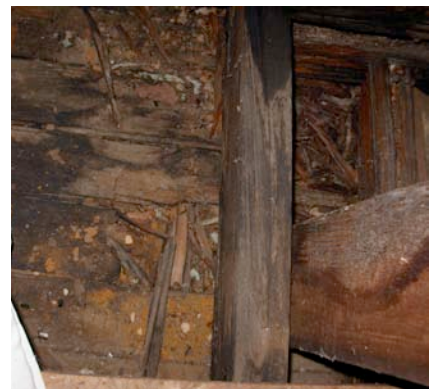
Fig. IV-58. Attic (Room 207). Rot and water damage around the south interior chimney affects the ceiling joists and the wood that forms the ceiling.

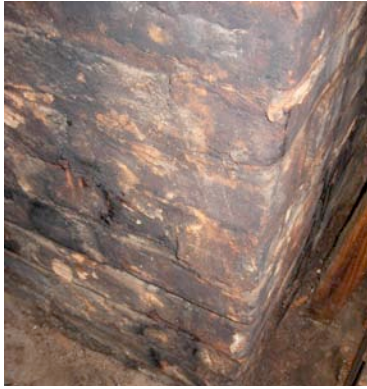
Fig. IV-59. Attic (Room 207). Buildup of creosote on the exterior bricks of central interior chimney. This buildup suggests that there is a crack or opening in the flue.

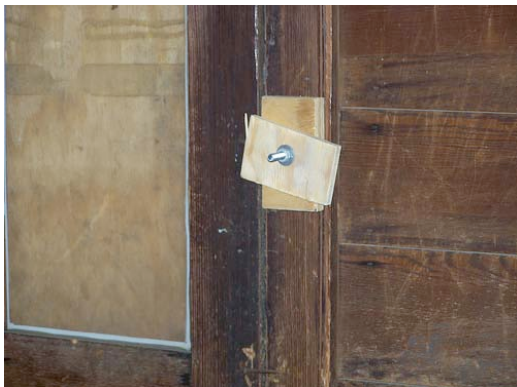
Fig. IV-60. Example of damage to wood frames, Room 105, a result of measures taken to secure the house openings.

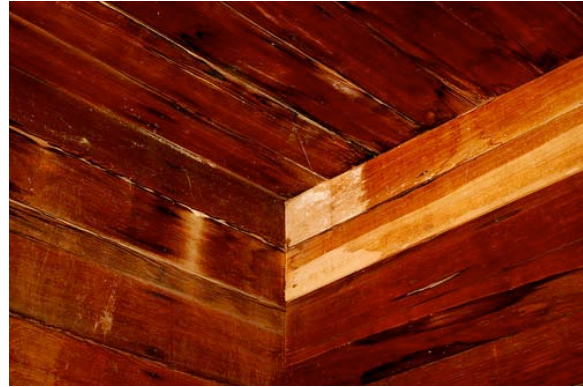
Fig.IV-61. Water damage at ceiling and upper walls, Room 102.

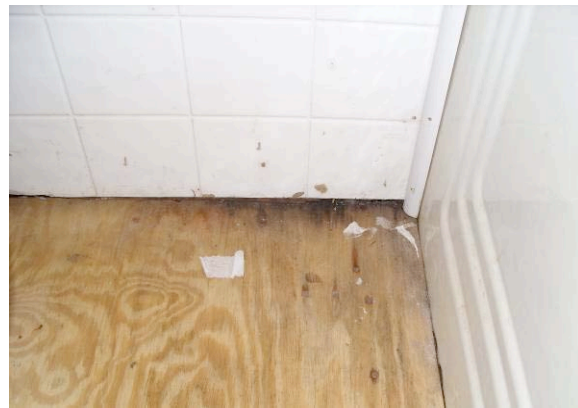
Fig. IV-62. Water damage on plywood subfloor, Room 103.

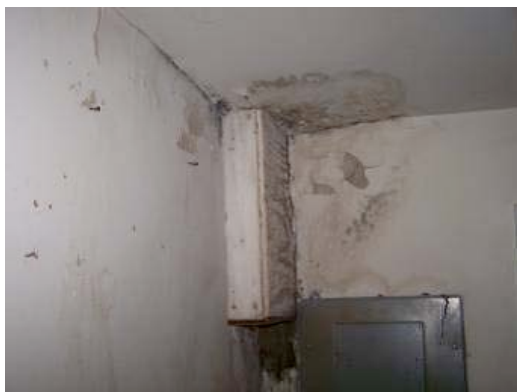
Fig.IV-64. Room 104 . Moisture around fuse box.

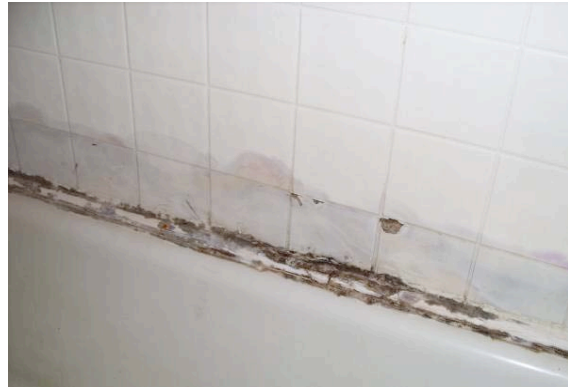
Fig. IV-63. Mildew at tub-tile panel intersection, Room 103.

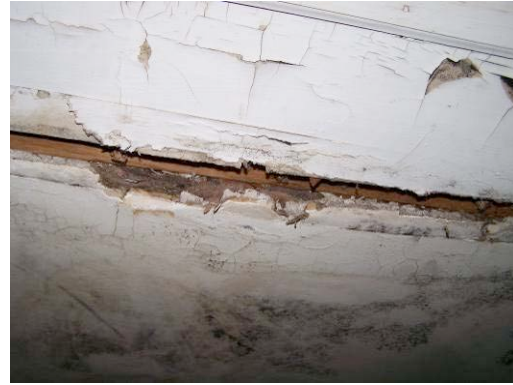
Fig. IV-65. Room 104. Ceiling above entranceway.

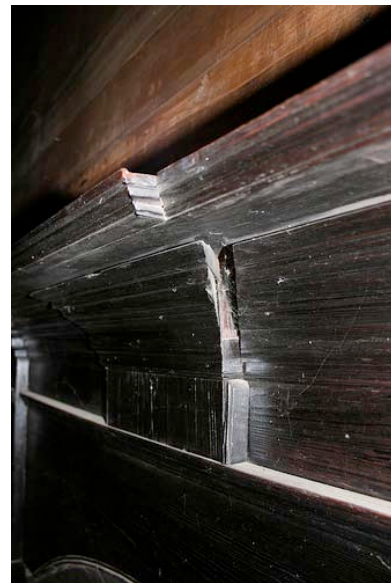
Fig. IV-66. Missing wood trim at fireplace mantel, Room 105.

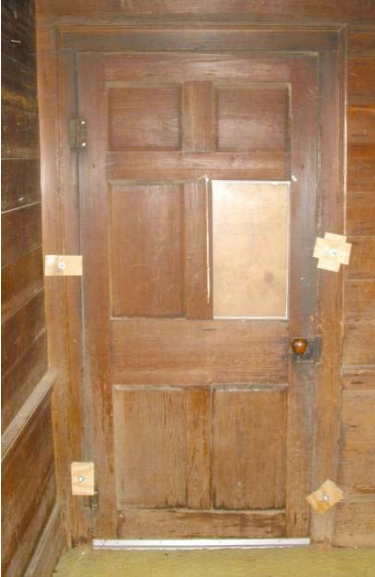
Fig. IV-67. Door D11, note Cross-and-Bible configuration.

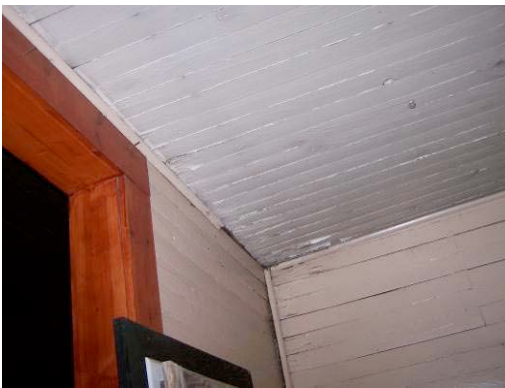
Fig. IV-68. Room 106. Northeast corner has missing shoe mold.

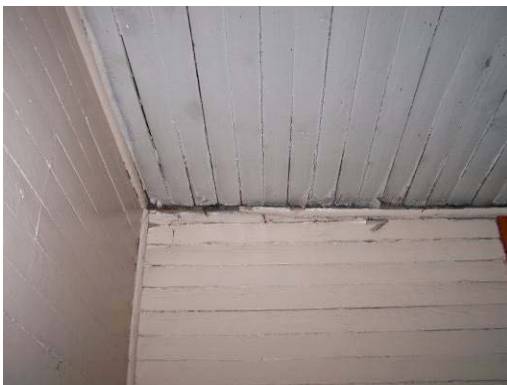
Fig. IV-69. Room 106. Northwest corner has moisture damage and missing shoe molding.

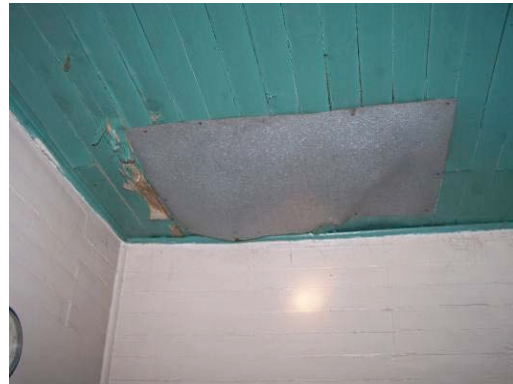
Fig. IV-70. Room 107, ceiling patch, where chimney or flue is subsiding.

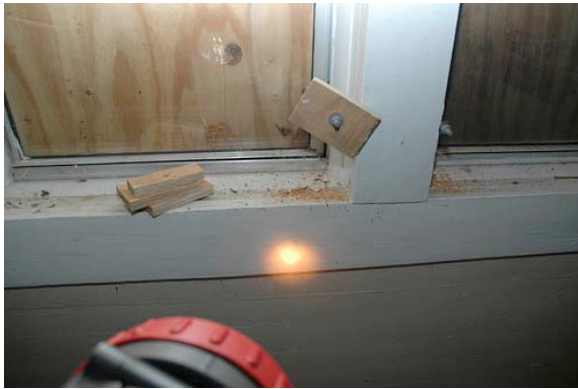
Fig. IV-72. Room 107, (W14).

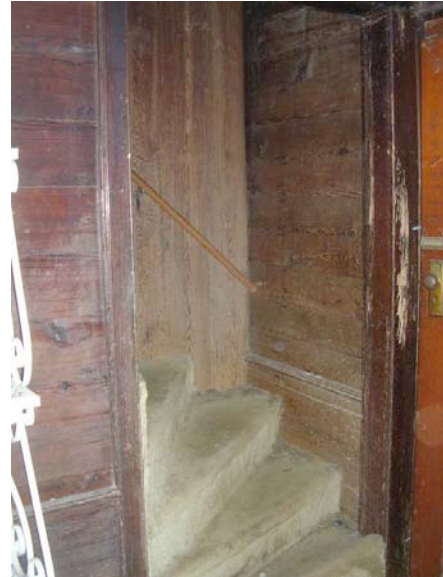
Fig. IV-73. Stairwell entrance to second floor.

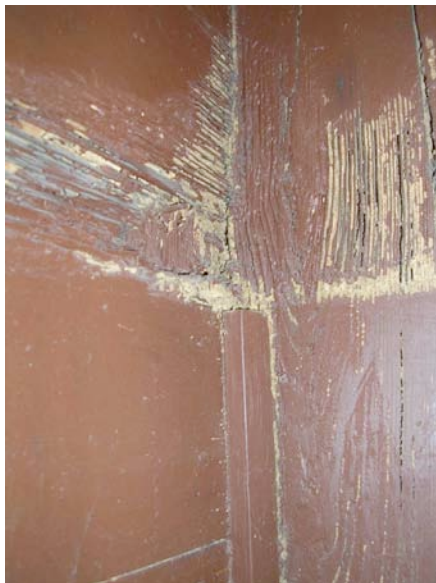
Fig. IV-74. Termite damage to paneling, Room 205.

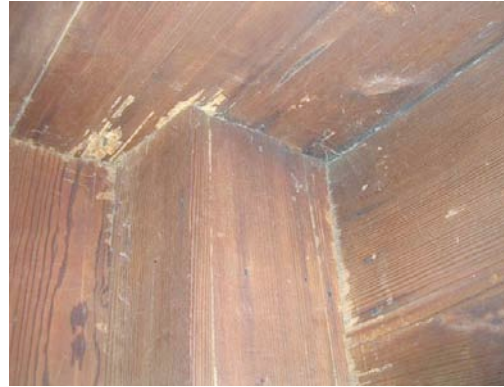
Fig. IV-75. Termite damage to northwest corner Room 203.

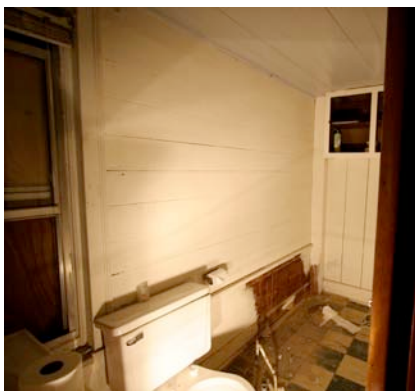
Fig. IV-76. Unpainted wainscoting in Room 204.

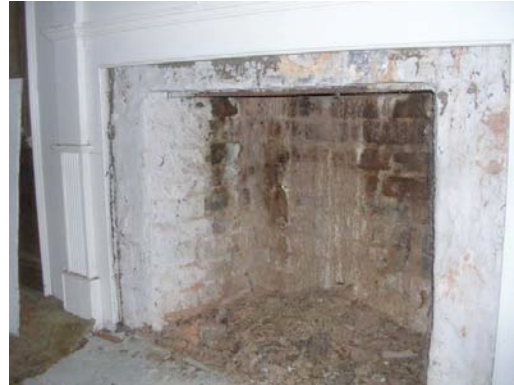
Fig. IV-77. Room 203. Firebox.

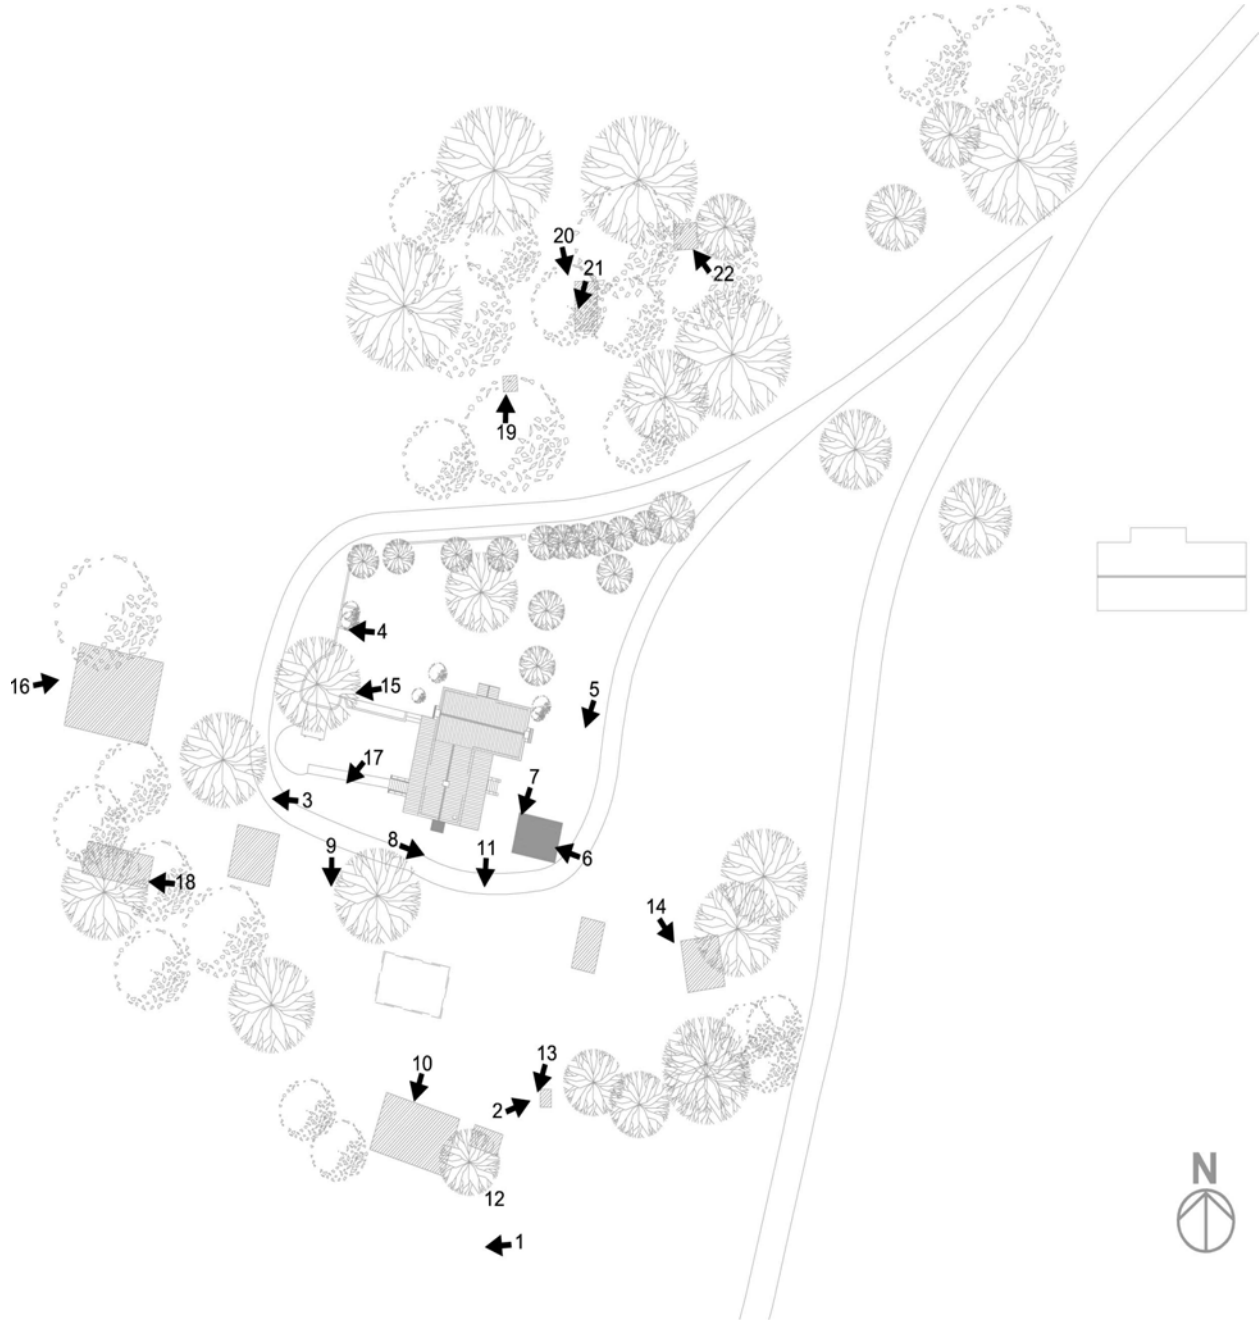
PART IV:: SITE PLAN PHOTO KEY

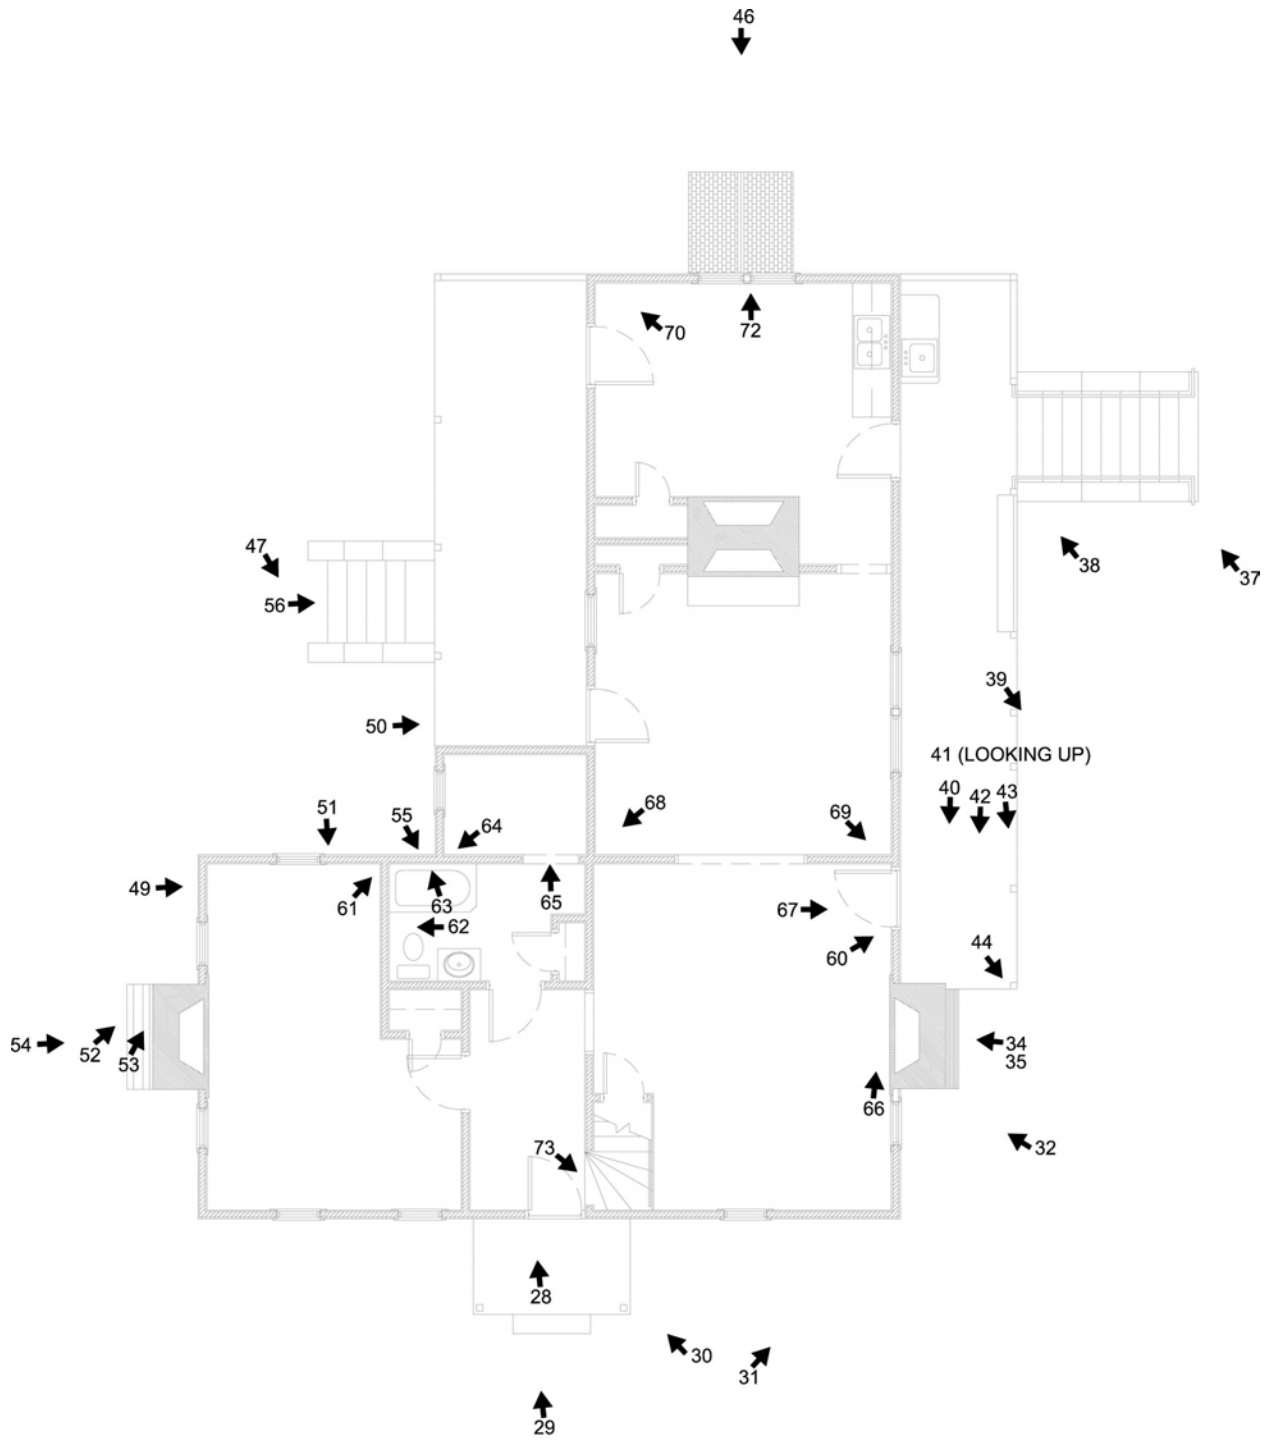
PART IV: HOUSE EXTERIOR AND 1ST FLOOR PHOTO KEY

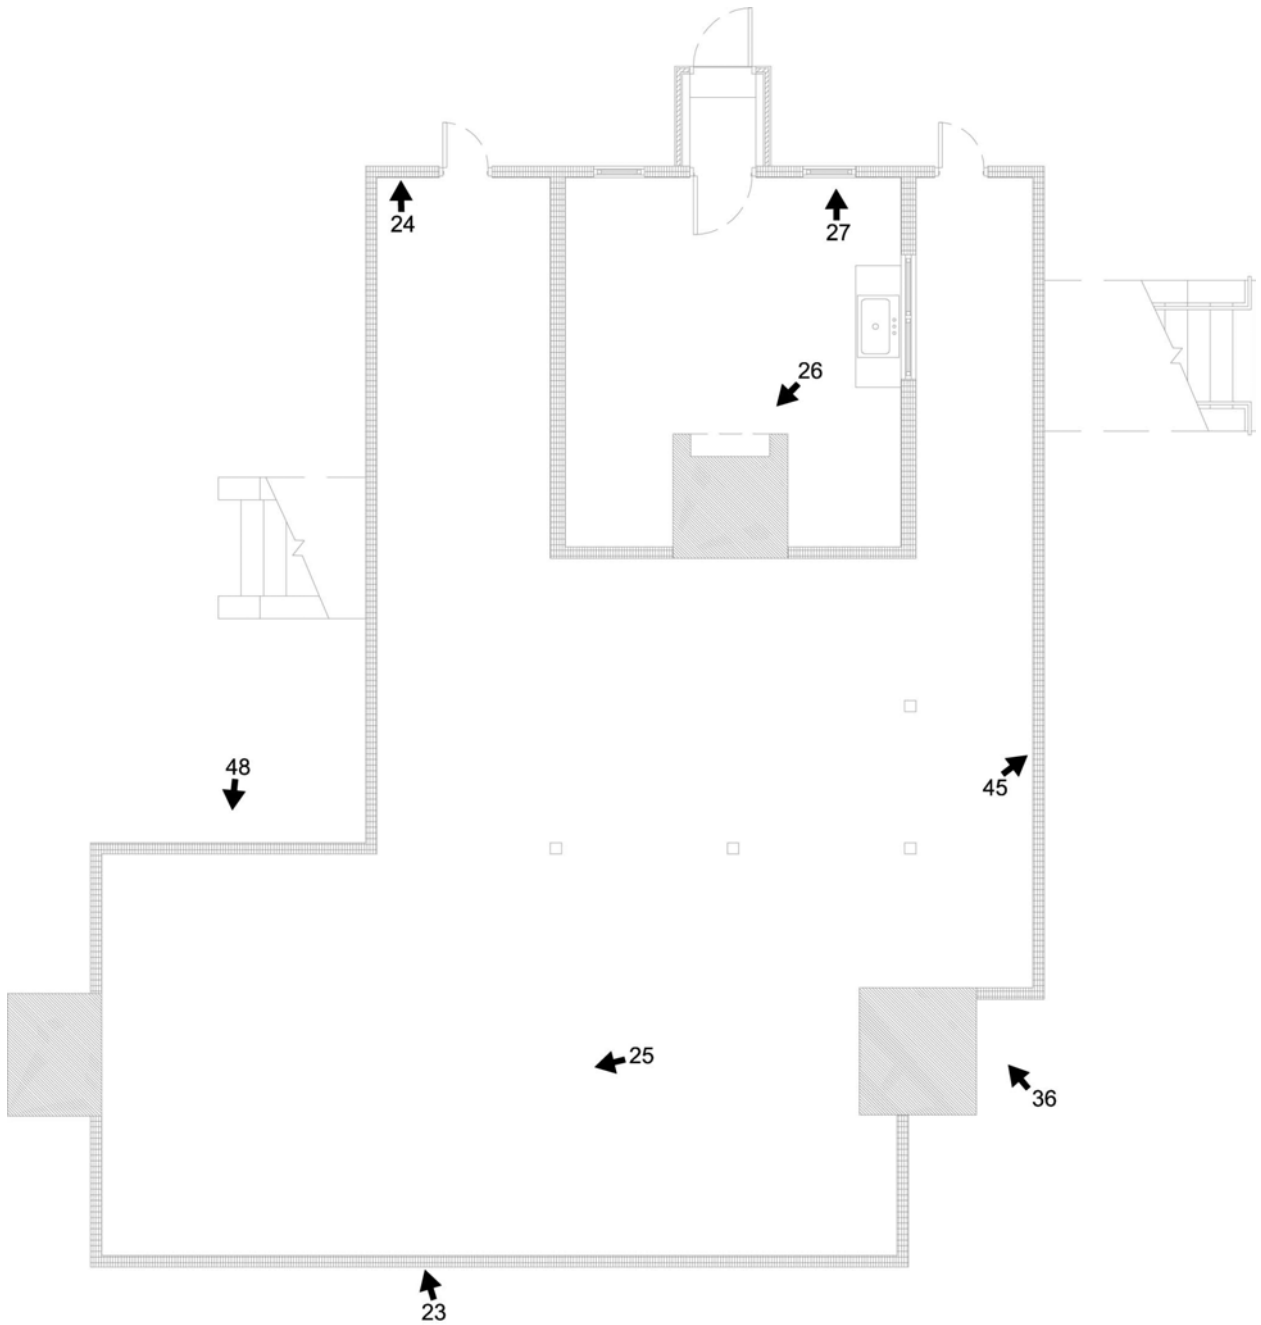
PART IV: BASEMENT FLOOR AND FOUNDATION PHOTO KEY

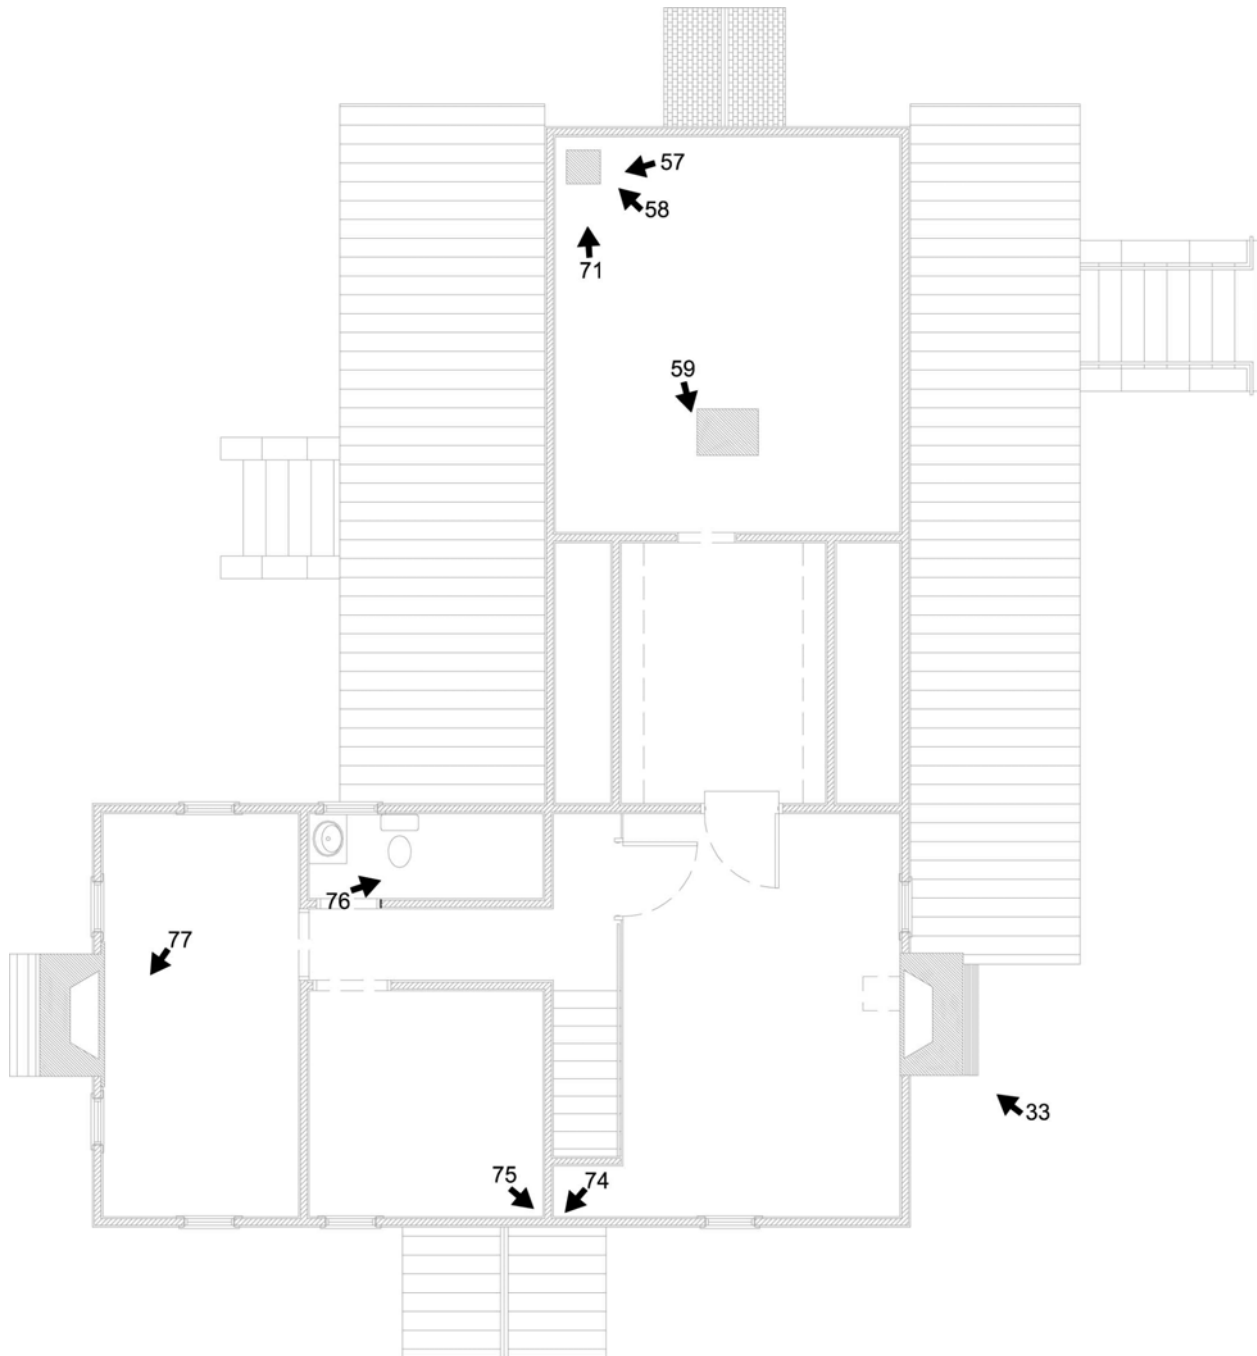
PART IV: 2ND FLOOR PHOTO KEY

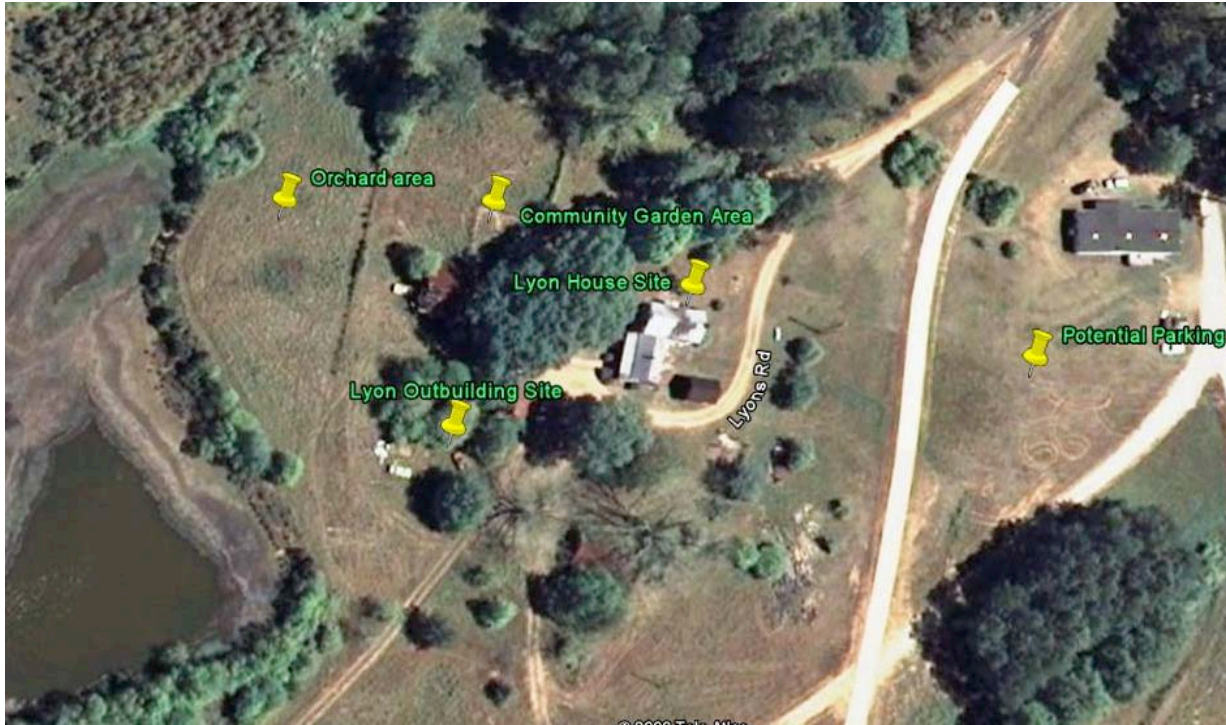
Fig. V-1 Lyon House and property, highlighting landscape interpretative site areas.
(Photo: Google Earth)

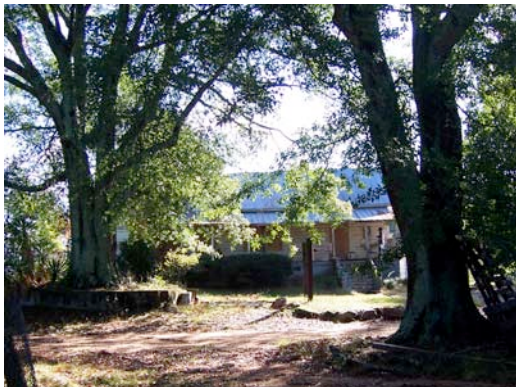
Fig. V-3. Lyon House and property with view of potential kitchen garden area.

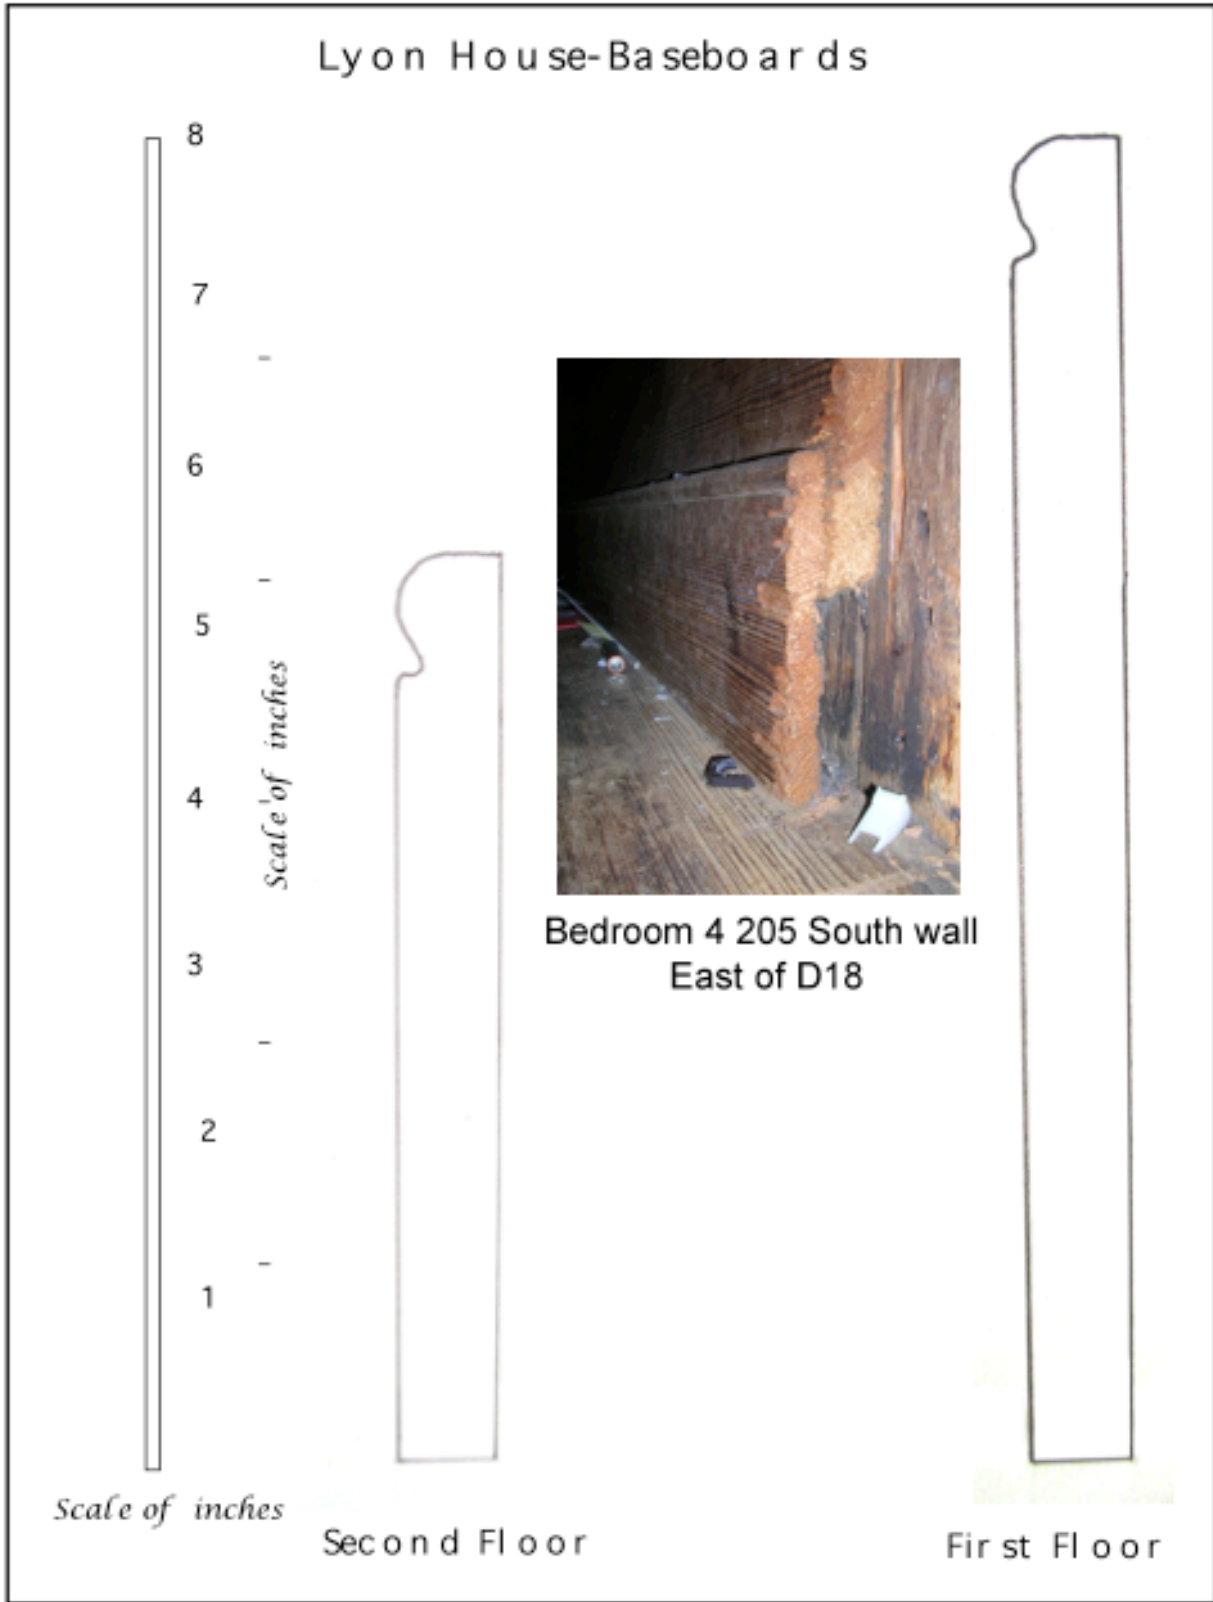
Fascia trim	-N and S facades of the two-story "I" house at the top of the fascia board under the roof edge	-No profile taken due to the interference of roof edge -- fascia trim is deteriorated on upper edge due to decay
