## Sherrill House

# The Sherrill House

Forsyth County, GA

## Historic Structures Report

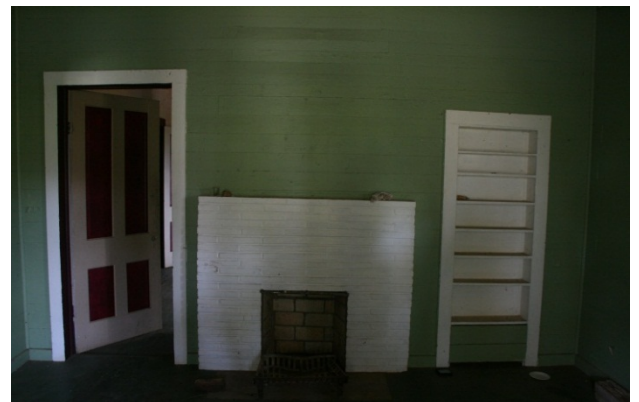
BC Figure 3: Fireplace in Room 104 that is missing a mantel

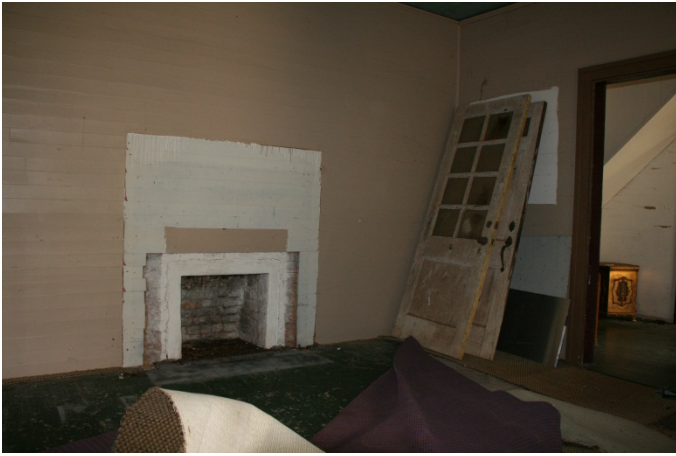
AD Figure 15: Missing mantel from fireplace in Room 101

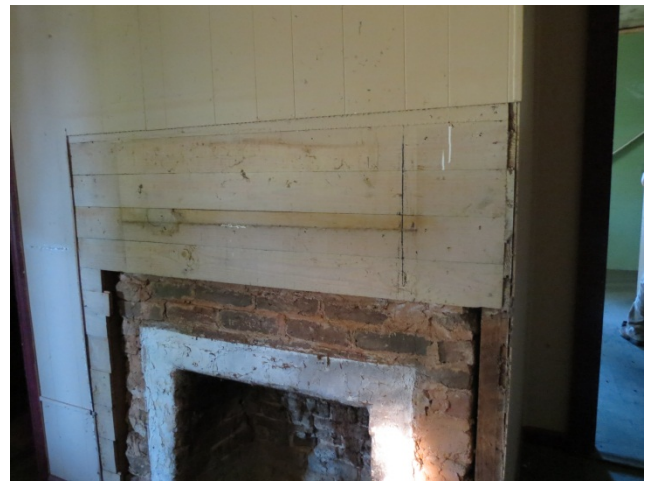
AD Figure 28: Fireplace in Room 105 that is missing mantle

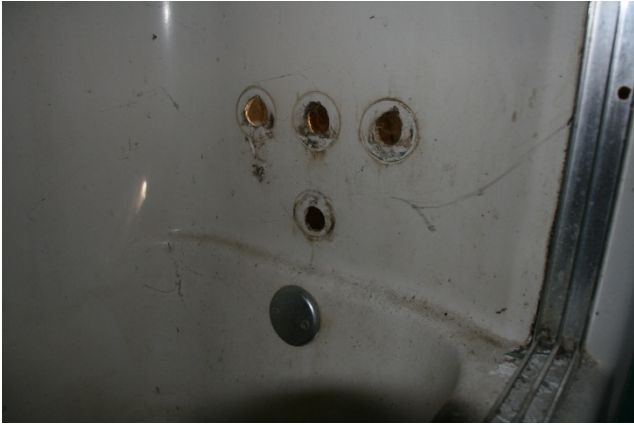
Plumbing is not functional in the house. The fixtures for the bathtub in Room 106 are gone and vegetation is growing in its place (AD Figure 55). Underneath the bathroom sink there are pipes, but they are outdated and rusting. PVC and cast iron pipes are found under Room 106 in the crawl space. There is no piping present in the kitchen, Room 110, although there is a sink present (AD Figure 56). The rest of the Sherrill House does not have any evidence of plumbing. The plumbing system is outdated or has been maintained for a significant amount of time.

AD Figure 55: Missing fixtures in the shower in Room 106

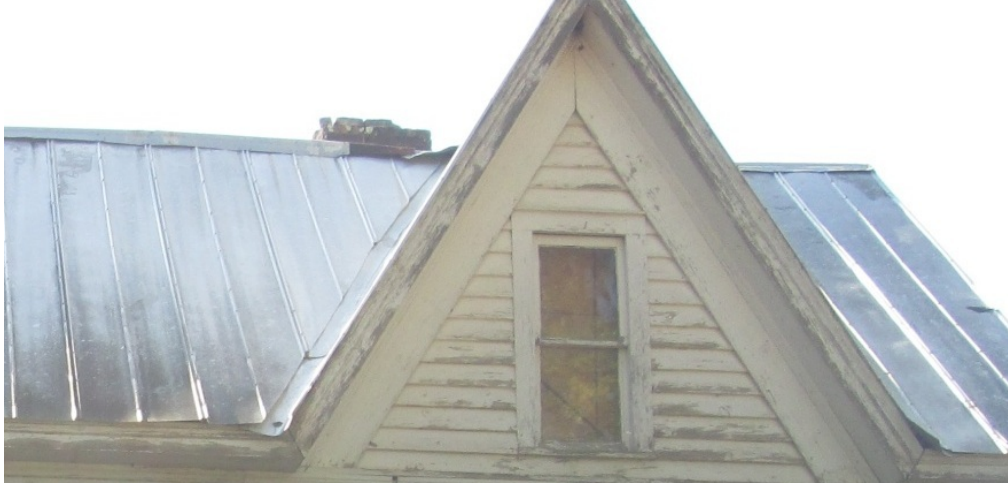
CA Figure 1: Damage to ridgecap, west corner of north facade, facing south.

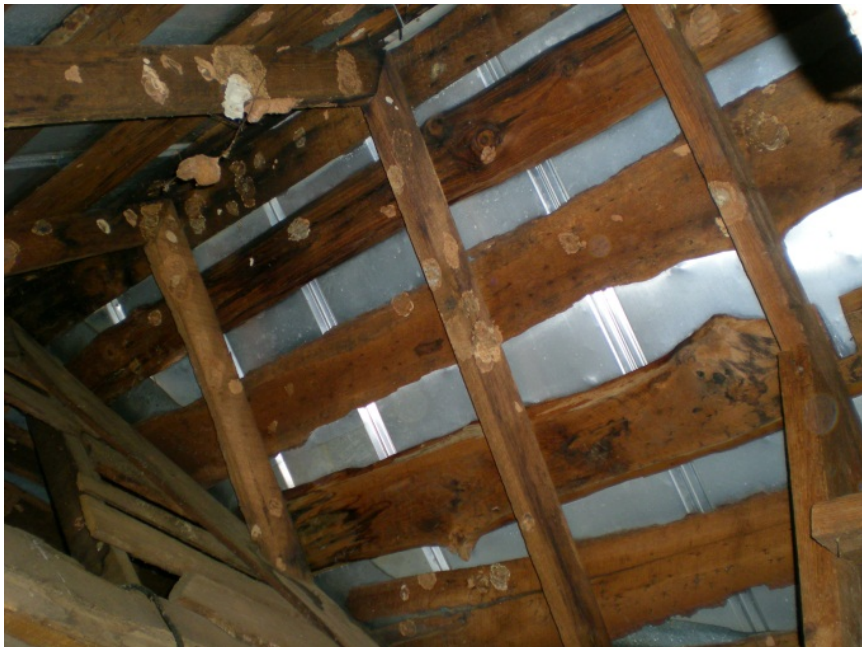
CA Figure 2: Black rot on roof sheathing due to ridge cap damage. Mud daubers nests are present on the sheathing and rafters. North end of attic facing northeast.

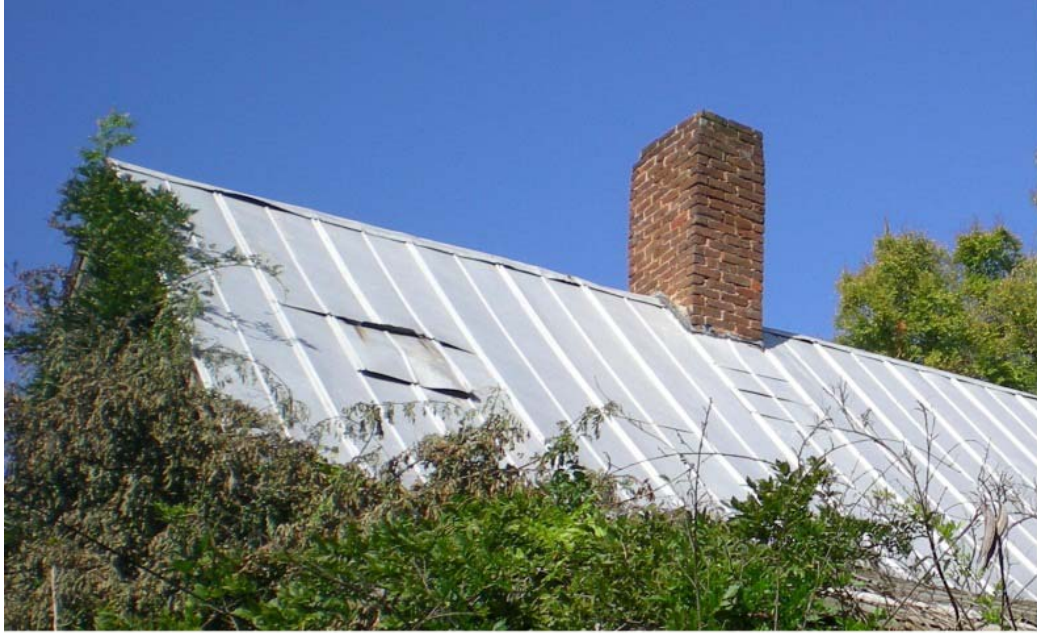
CA Figure 3: Inappropriate repair to roof enables water to enter building. East façade along exterior of room 109, facing northwest.

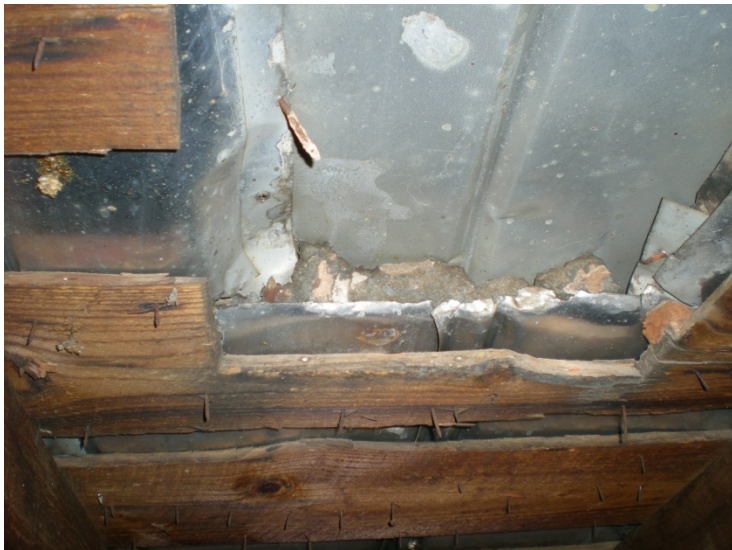
CA Figure 4: Inappropriate roof repair as viewed from the attic facing east.

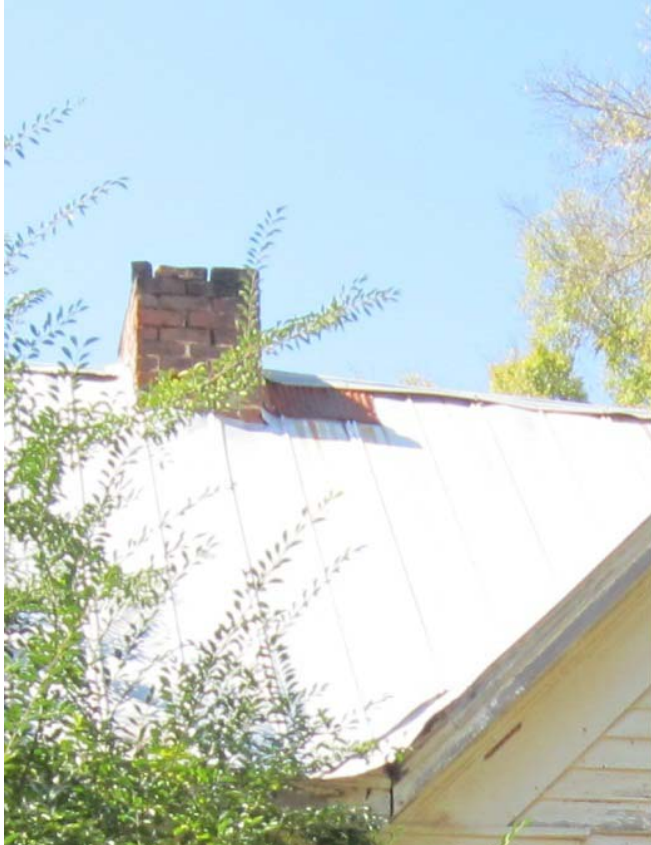
CA Figure 5: Damage to ridge cap and flashing east façade facing northwest. Note galvanic corrosion to repair and lack of flashing around to chimney.

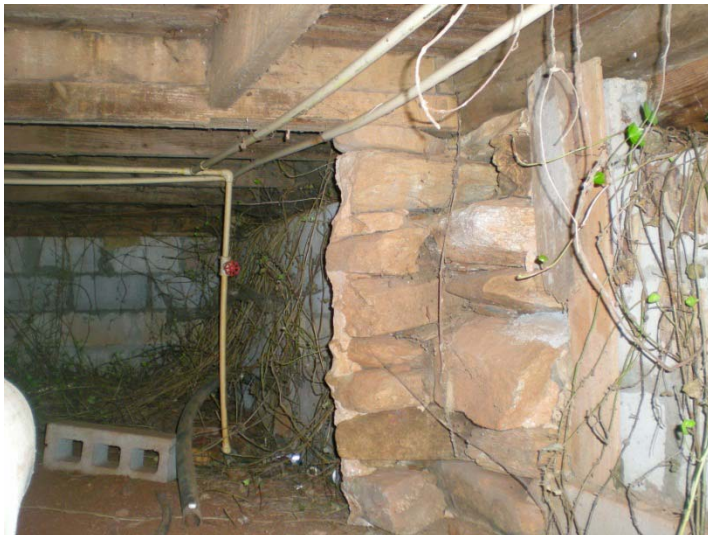
CA Figure 6: Stacked stone, PVC pipes, and CMU infill under Rooms 109 and 110 facing east. Note black rot along sill where vegetation is encroaching.

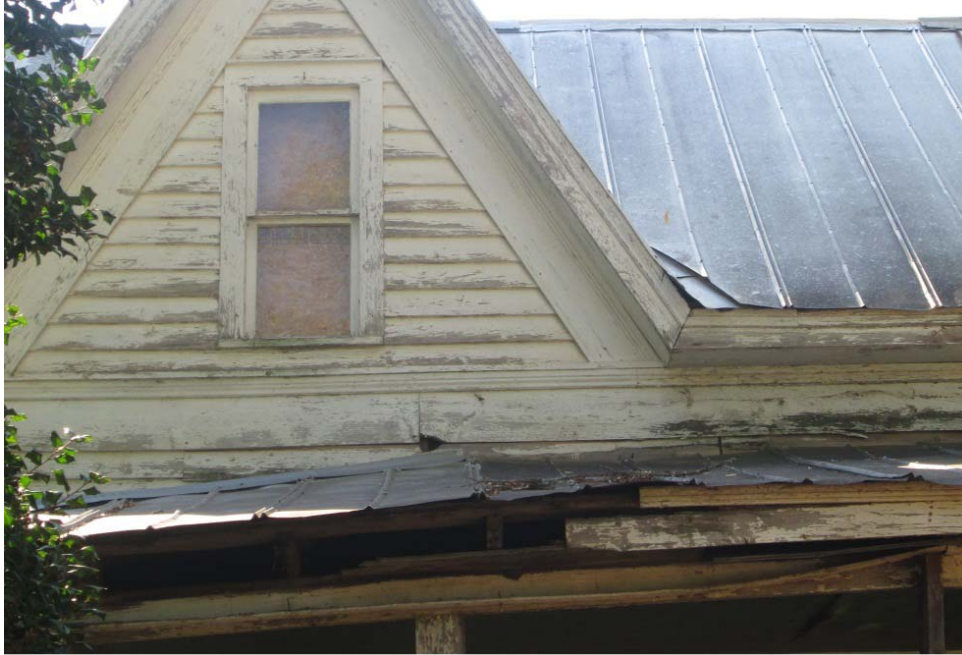
CA Figure 7: Brown rot on the fascia board of porch; northeast corner of porch, north facade.

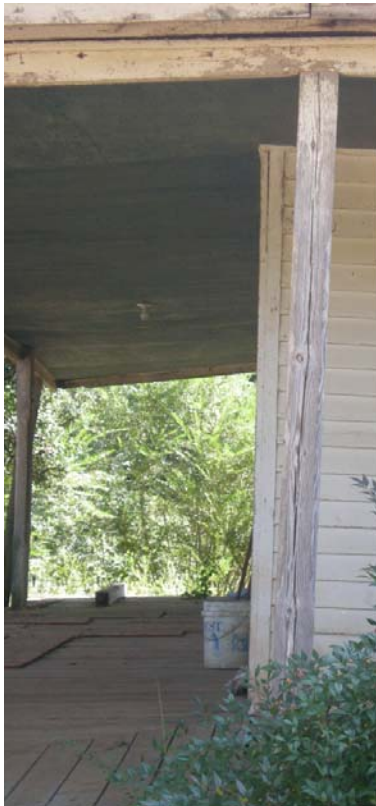
CA Figure 8: Floor boards have been replaced with plywood. Note leaning columns and differing sizes of floor boards. Northwest corner of building facing east.

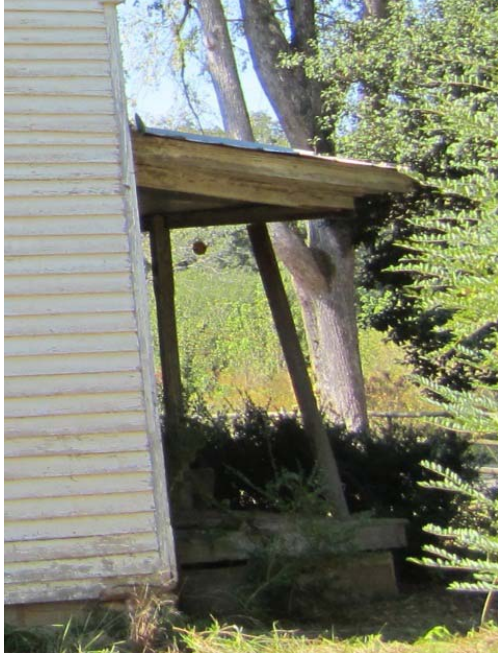
CA Figure 9: Detached column on porch, north facade facing northwest

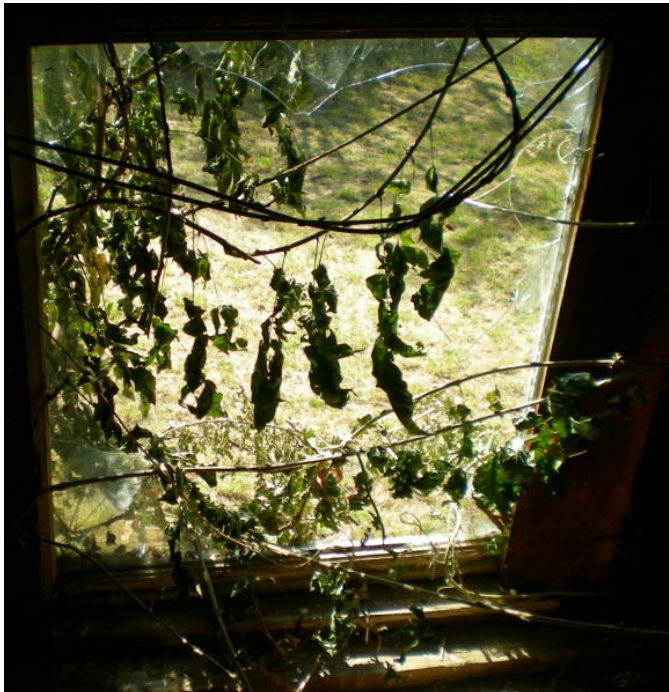
CA Figure 10 Gable window has been broken and left open, allowing vegetation to intrude. Interior of attic, south façade, facing south.

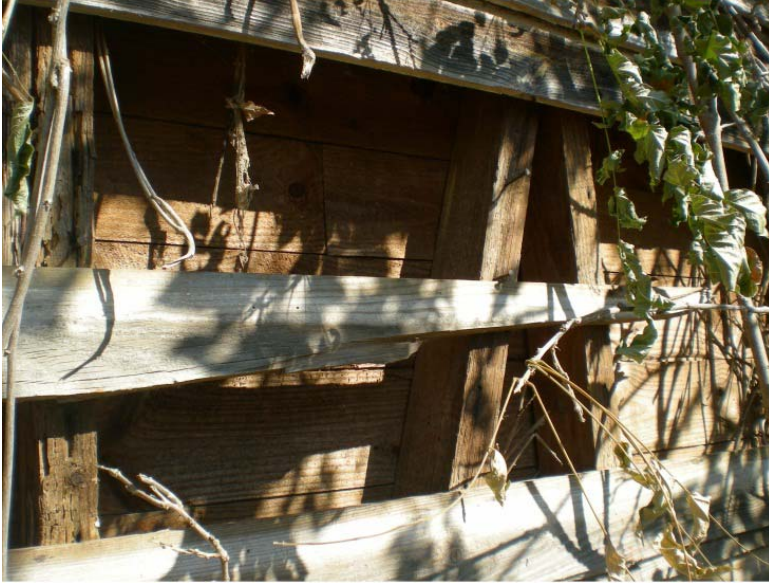
CA Figure 11: Intrusive vegetation and ultraviolet light degradation. Note exposed braced framing and inappropriate repair to siding. South façade facing northeast.

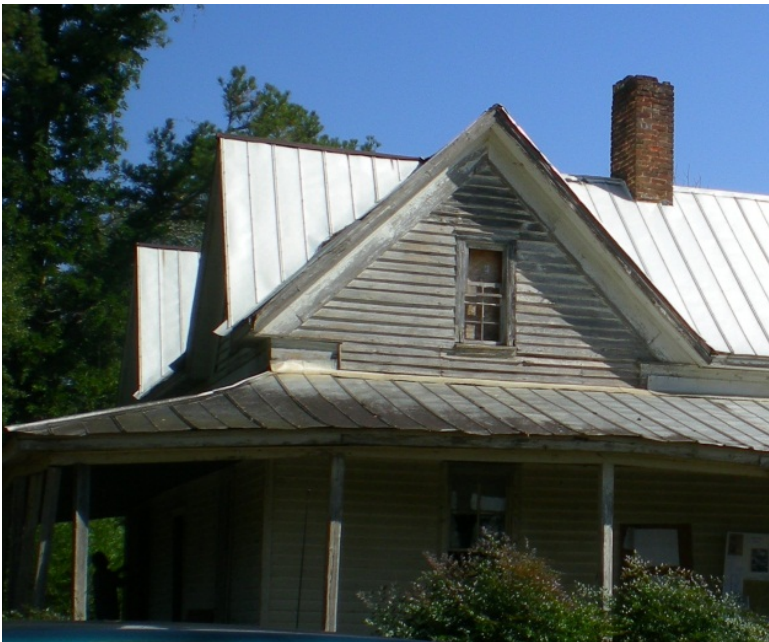
CA Figure 12: Accumulation of debris has resulted in moisture damage to the porch roof. Northwest corner of porch on west facade, facing east.

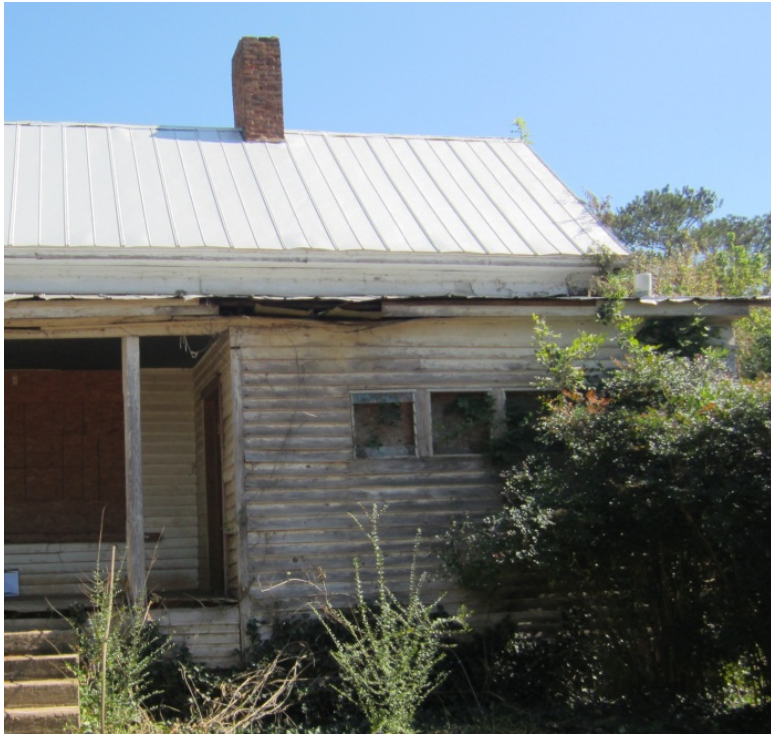
CA Figure 13: Invasive vegetation, west facade, Room 111. Note residual vegetation and black rot to fascia boards.

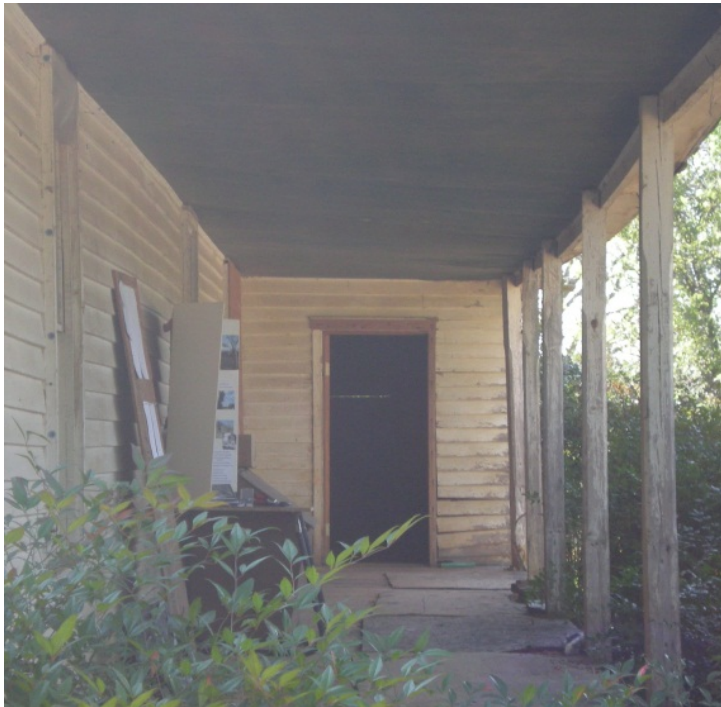
CA Figure 14: Facing south from NW corner of north facade along porch. Note loose siding and missing floorboards repaired with plywood.

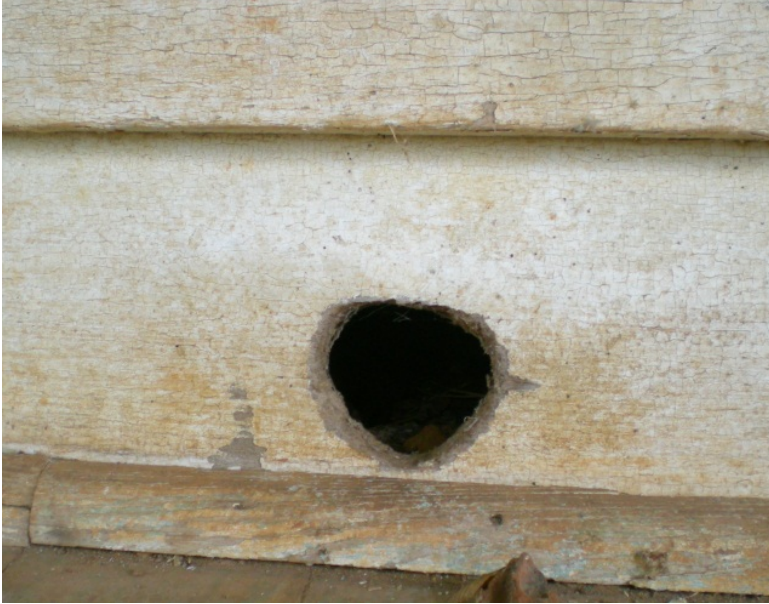
CA Figure 15: Hole in siding due to presence of rodents or other pests; west facade along porch, facing east.

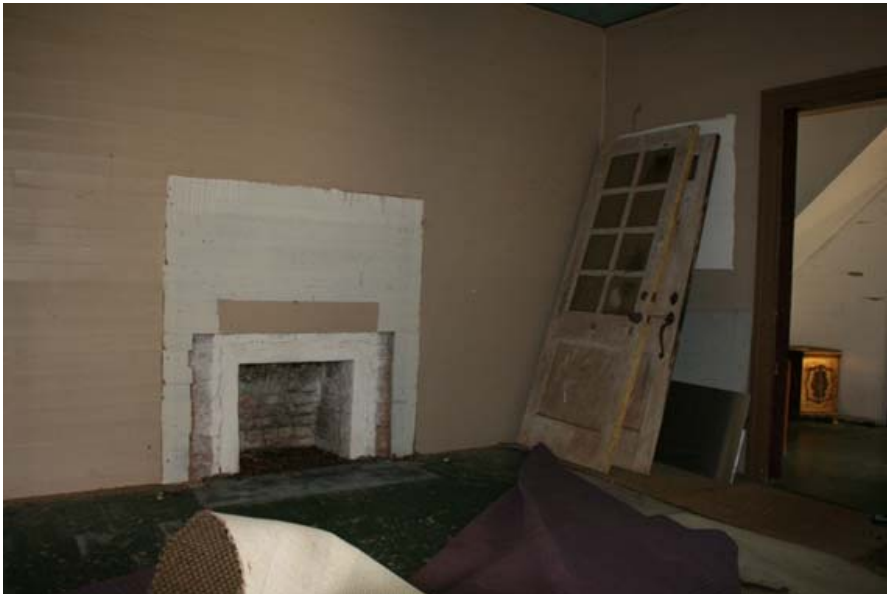
CA Figure 18: Room 101- Missing mantel, tongue and groove flooring under carpet

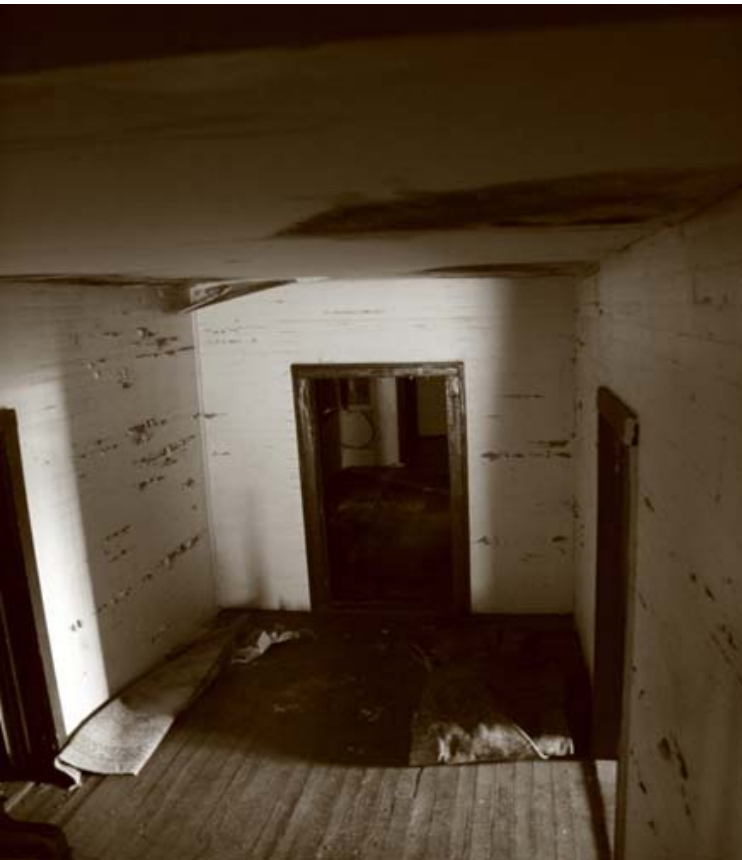
CA Figure 20: Room 102-Water damage/mold on ceiling, peeling paint on walls

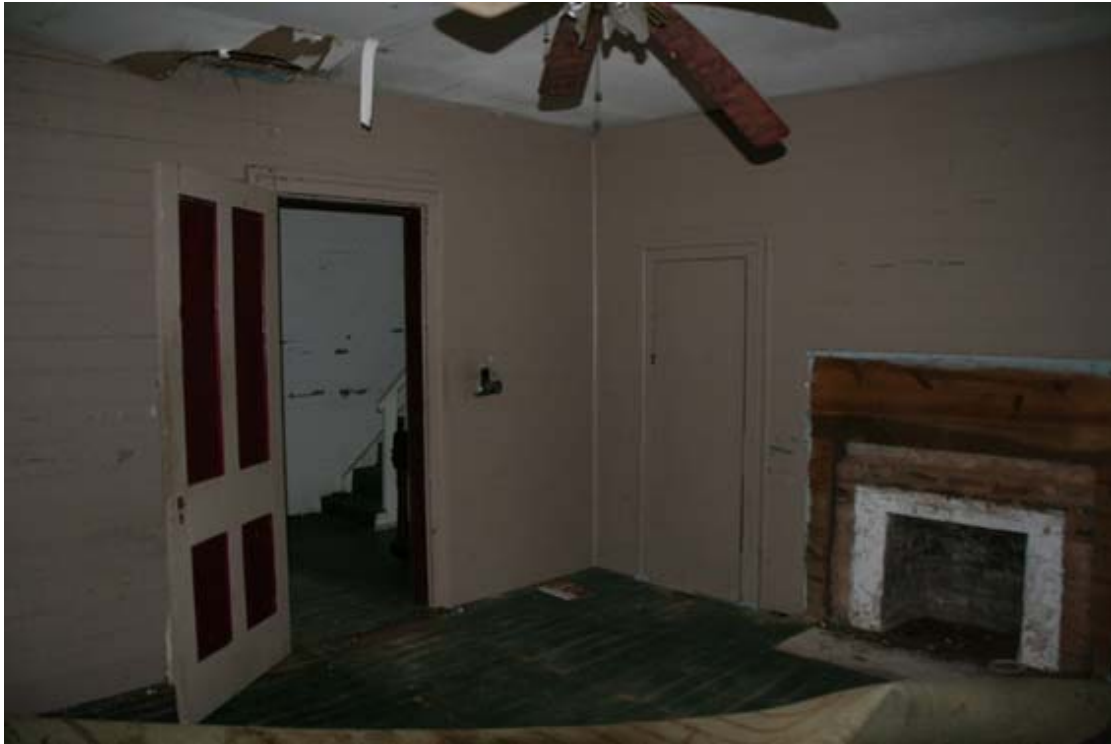
CA Figure 23: Room 104-Damaged ceiling due to water damage

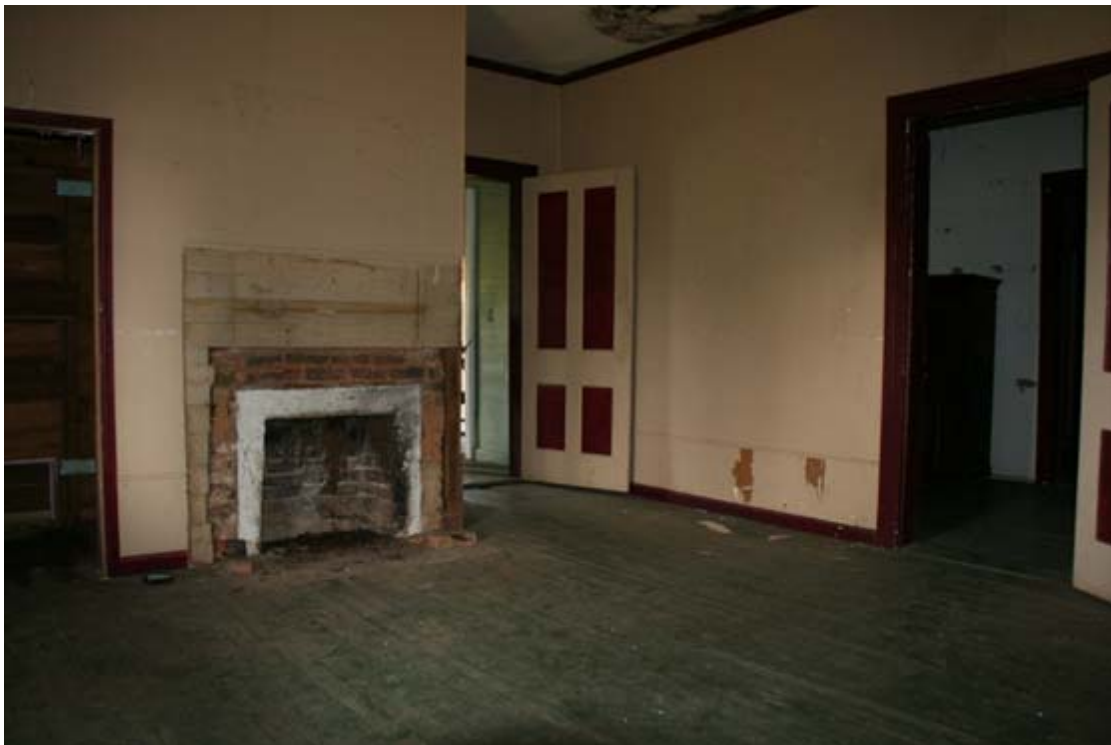
CA Figure 24: Room 105-Missing mantel; tongue and groove flooring

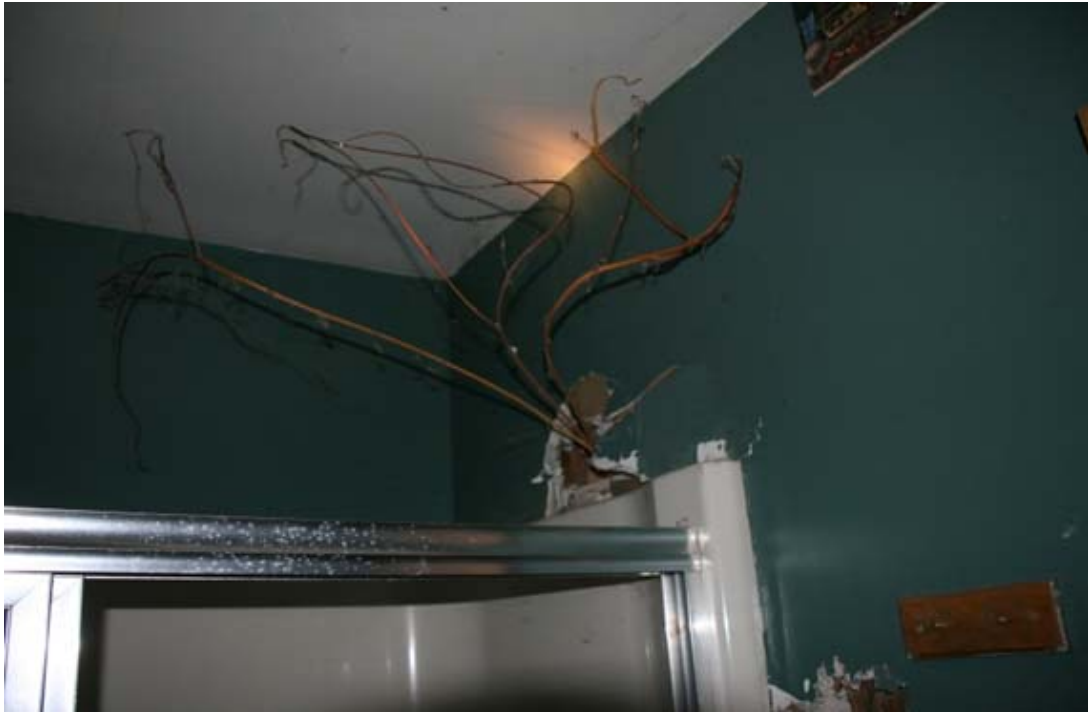
CA Figure 25: Room 106-Vegetation growing through a hole in the east wall

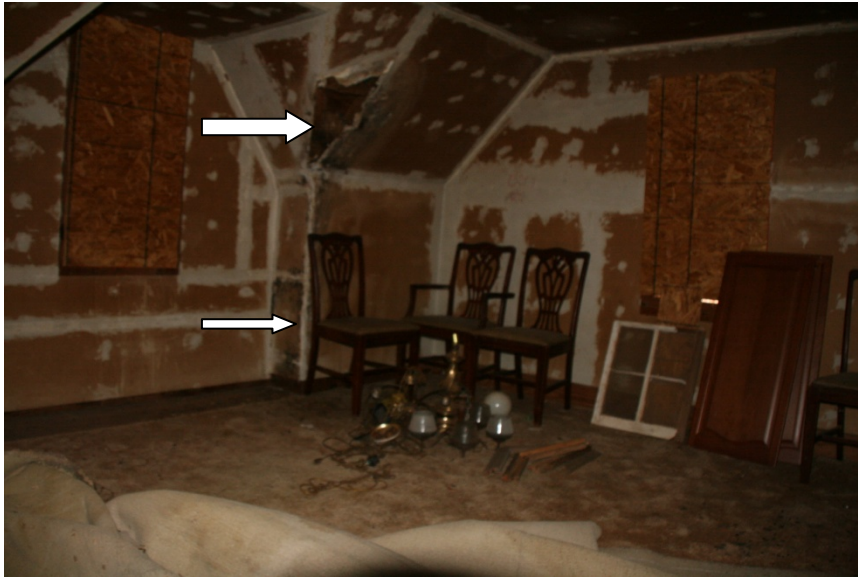
CA Figure 29: Room 201-Top arrow denotes hole in drywall with accumulated debris. Bottom arrow denotes black mold growth from water leak.

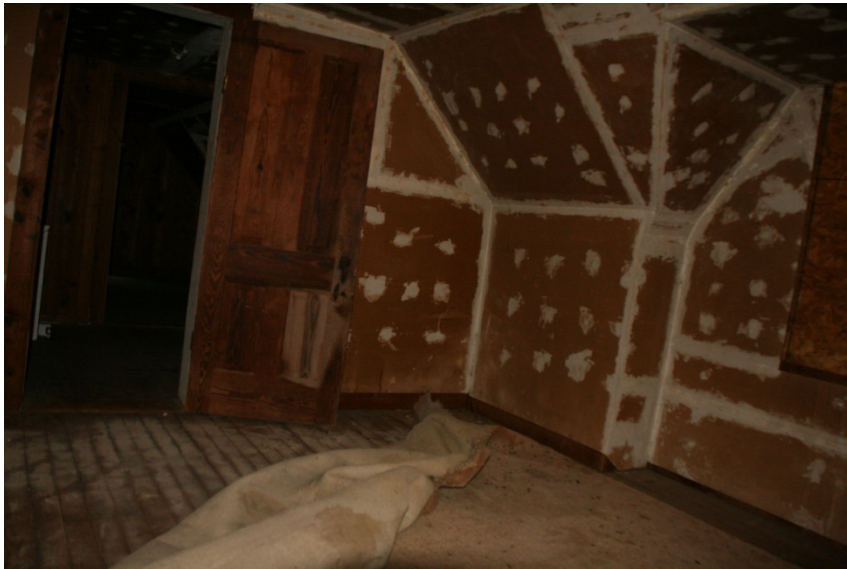
CA Figure 30: Room 201-Door D19 with matte finish on stain, worn carpet, typical drywall condition, and missing pieces of baseboard.

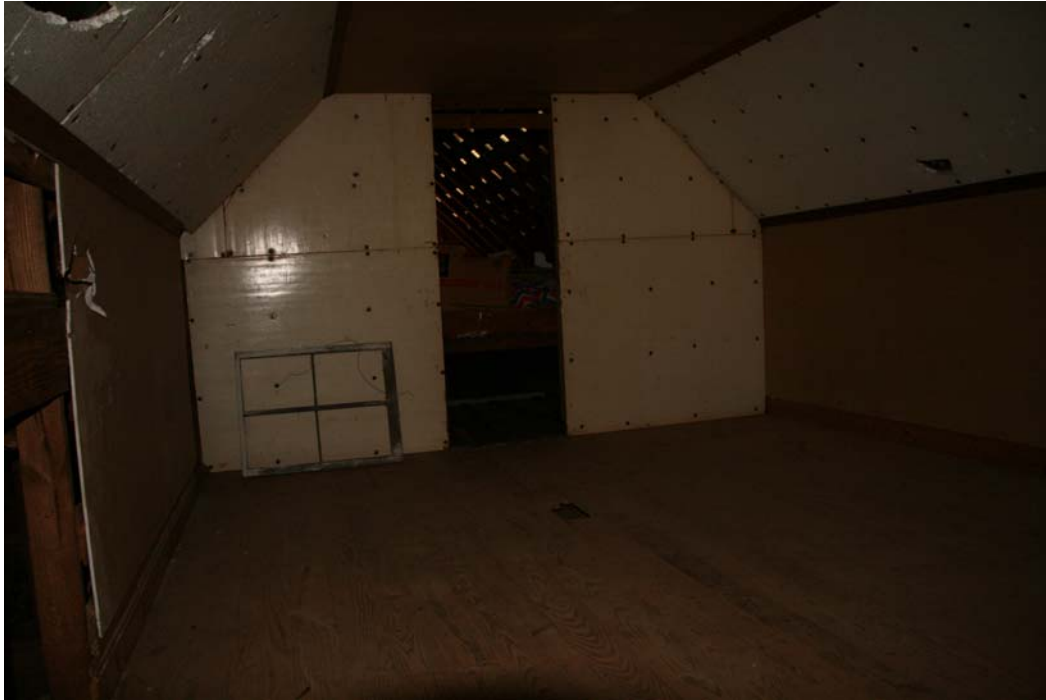
CA Figure 33: Room 205-Significant damage from roof leaks has damaged the insulation panel in this room and caused water and mold damage in Rooms 102 and 105 below.

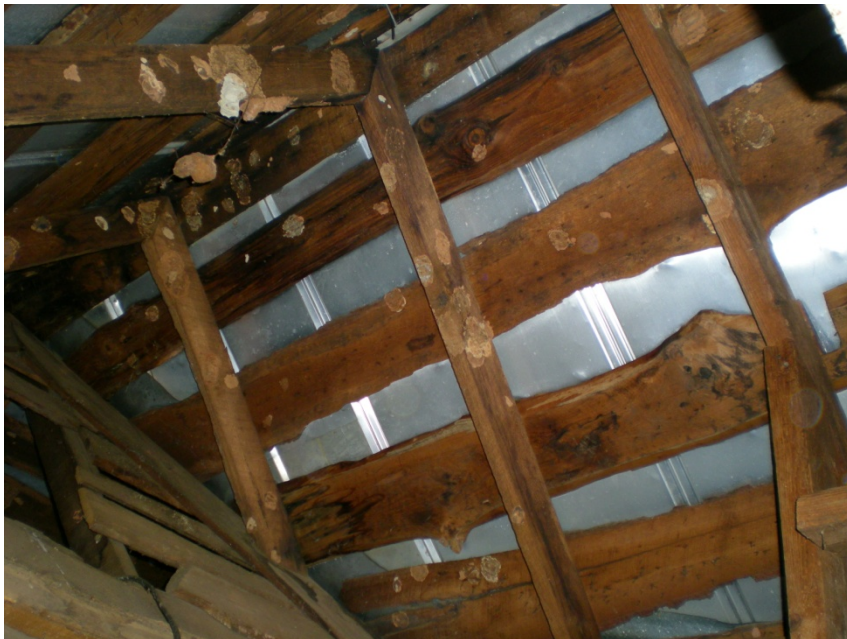
CA Figure 34: Room 208- Stinging insect nests (both active and inactive).
