# RESILIENT INFRASTRUCTURE

## RE-TESTING OF A FIRE-DAMAGED BRIDGE

Alexander M.C. Au,  
Senior Bridge Engineer, Highway Standards Branch, Ontario Ministry of Transportation, Canada

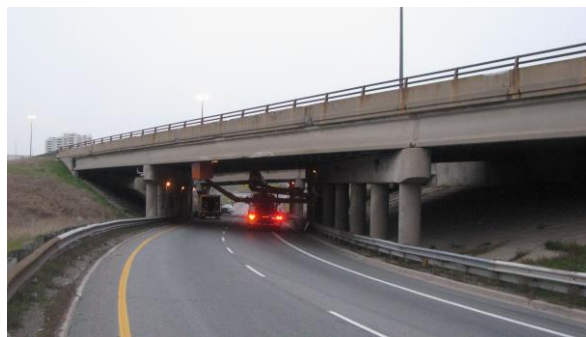
Figure 1(b): South Elevation of the Bridge

The bridge structure was damaged by a fire created by a truck accident in the early morning of September 4, 2008. The damage was severe and was confined to the south-west portion of the main span. Two repair works were applied to the bridge separately in 2008 and in 2009. The first repair work was an emergency deck soffit repair and massive transverse diaphragms were constructed between girders. After the first repair in September, a load test (Au, Lam and Tharmabala 2010) was carried out in October 2008. It was concluded that the bridge was able to carry the Canadian Highway Bridge Design Code (CHBDC) design load. The bridge was then re-opened for full traffic shortly after the load test. The first repair did not cover minor damages. The second repair in 2009 included concrete patching and CFRP wrapping of 6 girders in the main span. The effect of the CFRP on the bridge stiffness and its behaviour would be small, and it would be expected to become significant at higher loads approaching bridge's ultimate capacity (Cerullo et. al. 2013). Figure 2 shows the girders with the CFRP wrapping. Behaviour load test was performed on 23 November 2014 to re-assure the bridge's performance. The bridge was inspected before the load test (see Figure 3). It was found that the girders were in a reasonable good condition (see Figures 1 (b) to 3).

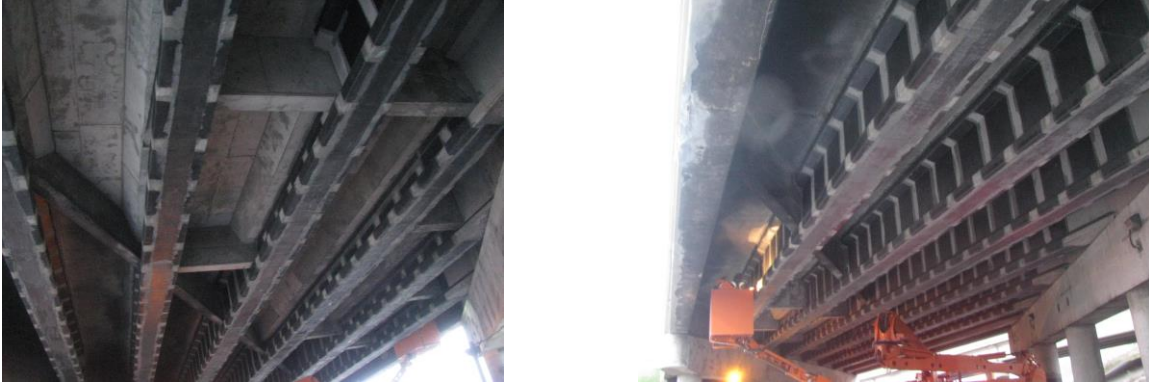
Figure 2: Girders with CFRP Wraps

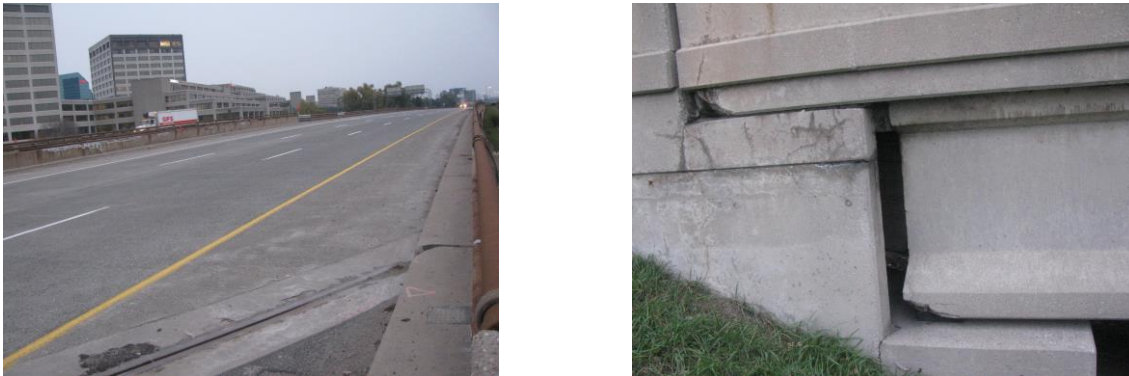
Figure 3: Bridge Conditions

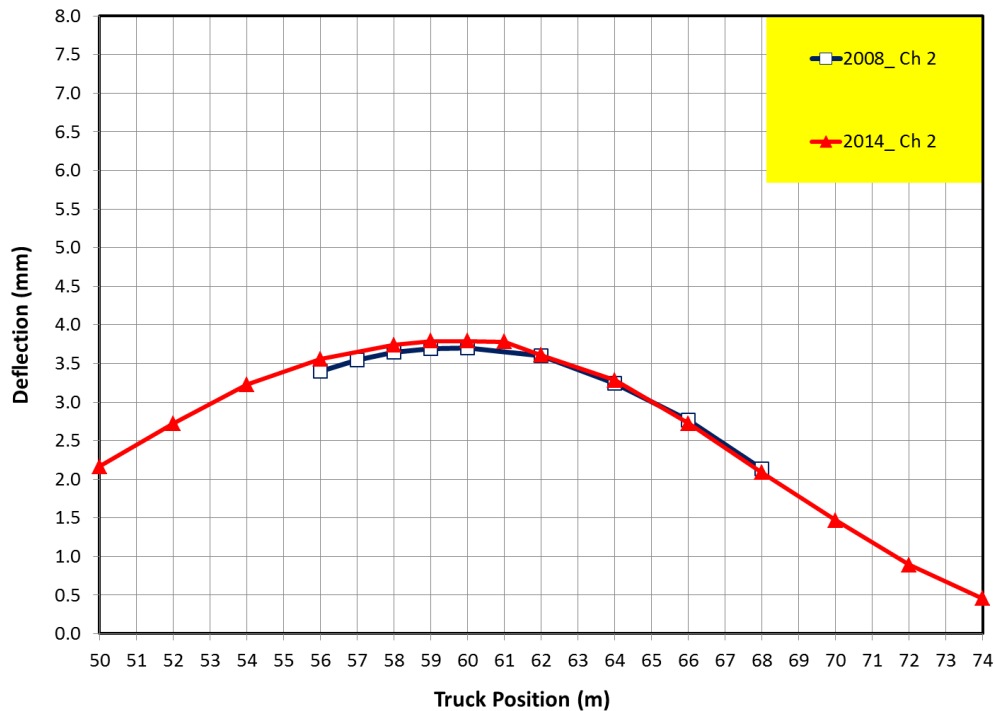
In Figures 9 and 10, the deflections of Girder 3 measured at sections B and C were found to be similar to that recorded from 2008 test and also behaved linearly. Figure 11 shows the transverse distribution of the deflections at section B. It indicates that the deflection distribution compared very well with the result from the 2008 load test. Load line 5 produced the highest deflection on Girder 3. The transverse deflection distribution is a reflection of the transverse load distribution of the bridge. Therefore, the lateral load distribution of the bridge is similar to that from the 2008 load test.

Figure 9: Deflections of Girder 3 at Section B due to Two 48 Blocks Test Trucks

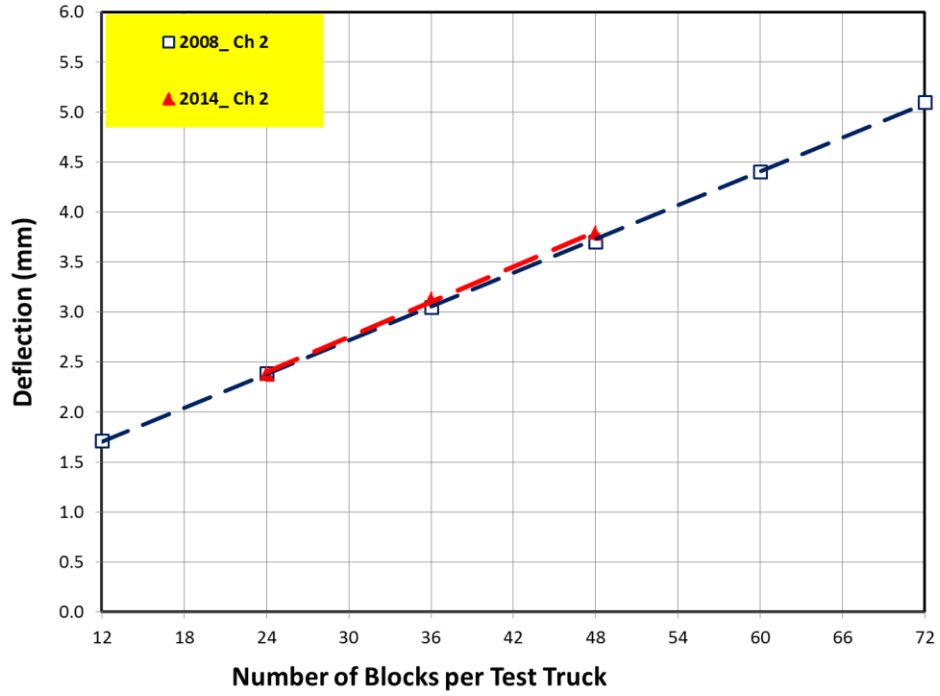
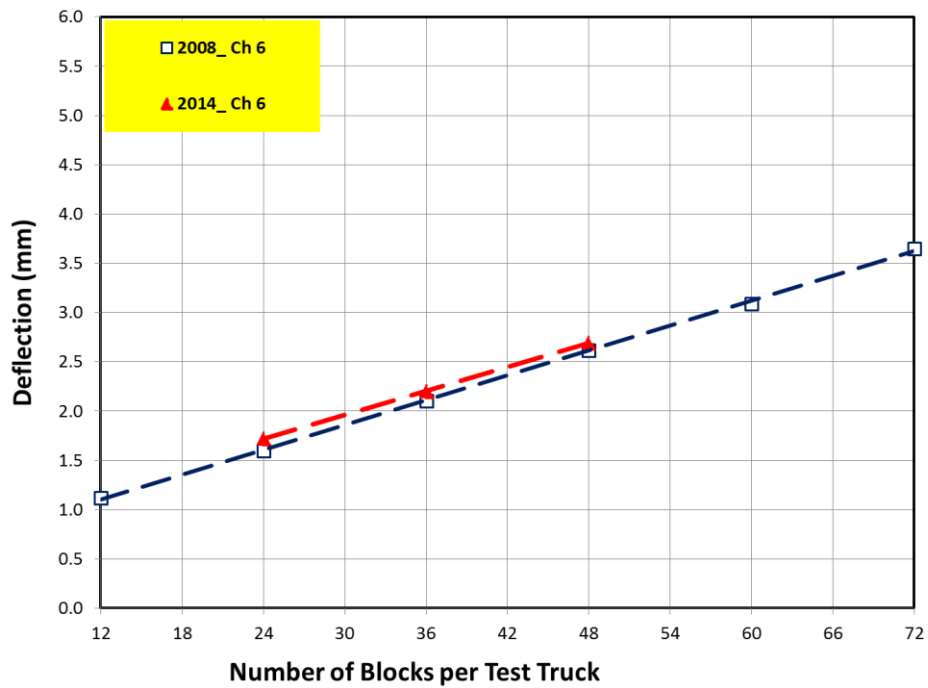
Figure 10: Maximum Deflections of Girder 3 due to Two Test Trucks with Different Load Levels

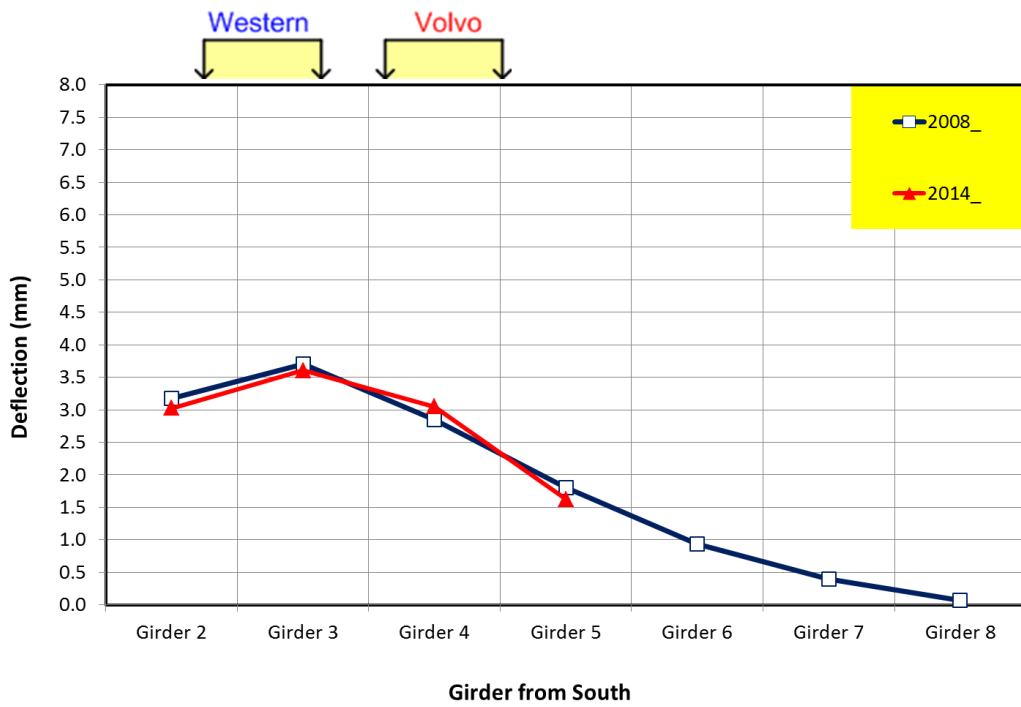
Figure 11: Transverse Deflection Distribution of Different Girders at Maximum Load Level

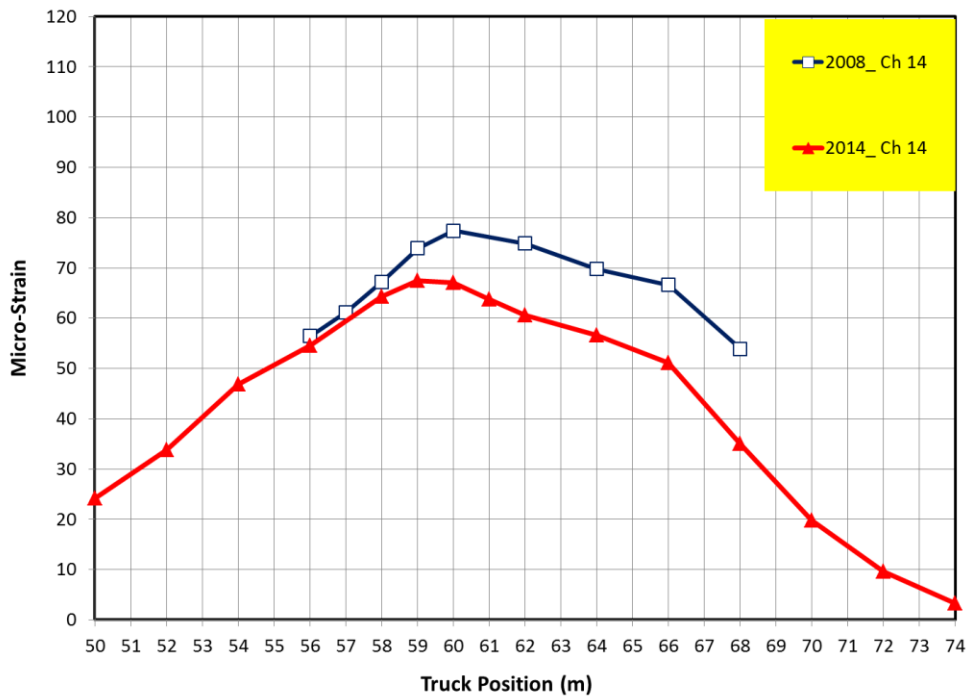
The largest strain was observed at strain gauge 14 (Girder 3 and Section B). Figure 12 shows a comparison of the strain measured from 2008 and from this load test. The current measurement was smaller than the strain measured in 2008, and the distributions over different load steps were similar with respect to the test truck locations. However, the comparison of strain measurement was not as good as the deflection measurement. This discrepancy was mainly due to the slightly different locations of the strain gauges in both load tests. Such discrepancy could be reproduced from a theoretical analysis.

Figure 12: Comparison of Strains at Girder 3 at 48 Blocks per Test Truck

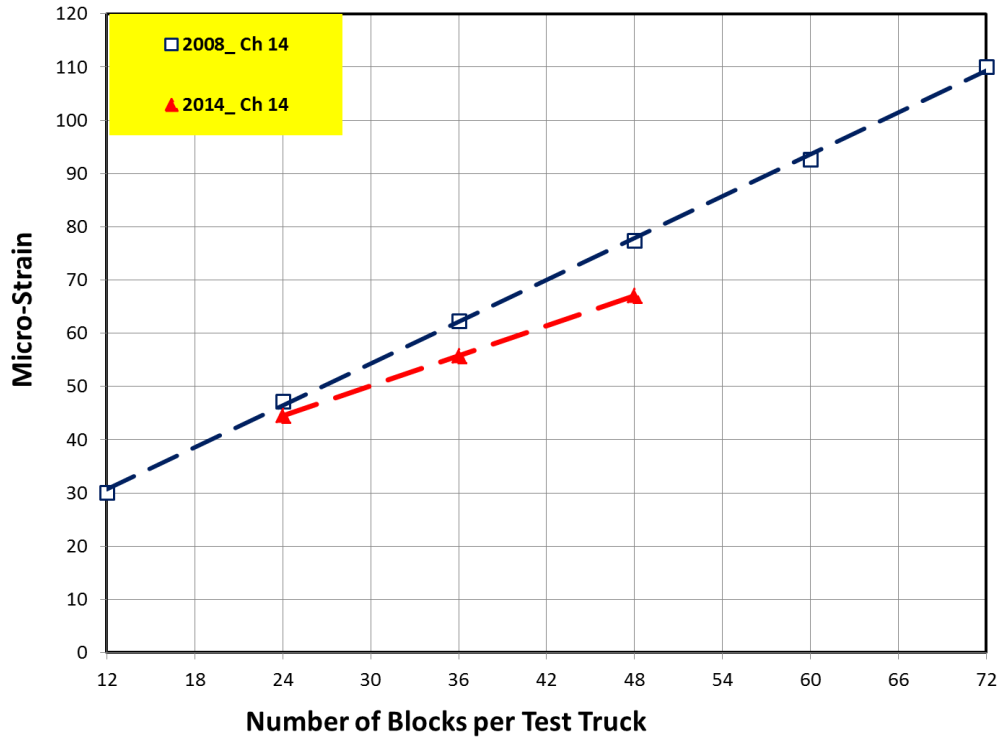
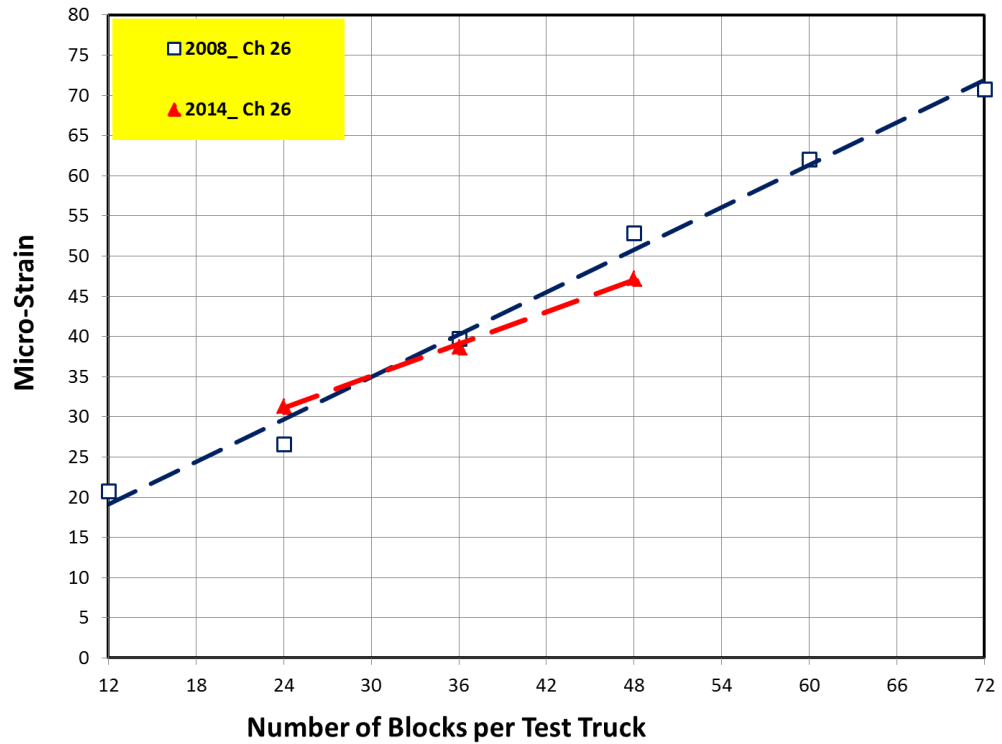
The linear relationship of the strain with respect to the applied load was confirmed in Figures 13 (a) and (b) for Sections B and C respectively. Both figures show a lower rate of increase in strain with loads and the strain was linear up to 48 concrete blocks per test truck.

Figure 13: Strains Measured at Soffits of Girder 3 at Sections B and C due to Different Load Levels

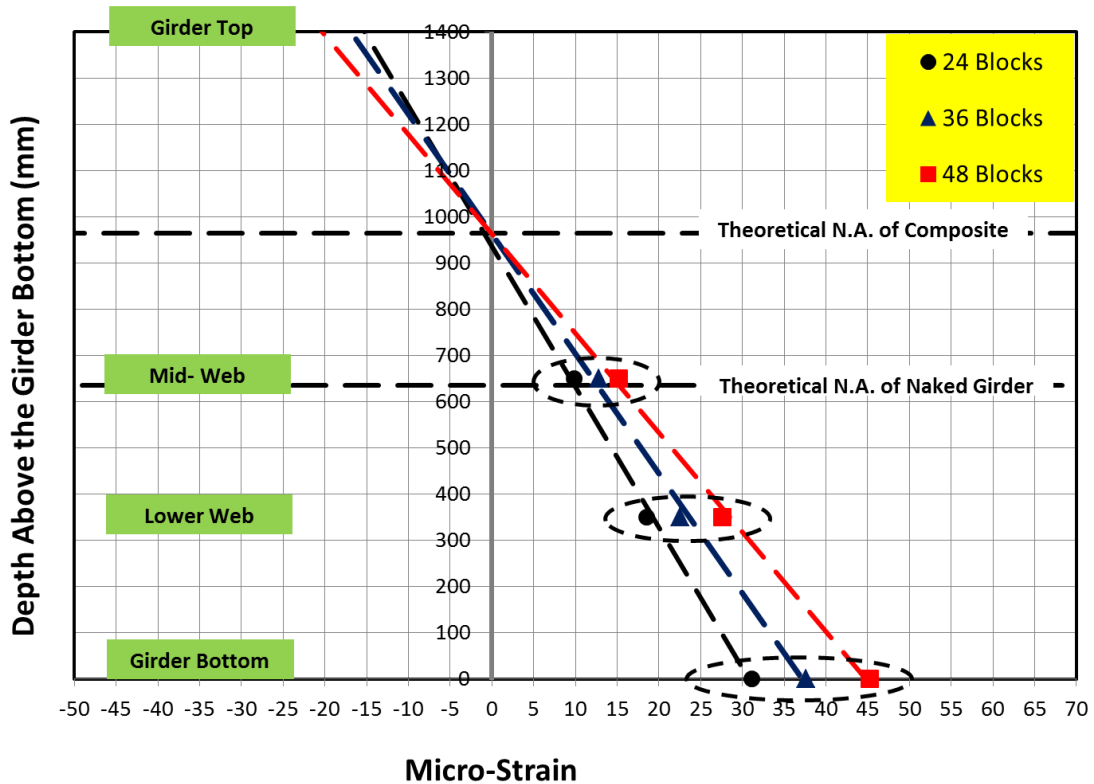
Figure 14 shows the vertical strain distributions at Section C of Girder 3. It was based on the strain gauges located at mid-web, lower web and girder soffit, under three different load levels at 24, 36 and 48 blocks per truck. The location of the neutral axis matches the one obtained from the theoretical analysis. It means that the bridge composite action remains unaffected.

Figure 14: Strain Measured at Section C of Girder 3 (Channels 24, 25 and 26)
