Mask Flaw Propagation Using 360nm Long Pass Filter

To test the flaw propagation to features of SU-8 resist in the presence of 360nm long pass (LP) filter during exposure.

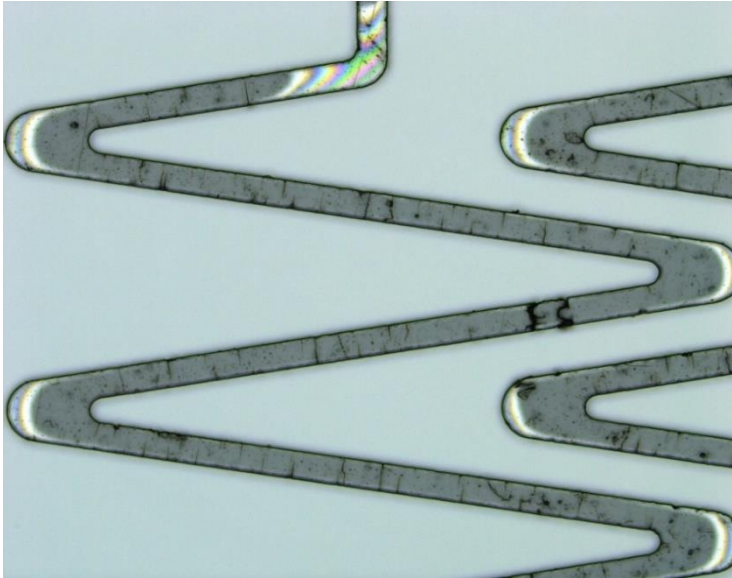
Figure 4 Flaws are evident on the surface of the features

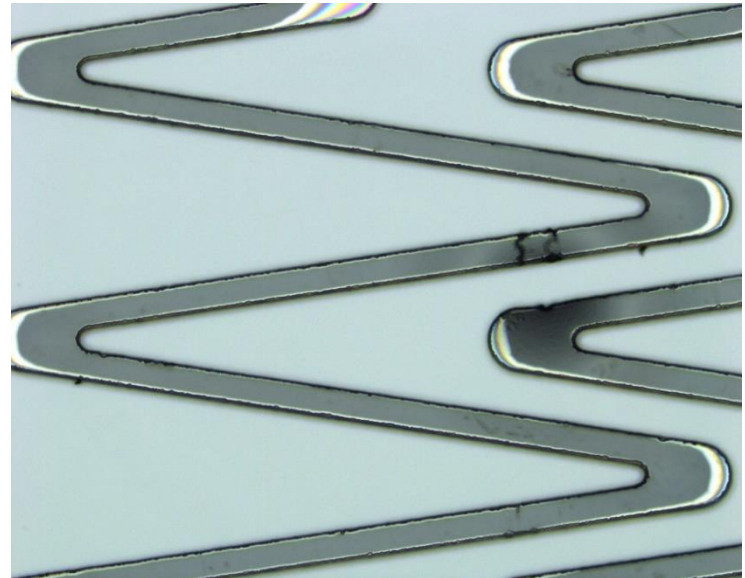
Figure 4 The surface is relatively smooth without any flaws

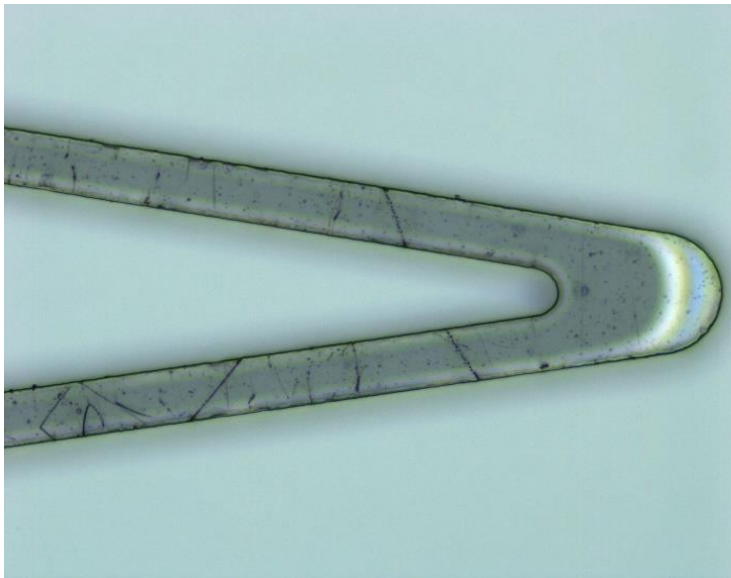
Figure 4 Flaws are evident on the surface of the features

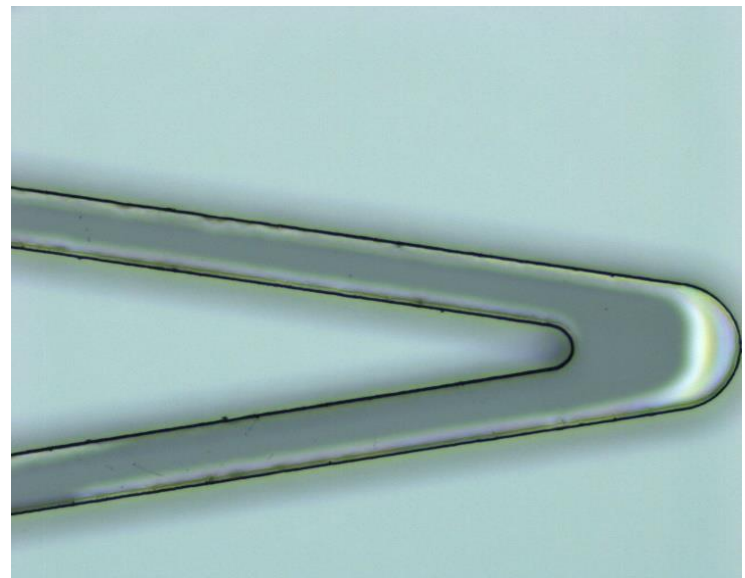
Figure 4 The surface is relatively smooth without any flaws

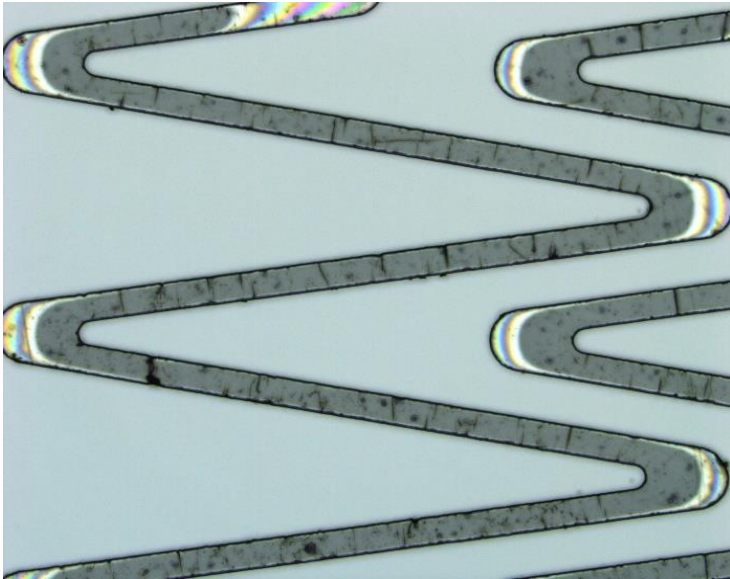
Figure 6 Flaws are evident on the surface of the features

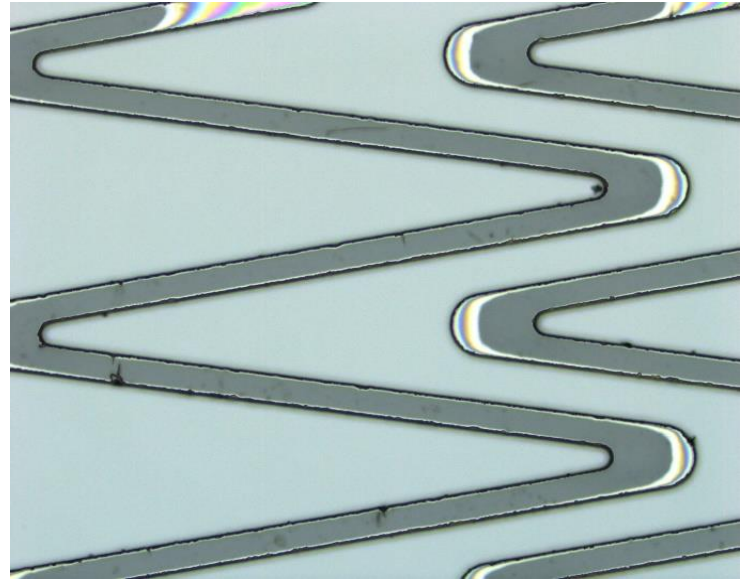
Figure 6 The surface is relatively smooth without any flaws

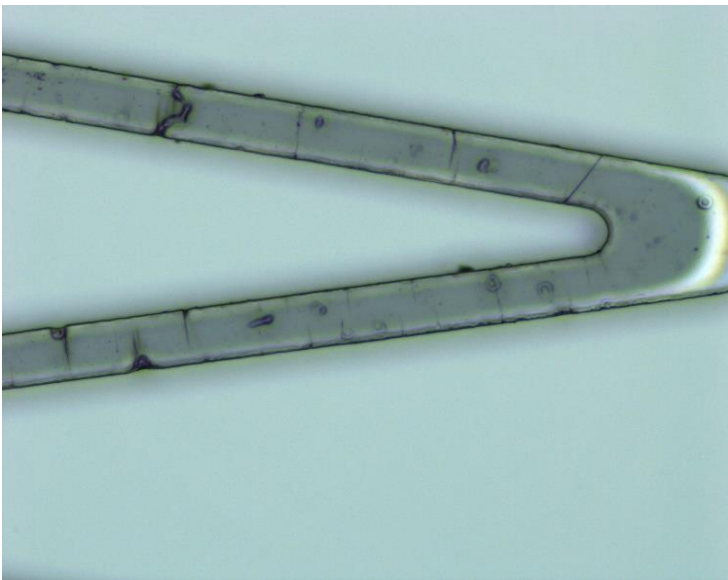
Figure 7 Flaws are evident on the surface of the features

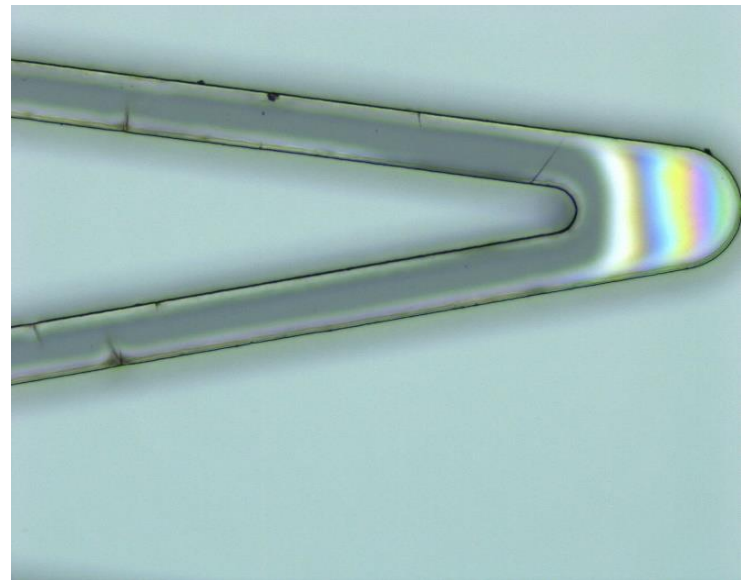
Figure 8 The surface is relatively smooth without any flaws

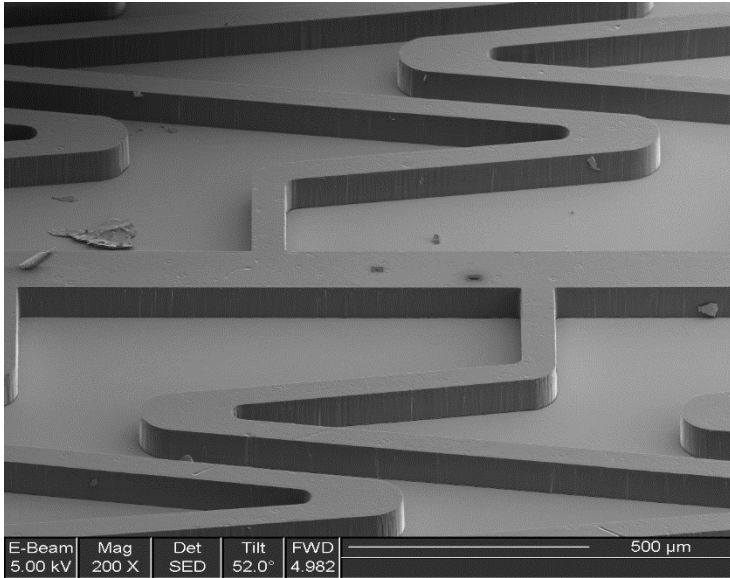
Figure 9 Flaws are evident on the surface of the features
Without LP filter

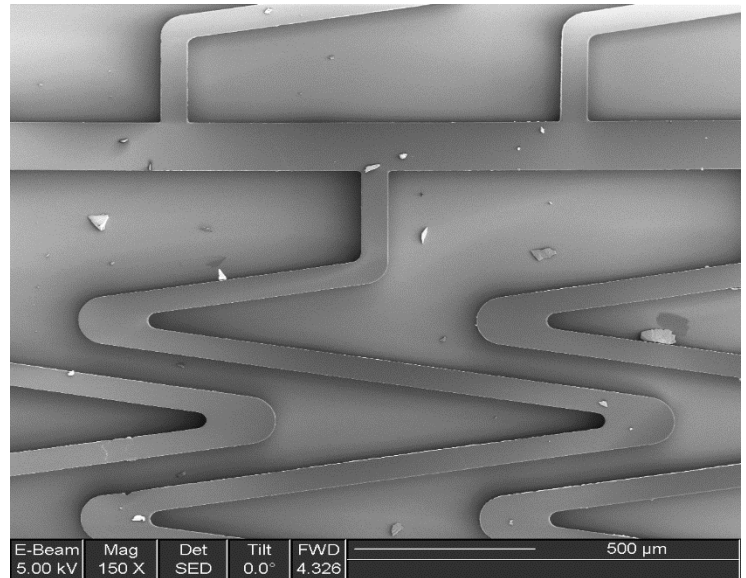
Figure 10 The surface is relatively smooth without any flaws

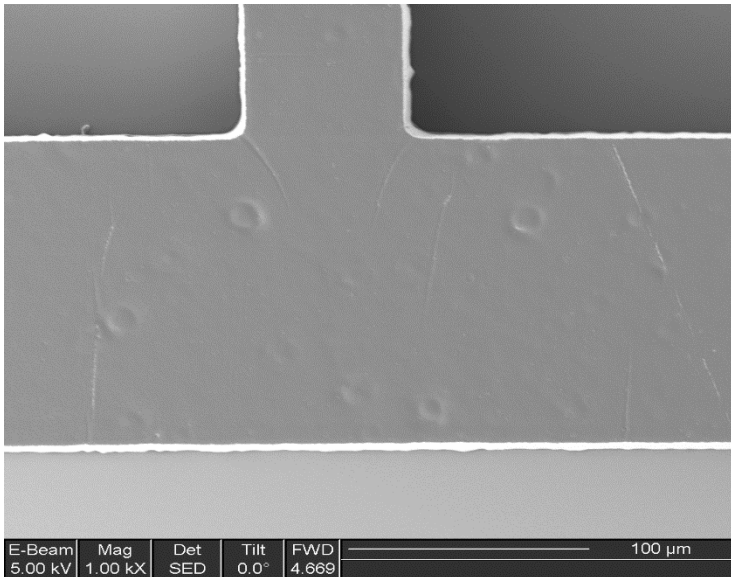
Figure 11 Flaws are evident on the surface of the features

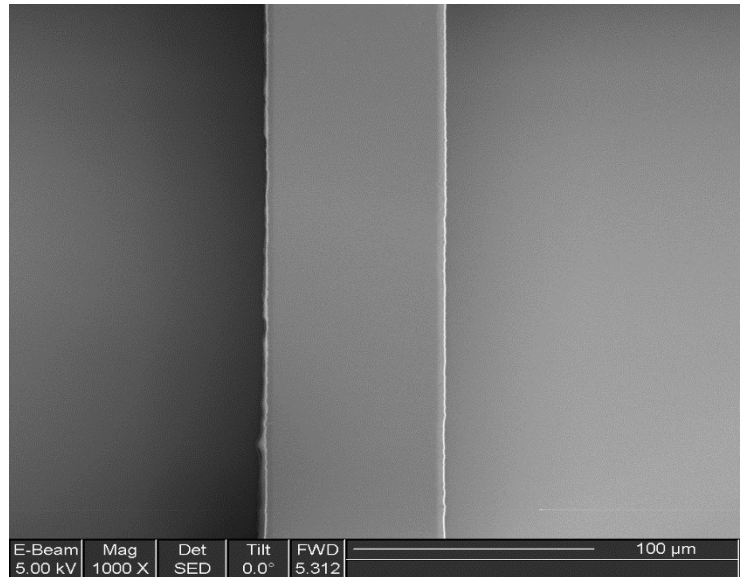
Figure 12 The surface is relatively smooth without any flaws

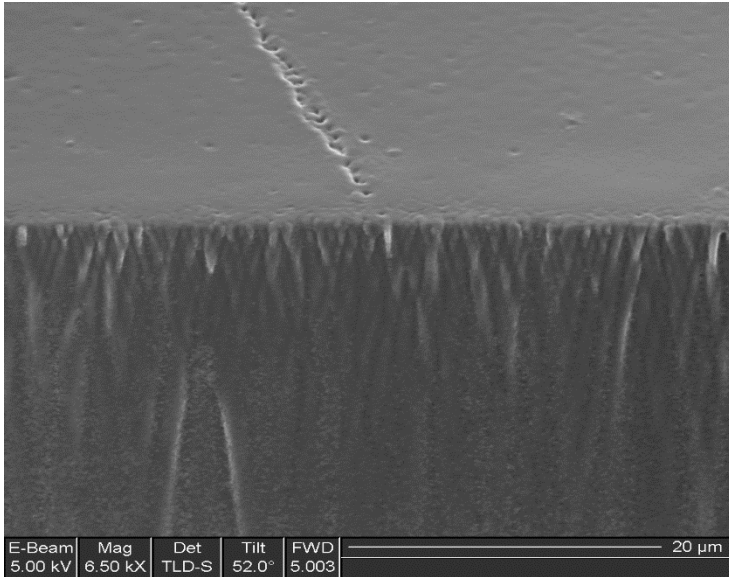
Figure 13 Flaws are evident on the surface of the features

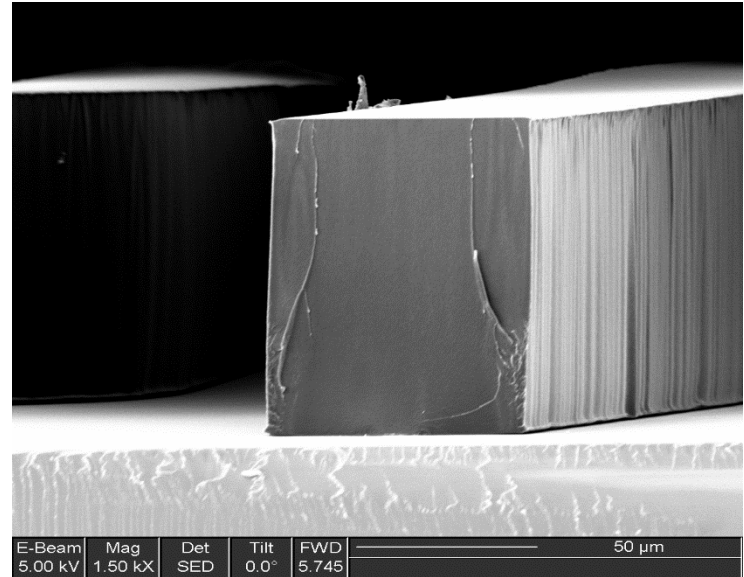
Figure 14 The surface is relatively smooth without any flaws

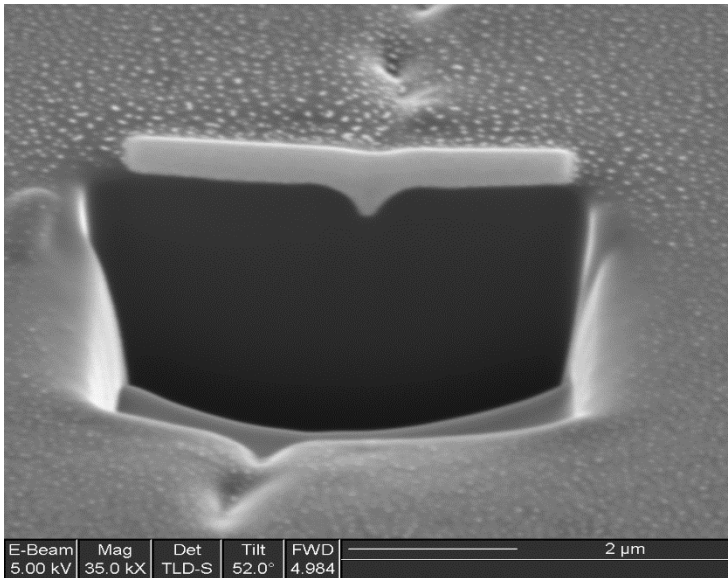
Figure 15 Analysis of the features through etching using FIB confirms that most of the flaws do not extend through the material

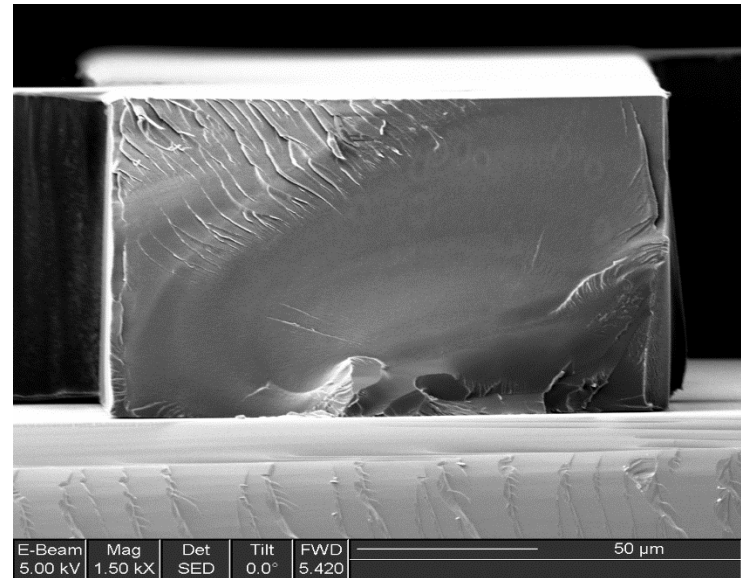
Figure 16 The surface is relatively smooth without any flaws

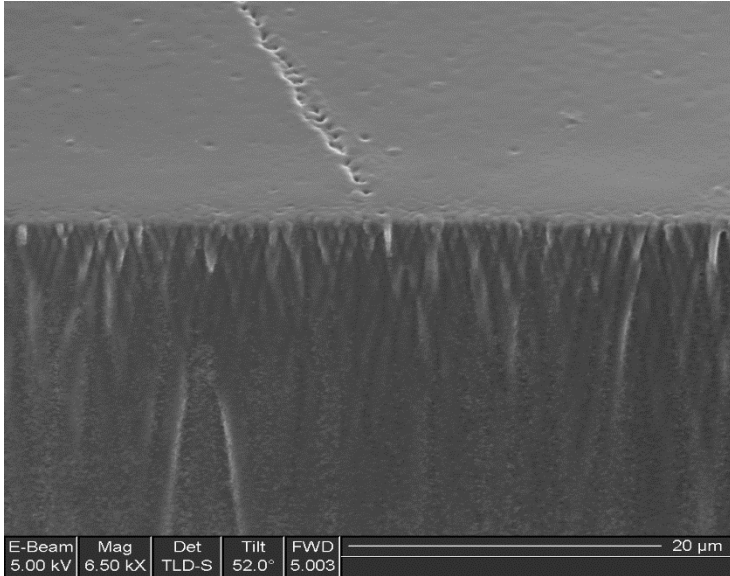
Figure 17 Flaws are evident on the surface of the features

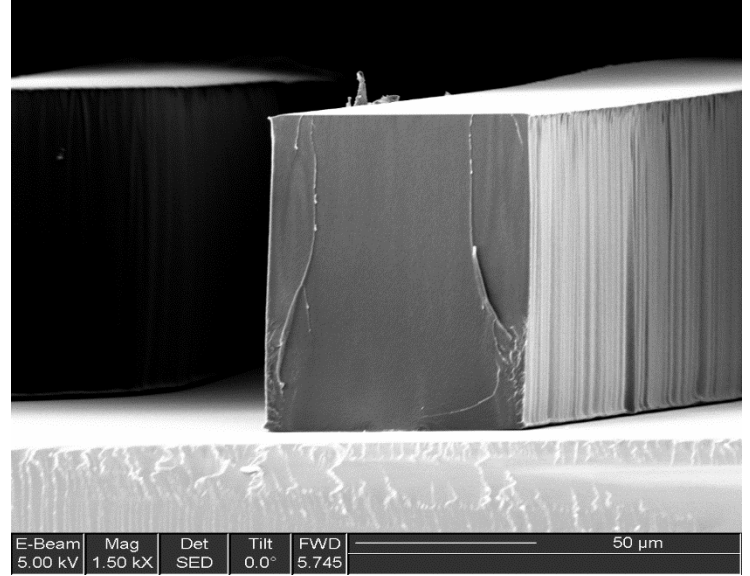
Figure 18 The surface is relatively smooth without any flaws

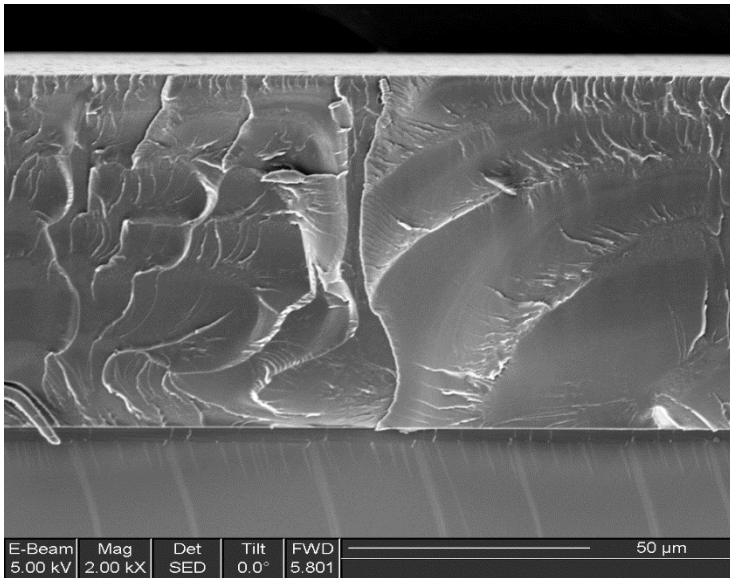
Figure 19 These cracks are observed less in numbers when compared to flaws on the surface

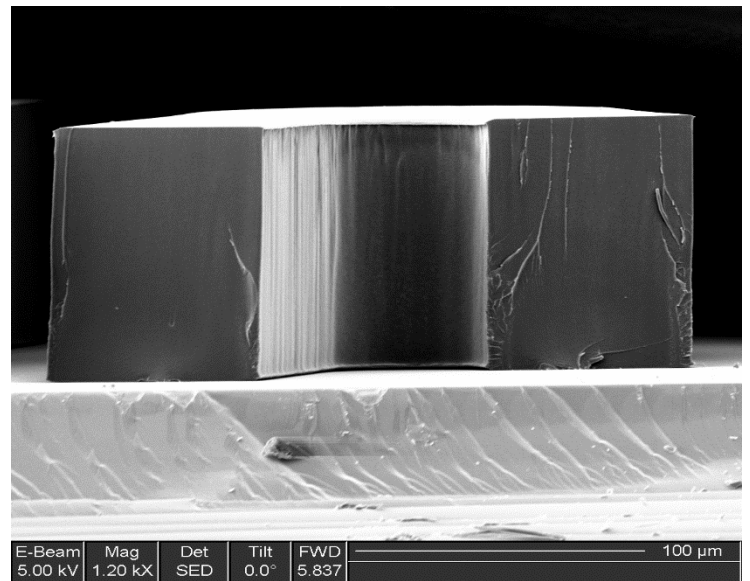
Figure 20 Exposed feature without the filter shows no such cracks
