Investigation of Premature Distress Around Joints in PCC Pavements: Parts I & II

JOINT TRANSPORTATION RESEARCH PROGRAM

INDIANA DEPARTMENT OF TRANSPORTATION
AND PURDUE UNIVERSITY

Report Numbers: FHWA/IN/JTRP-2012/25 & FHWA/IN/JTRP-2012/26

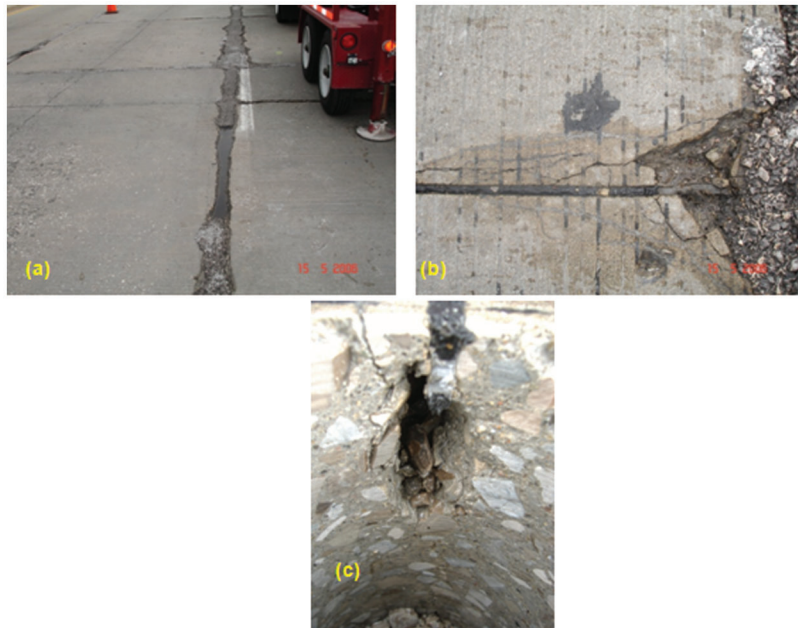
Some of the Indiana concrete pavements constructed within the last 10 to 20 years have recently shown signs of premature deterioration, especially in the areas adjacent to the longitudinal and transverse joints. This deterioration typically manifests itself as cracking and spalling of concrete combined with the loss of material in the direct vicinity of the joint (see Figures 1.1a and 1.1b) (1). In addition, “bulb-shaped” damage zones were also observed under the sealed parts of the joint (see Figure 1.1c).

Figure 1.1 Condition of the EB pavement at W. 86th St. (east of the intersection with N. Payne Rd. in Indianapolis, Indiana, referred to as AL location): (a) general view, (b) close-up of damaged region near the intersection of transverse and longitudinal joints and (c) example of bulb-shaped damage zone under the joint sealant (1).

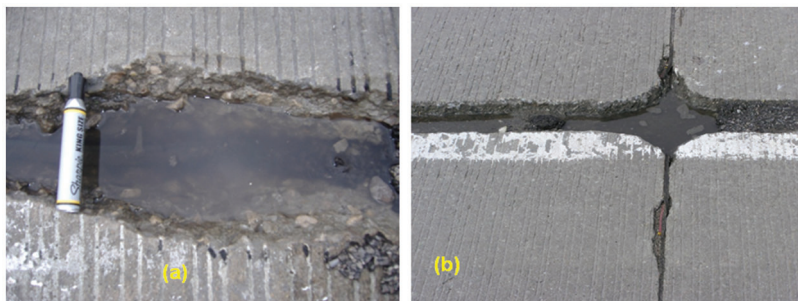
Figure 1.2 Examples of water accumulation in the longitudinal joints: (a) close-up of the longitudinal joint, (b) intersection of the longitudinal and transverse joints.

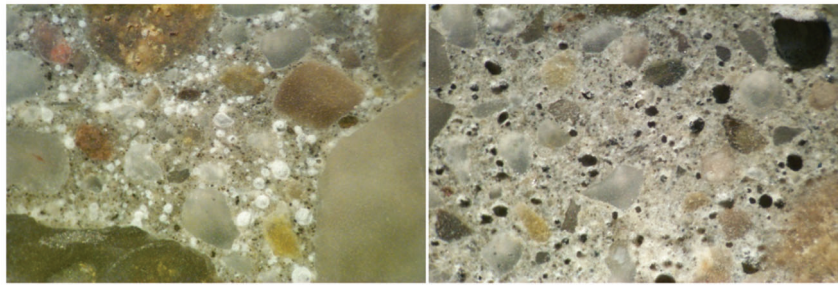
Figure 3.2 Typical appearances of the infilled voids (a) and empty air voids (b) as seen using optical microscopy (1).

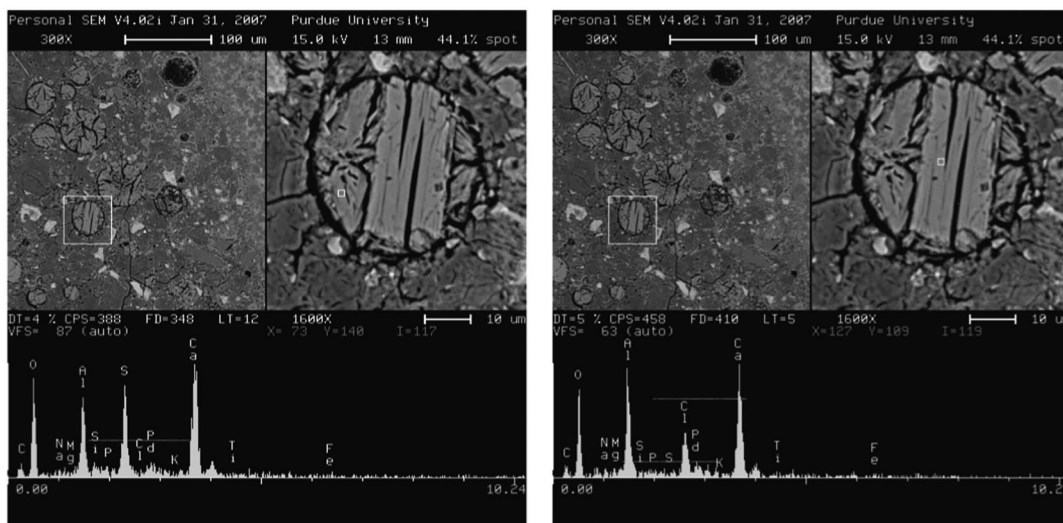
Figure 3.3 SEM image from a specimen from SR 67 showing an air void completely filled with mixture of ettringite (spectrum, left) and Friedel's salt (spectrum, right) (1).

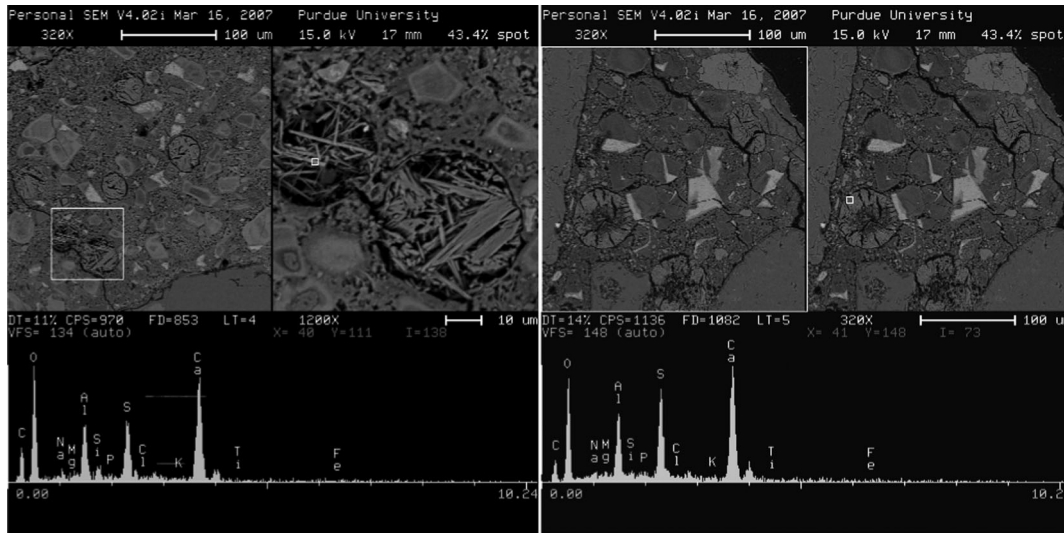
Figure 3.4 Numerous large air voids filled with ettringite (left and right) and some cracks in the matrix (right) (*l*).

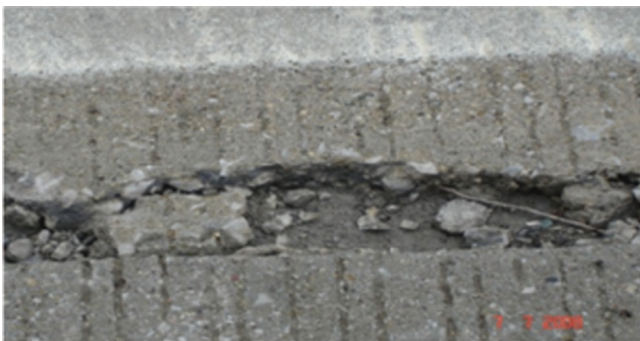
Figure 1.1 Deteriorated longitudinal joint, I-94.

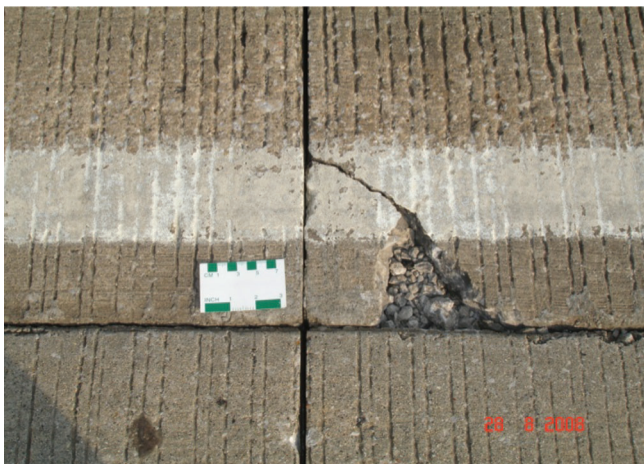
Figure 1.5 Occasional corner cracking in the EB lanes of eastern most portion of this project in the area with unsealed joints (identified as Section 5).

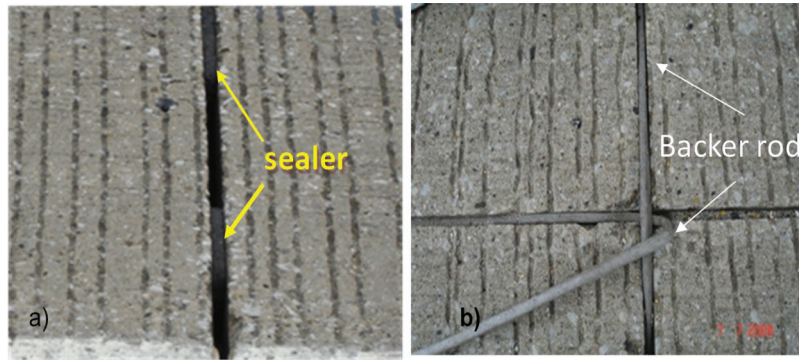
Throughout the project in the WB lanes the joint sealer was not in good condition. It often was not at a consistent depth, appearing punched down an inch or more into the joint (as shown in Figure 1.6a), dislodged or missing altogether, exposing the backer rod (as shown in Figure 1.6b).

Figure 1.6 Sealer and backer rod at some joints: (a) sealer at variable depths, (b) sealer missing and backer rod exposed.

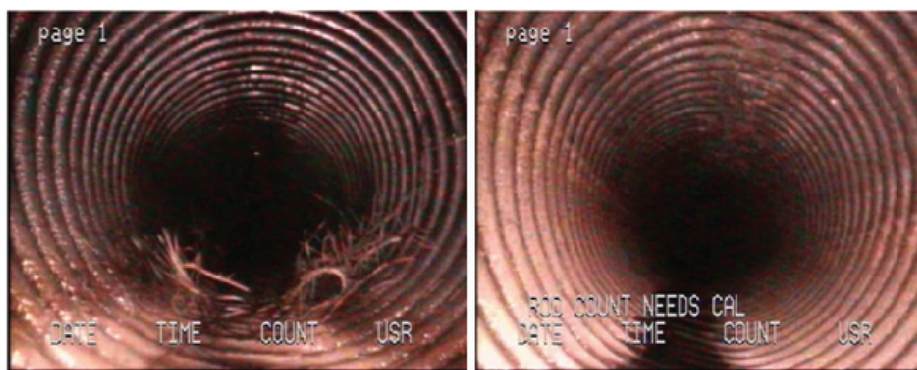
Figure 4.4 Drain 1. Vegetation growing in the drain pipe (left); a small amount of water in the bottom of the drain (right).

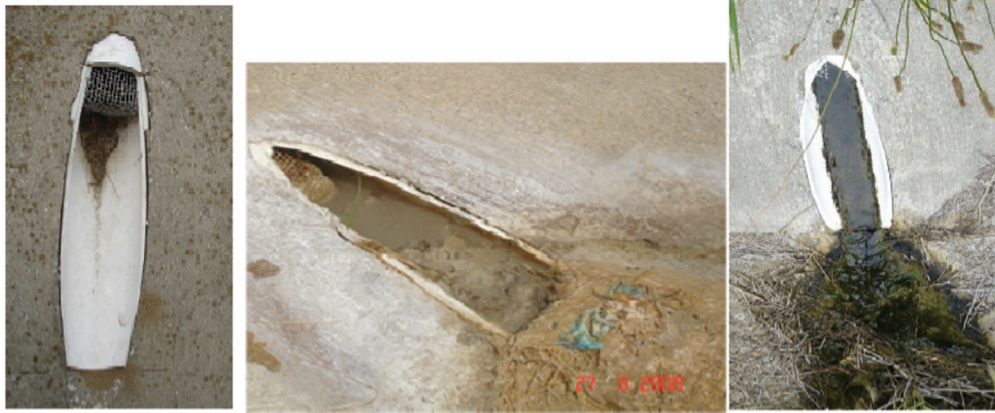
Figure 4.5 The condition of the drain outlets varied.

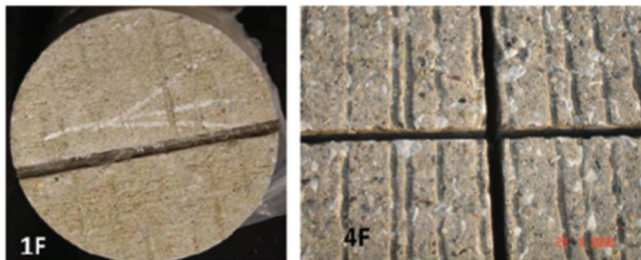
Figure 4.6 Surface appearance of a sealed joint (left) and unsealed joint (right).

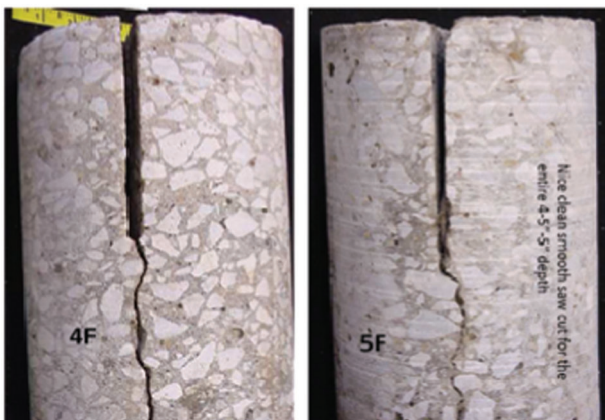
Figure 4.8 Cores from unsealed sawn joints.

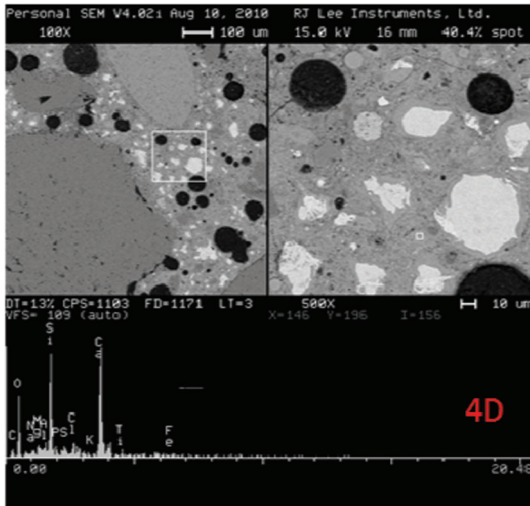
The presence of unhydrated or poorly hydrated cement grains suggests poor curing (10). There were moderate to high occurrences of poorly hydrated cement grains in the very top few mm of the pavement surface and joint face in several Section 1 specimens (1C1, 1D1 and 1F2) and in some specimens from the other sections as well, suggesting curing conditions were less than optimal. It is uncertain to what extent, if any these 2–5 mm thin outer layers of poorly cured concrete may contribute to the overall durability of the concrete pavement, or the durability of the joint face, but it may be worth considering in further studies and investigations. The poorly hydrated cement grains at the sawn joint face of all sealed joints compared to a well-hydrated surface on the sawn joint face of the unsealed

Figure 4.14 Presence of poorly hydrated cement grains (bright angular particles with strong Si and Ca peaks) common in the top 0–2 mm of many specimens and at the sawn joint face.

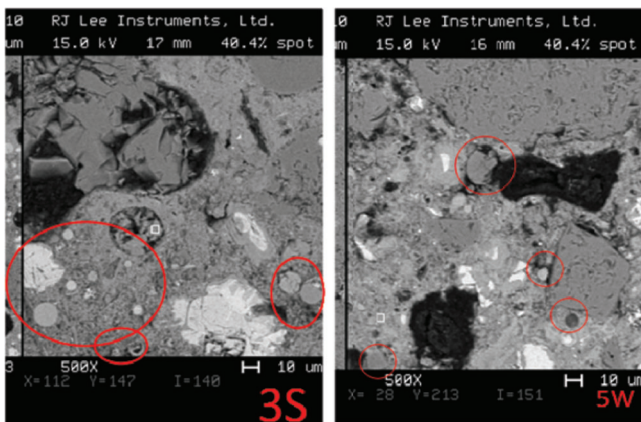
Figure 4.15 Fly ash particles identified unexpectedly in specimens from Section 5 and specimen 3S (round particles inside red circles).

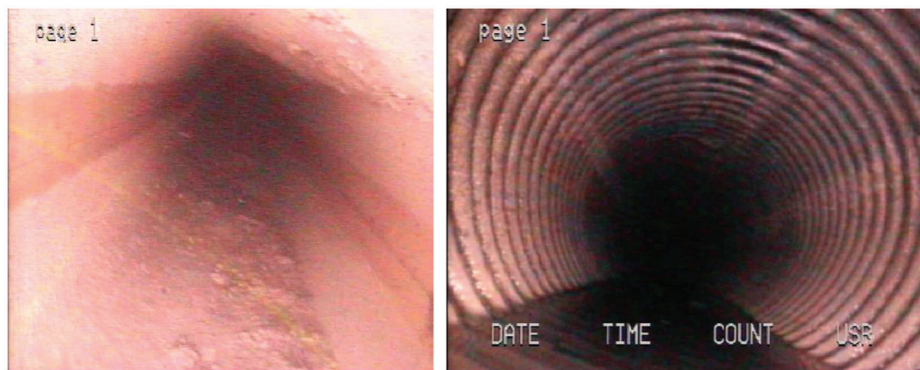
Figure A.4 Drain 2. Initial PVC section completely submerged (left) and corrugated pipe further in with 1 in. of water (right).

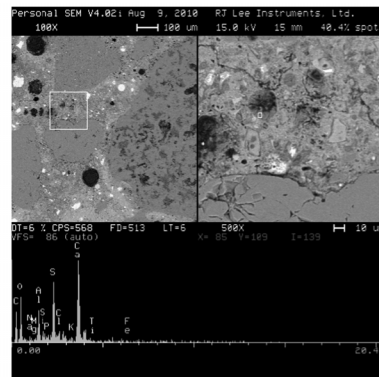
Fig. 1S-2
Needles of ettringite in air-void, dense microstructure, a few empty microcrack, empty air-voids, x500

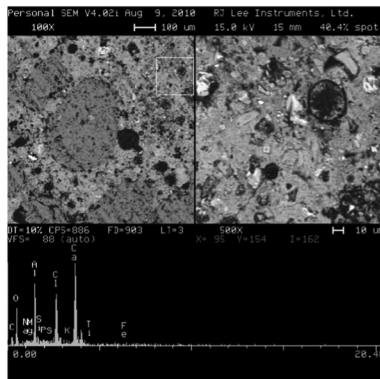
Fig. 1S-3
Friedel's salt in cement matrix, ettringite in air-void, x500

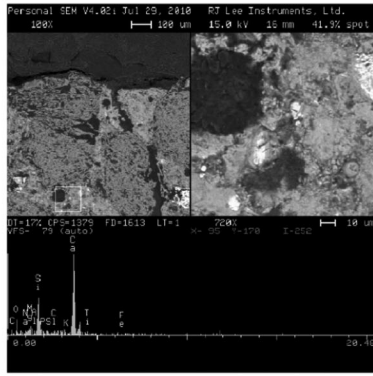
Fig. 1W-1
Top of the specimen, fly ash particle, empty air-void, partially reacted cement grain, empty crack between aggregate, x720

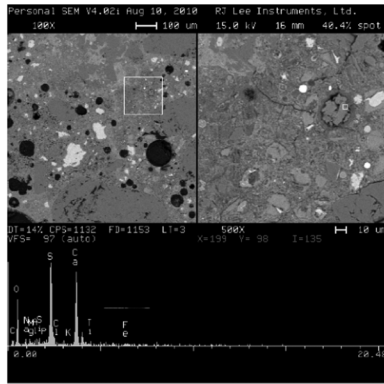
Fig. 3S-1
Gypsum in air-void, many empty air-voids, small empty micro-crack in the matrix, x 500

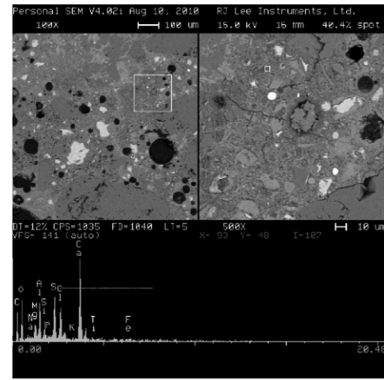
Fig. 3S-2
Traces of ettringite and Friedl's salt, x500

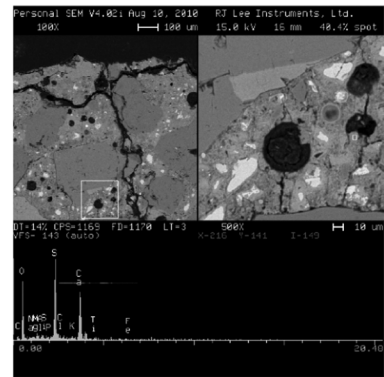
Fig. 3S-4
Air-void partially filled with gypsum, empty cracks near the surface, x 500

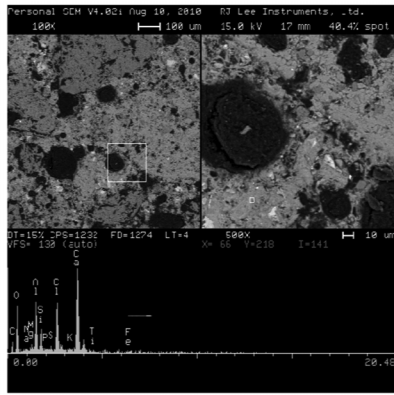
Fig. 3S-5
Friedl's salt in a matrix, porous cement matrix,
a few unhydrated cement grains, x 500

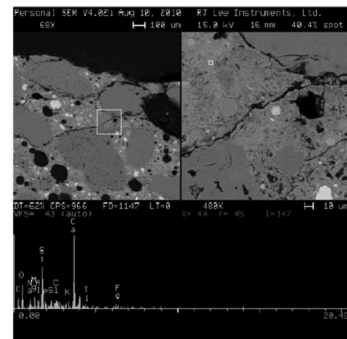
Fig. 4D-4
Empty cracks parallel to the surface (probably caused by freezing and thawing).

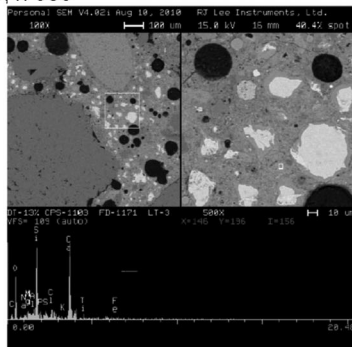
Fig. 4D-5
Many anhydrous cement grains, empty air-voids, x 500

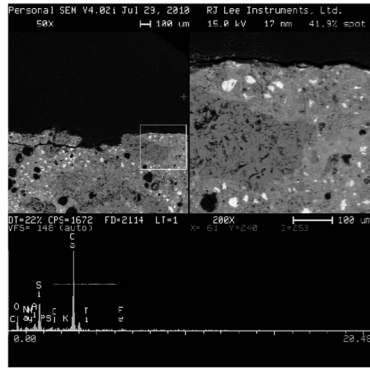
Fig. 5W-1
Surface of the specimen, many unreacted cement grains, dense microstructure, x 200

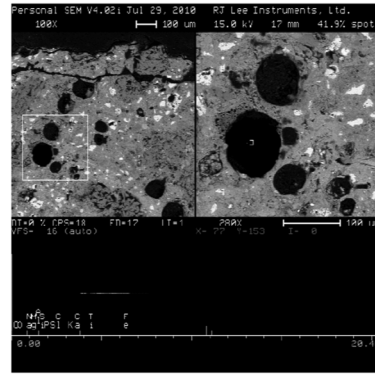
Fig. 5W-2
Empty air-voids, empty crack propagates parallel the surface, x 280

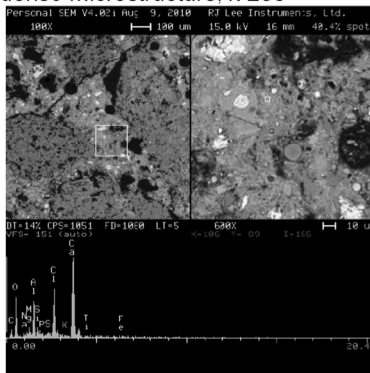
Fig. 5W-3
Friedl's salt in a matrix, empty microcrack, fly ash particle, x 600

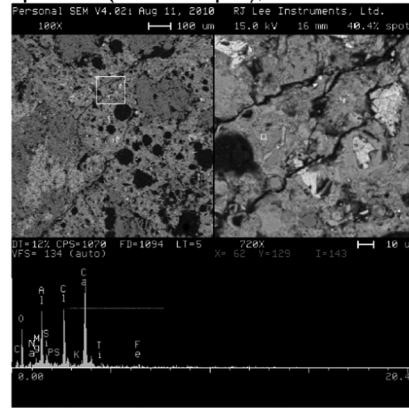
Fig. 5W-10
Friedl's salt in a matrix, empty cracks propagated only through the matrix not through the aggregate, x 720
