DEGRADATION ASSESSMENT OF NUCLEAR POWER PLANT EXTRACTION STEAM PIPING AFTER LONG TERM SERVICE

Degradation due to ageing in a Nuclear Power Plant's Extraction Steam Piping has been assessed. Samples of twelve years old seamless carbon steel SA 106B pipe have been taken and subjected to metallographic examination, hardness testing, radiographic examination and ultrasonic thickness measurement to investigate and analyze ageing in piping material. Metallographic examination of aged sample revealed irregularly distributed graphite nodules in ferrite grains and on grain boundaries as well, the reduction in pearlite phase has also been observed from 40% to 25%. This Transformation in microstructure has reduced hardness of steel. Reduction in hardness has found 20.4% and 0.7% on inner and outer layer of the pipe material respectively. Corrosion pits having average depth of 0.07 mm have been found on external surface. Radiograph of aged pipe revealed material removal and wall thinning due to erosion on inner surface of pipe. The extent of erosion had been checked, which has found 8.7%.

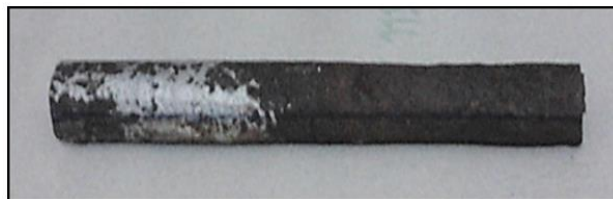
Visual examination shows no disturbance in the uniformity of as received pipe (Figure 2). Whereas, aged pipe shows marked surface corrosion (Figure 3), confirming the long term service in sea shore environment. Corrosion has the potential to reduce a product's design life by premature degradation [23]. Examination of corroded surface under metallurgical microscope (Figure 4) revealed formation of 0.07 mm deep corrosion pits.

Figure 3 SA 106-B Seamless Pipe (Aged)

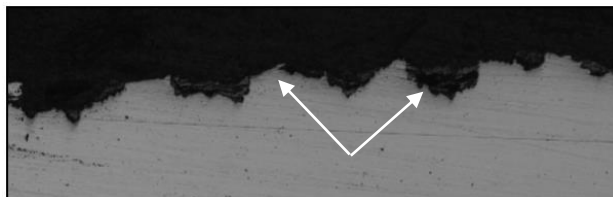
Figure 4 Diamond Polished External Surface of Aged Pipe Sample Showing Corrosion Pits (arrows), 100X

Piping used in high temperature pressure application degrades with time, so is the case with nuclear power plant's extraction steam piping. Corrosive environment formed 0.07 mm deep pits, whereas mechanical rubbing and impinging of hot and pressurized steam has scratched the internal surface. Reduction of 8.7% in thickness has also occurred due to erosion. This deterioration due to erosion and corrosion can be minimised by using Chrome-Molybdenum-Copper steel pipe with protective coating.

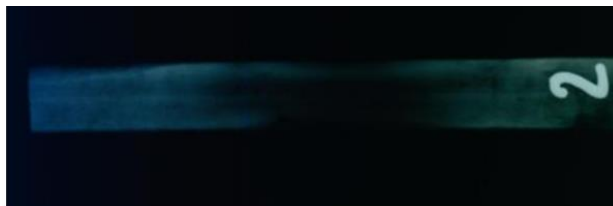
Section of an as-received pipe was subjected to radiographic testing (RT) which revealed no material degradation (figure 5). Radiographic examination of aged pipe revealed the material removal on the internal pipe surface (figure 6). This has occurred due to mechanical rubbing of steam [25] which was being supplied from middle stage extraction of high pressure turbine to deaerator at 0.1 MPa pressure and 250 °F temperature.

Figure 6 Radiograph of Aged Pipe

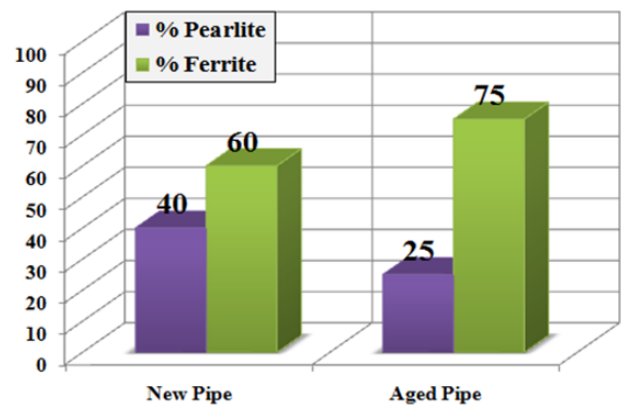
Amount of pearlite and ferrite was 40% and 60% respectively in new carbon steel, which has changed to 25% pearlite and 75% ferrite (Figure 10). Softness is induced with increment of ferrite content, which eventually leads to failure.

Figure 10 Change in Amount of Pearlite and Ferrite Phase after Prolong Service
