Case Report

# A-DInSAR Monitoring of Landslide and Subsidence Activity: A Case of Urban Damage in Arcos de la Frontera, Spain

**Abstract:** Terrain surface displacements at a site can be induced by more than one geological process. In this work, we use advanced differential interferometry SAR (A-DInSAR) to measure ground deformation in Arcos de la Frontera (SW Spain), where severe damages related to landslide activity and subsidence have occurred in recent years. The damages are concentrated in two residential neighborhoods constructed between 2001 and 2006. One of the neighborhoods, called La Verbena, is located at the head of an active retrogressive landslide that has an extension of around  $0.17 \times 10^6$  m<sup>2</sup> and developed in weathered clayey soils. Landslide motion has caused building deterioration since they were constructed. After a heavy rainfall period in winter 2009–2010, the movement was accelerated, worsening the situation. The other neighborhood, Pueblos Blancos, was built over a poorly compacted artificial filling undergoing a spatially variable consolidation process which has also led to severe damage to buildings. For both cases, a short set of C-ban

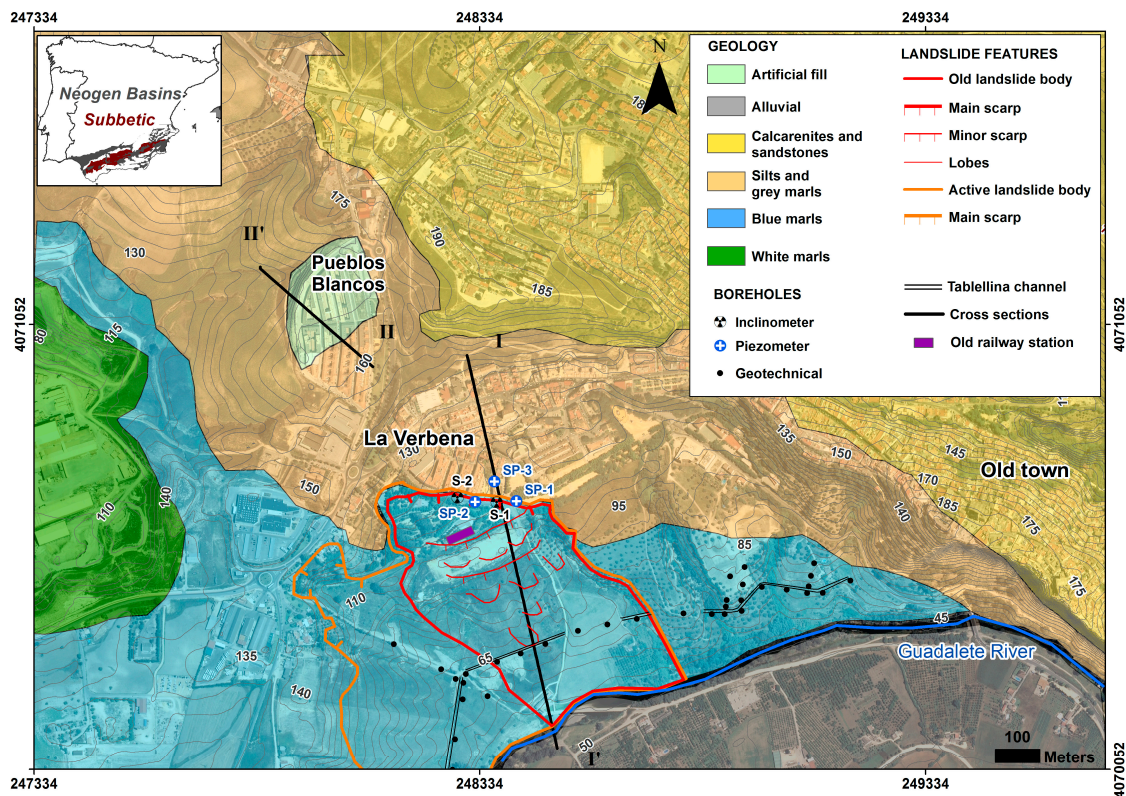
**Figure 2.** Local geology of the studied area. Old and active landslide features are identified. The Tablellina water channel trace is discontinuous because it is partially buried.

The Arcos de la Frontera landslide develops in weathered GBM on the lower part of a slope whose base is being eroded by the Guadalete River (Figure 2). The landslide extension is around  $0.17 \times 10^6 \text{ m}^2$  and the direction of the movement is southeast, towards the river. Regarding the style of the activity, it can be classified as a retrogressive landslide, since the surface of rupture is extending in a direction opposite to the movement of the displaced material [17]. Evidence of retrogression are the presence of older crown features downslope and lobular morphologies at the toe (Figure 2). The presence of cracks at the surface and the high permeability of weathered GBM permit water percolation, which can trigger a rapid response of the landslide to daily rainfall. According to Cruden and Varnes' movement classification [17], the landslide has a very slow velocity.

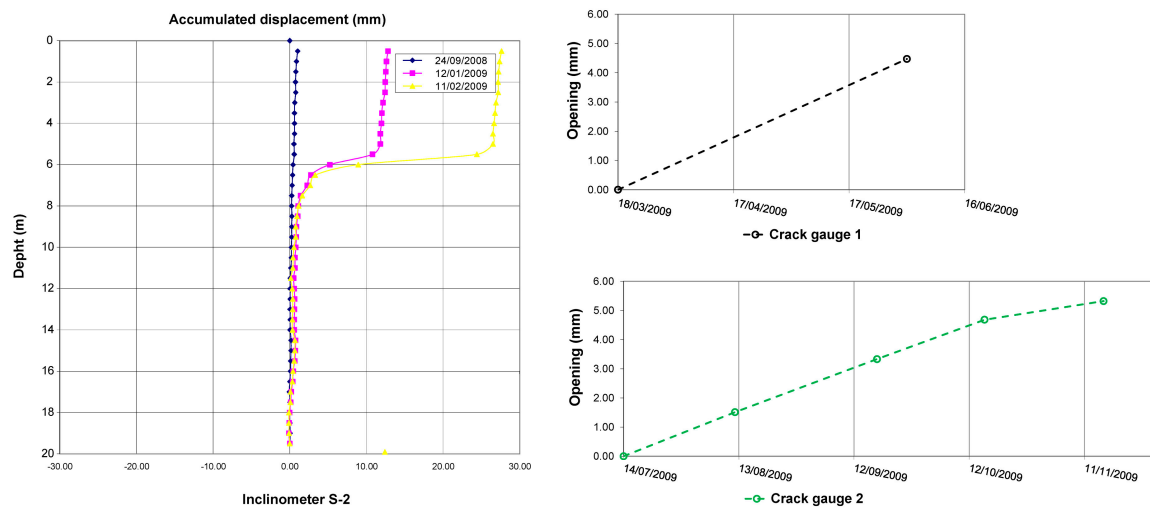
More recent geotechnical campaigns were focused on the La Verbena neighborhood [42,43], in which two inclinometers (S-1 and S-2) and three piezometers were installed (Figure 2). Continuous core samples of the soil were recovered before placing the inclinometric devices, and the materials were identified as silts and grey marls [43]. Two readings were performed between September 2008 and February 2009. Inclinometer S-1 (25 m length) detects terrain shear at 24 meters deep and around 30 mm of cumulative terrain motion towards the maximum slope direction, while in inclinometer S-2, the slip rupture was clearly detected at 6 m deep showing cumulative displacements of less than 30 mm towards the maximum slope direction (Figure 3). Crack monitoring gauges were installed inside the most damaged buildings of the La Verbena neighborhood [44,45]. Two periods were monitored, one from 18 March 2009 to 1 June 2009 and the other from 14 July 2009 to 16 November 2009. The maximum recorded displacements were 4.47 mm and 5.3 mm, respectively (Figure 3). The phreatic level was measured in 11/09/08 at both inclinometric boreholes, this was at 9 m depth at S-1, while S-2 was dry. The only data available from the piezometers was the phreatic level measured on 3 September 2010, which was at 2.5 m depth at SP-1, 4.5 m depth at SP-2, and 3.2 m depth at SP-3. These phreatic level measurements were taken two years apart. In that period of time a heavy rain period occurred, starting in December 2009 and lasting until February 2010, which explains the rise of the water table of almost 5 m. During those three months, a total amount of 670 mm of rainfall was measured at the Jerez de la Frontera meteorological station [46] (located 30 km from the studied area). This is a much higher value than the average accumulated rainfall for the same season, registered from 1980 to 2012, which was 252.4 mm.

**Figure 3.** Graphs of the accumulated deformation measured at the inclinometer S-2 (modified from [42]) and maximum opening of cracks measured in the indoor walls of the most damaged building.

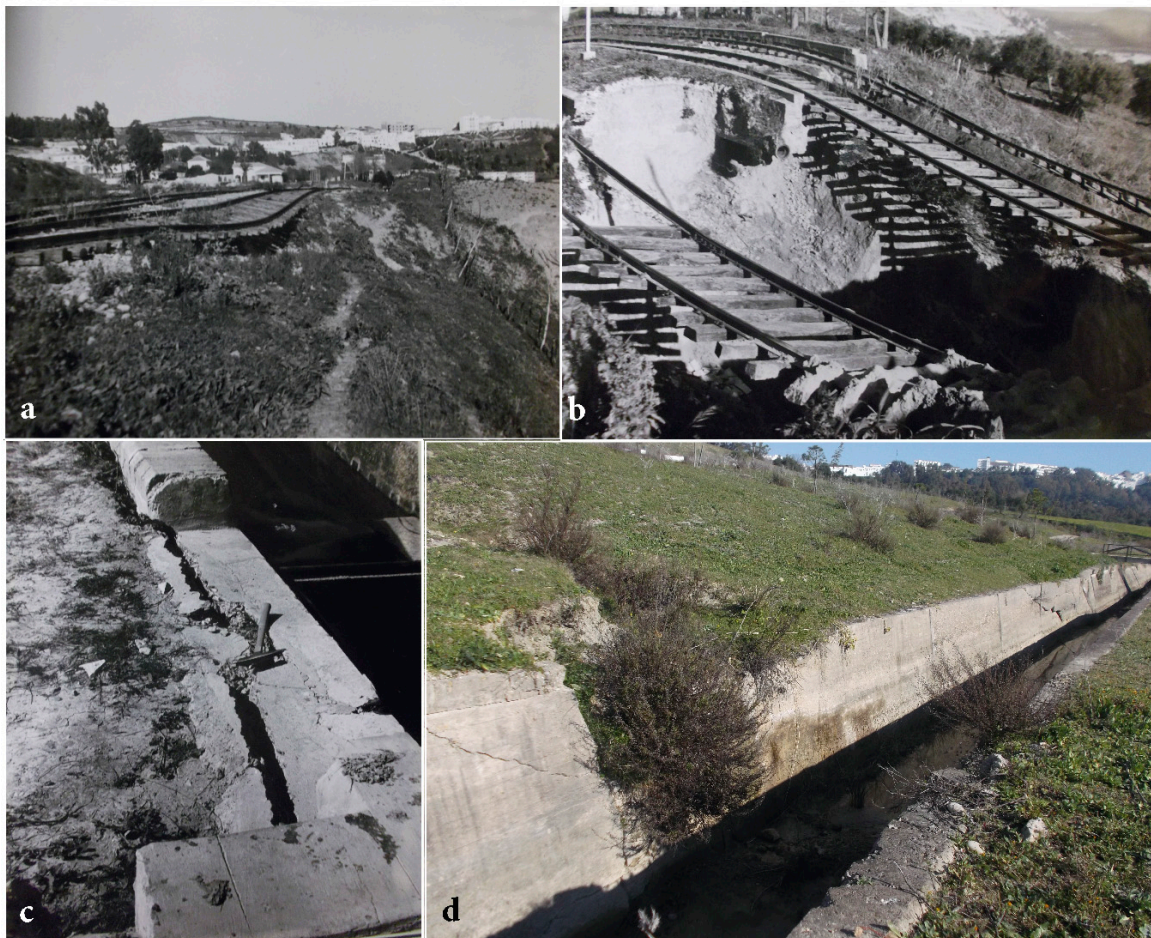
The Arcos de la Frontera landslide activity has been causing severe damage to infrastructure for decades. In the '70s, landslide motion was provoking the deterioration of the Tablenilla irrigation water channel located at the foot of the slope (Figure 2). The old railway station and rail track area that is currently occupied by a park were also affected by the same process (Figure 4a–c). A geological study was carried out in order to evaluate slope instability [40], which concluded that the water channel had to be buried through a non-weathered GBM formation, as shallow landslide processes were taking place in the weathered GBM layer and damages were expected to worsen during intense precipitation periods. The water channel has undergone stability problems since then and various remedial works have been carried out along its trace [47,48], with the latest one in 2011 [49]. In 2015 we detected cracks and bulks along the channel, which indicate landslide activity in the area (Figure 4d).

**Figure 4.** (a,b) Damaged railroad close to the old railway station [40]. The slope was affected by numerous landslides in the weathered layer of the GBM. (c) Detail of a crack presented in the Tablellina irrigation water channel, located in the low part of the slope [40]. (d) Cracks and bulks in the Tablellina water channel in 2015. The location of the photographs is labelled in Figure 1.

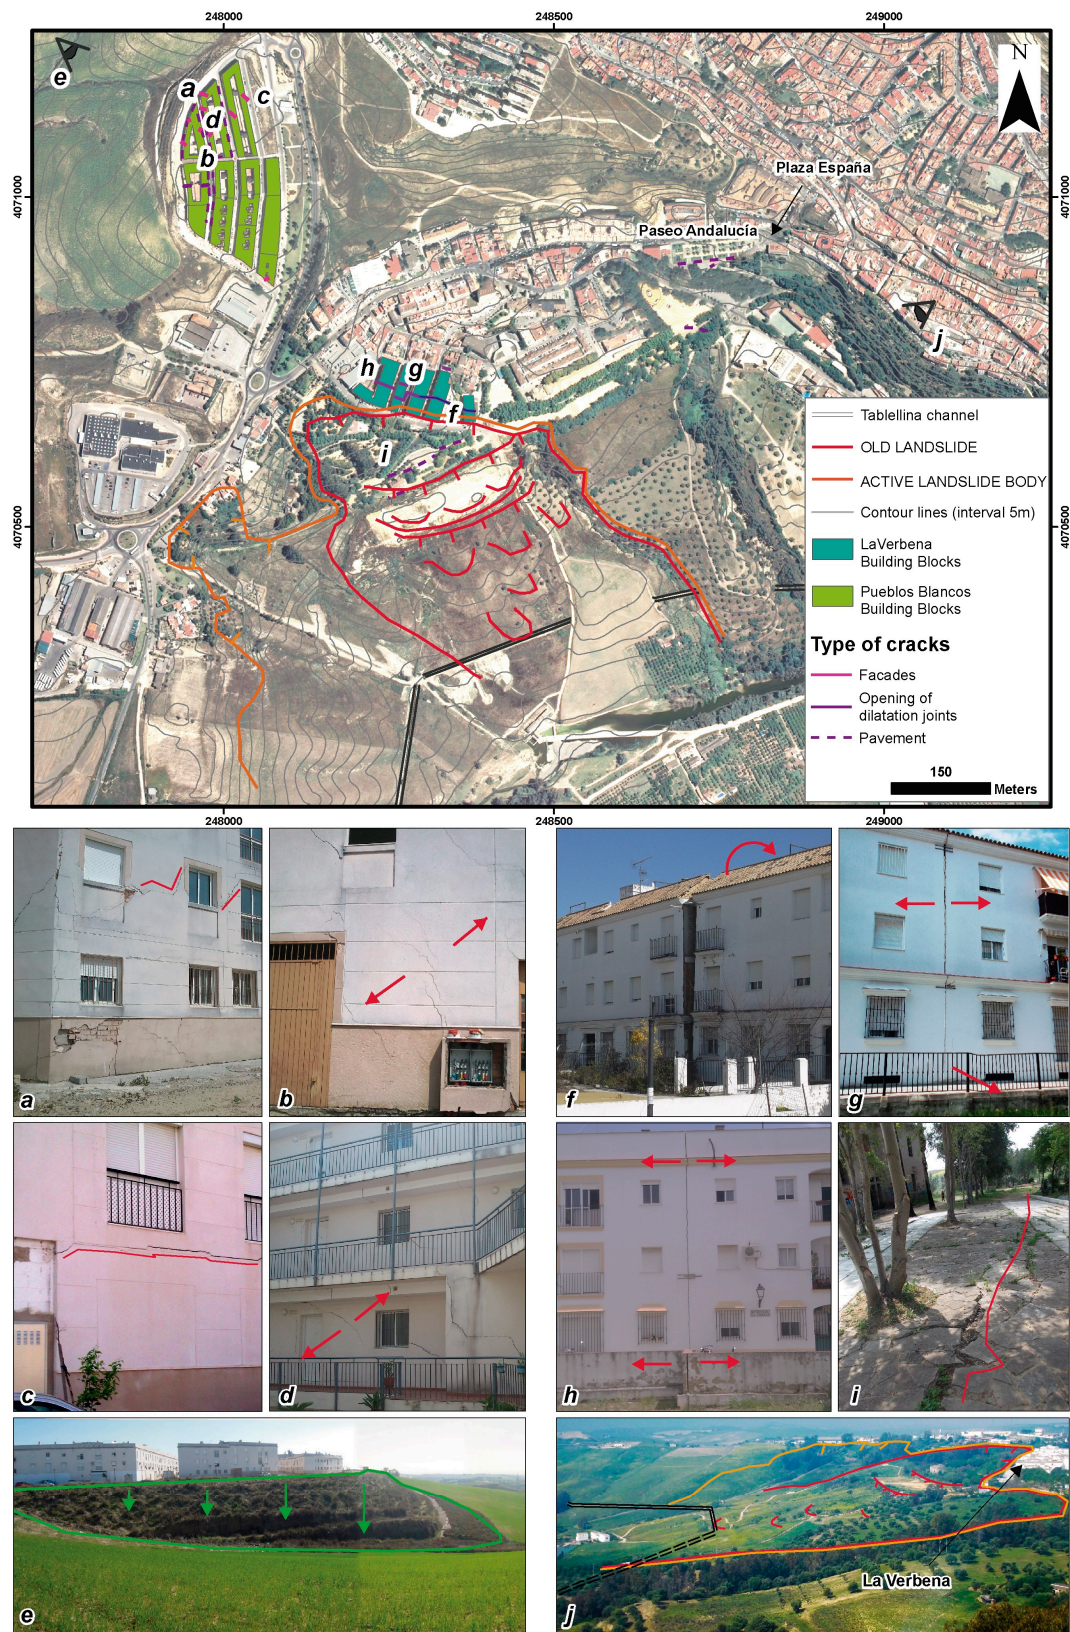
The La Verbena neighborhood is formed by five buildings located in the landslide crown-area and is cross-cut by the main scarp. Nonstructural damages, such as cracks in common and private zones and the opening of the dilatation joints, started soon after it was constructed [50]. Local remedial works were carried out, but in 2007 structural problems were detected in at least one of the buildings [51]. The downslope motion was progressively damaging sewer and water systems, pillars, partition walls, foundations and roads [52]. The most affected building (building f in Figure 5) housed 22 families and is divided in two by a dilatation joint. In October 2009, it was evacuated due to severe structural damages caused by landslide motion, as one part of the building had tilted with respect to the other, having reached a separation of more than 1 m (Figure 5f). Short after, an intense precipitation period spanning December 2009–March 2010 triggered the acceleration of the landslide, which aggravated the state of building f, declared derelict in March 2010 [53]. Adjacent buildings, public areas and water supplies were also affected during this period (Figure 5g–i). Local and national authorities compromised to repair urban damage and stabilize the landslide in 2010. Remedial works were planned to consist of two phases that started in 2011 and concluded in 2014, including the drainage of the slope, sewage network repair and reinforced grouting, with a total estimated cost of around 2.6 million euros [54–56]. A third phase of remedial works is currently being planned [57]. Considering standard housing prices, the economic loss to the dwelling owners of the run-down building amounts to 1.3 million euros.

**Figure 5.** Inventoried cracks layout of La Verbena and Pueblos Blancos neighborhoods along with main landslide features. (a–e) Pueblos Blancos: 45° angle dip and horizontal cracks in facades and in the internal patios and general view of the earth fill undergoing differential compaction. (f–j) La Verbena: building tilting, opening of the dilatation joints, pavement disrepair caused by numerous cracks at the head of the scarp (old train station location) and general view of the Arcos de la Frontera landslide.

The main damages present in Pueblos Blancos buildings are cracks on facades and walls, a with 45°-dip angle and horizontal and vertical directions. We also detected damages in non-structural elements such as parapets, ledges, stairs, windows, door frames and banisters. Damages are present outdoors, indoors and on the internal patios, as well as in the street pavement (Figure 5a,b,d). The layout of the crack distribution shown in Figure 5 indicates a progressive worsening of damage towards the northwest. The most deteriorated buildings are those located in the area where the thickness of the filling is greater, between the Tango and Seguirilla streets (labeled in Figure 5). Stabilization measures, with an estimated cost of 3 million euros [58], were carried out in 2009 [59]. They consisted of pile driving the most affected areas, drainage measures, and the construction of an anchored wall. However, we have detected surface displacements in Pueblos Blancos for the period 2011–2012, as discussed in the next section, and ongoing building deterioration between 2013 and 2015 by visual inspection. In both field campaigns we noticed that an entire block is uninhabited, one was semi abandoned due to deterioration and the streets surrounding them was closed to traffic as a result of disrepair.

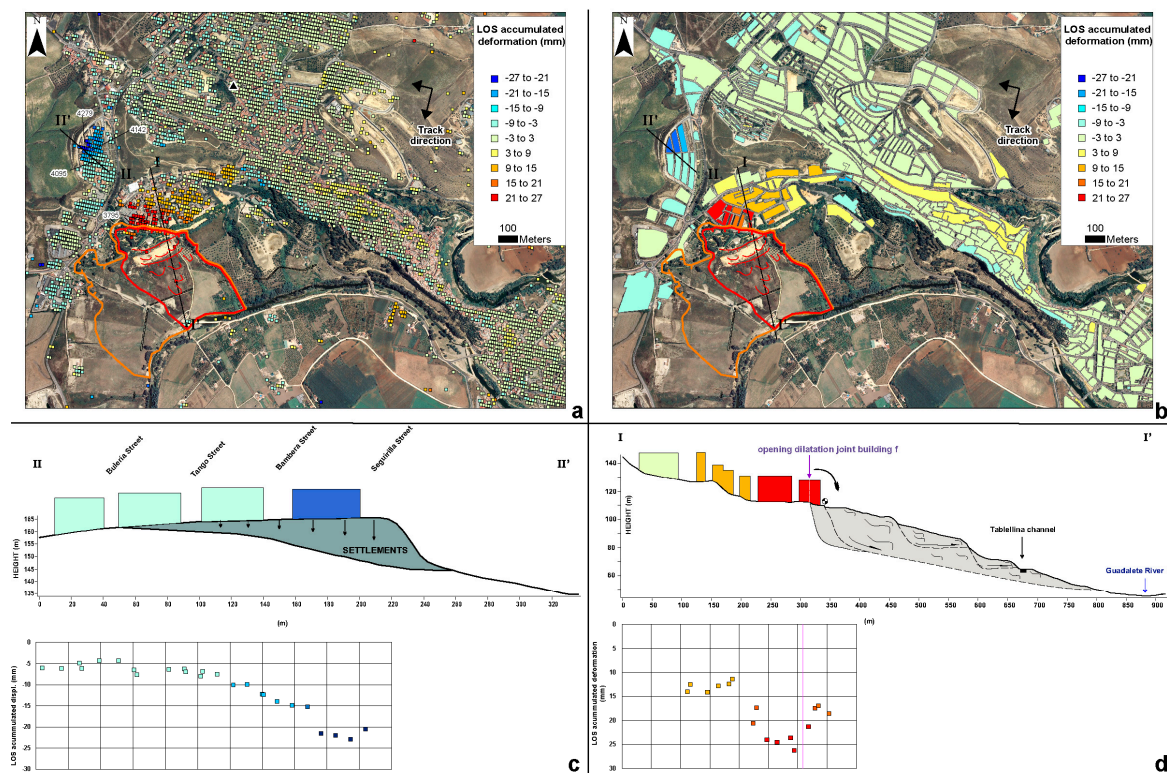
The results of the accumulated LOS displacement obtained with A-DInSAR are shown in Figure 7a, with positive values indicating movement towards the satellite. Pixel density is around 1600 pixels/km<sup>2</sup>, which is a relatively high value for C-band data, but is constrained to urbanized sectors. No prevalent phase-coherent radar targets were detected in vegetated areas, nor in the main body of the La Verbena landslide, as coherence is almost completely lost due to temporal decorrelation. However, pixels were detected at the crown of the landslide, which is urbanized.

**Figure 7.** (a) Accumulated line-of-sight (LOS) displacement map. The reference point used for A-DInSAR processing is marked with a black triangle. (b) city block accumulated LOS displacement for the period April 2011–February 2012. Positive values indicate movement towards the satellite. Black arrows at the upper right of the scenes indicate the descending track direction of the satellite and right-looking mode. Landslide features and the Tablellina channel are depicted in both scenes. (c) Pueblos Blancos cross section with buildings (earth fill in green) and projected accumulated LOS displacement pixels along the cross section line II–II'. (d) La Verbena landslide cross-section with buildings (depleted mass in grey) and projected accumulated LOS displacement pixels along the cross section line I–I'. Building f and inclinometer S-1 are depicted (Figure 5f).

The standard deviation of the accumulated LOS displacement was 5.5 mm, considering all pixels of the studied area. The highest displacements rates were located in the Pueblos Blancos and La Verbena areas, while in the old town most of the values comprised between  $-3$  and  $3$  mm. We consider

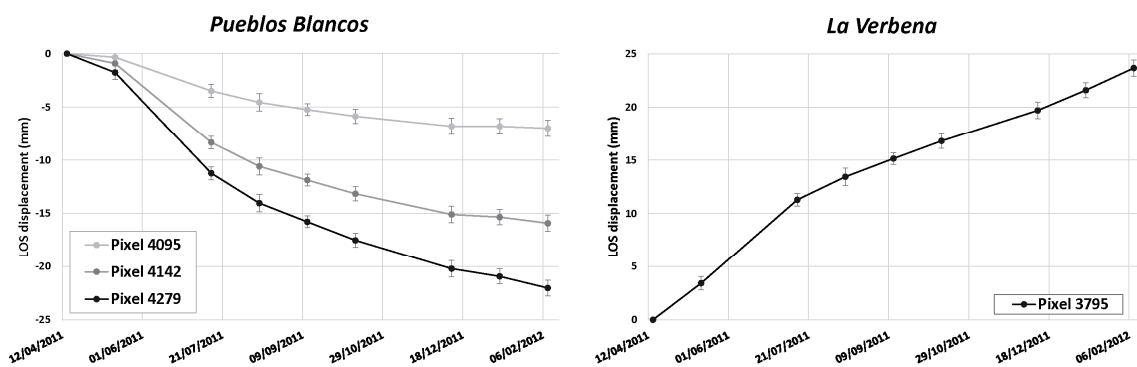
**Figure 8.** LOS deformation time series for a number of pixels for Pueblos Blancos and La Verbena. Their location is labeled in Figure 7.

The deformation phenomena detected with A-DInSAR in the Pueblos Blancos neighborhood is related to the compaction process of loose artificial earth filling. The measured accumulated LOS displacement reached  $-33$  mm. The negative sign indicates movement away from the satellite due to subsidence or vertical negative displacement. The magnitude of the measured displacement increases progressively towards the northwest, which correlates with the gradual increase of the earth fill thickness (Figures 7c and 8), as well as with the degree of building deterioration (Figure 5). The orientation of the  $45^\circ$  angle dip cracks of the facades also indicate that the compaction of the loose earth fill produces more settlement towards the northwest, which is congruent with the A-DInSAR results. Remedial solutions (micropiles among others) were carried out before the A-DInSAR monitoring period.

The La Verbena neighborhood is located at the crown of the Arcos de la Frontera active landslide. Taking into account that the positive sign of the velocity indicates movement towards the satellite, we interpret the A-DInSAR measurements as showing landslide displacement towards the southeast, projected along the satellite line-of-sight (LOS). The accumulated LOS displacement reached up to
