# Seismic microzoning maps for restoration of monuments in Seville: Nuestra Señora de los Reyes Convent

A. Jaramillo Morilla & E. J. Mascort Albea

doi: 10.14575/gl/rehab2014/094

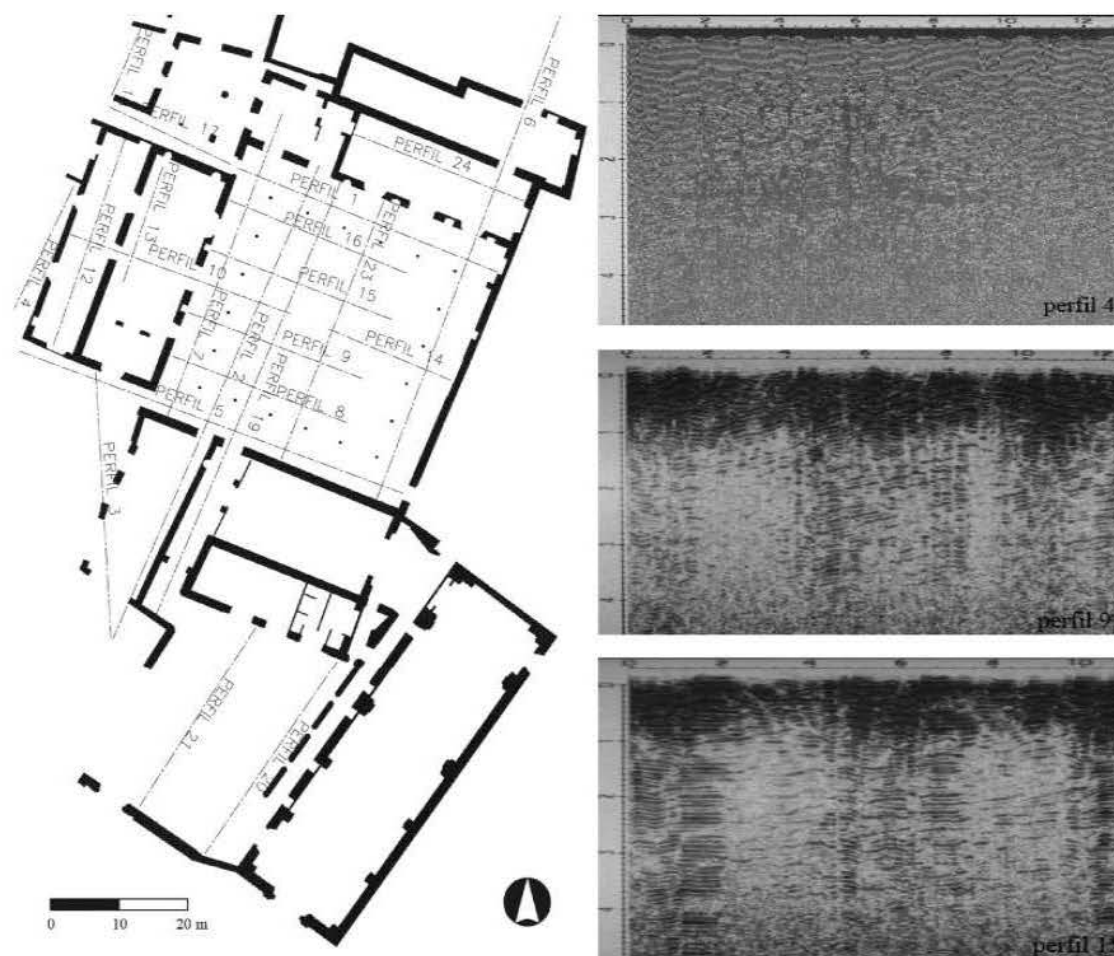
The profiles performed from the convent, together with the boreholes and soil test pits, enable an accurate terrain characterisation. Geo-radar profiles confirm the existence of soft fill layers, according to SPT testing (Jaramillo, 2013).

Figure 1. On the left, floor plan showing geo-radar tracing in the Convent. On the right, most relevant profiles showing soft fill-in layers.

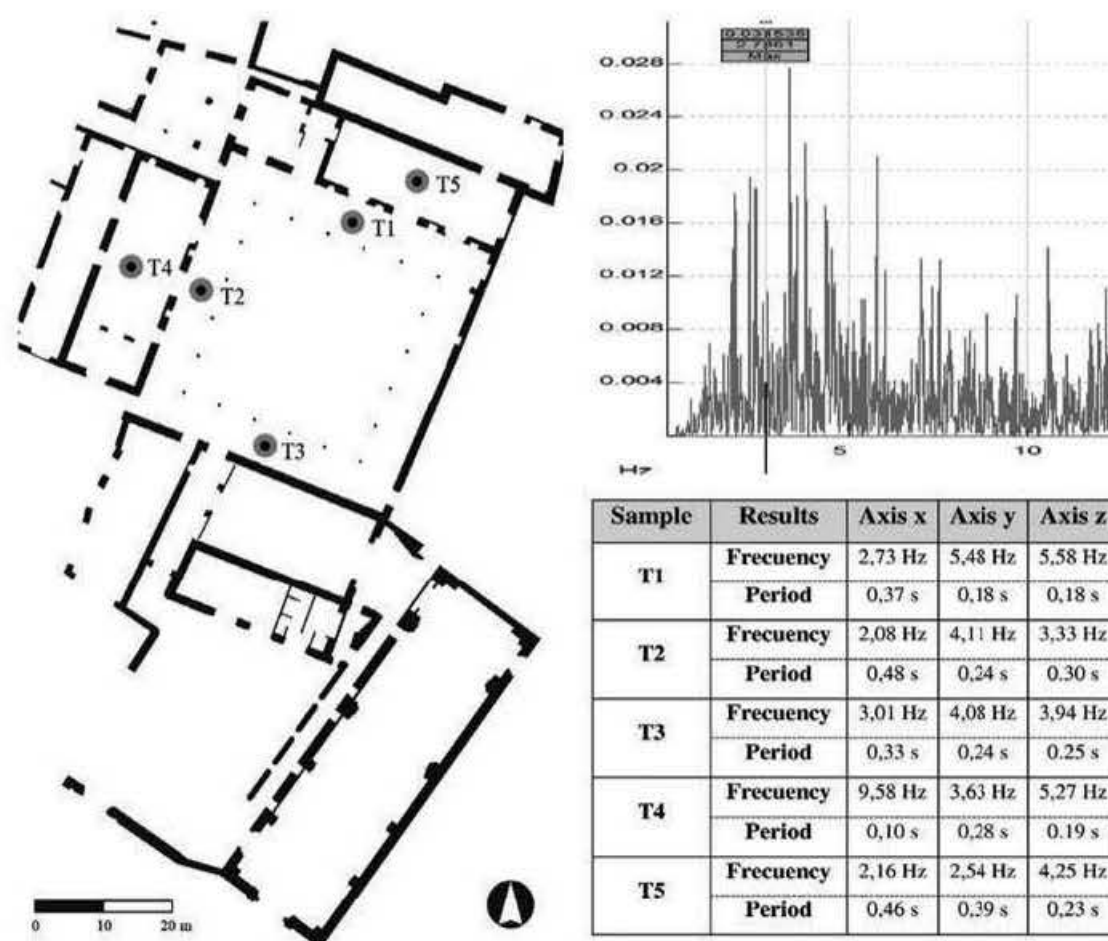
Figure 2. On the left, natural vibrations site plan. On the right, graphic sample and results table.

Very high values in room I floor slab, since it is not from slab consolidation works, could be due to added constriction from injections performed in the subsoil from the adjacent building.

Z axis values are quite similar because of wood slabs frequencies, normally over 4 Hz (0,25 s).

High relative periods in the cloister longitudinal axis means lack of arcade bracing, whilst horizontal plane values in room 2 are below usual, meaning the lack of model rigidity.

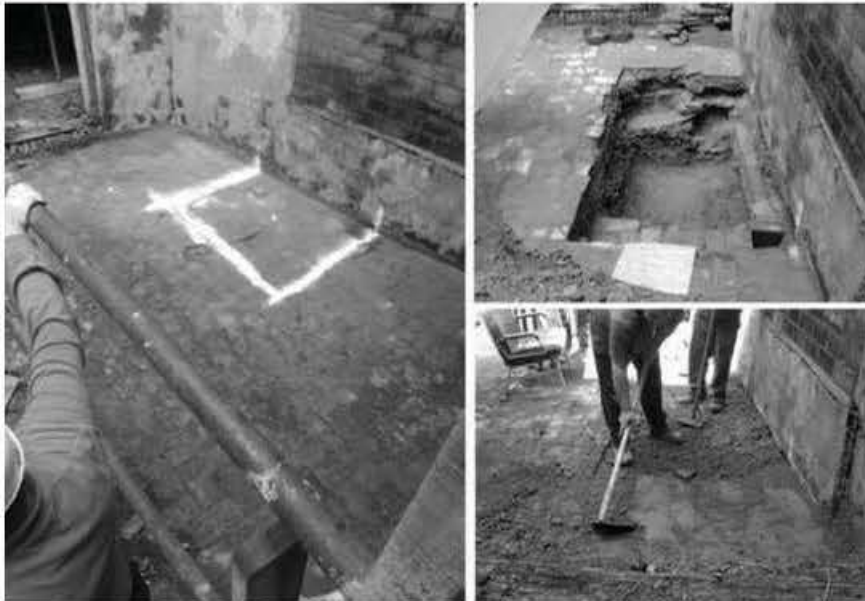
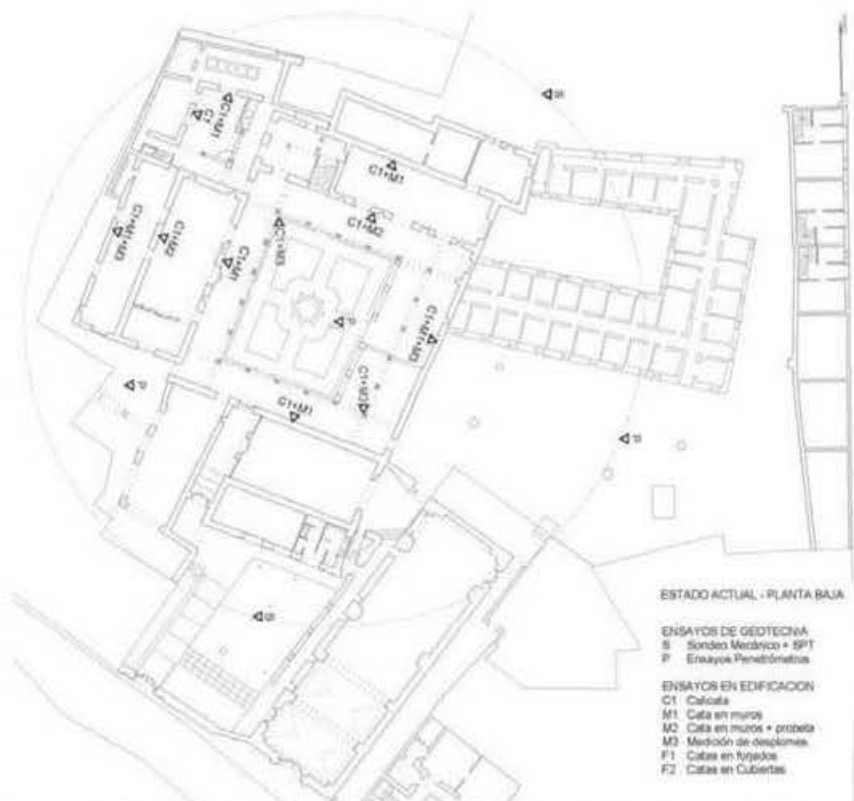
Figure 3. On top, test campaign photos showing soil pits placement. At the bottom, Nuestra Señora de los Reyes Convent site plan including test location.

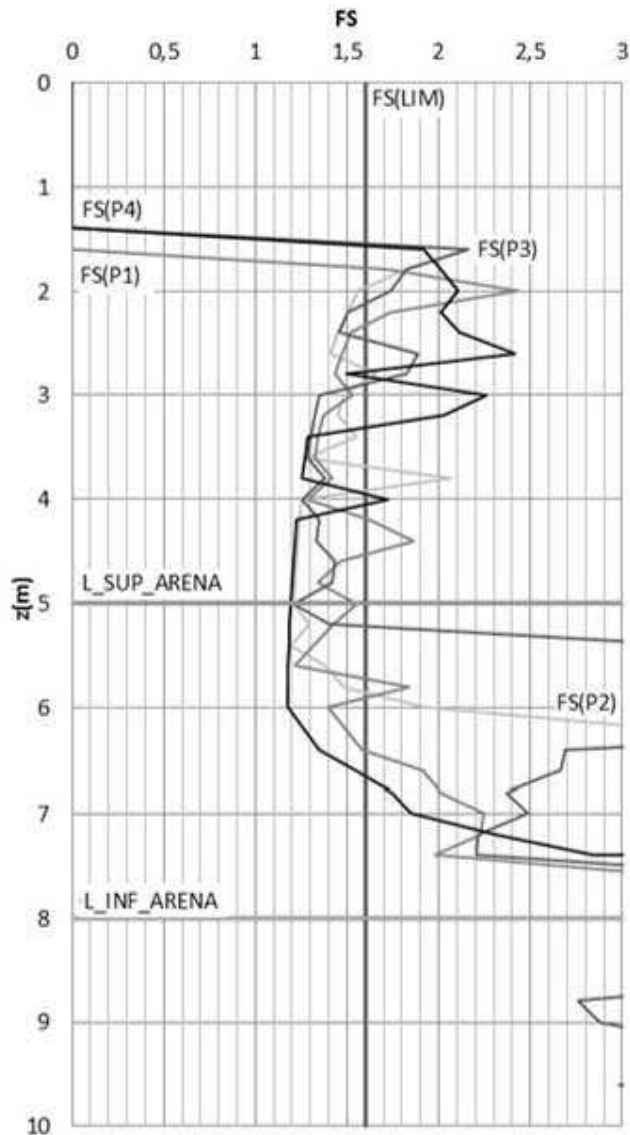
Figure 4. Safety coefficient is below 1.5 until 6-6.6 meters depth, which is less than minimum required by Spanish Technical Building Regulations (CTE) and NCS-2002 Seismic Regulation.

In general, this ground has a safety coefficient up to 1 but not reaching the 1.5 as minimum value that we consider needed for heritage buildings tipology.

This risk also leads us to propose ground improvement works in the first 8 meters.

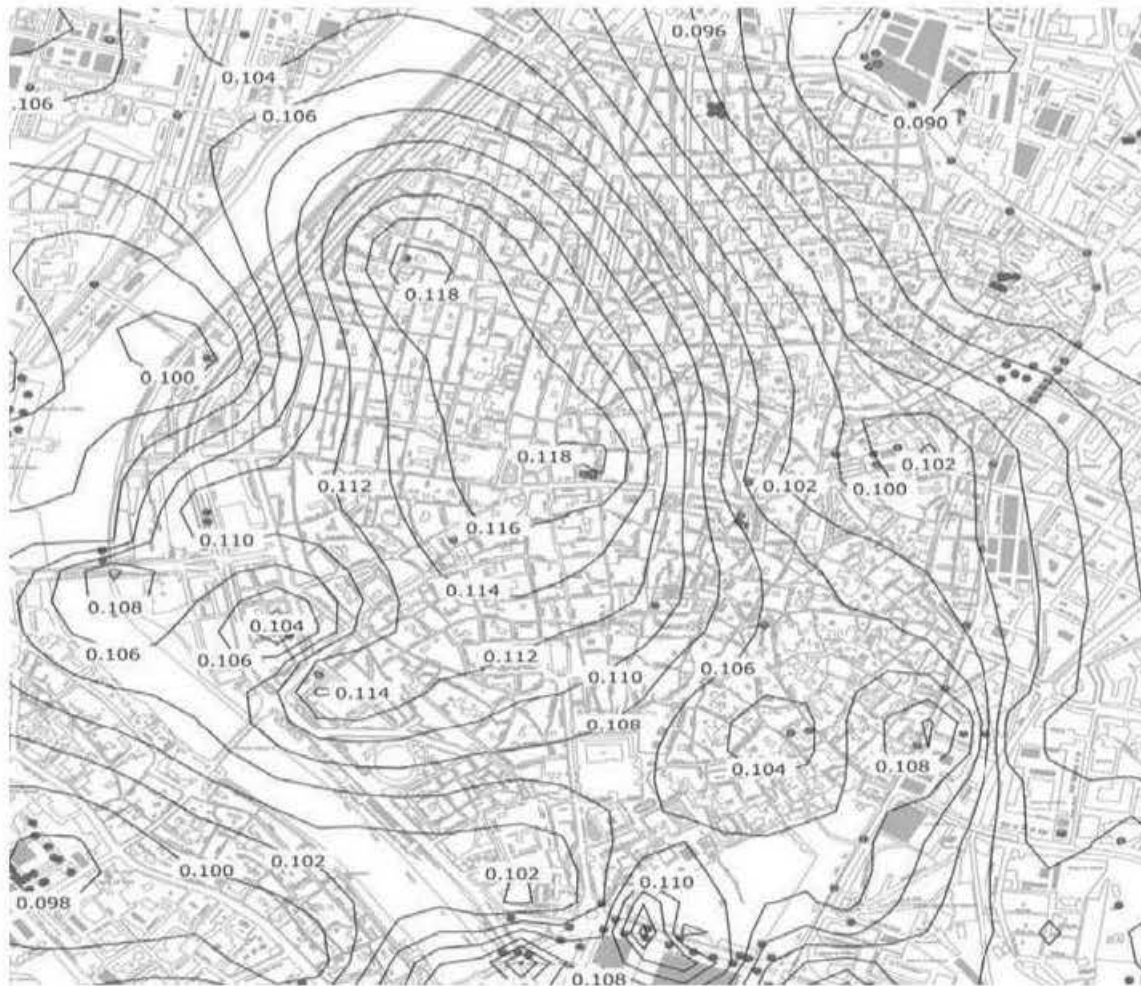
Main conclusion is a detailed seismic analysis is needed for buildings placed in particular points, since they may have an important acceleration value (ITE, 2013).

Figure 5. C terrain coefficients floor plan in Seville, coming from 1.1 to 1.7, S values going from 0.88 to 1.37, and seismic acceleration between 0.06 to 0.1.

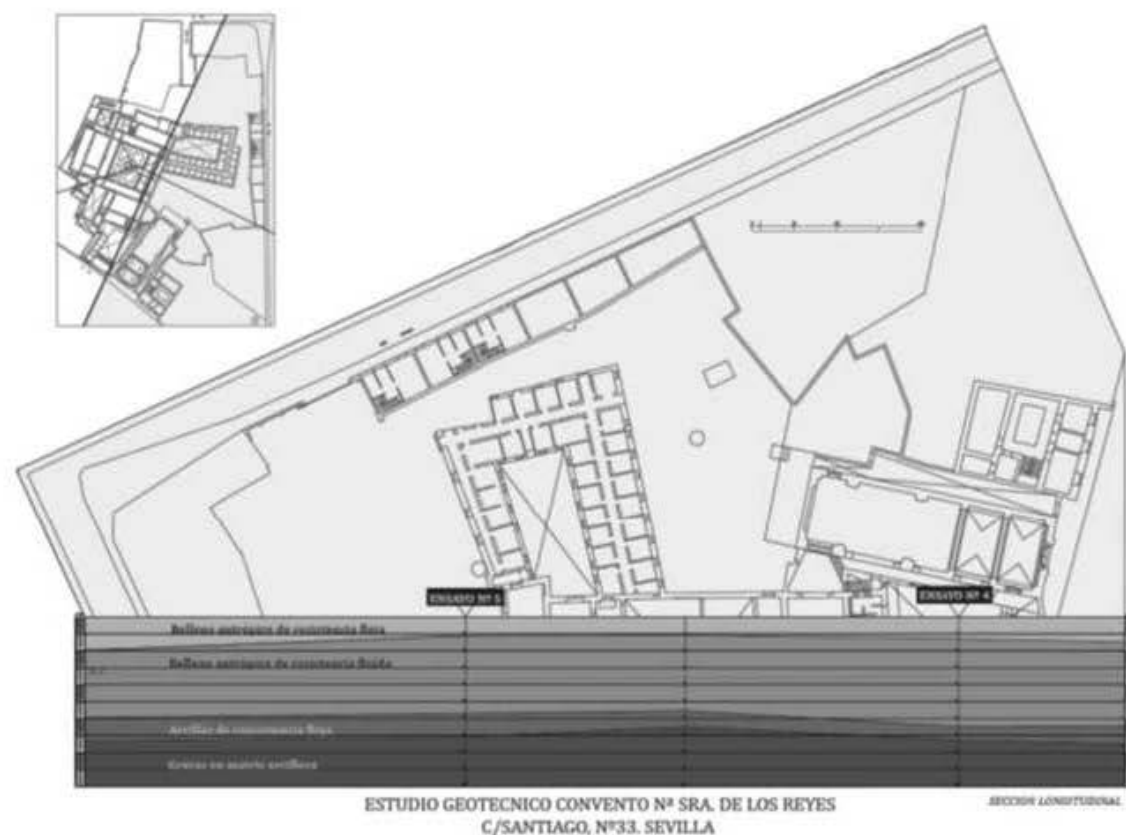
C terrain coefficient on this plot is very high reaching 2 before terrain improvement, and could reach the value of 1.5 after it.

Figure 6. Convent floor plan shows relevance of ground study in heritage buildings protection.

New building use needs better security and structure conditions, so a terrain injections network is recommended to homogenise the surface layers, both the very soft and the layer from adjacent constructions with cement residues and could be rigid points.
