Analysis and Diagnosis of the Church of Santiago in Jerez de la Frontera (Spain)

E. Rodríguez-Mayorga ^(*), E. Yanes-Bustamante ^(*), A. Sáez-Pérez ^(*)

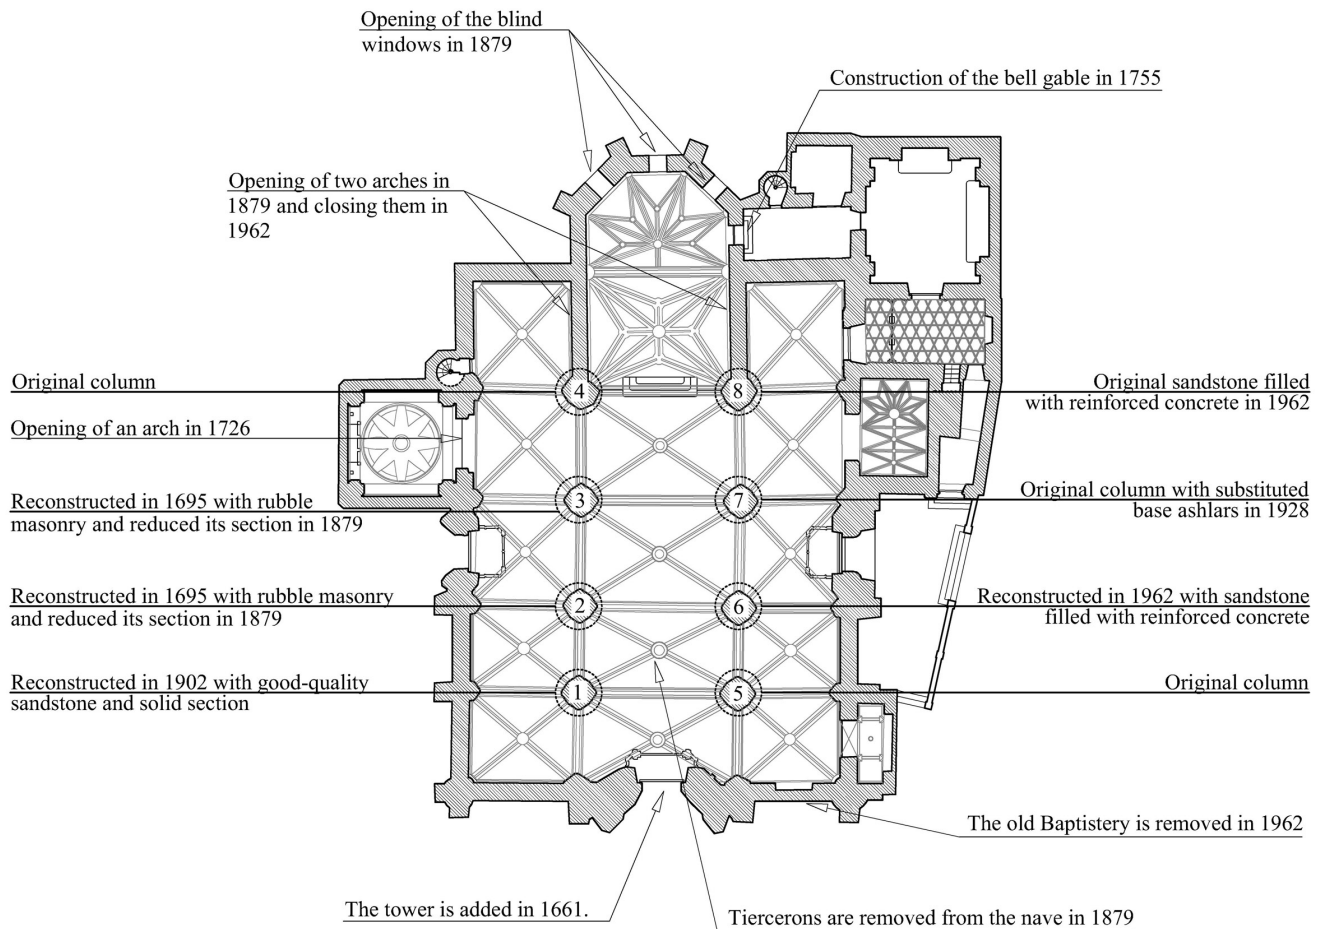
As a consequence of the building history, the structure is heterogeneous in two main aspects: material and geometry. Figure 2 summarizes the modifications described above.

Figure 2. Summary of the works that have happened in Santiago Church and resulting state of the columns.

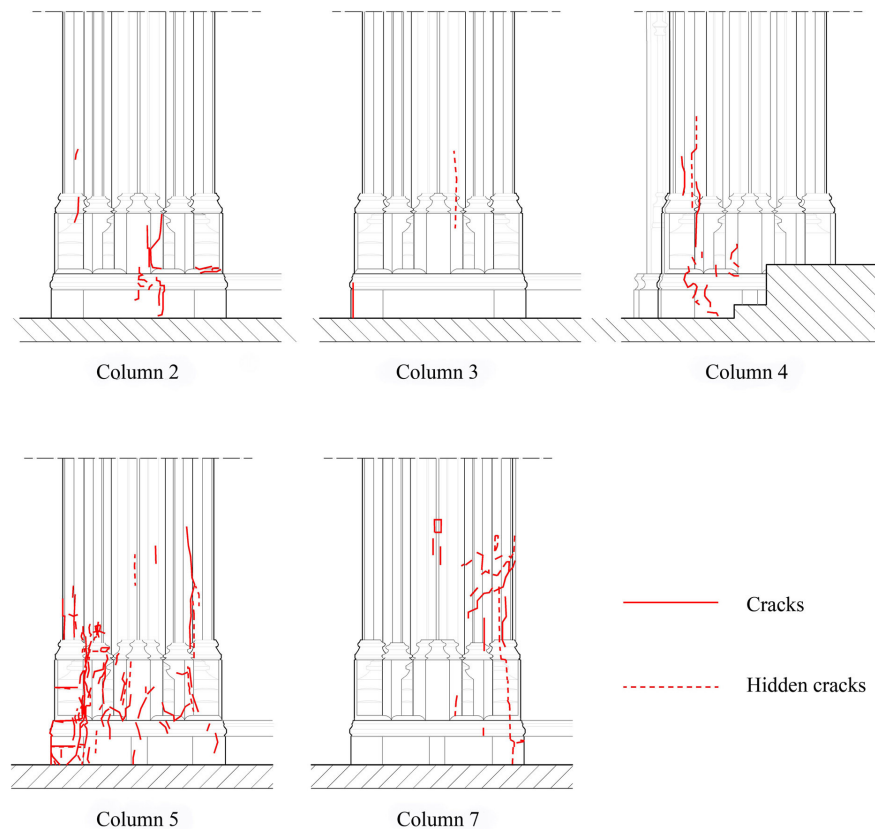
In 2005, the structure of the church was damaged to such an extent that the closure of the temple was mandatory. Significant damage could be observed at a glance. The lower areas of columns were the most important cause for concern since they were cracked and crushed. The most damaged columns were columns number 5 and 7, while columns number 1 and 8 did not exhibit any defect. Figure 3 illustrates the crack pattern through visual inspection in the columns.

Figure 3. Crack pattern in the four lower meters of columns viewed from the nave.

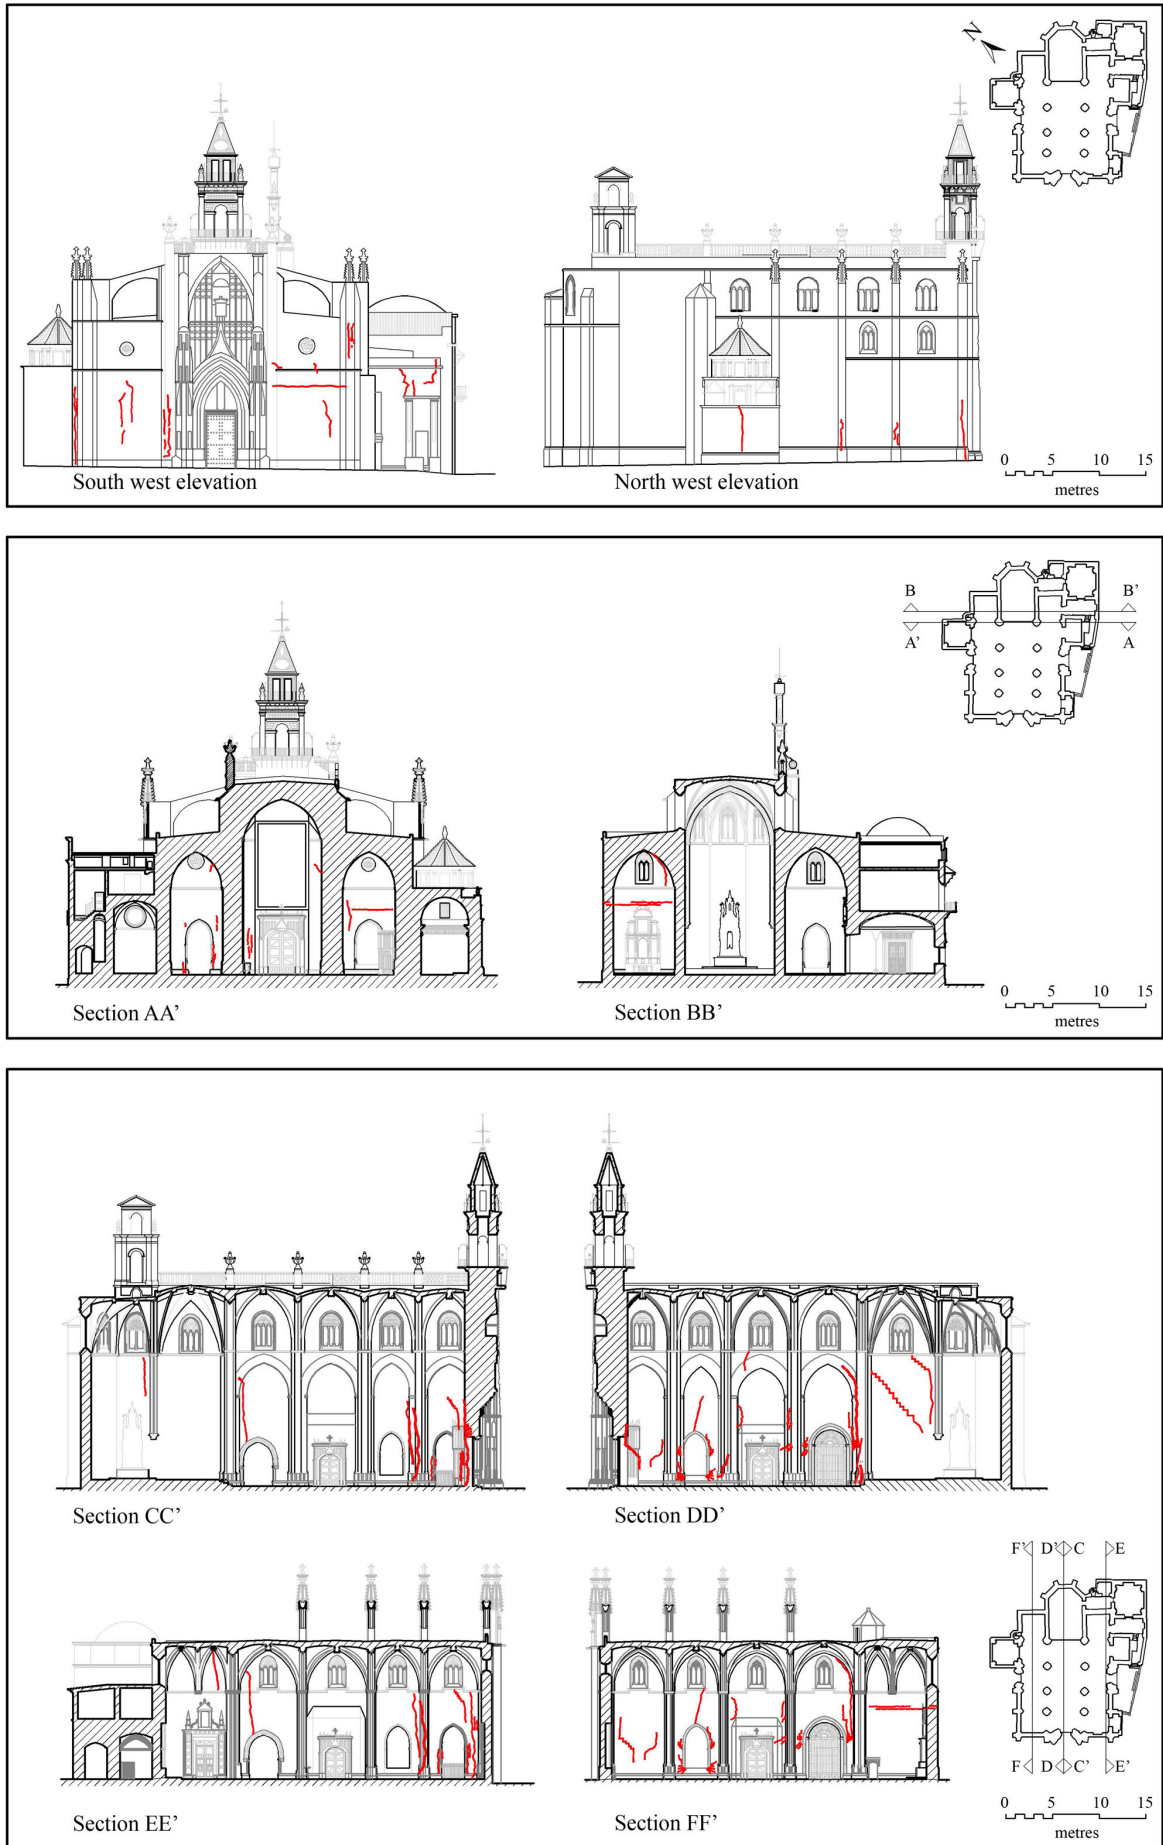
Cracks in walls were significant as well. In almost all walls, cracking and crushing appeared mainly in window corners and arch haunches, as well as in the lower part of the buttresses. Figure 4 summarizes their crack pattern through visual inspection.

Figure 4. Crack pattern in walls.

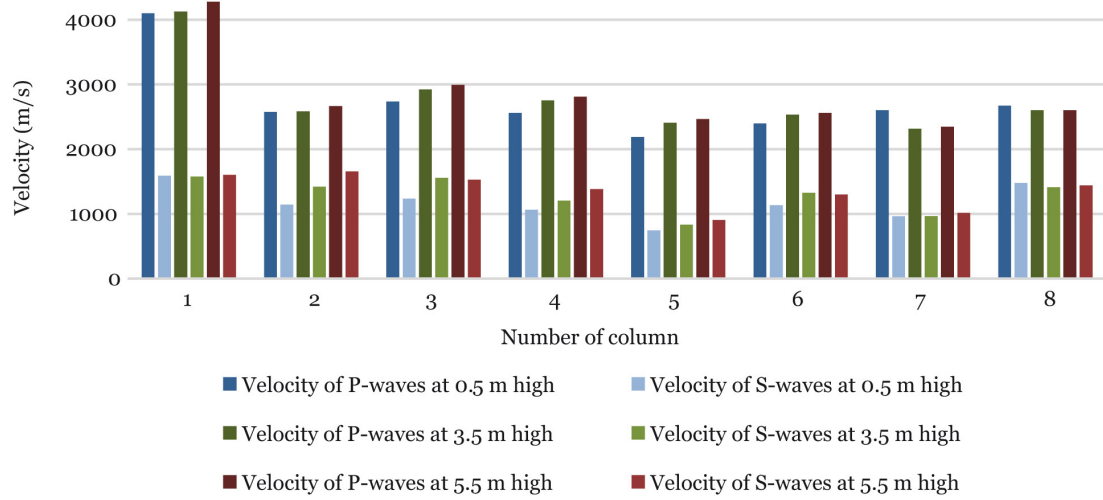
waves crossing the column sections were measured in three different planes (0.5, 3.5 and 5.5 m from the soil level) in order to identify the influence of rising damp in the masonry. These data are summarized in Figure 5. Two main conclusions may be drawn:

- In general, lower values of wave velocities are recorded at the inferior part of the columns, due to the deterioration induced by rising damp. Exceptions can be found in columns 7 and 8 due to its history: the lower ashlar of column 7 were substituted and column 8 was filled with reinforced concrete (Figure 2).
- Large differences exist among the measured velocities. For instance, the values of P-waves for the lower sections range from 2186 m/s (column 5) and 4279 m/s (column 1). This heterogeneity was also expected due to the historical evolution of the structure (Figure 2).

Figure 5. Chart summarizing the velocities of P and S waves in columns.

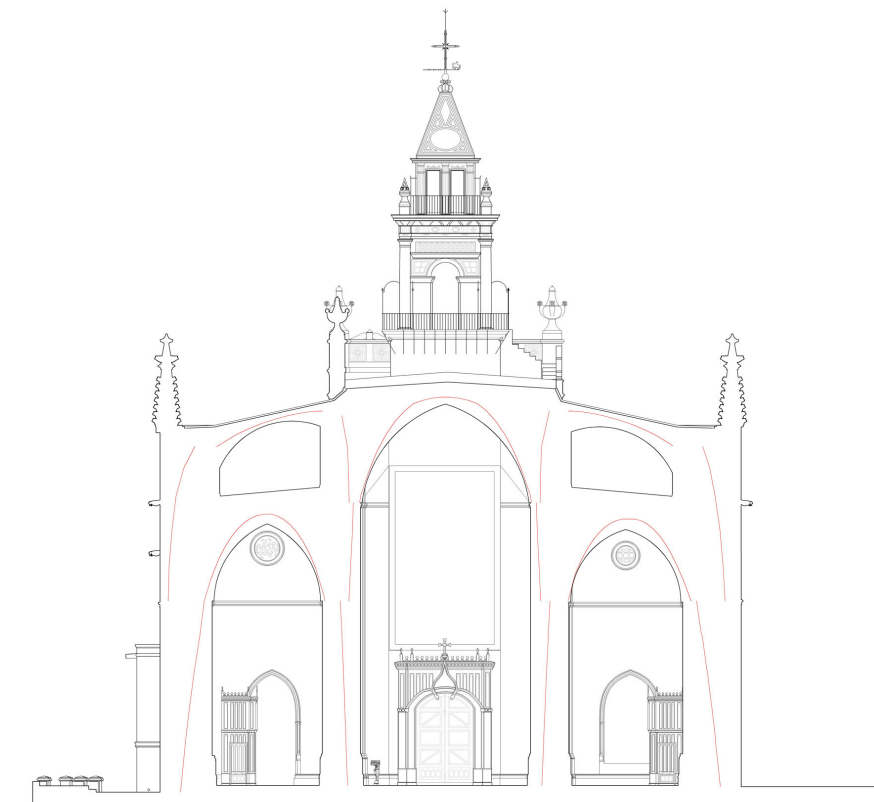
The complete analysis of the thrust line in the plane of the columns 2 and 6 is depicted in Figure 7. It may be observed that although the thrust line is inside the structure, it does not lie always inside the middle third. This is due to the geometrical irregularities described in the previous section and it is one of the causes for the observed cracks in structural elements. Therefore, the malfunctioning of the structure is partially caused by the geometry, since:

- The buttresses thickness is too small to balance the load from the vaults. This problem is further worsened by the position of the pinnacles.
- The dead loads over the columns are different.

Figure 7. Thrust line analysis of the transversal section including columns number 2 (right) and 6 (left).

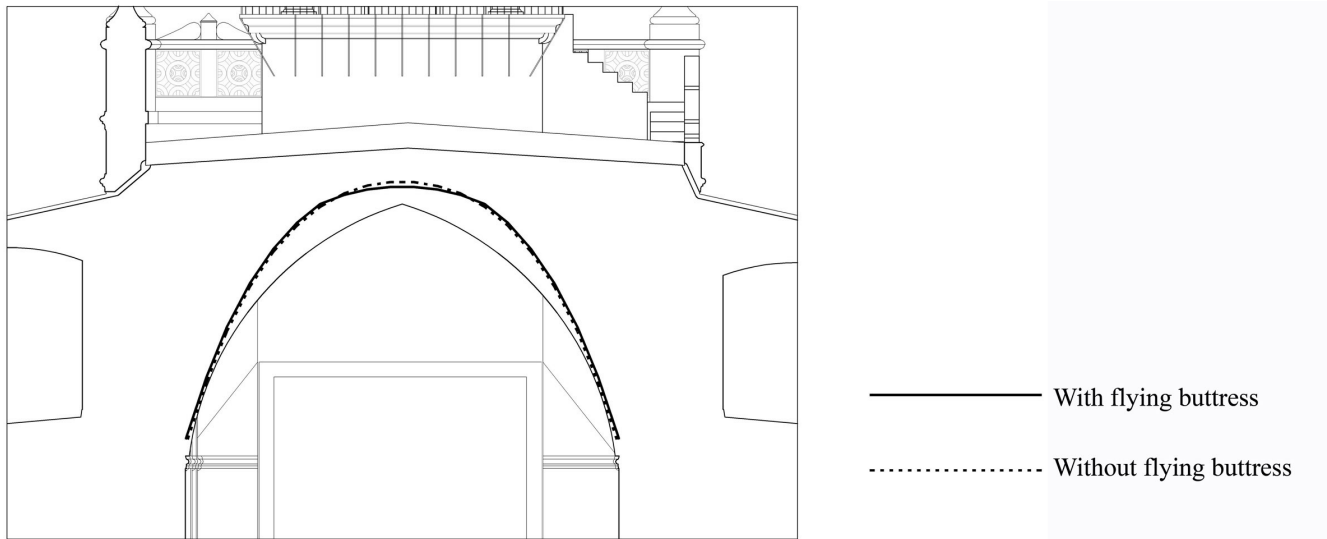
would not exist was carried out. The result of this comparison is depicted in Figure 8. It clearly shows that the position of the flying buttress is misconceived as a structural element, since both thrust lines are almost coincident.

Figure 8. Comparison of the behaviour of the central arch with and without flying buttress.

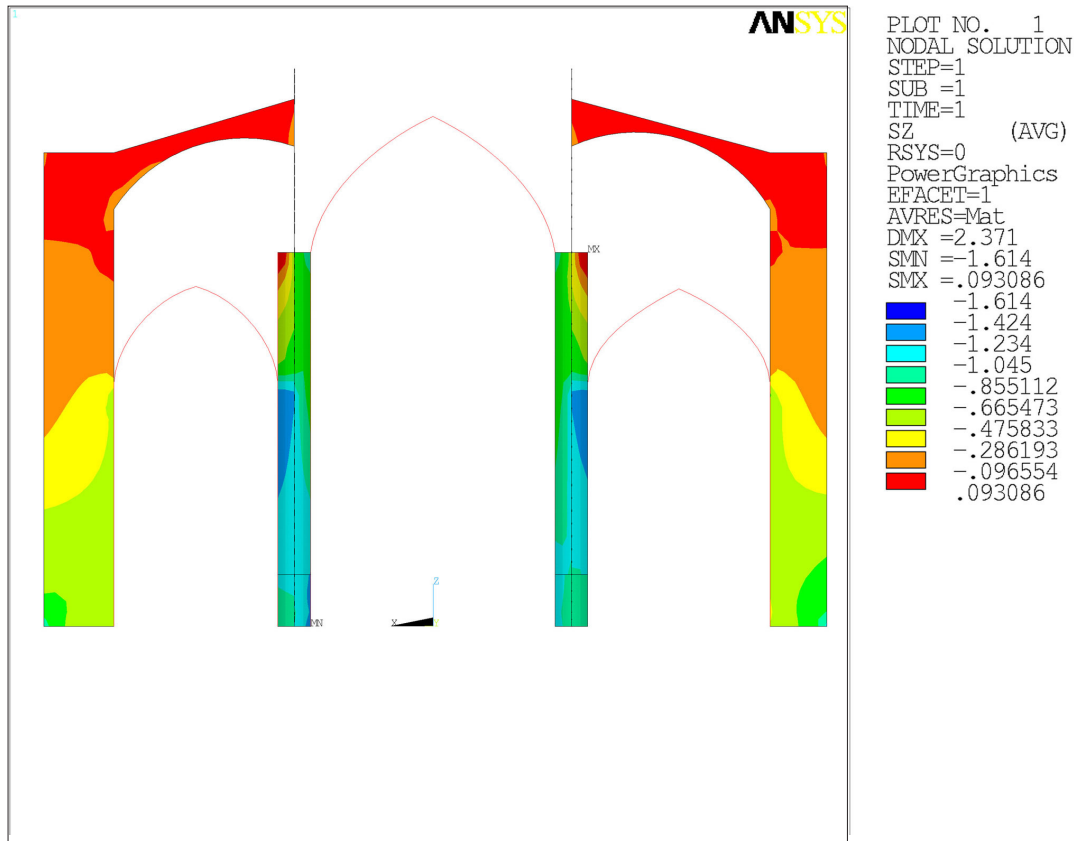
As pointed out above, the FE results were favourably compared with the plane thrust line analysis and the observed crack pattern, thus validating the model. For instance, Figure 10 shows the FE analysis of the same plane considered for the previous thrust line analysis (columns 2 and 6), where the concentration of vertical stresses in the exterior area of the buttress close to column 2 (1.045 MPa in the lower sections) can be easily identified. The compressive test carried out to this buttress stone led to characteristic compressive resistance values from 1.6 MPa to 1.2 MPa in dry and saturated conditions, respectively (Table 1). This fact explains the cracking observed in this area (as shown in Figure 4).

Figure 10. Values of the vertical stresses in MPa of the plane crossing columns 2 (right) and 6 (left).

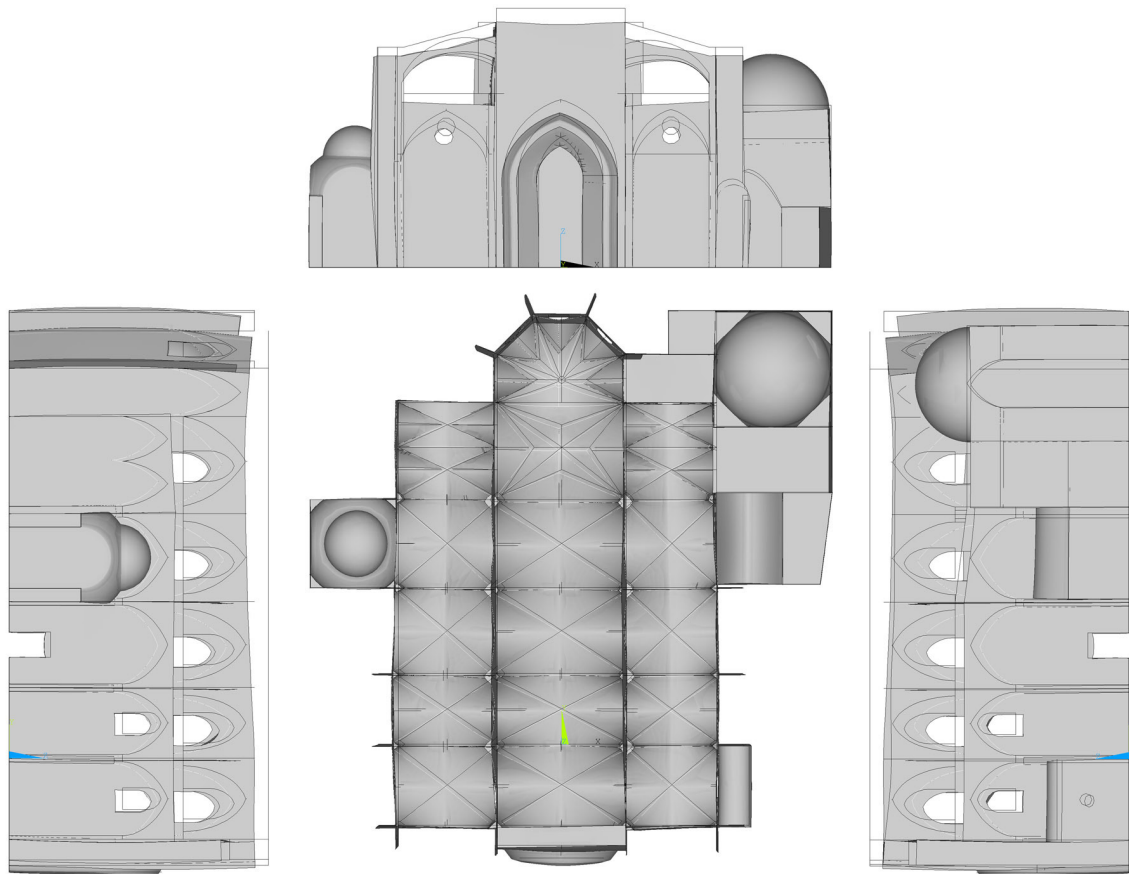
Further results from the F.E. analysis are depicted in Figures 11 and 12. An unsymmetrical deformed shape can be observed, with a general movement of the structure towards the Gospel side and the west-end (Figure 11) which is coherent with the in-situ observations. These irregularities may also be observed as

Figure 11. Deformed shape obtained from the calculation. Displacement scale factor 1500.

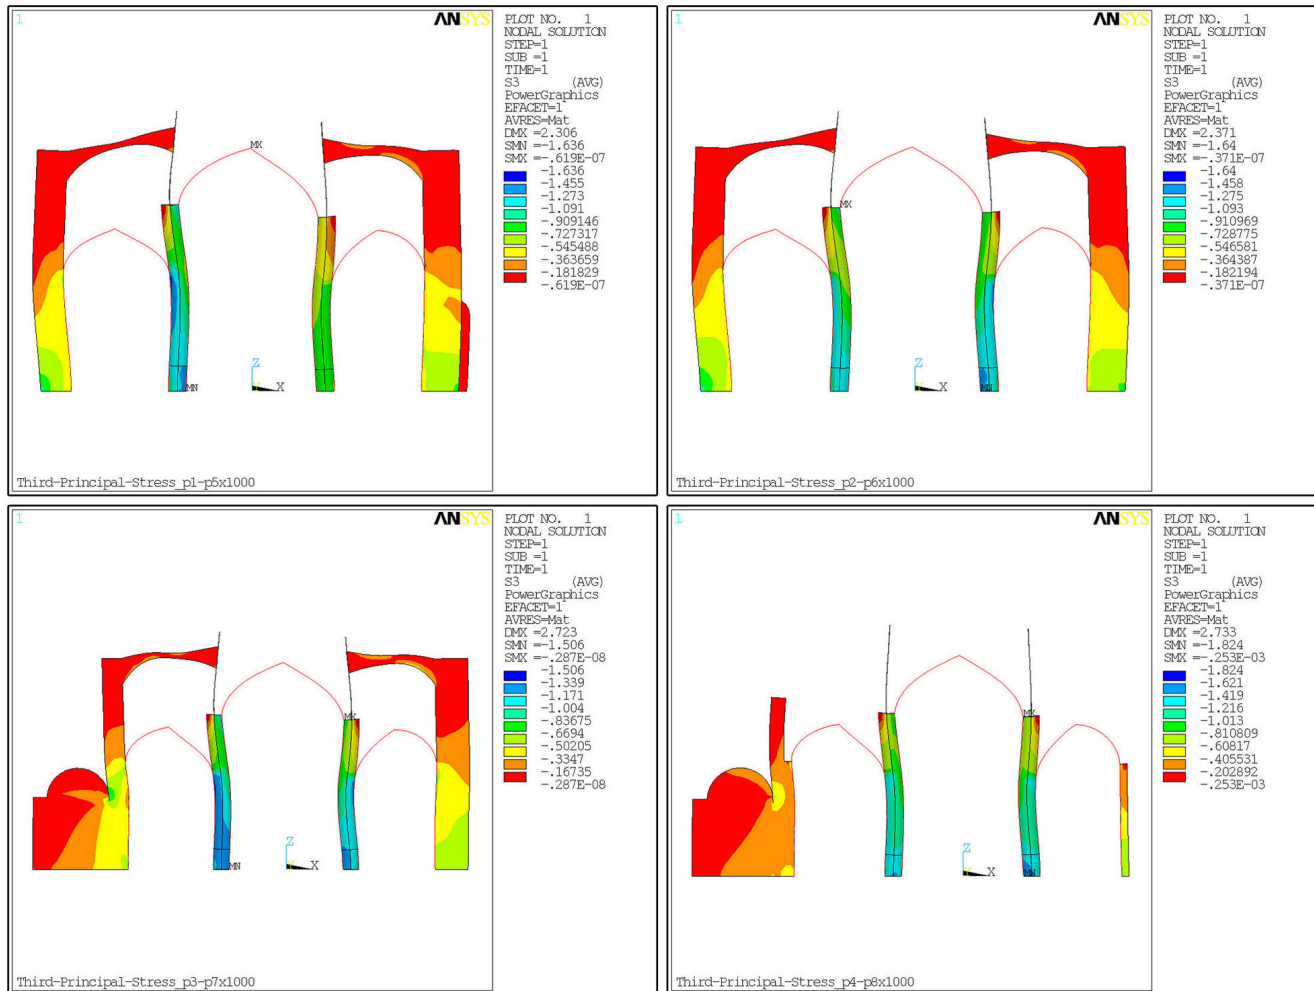
the vertical displacements are concerned. Such values are smaller in the west end, provided the columns are closer in this area and, consequently, the loads the columns bear are also smaller. The heterogeneous behaviour of the church due to different materials and spans of arches is illustrated in Table 2. Table 2 summarizes the vertical reaction loads obtained from the F.E. model for each column, as well as the percentage of the total load that each reaction implies. Such resulting loads depend on both the position of the column and its material. This table also reflects the maximum values of stresses in the columns, leading to values close to the compressive resistance, in particular regarding the columns with original material (columns 4, 5 and 7).

Figure 12. Third principal stresses (compression) obtained for the planes of the columns 1 and 5 (up left); 2 and 6 (up right); 3 and 7 (down left); 4 and 8 (down right). View from the west end. Values in MPa.

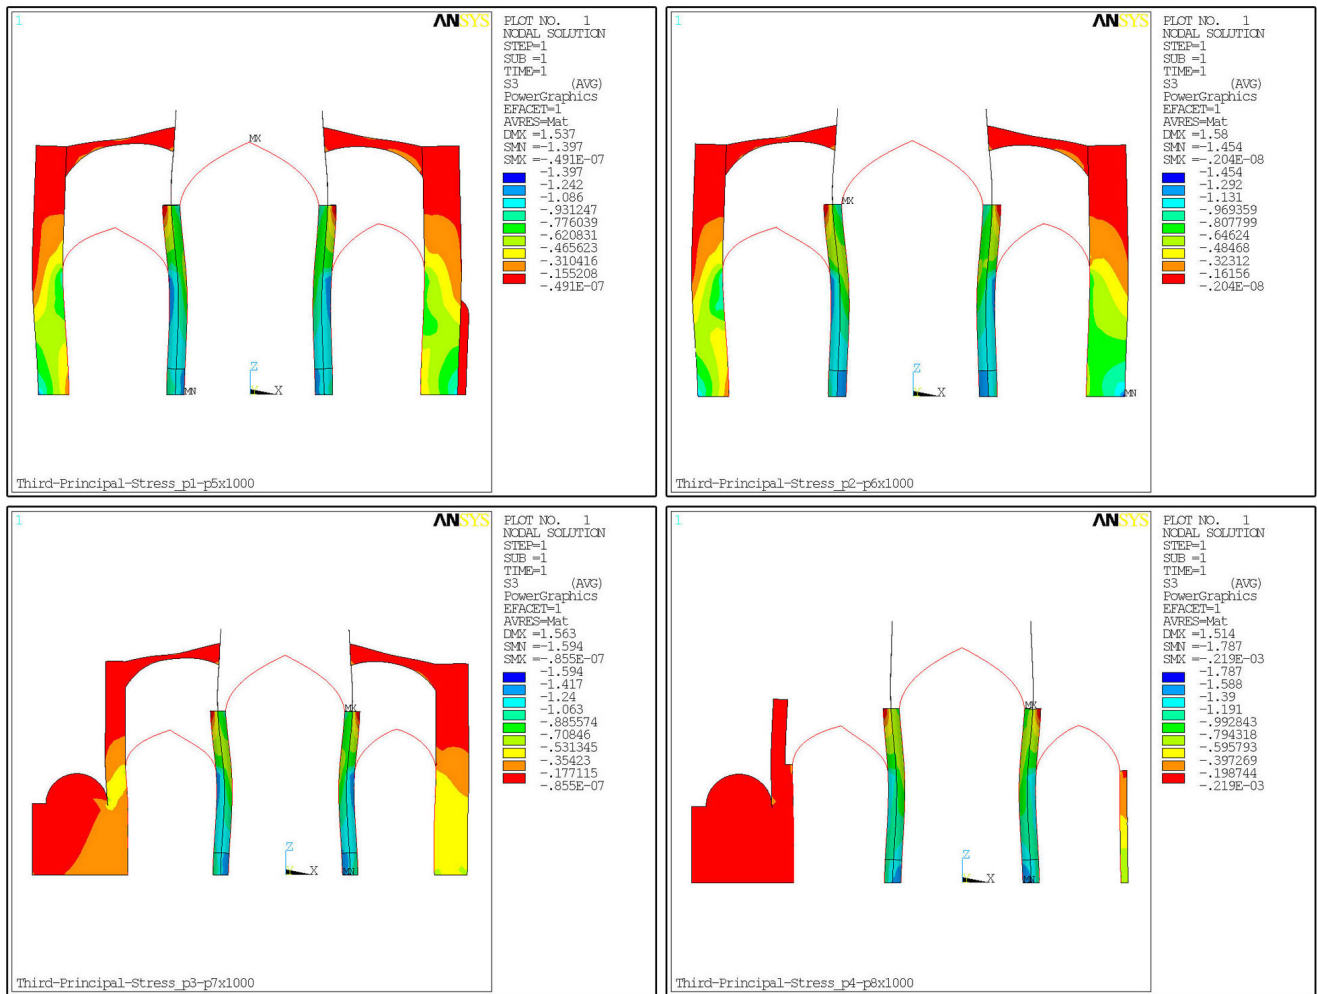
Figure 13. Third principal stresses (compression) obtained for the planes of the columns 1 and 5 (up left); 2 and 6 (up right); 3 and 7 (down left); 4 and 8 (down right) in an ideal situation of good-properties masonry. View from the west end. Values in MPa.

To check the potential benefits of the consolidation and homogenization of the material through grout injection, a new calculation was performed using the same F.E. model developed in section 5.2 (Figure 9), but setting all the material properties to match those of column number 1. Column 1 is adopted as reference since, although it is not an original one but reconstructed, it presents the largest resistance values and the basic aim would focus on homogenising the mechanical properties of all the columns. The results in terms of stresses improve, as it may be seen by comparison of results in Figures 12 and 13. Table 3 is similar to Table 2 with the values obtained from the calculations in this hypothetical situation of a homogenized material. The favourable effect of consolidation and homogenization can be easily checked by comparison of Tables 2 and 3. The load values that each column has to bear are more homogeneous than in the initial situation and the values of expected stress levels are more similar among columns. Although, due to the geometrical irregularities that cannot be corrected, some heterogeneity in

these values still persists. However, the improvement of the materials after grout injection makes possible for columns to support the loads that they receive.
