# Analysis of constructive pathologies of a building constructed on expansive ground and repair proposal

For this analysis, we provide as a case study the repair proposal project on the housing development located on block 4 PP G-4 UE-1, Guillena, Seville, by assignment of the owners association.

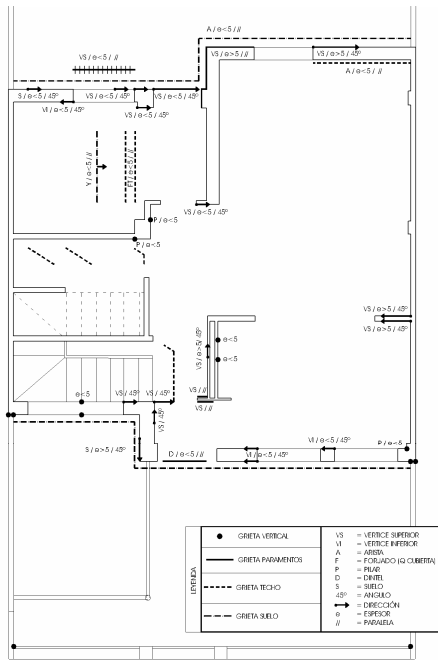
We confirm that the buildings show a generalize damage by fissures in the interior masonry wall, and cracks in the outward facing facades with values between 1 to 8mm, whose inclination indicates a differential settlement in the perimeter of the building with the courtyard.

We also perceive damage caused by the increase of the thickness joints flooring on the area affected by the foundation deflection, as well as the racking of the carpentry, windows and doors.

Figure 1. Graphic representation of the damage on the ground floor

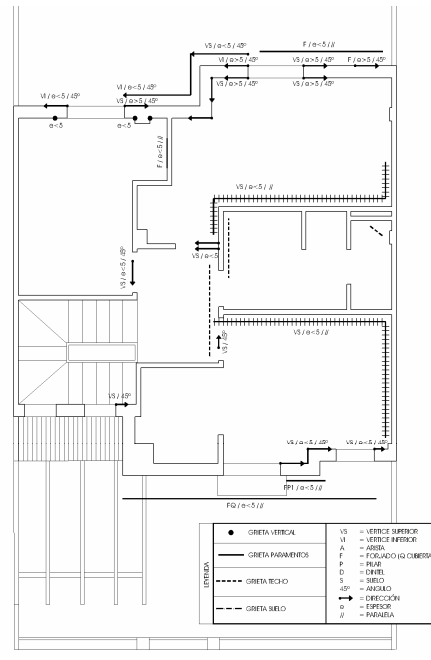
Figure 2. Graphic representation of the damage on the first floor

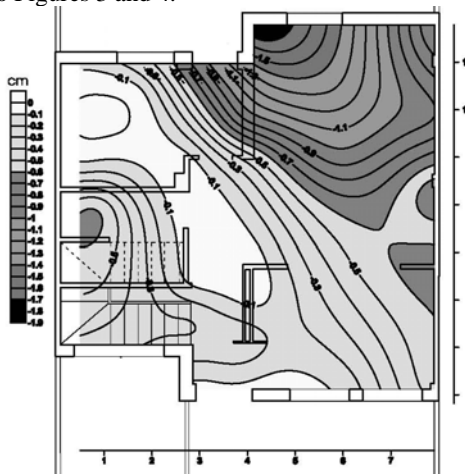
Figure 3. Topographic levelling of ground floor.

Floor	Portico	Distance between pillars	Differential settlement	Angular distortion	S.L.S		U.L.S	
					value	TESTING	value	TESTING
Ground floor	P5 - P4	2,50m	1,1cm	L/227	L/300	fail	L/150	OK
	P1 - P4	5,30m	2,2cm	L/240	L/300	fail	L/150	OK
First floor	P5 - P4	2,50m	0,8cm	L/312	L/300	OK	L/150	OK
	P1 - P4	5,30m	2,0cm	L/265	L/300	fail	L/150	OK

According to the previous data, we deduce that the differential settlement is concentrated in the interior façade which adjoins with the garden courtyard, area which allows the filtration of the rain water and irrigation water to the ground.

The change of the ground humidity condition caused by the water filtration implies a change in its volume, due to the high expansive levels of the clays.

As a consequence, the low inertia of the surface foundation and the absence of the rigidity ground-structure, allows the deflection of the structure against the change of the ground volume.

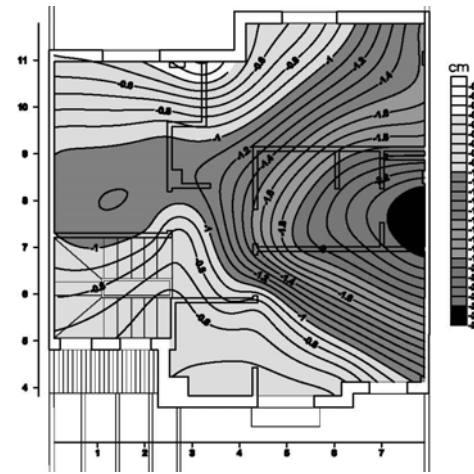
Figure 4. Topographic levelling of first floor

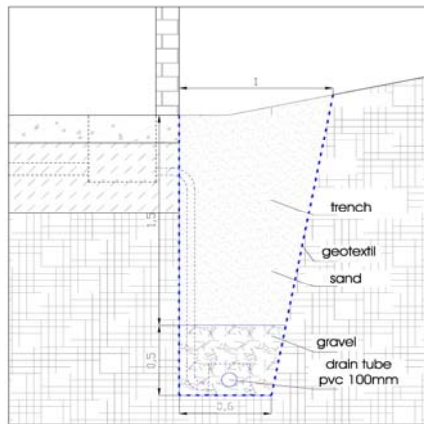
Fig. 6. Drain trench

For these reasons the repair proposal will be focused on the cause of the damage in order to reduce the humidity change and thus, the volume change. In order to do that, a drain trench is designed along the interior perimeter of the housing, according to Figure 6.

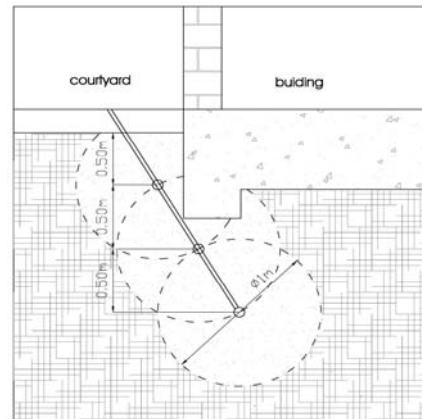
Fig. 7. expansive mortar injection

Moreover, in order to prevent the absent of the foundation support after the settlement of the foundation, we propose a repair by expansive mortar injection on the ground with three levels and at a depth of 1.5 m, as shown in Figure 7.

This intervention is designed along the interior perimeter of the concrete slab affected by deformations higher than 15mm.
