PITTING CORROSION SUSCEPTIBILITY OF SUPER AUSTENITIC STAINLESS STEELS IN SEA WATER

C.A. Loto

Department of Mechanical Engineering
University of Lagos, Akoka
Lagos, NIGERIA

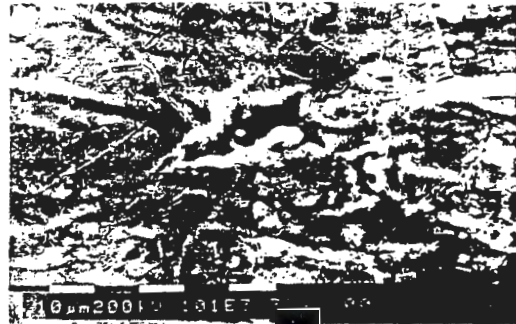
(b)

The as-received tubes surface, for example as in Figs. 1(a) and 2(a) were rough with etch-like appearance. The grain boundaries were microscopically visible in some cases. A comparison of some of the tubes surface before and after the test shows some distinct difference with respect to changes in surface feature(s), Fig. 1(b) and 2(b). In particular, sites of local corrosion attack could be located in the tested 316L alloy.

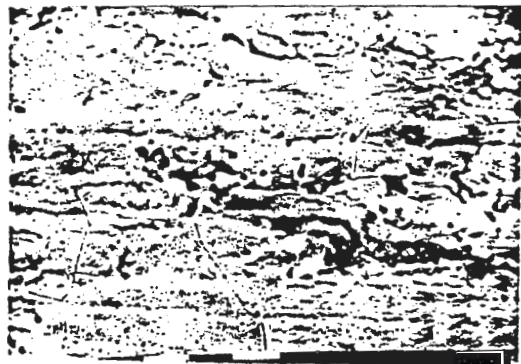
(b)

Surface examination of the cut tube specimens shows the effect of the sea water modification on some of the tested tubes, either by creating local corrosion attack sites, Fig. 2 or opening up the previously etched grain boundaries. When examined with the scanning electron microscope (S.E.M.), no particular form of inclusion was observed in any of the as-received test specimens. It could not therefore be said that surface preparation or characteristics contributed in any significant way to any pitting corrosion observed.

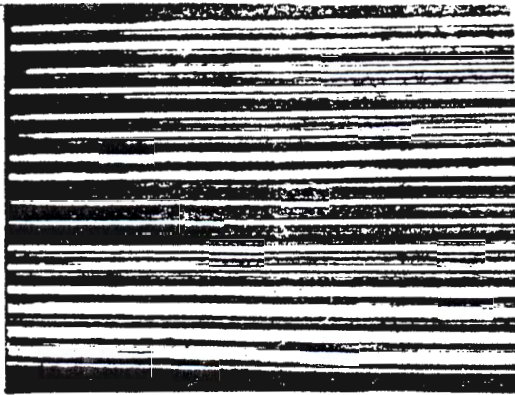
FIG. 3.

of the split and cleaned test tubes is presented in Figure 3. The super austenitic stainless steels were very corrosion resistant in general, with respect to pitting corrosion.

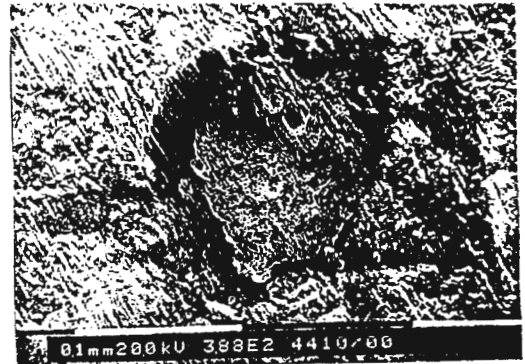
FIG. 6.

5. S.E.M. micrograph of a local corrosion attack site on inner surface of 1925HMO (NO8925) alloy tube exposed to sea water in the test rig.
6. S.E.M. micrograph of the inner surface of the tested 254SMO (S31254) alloy tube showing a ring form of local corrosion attack.

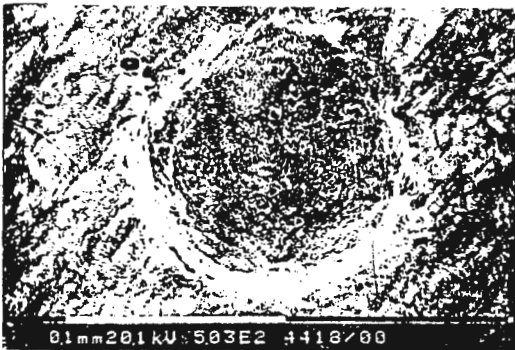
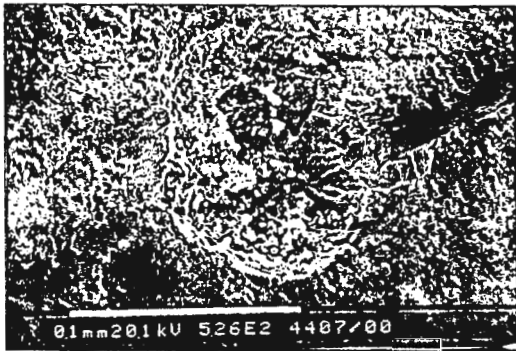
FIG. 4.

All the steel alloys corroded slightly with very little microscopic pits in the steam outlet portion. Quite a number of microscopic pits or sites of local corrosion attack were obtained along the weldment of the tubes made with AL6XN (NO8367) alloy in all the test runs as exemplified in Fig. 4. The 1925 HMO (NO8925) steel alloy was very resistant to pitting corrosion, though it suffered under-deposit corrosion in the steam chamber portion. The 254 SMO steel alloy was also very resistant to pitting corrosion. A ring form of local corrosion attack was, however, once obtained in its outlet portion, Fig. 6. Though, not a super austenitic stainless steel due to its relatively lower Mo content, the 316L (S31603) alloy was used along with the other steel alloys for comparison purpose. It failed visibly in all the test runs. In many cases, a cluster of pitting corrosion was observed; the pits were fairly deep penetrating and some times, perforation(s) occurred. An example of a microscopic pit observed in this steel is presented in Fig. 7. The corrosion pits observed in all the super austenitic stainless steels were not deep penetrating. They were shallow, flat, and some roundish.

All the steel alloys were relatively very corrosion resistant in sea water except the 316L which has lower Mo content. Corrosion pits could not be identified distinctly in 904L and 254 SMO alloys. The AL6XN alloy had microscopic corrosion pits, all along the weldment. This could be due to welding defects during fabrication. Though no deep penetration of any of the pits could be observed, the long term effect is very difficult to determine. However, the pitting condition did not seem to pose any danger during a short term use.

Pitting corrosion susceptibility of AL6XN (NO8367) at the Weldment could be attributed to some welding defects; the general body area of the steel has very good pitting corrosion resistance in sea water.

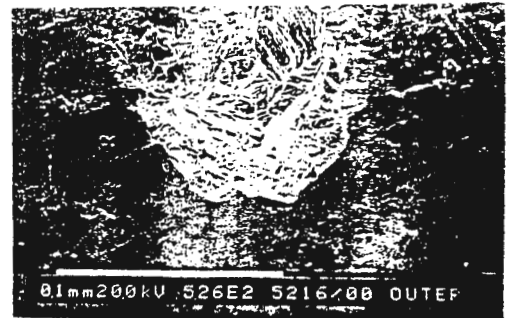
FIG. 7.

7. S.E.M. micrograph of the microscopic pit on the inner surface of 316L alloy tube used exposed to sea water in the test rig.
8. S.E.M. micrograph of the biofouling/biological materials in the outlet portion of the inner surface of 904L (NO8904) alloy tube, within which bacteria and other microorganisms were located.

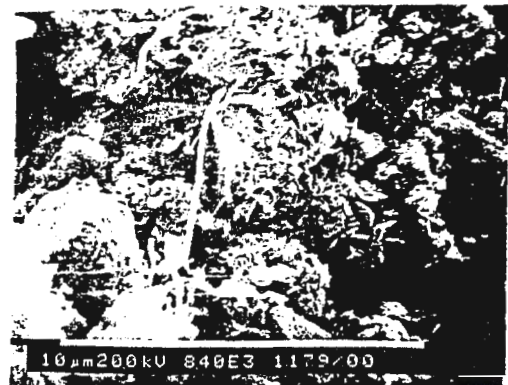
FIG. 9

9. S.E.M. micrograph of the biological materials in the outlet portion of the inner surface of AL6XN (NO8367) alloy tube within bacteria were located.
10. S.E.M. micrograph of the less dense biological materials at the steam chamber on the inner surface 316L alloy tube showing the presence of bacteria.

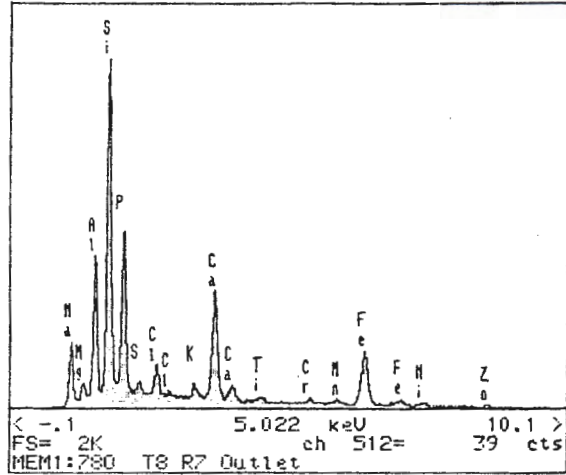
FIG. 12

The EDAX analysis, Fig. 12, confirms the presence of different chemical elements and these include Si, P, Ca, Na in addition to Cr, Mo, Ni etc. Sulphur could not be detected distinctly as it shares the same signal with Mo and it is also being marred by the gold (Au) used in locating the specimen surface. The effects of these elements are not clearly known. While the chloride ions (Cl⁻) from the sea water would make a significant contribution towards the depassivation of the alloys' protective film, others such as Cr, Ni, Mo, and Si were presumably giving protective effects of stabilising the alloys passive film, and at the same time, preventing the biofilm's growth that could lead to increased corrosion.

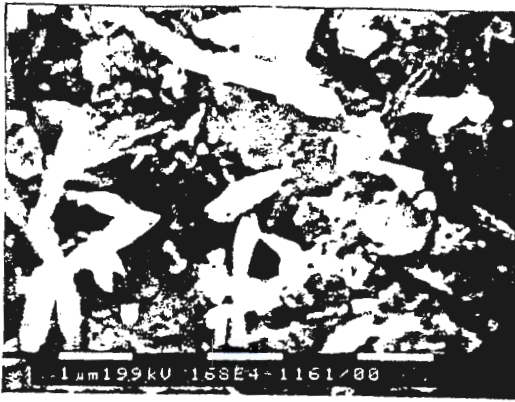
Fig-11.

11. S.E.M. micrograph of the less dense biological materials at the steam chamber on the inner surface of 316L alloy tube showing the present of bacteria (at higher magnification).

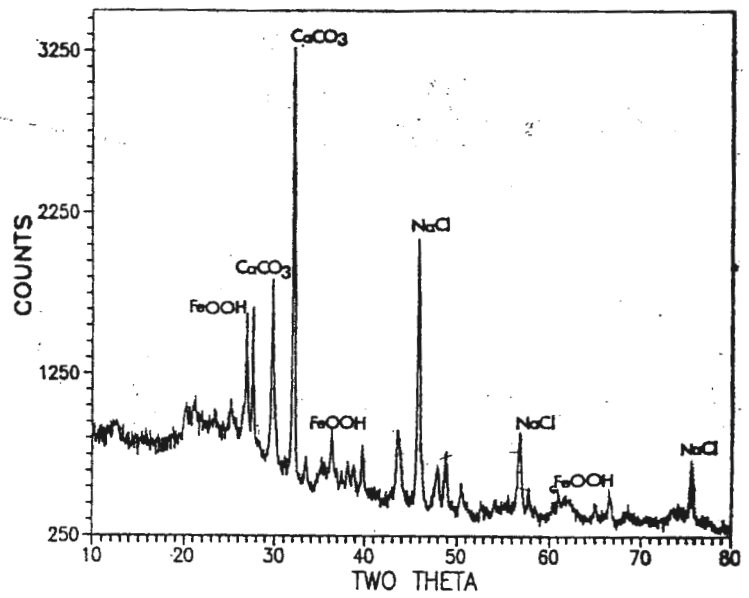
The X-ray diffraction analysis, Fig. 13 confirms the presence of CaCO₃, NaCl and FeOOH in the outlet biofilm. Since no significant corrosion was observed in the alloys except the 316L, the effects of these chemical compounds on the corrosion resistance or pitting corrosion susceptibility of these alloys could not be ascertained.
