Full scale testing of wind turbine blade to failure - flapwise loading

Citation (APA):
Jørgensen, E. R., Borum, K. K., McGugan, M., Thomsen, C. L., Jensen, F. M., Debel, C. P., & Sørensen, B. F. (2004). Full scale testing of wind turbine blade to failure - flapwise loading. (Denmark. Forskningscenter Risoe. Risoe-R; No. 1392(EN)).

Abstract A 25m wind turbine blade was tested to failure when subjected to a flapwise load. With the test setup, it was possible to test the blade to failure at three different locations.

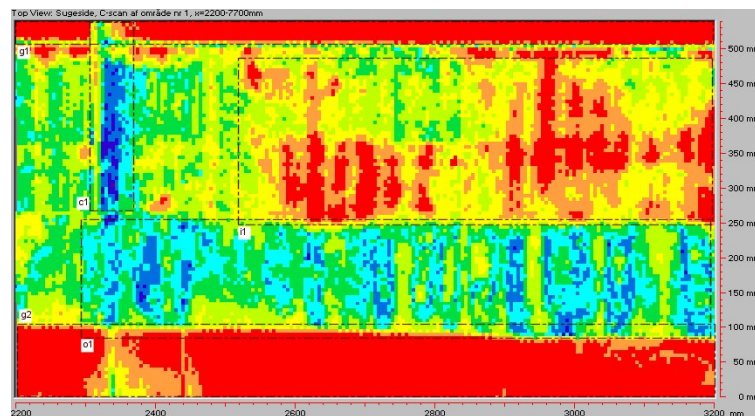
Figure 3 Ultrasonic scan from 2.2m to 3.2m (section 3)

In this scan a good adhesion between the layers is seen, even though there are areas (marked i1, red), which indicates missing adhesion or epoxy. In this scan red "lines" are seen in upper right part of the figure, which indicates how the epoxy is put in lines during manufacturing of the blade. In other areas these lines where much more dominant and larger areas with a bad adhesion/distribution of epoxy was also seen in some areas.

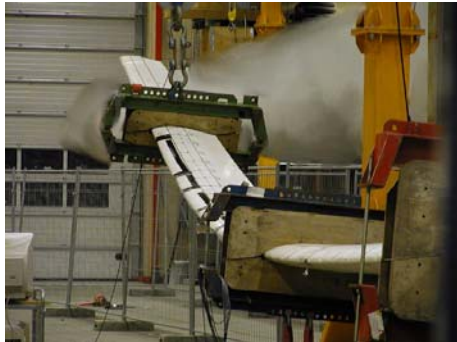
Figure 7 Test of section 1, large deflection is seen in this test.

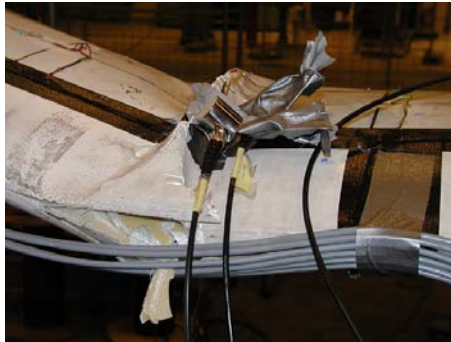
In test of section 1 (19.3m to 23.3m) the blade failed 20.1m from the root, with a load introduction as given in figure 4. In the figures below the large deflection in this test is seen as well as a picture of the failed section of the blade.

Figure 8 The blade failed 20.1m from the root section. AE sensors where mounted very close to the failure

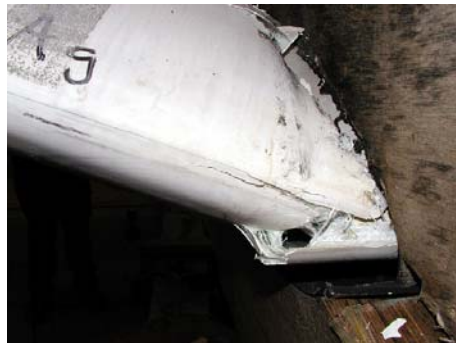
In test of section 2 the blade failed 15.3m from the root (unfortunately at the yoke), with a load introduction as given in figure 5.

Figure 9 In test of section 2 the blade unfortunately failed at the loading yoke at 15.3m from root section

The failure of section 2 at the 15.3m loading yoke was unwanted, but as seen in the calculations (simple FE model) prior to the test and the AE readings during the test it was not a surprise. At the moment of failure however the broken blade “sprang back” against the clamping yoke. At this point it was observed that SPARTAN sensor 1 signalled a significant burst of AE activity, where it had previously been relatively inactive. A close inspection of the blade at this area was carried out. It was eventually discovered that lateral cracking inside the central loading spar (x =11m) had been generated and this became significant during the testing of section 3.

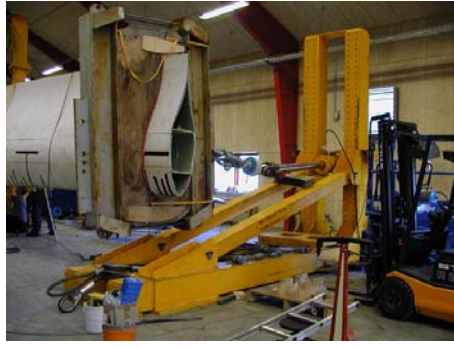
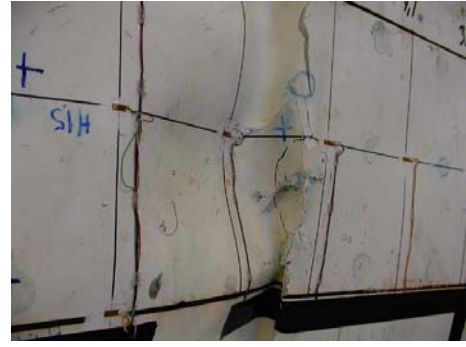
In test of section 3 the blade failed 4.4m from the root, with a load introduction as given in figure 6.

Figure 10 Test of section 3 with load introduction at 11.3m *Figure 11 Failure 4.4m from the root.*

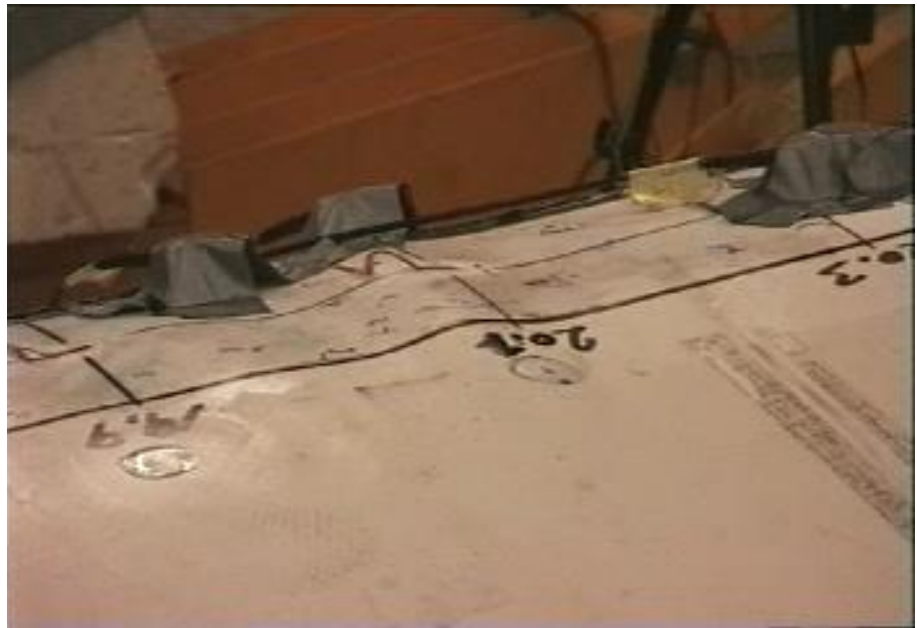
At a specific spot on the blade in test section 1, the skin is visually observed to be buckling. The strain gauges in this area, showed at the same time very high compressive and tension strains. According to figure 27 the strain gauge located on the top of the buckling wave (strain gauge #201.1) showed tension and in the bottom (strain gauge #199.1) showed compression as expected. The area of this debonding of the skin laminate, indicated by the strain gauge measurements as well as seen visually, was corresponding very well with the areas of improper bonding as found in the ultra sonic measurement prior to the test. It should be mentioned that the skin laminate is only a minor part of the load carrying part in a flapwise load situation. The results are shown here for the good correlation between strain gauge measurements, the visual identification and the prediction of the bonding situation based on the ultra sonic test of this area. Even though the skin only contribute as a minor part to the strength of the blade in a flapwise load situation the blade actually failed in this area of delamination (20.1m from the root section).

Figure 27 Photo of skin behavior (skin laminate debond from the main spar)

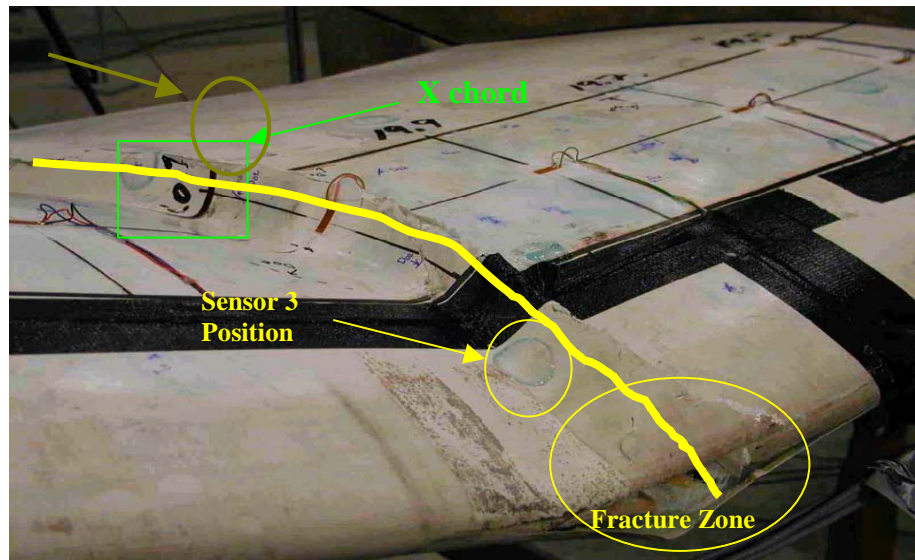
Figure 30 Blade failure at the 20.1m chord. Note position of sensor 3

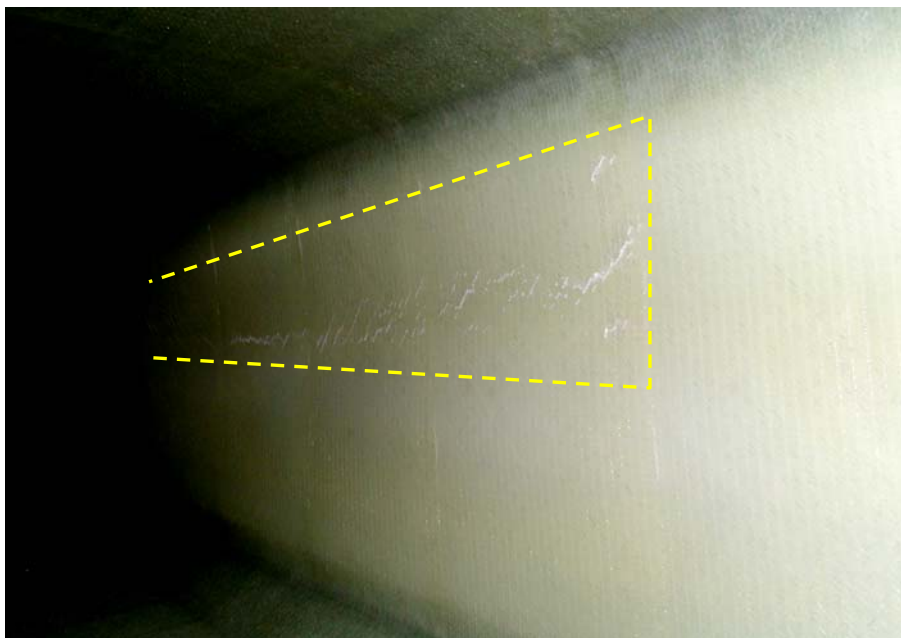
Figure 36 Image taken from inside the central spar showing lateral cracking (enclosed by yellow dashed lines) at approximately 11.3m chord. This damage occurred when the blade “sprang back” against the clamping yoke during section 2 blade failure.

the interior of the blade was reinforced at the 11.3m loading yoke. This successfully prevented the growth of the lateral cracks and permitted load to failure at the 4.5m chord. And once again, the AE activity recorded throughout this loading successfully identified 4.5m as the failure chord in preference to the 7m chord.
