## Improved design of large wind turbine blade of fibre composites based on studies of scale effects (Phase 1). Summary report

Risø-R-1390(EN)

# Improved design of large wind turbine blade of fibre composites based on studies of scale effects (Phase 1) - Summary Report

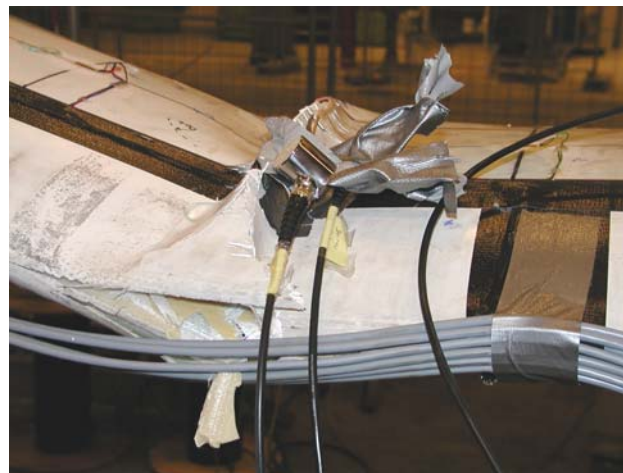
The global deflection of the blade was found not to be very sensitive to the damage that happens in the blade. It is therefore very difficult to give any criteria based on the global deflection about how close the blade is to failure. Fig. 2.5 shows the deflection of the blade (Test section 1) before failure and Fig. 2.6 shows the failure zone in the blade just after fracture.

*Fig. 2.6 Failure of section 1*

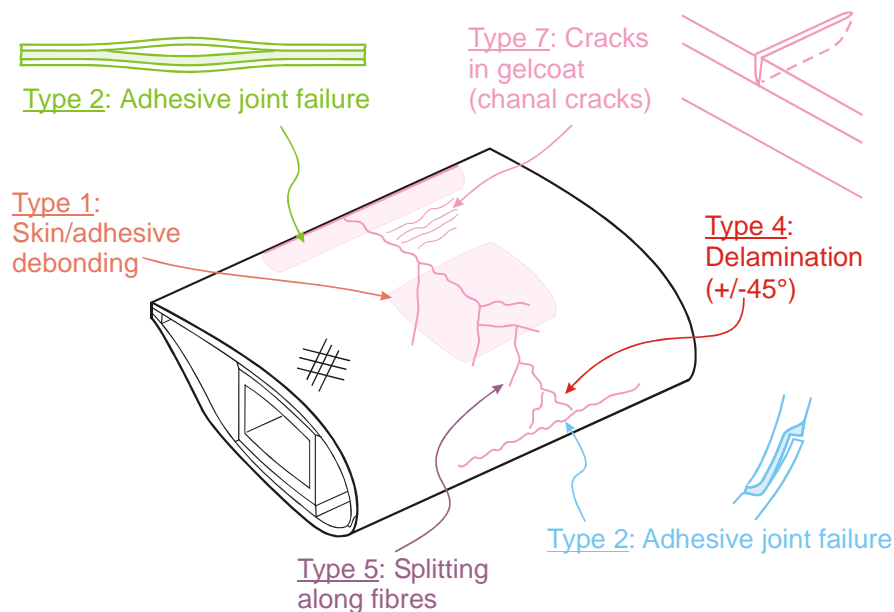
Test section 1 failed at a distance from the root of about 20.1 meters; that is about in the middle of the test section. A sketch of some of the damage types found in this test section during the examination is given in Fig. 3.3. Fig. 3.4 shows the post failure damage, caused to the leading edge, at a stage where the blade still is supported by the unengaged loading chain. Following the disengagement of the loading chain, section 1 was cut from the blade and examined as described above.

*Fig. 3.3: Sketch illustrating of some of the damage types found during the examination of the downwind skin of test section 1 subjected to a compressive load. Damages to the adhesive layers: Types 1 (skin/adhesive debonding) and 2 (adhesive joint failure between skins) at the leading as well as the trailing edge. Damage to the downwind skin under compressive load: Types 4 (delamination driven by a buckling load), 5 (laminare failure in compression) and 7 (gel-coat cracking and gel-coat/skin debonding). (BSQR\_Skitser\_af\_brudmåder\_Vestasvinge\_b.doc)*

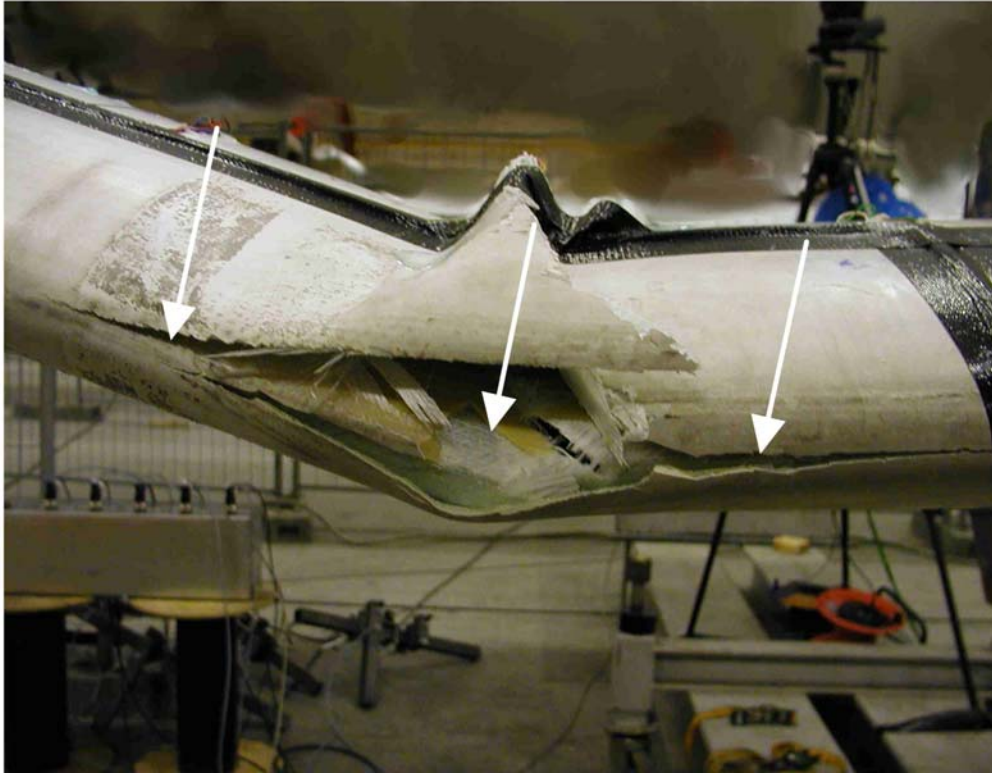
*Fig. 3.4: The damage in test section 1 at the leading edge: Type 2 (adhesive joint failure between skins) at the arrows. The blade is still under load by the unengaged outer yoke. (D - P9250083m.jpg)*

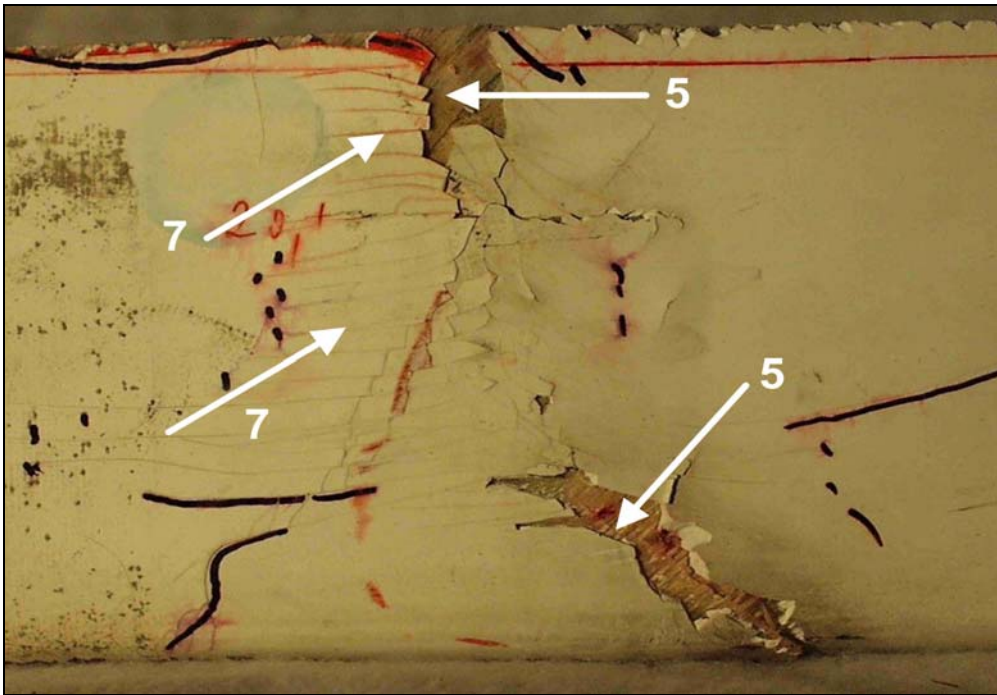
Fig. 3.5 illustrates compressive load damage caused to the downwind skin in at the leading edge. Damage types:

- Type 5 (*laminare failure in compression*) and
- Types 7 (*gel-coat cracking and gel-coat/skin debonding*) are identified.

*Fig. 3.5: Compressive load damage caused to the downwind skin at the leading edge (at the bottom). Damage Types 5 (laminate failure in compression/splitting) and 7 (gel-coat cracking and gel-coat/skin debonding) are identified. (D - sec1-damage-leading edge-compression.jpg)*

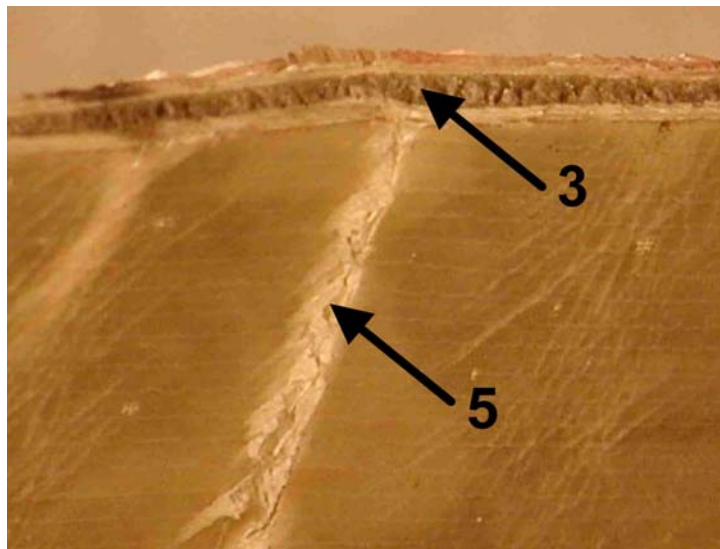
The compression damage caused to the inside surface of the downwind skin of Fig. 3.5 is shown in Fig. 3.6. Again damage type:

- Type 5 (*laminare failure in compression*) is noticed, and furthermore damage type
- Type 3 (*sandwich panel face/core debonding*) is noticed in the downwind skin laminate.

*Fig. 3.6: Compression damage on the inside surface of the downwind skin shown in Fig. 3.6. Damage type 5 (splitting & compressive failure of skin laminate fibres). (D - sec1-damage-inside leading edge-2.jpg)*

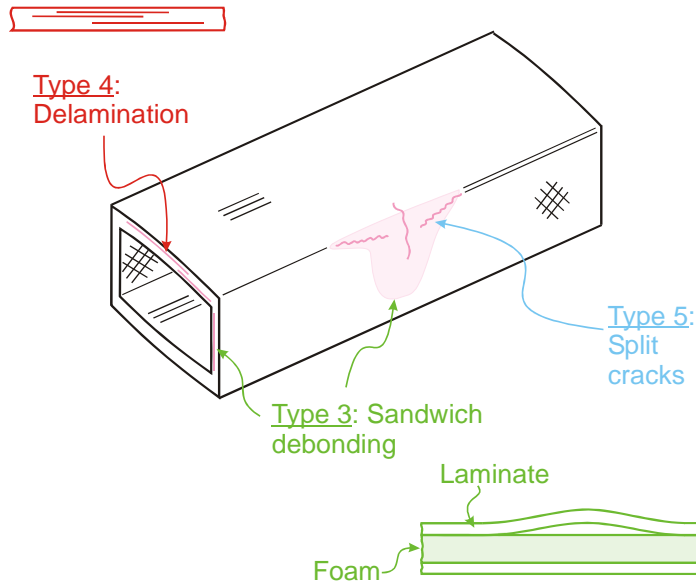
Fig. 3.7 makes up a sketch of the damages found on the main spar outer surface facing the leading edge. These damages are further shown in the photos in Fig. 3.8:

*Fig. 3.7: Sketch showing visible damage to main spar outer surface: types 3 (sandwich panel face/core debonding), 4 (delamination driven by a buckling load) and 5 (fibre failure in tension; laminate failure in compression). (BSQR\_Skitser\_af\_brudmåder\_Vestasvinge-b.doc)*

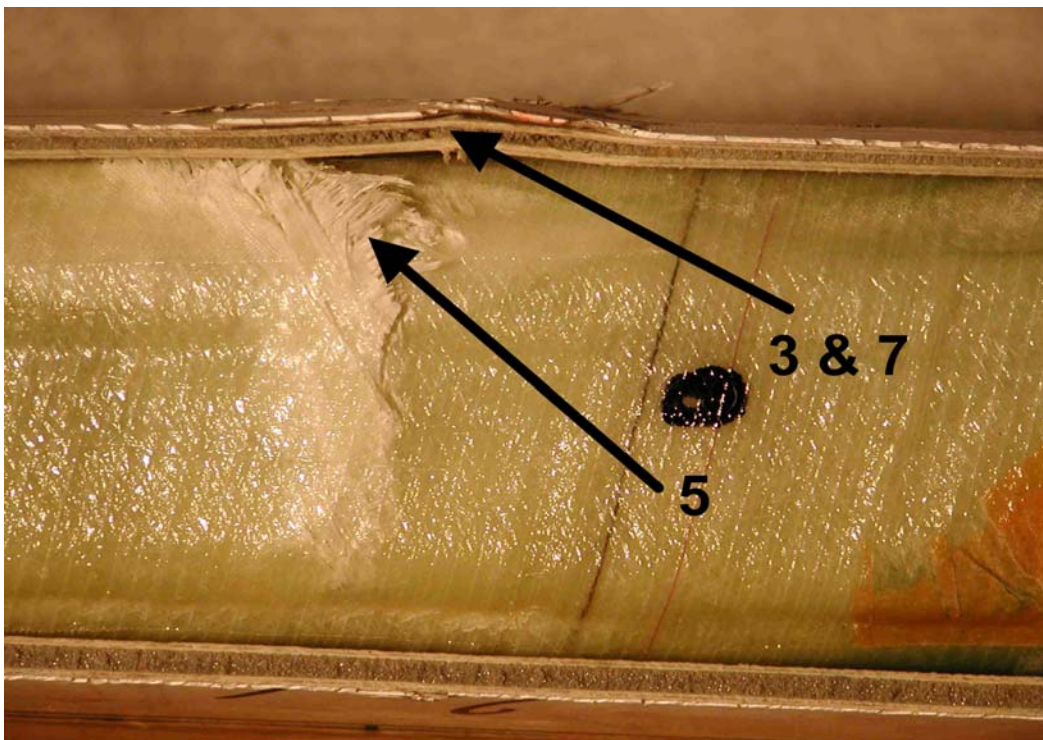
- Type 3 (*sandwich panel face/core debonding*)
- Type 4 (*delamination driven by a tensional or a buckling load*)
- Type 5 (*fibre failure in tension; laminare failure in compression*)
- Type 6 (*skin/adhesive debonding induced by buckling, a specific type 1 case*)
- Type 7 (*gel-coat cracking and gel-coat/skin debonding*).

*Fig. 3.8: Outer surface of the main spar facing towards the leading edge; cuts in the upper (top) and lower skins. Upper part of the structure was exposed to a compressive load. Damage types 3 (sandwich panel face/core debonding), 5 (laminate failure in compression) and 7 (gel-coat cracking and gel-coat/skin debonding). (D - outer surf, web vs lead-edge.jpg)*

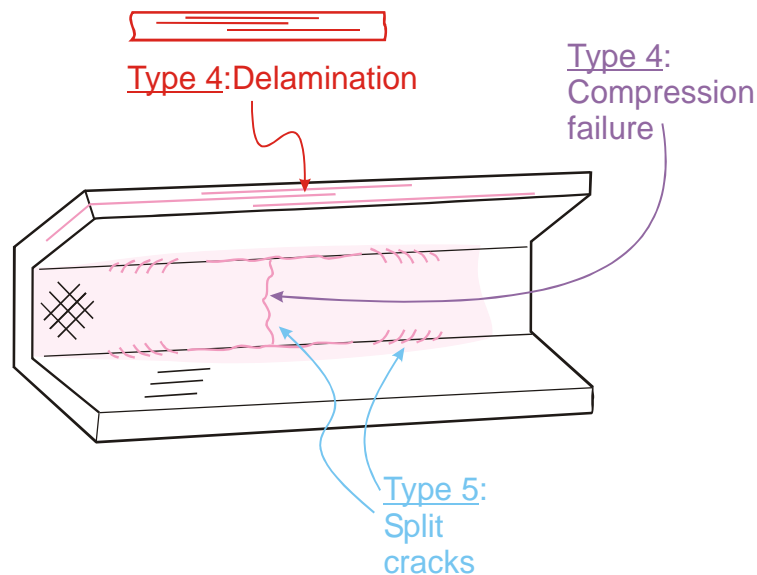
A sketch of the visible damage caused to the internal surface of the main spar after cutting-up is given in Fig. 3.9:

- Type 4 (*compression delamination*) in the upper flange laminate and
- Type 5 (*splitting & tensile failure of main spar fibres*) in the web.
- Type 1: skin/adhesive debonding has occurred.

*Fig. 3.9: Sketch of the visible damage caused to the internal surface facing the leading edge of the main spar after cutting-up. Upper part of the structure was exposed to a compressive load: Damage types 4 (delamination driven by buckling load) in upper flange and 5 (fibre failure in tension; laminate failure in compression) in the web. (BSQR\_Skitser\_af\_brudmåder\_Vestasvinge-b.doc)*

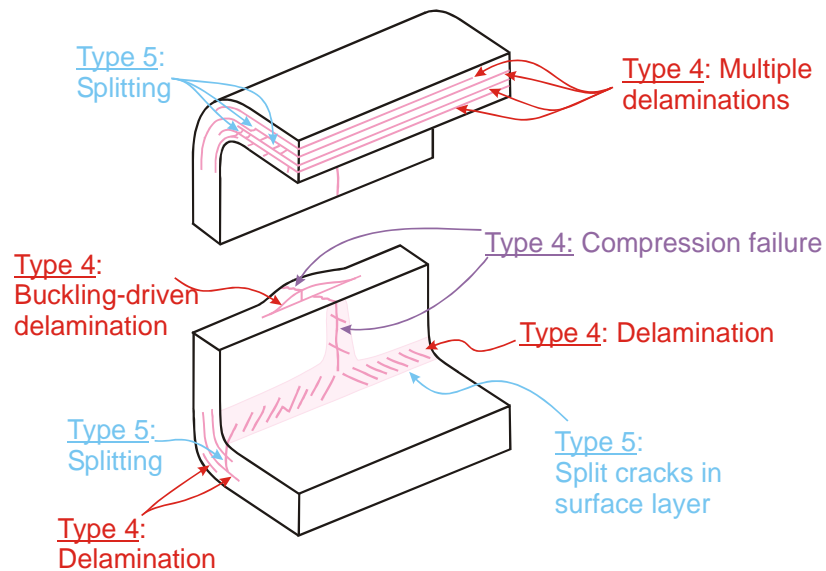
Finally, the sketch drawn up in Fig. 3.10 illustrates an additional damage – an internal, non-visible damage - inflicted onto the main spar:

- Type 4 (*a buckling-driven delamination of the main spar web*) damage.

*Fig. 3.10: Non-visible type 4 damage inflicted onto the main spar (delamination driven by a tensional or a buckling load) as well as multiple type 5 damages (fibre failure in tension; laminate failure in compression) in the flanges. (BSQR\_Skitser\_af\_brudmåder\_Vestasvinge\_b.doc)*

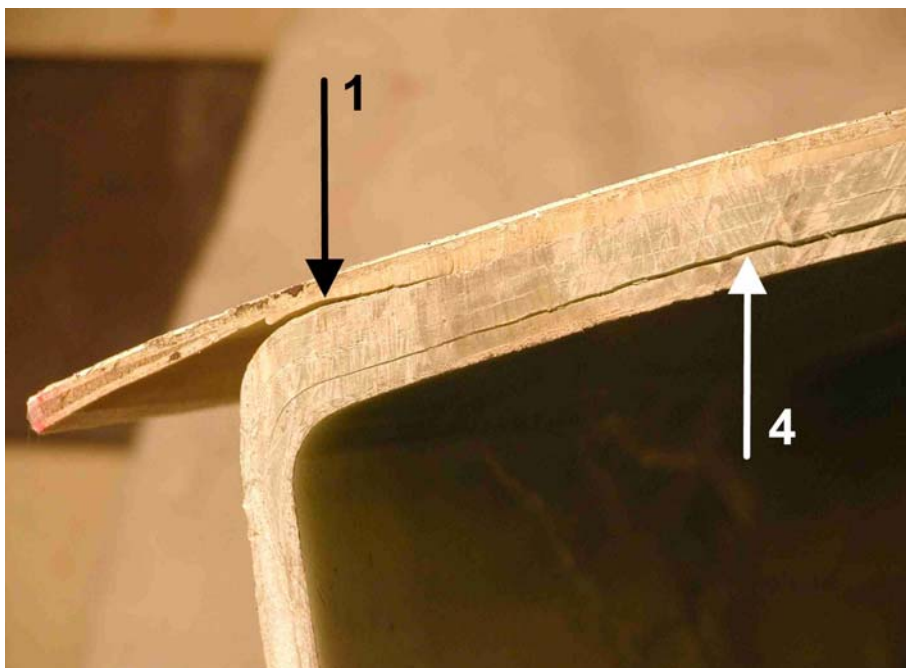
Fig. 3.11 illustrates the downwind skin and the main spar flange of test section 2 and reveals damage types:

*Fig. 3.11: Downwind skin and main spar flange of test section 2. Damage types 1 (main spar flange/adhesive layer debonding) and 4 (delamination driven by a buckling load). (D - skin-main spar adhesive layer debonding and main spar laminate debonding.jpg)*

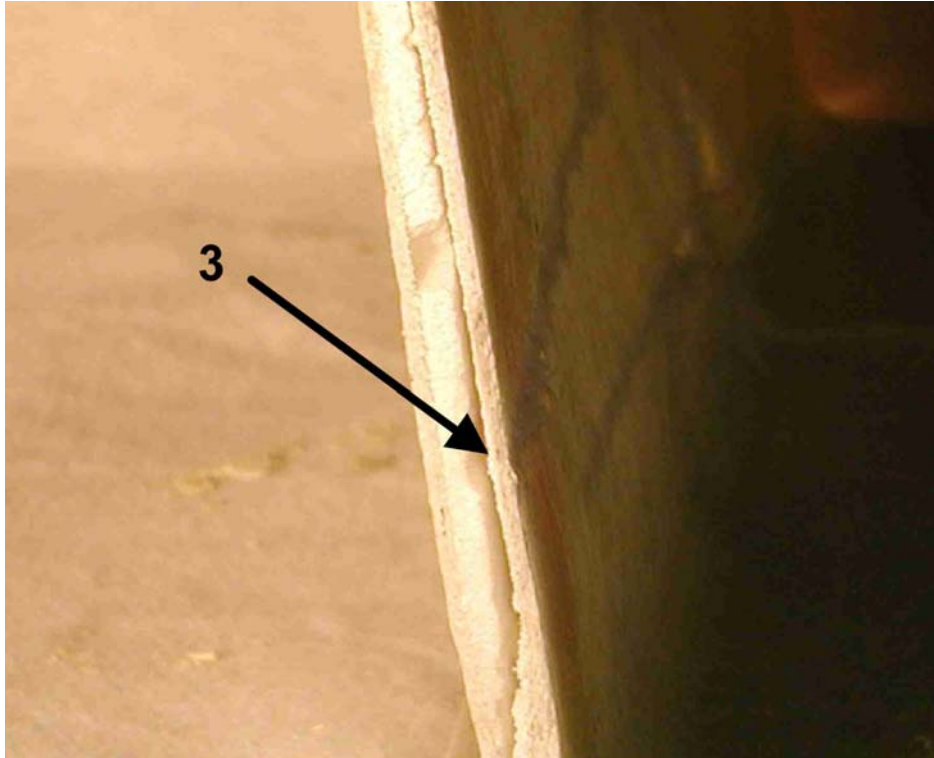
The damage type 3 (*web sandwich panel face/core debonding*) is noticed in Fig. 3.13. Damage growth took place at the laminate/core interface, but a deviation of the damage path into the core material is also noticed.

*Fig. 3.12: Main spar web sandwich. Damage type 3 (web sandwich panel face/core debonding). (D - 2-sandwich face-core delam P1290045.jpg)*
