Design errors in nuclear power plant

Forskningscenter Risø, Roskilde

Publication date:
1974

Citation (APA):
Taylor, J. R. (1974). Design errors in nuclear power plant. (Risø-M; No. 1742).

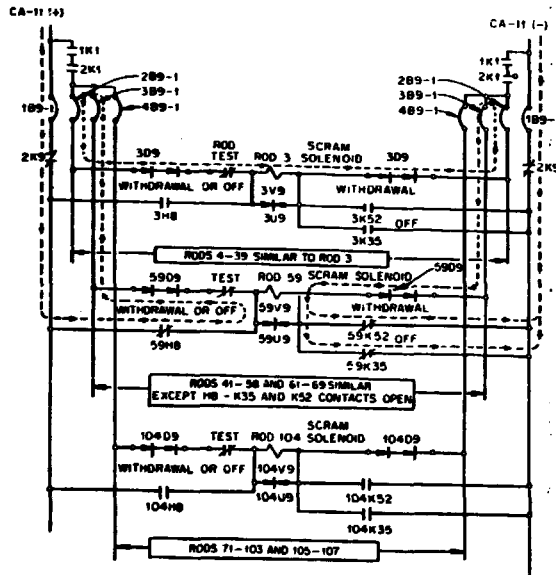
Fig. 2 Rod-scram solenoid circuit and failure path.

review indicated that a possible electrical path for combination of four diodes failing in the shunted mode in the electrical circuit of a rod, along with that rod's assignment switch being in the Withdrawal or Off position. Rod No. 59 became the prime suspect because it was the only rod in the Off position. Figure 2 also shows the current path from the auxiliary circuit through rods 59 and 3. All other rod solenoids would be similarly energized owing to the parallel-wiring characteristics of the circuit. A visual inspection showed that the No. 59 rod diode quad package was cracked and that a drop of solder protruded through

the crack midway up the canister. Although the four diodes in a rod circuit are electrically connected as shown, they are physically situated in a plug-in canister called a diode quad package that closely resembles a metallic vacuum tube.

CIRCUIT SHOWN AS FOUND SEPTEMBER 30, 1970
CURRENT PATH SHOWN FOR ROD 3 AND ROD 59
ALL OTHER RODS' CURRENT PATHS SIMILAR TO ROD 3

The primary scram system of the N reactor failed to operate on signal because of undetected failures of diodes in the scram circuit. The reactor was shut down promptly, however, by the backup ball safety system. The reliability of the primary scram system was improved, after the fact, by the addition of an administratively controlled switch in the main circuit.
