A PERFORMANCE TEST OF WOOD-PLASTIC
PARQUET FLOORING

Klaus Singer and Arne Vinther

August 1972

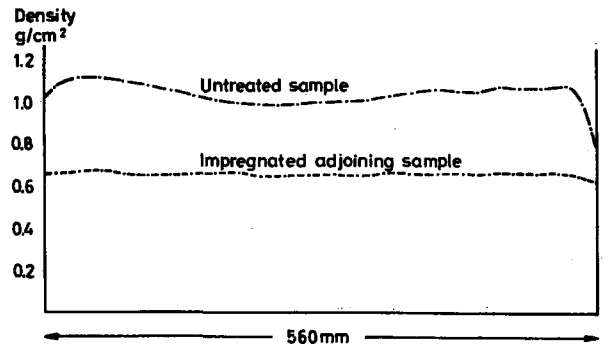
For: Untreated sample, read: Impregnated adjoining sample, and vice versa.

Fig. 2. Depletion of polymer from the ends of the sticks as seen in variation of density.

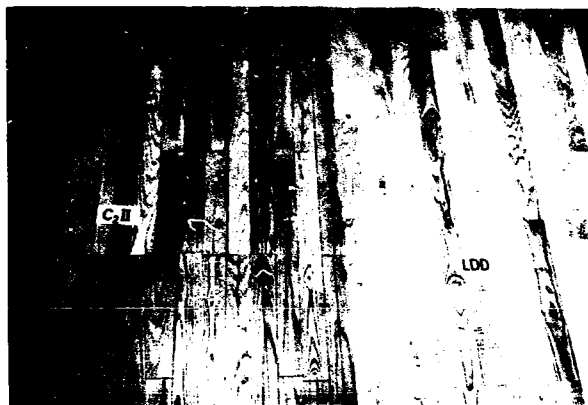
Right from the beginning of the testing some thin cracks in the longitudinal direction were observed in some of the face strips, especially in those containing polymethylmethacrylate (fig. 7a + b). These cracks probably occurred during the polymerization reaction. They did not increase in size or in number later on, but they became more visible because dirt gathered in them.

Fig. 7a. Crack formation in PMMA-impregnated ash strips (C₂II).
LDD is a non-impregnated lacquered reference panel.

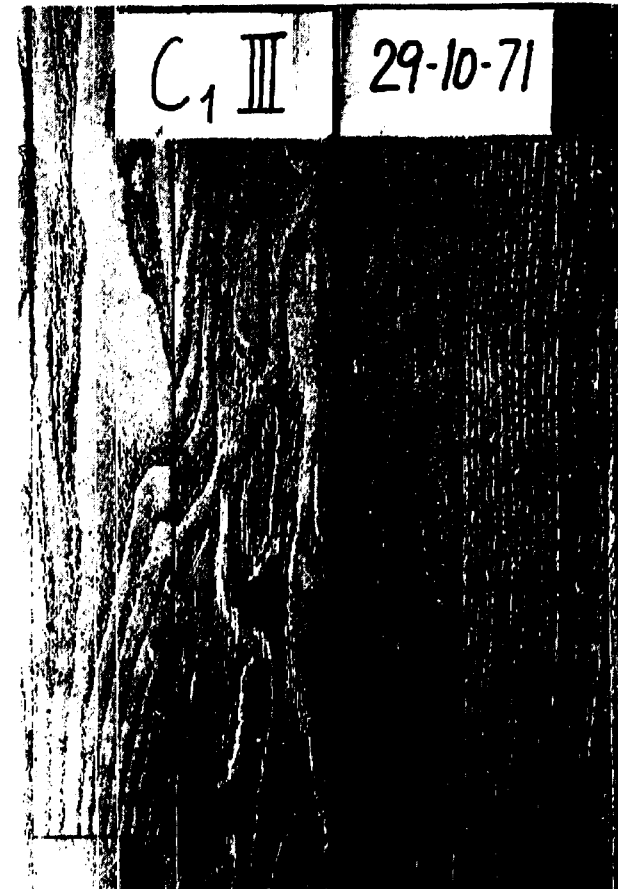
It is incontestable that the three plastic-impregnated, but never surface-treated, panels of ash which have been down for three years and consequently exposed to almost one million person passages, have been remarkably worn at the poorest impregnated areas. Figure 20a, b, and c illustrates the "micro-washboard" appearance of these never surface-treated panels, and that no significant difference in wearability of the three tested wood-plastics can be observed. However, no measurements of the wear have been performed.

Fig. 20a, b, and c. The "micro-washboard" appearance of the never surface-treated panels.
