Fukushima: Status for en igangværende ulykke

Bent Lauritzen og Erik Nonbøl

Risø DTU

Fukushima

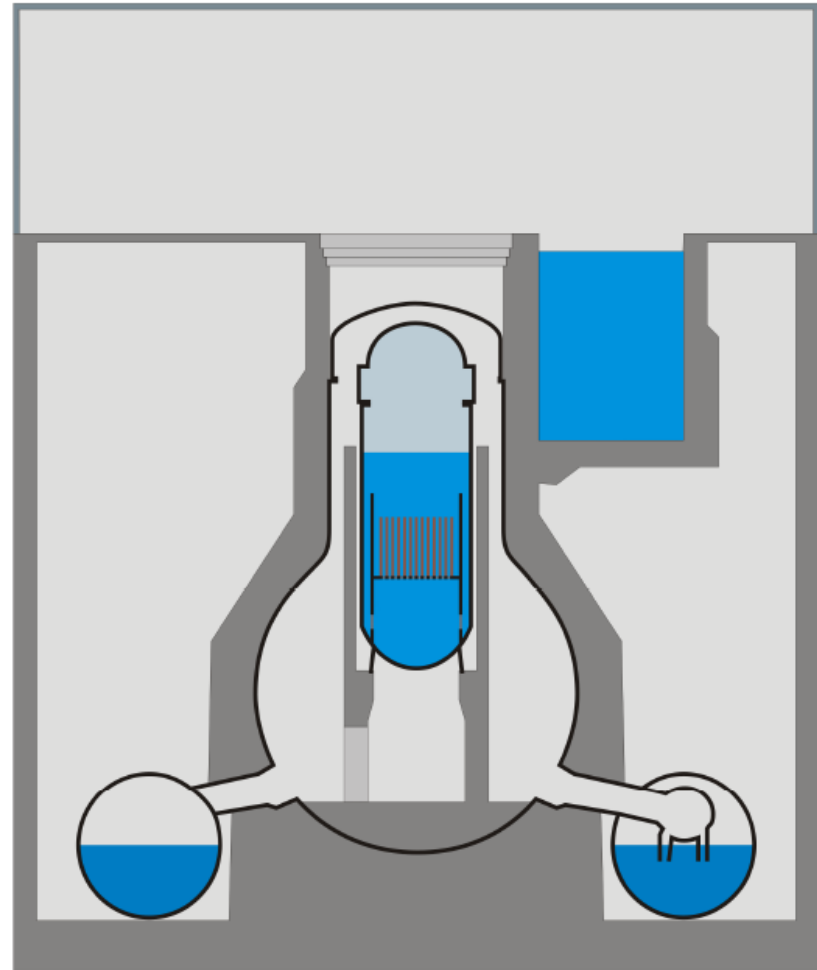
- ▶ 11.3. 15:41 Tsunami hits the plant
 - ◆ Plant design for tsunami height of up to 5.7m, protection 6.5m
 - ◆ Actual tsunami height ~14m
 - ◆ Flooding of
 - Diesel generators and/or
 - Essential service water building

- ▶ Station Blackout
 - ◆ Common cause failure of the power supply
 - ◆ Only batteries are available
 - ◆ Loss of all emergency core cooling systems, only the steam driven containment isolation pump is available

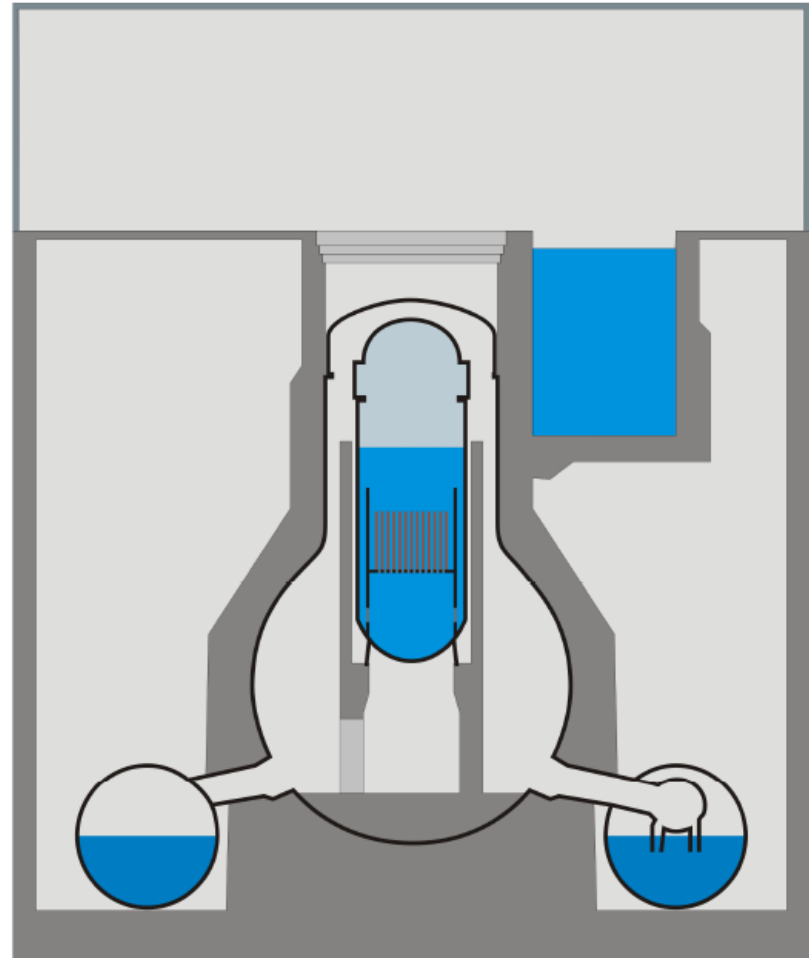
- ▶ 11.3. 16:36 in Unit 1
 - ◆ Isolation condenser stops
 - ◆ Pool empty?

- ▶ 13.3. 5:30 in Unit 3
 - ◆ Reactor Isolation pump stops
 - ◆ Batteries empty?

- ▶ 14.3. 13:25 in Unit 2
 - ◆ Reactor Isolation pump stops
 - ◆ Pump failure?

- ▶ Reactors of Units 1-3 are cut off from any kind of heat removal

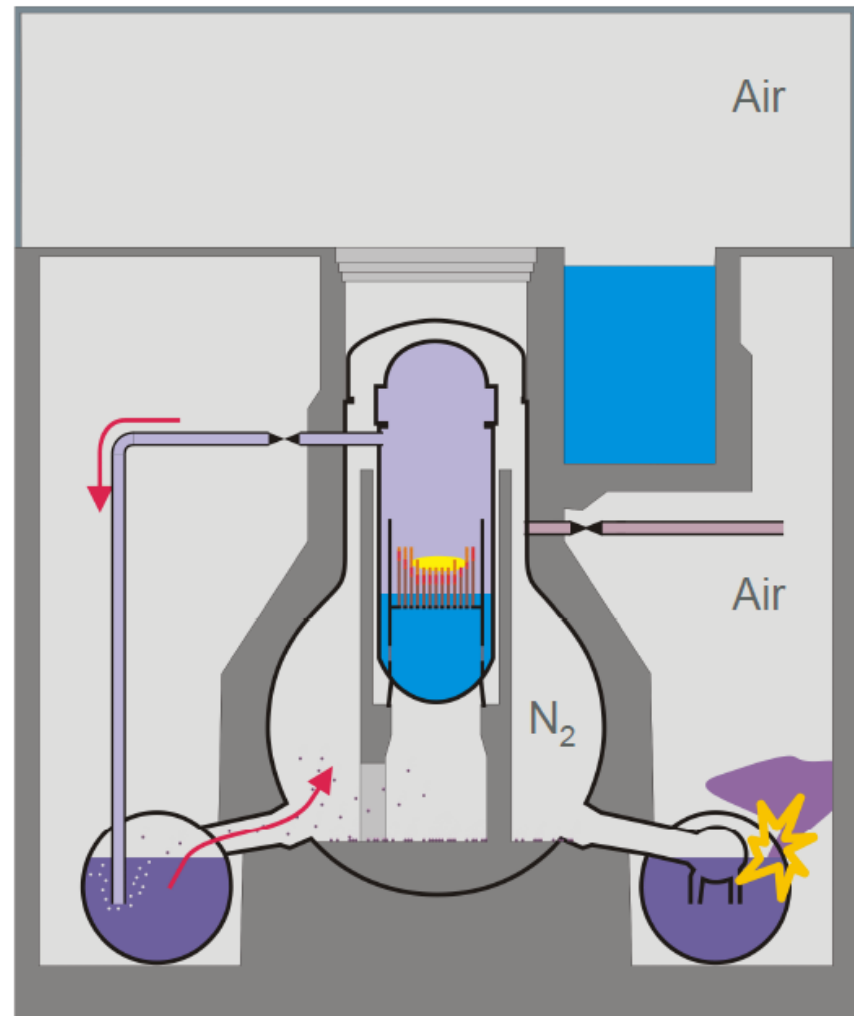
- ◆ Probably damage of the condensation chamber following a pressure increase in the reactor pressure vessel and containment (highly contaminated water)
- ◆ Uncontrolled release of gas and **fission products** from the containment
- ◆ Temporal evacuation of the plant
- ◆ High local dose rates on the plant site

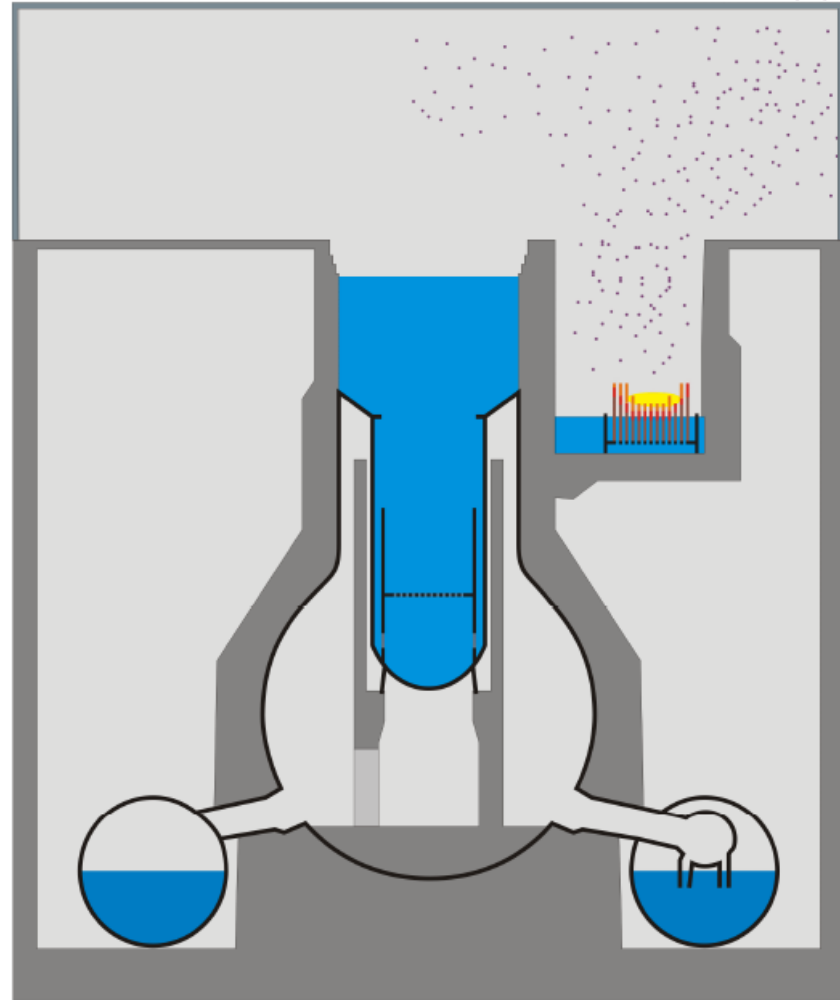
- ▶ Spent fuel stored in pool on reactor service floor
 - ◆ Due to maintenance in Unit 4 entire core stored in fuel pool
 - ◆ Dry-out of the pools
 - Unit 4: in 10 days
 - Unit 1-3,5,6 in few weeks
 - ◆ **Leakage of the pools due to Earthquake?**

- ▶ Consequences
 - ◆ Fuel melt in direct contact to the atmosphere
 - ◆ Nearly no retention of fission products
 - ◆ Large release possible

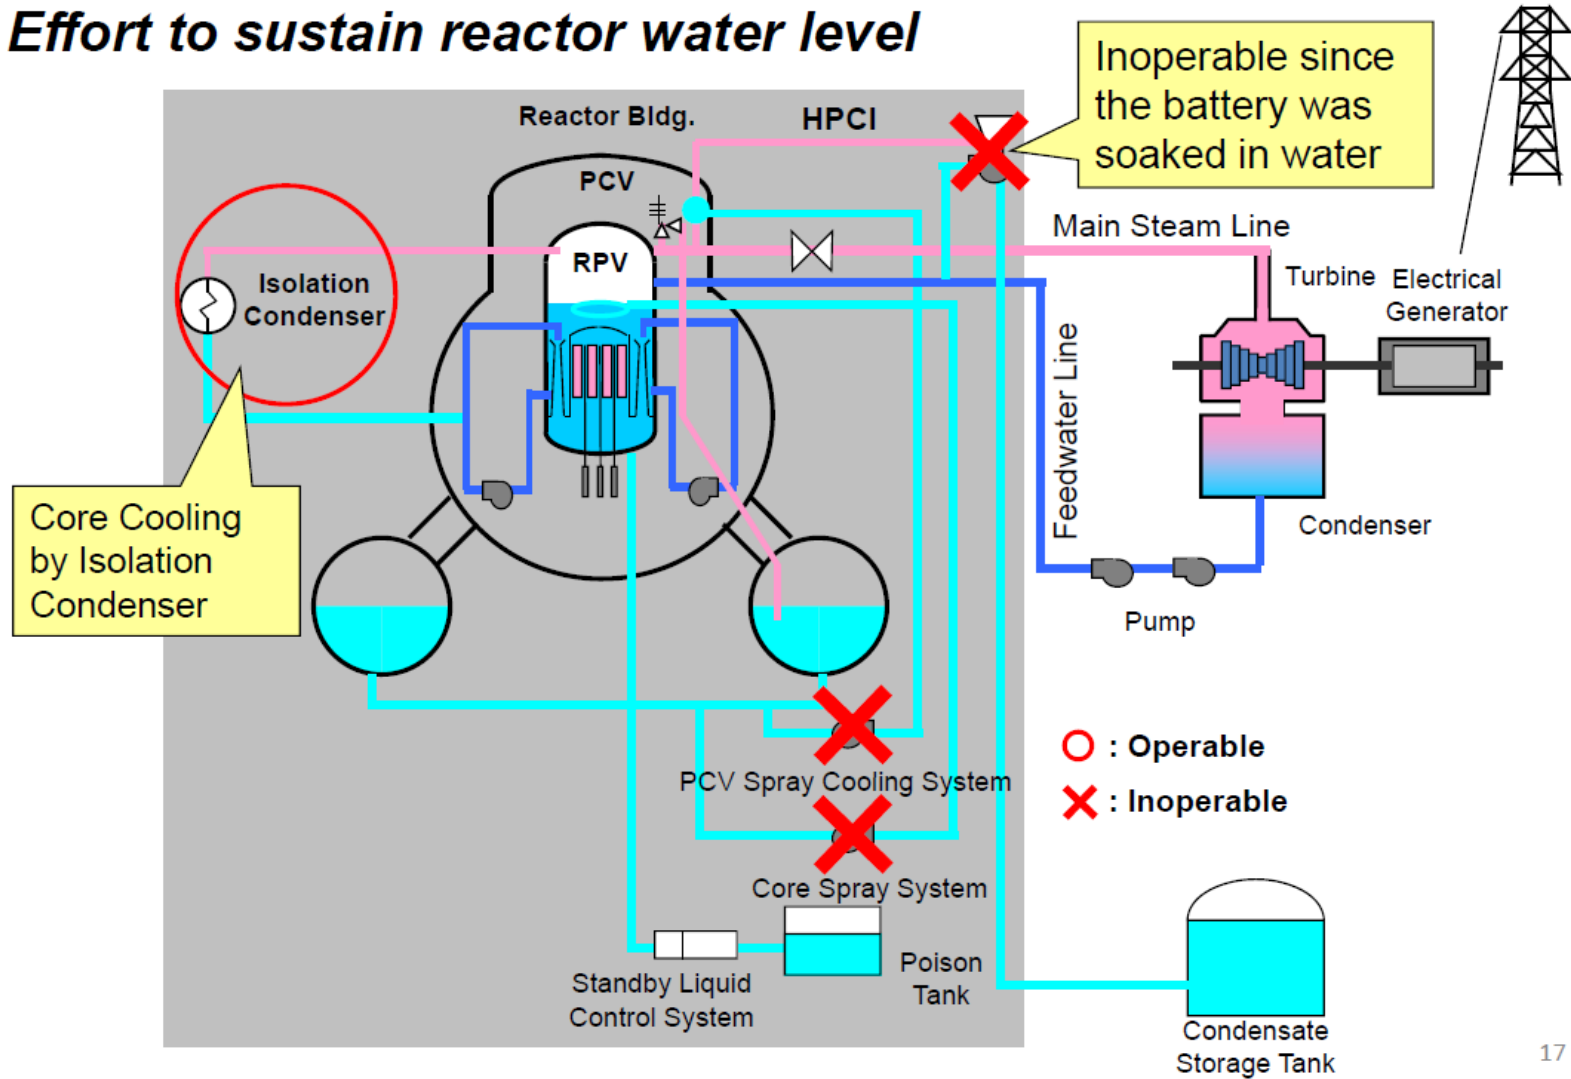
3-7. Major event progression at Unit 1 (1/4)

Effort to sustain reactor water level

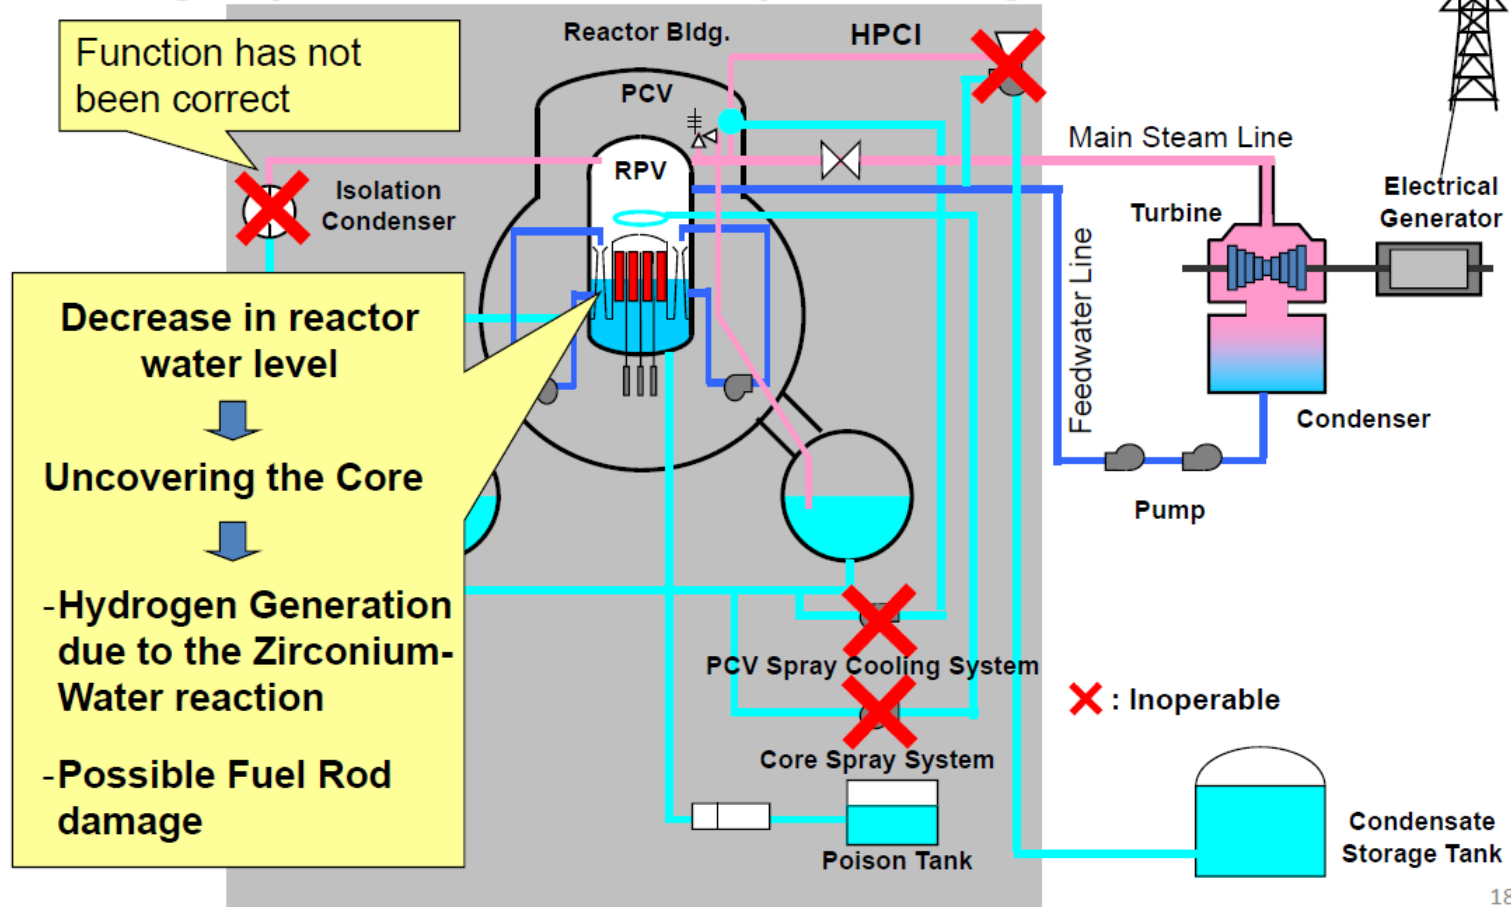
3-7. Major event progression at Unit 1 (2/4)

Decrease in reactor water level due to loss of cooling capability of emergency condenser, followed by uncovering the core

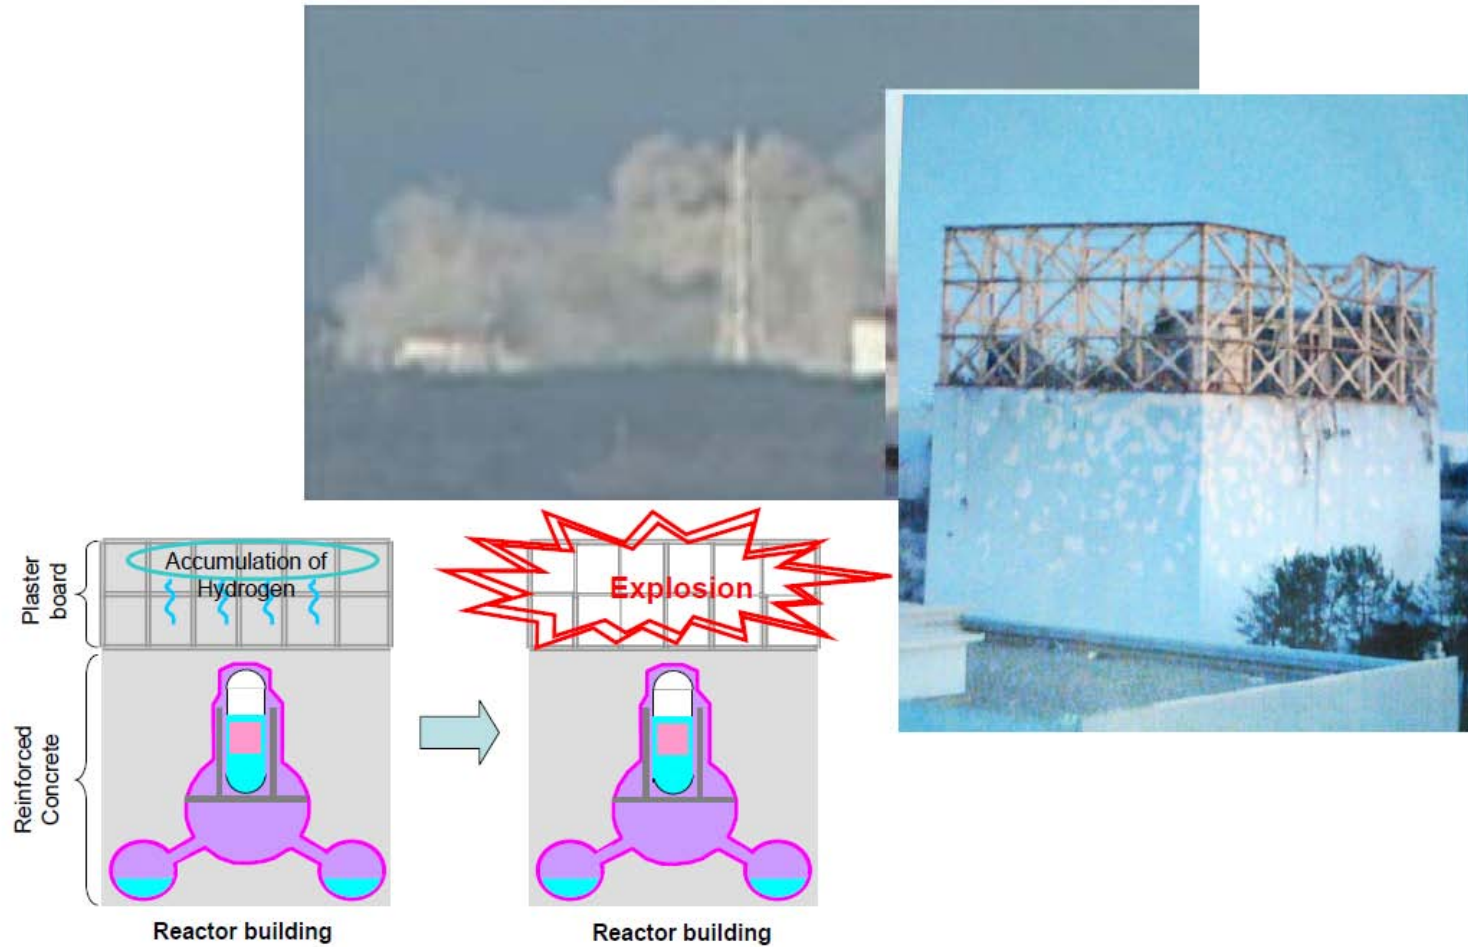
3-7. Major event progression at Unit 1 (3/4)

Hydrogen explosion in the operation floor

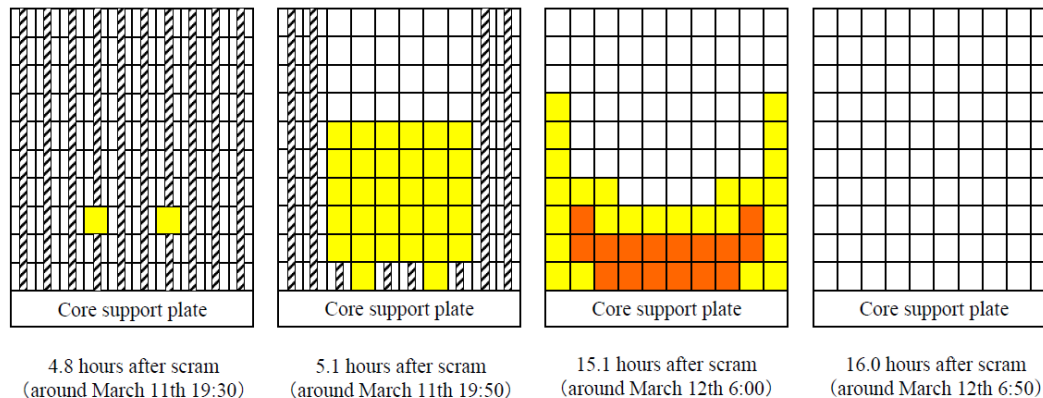
Degree of fuel damage

- Melting starts from the central part of the core.
- In 16 hours after scram (around March 12th 6:50), most part of the core fell down to the RPV bottom.
- Although RPV is damaged in this provisional analysis, the actual damage of RPV is considered to be limited according to the temperatures presently measured around the RPV.

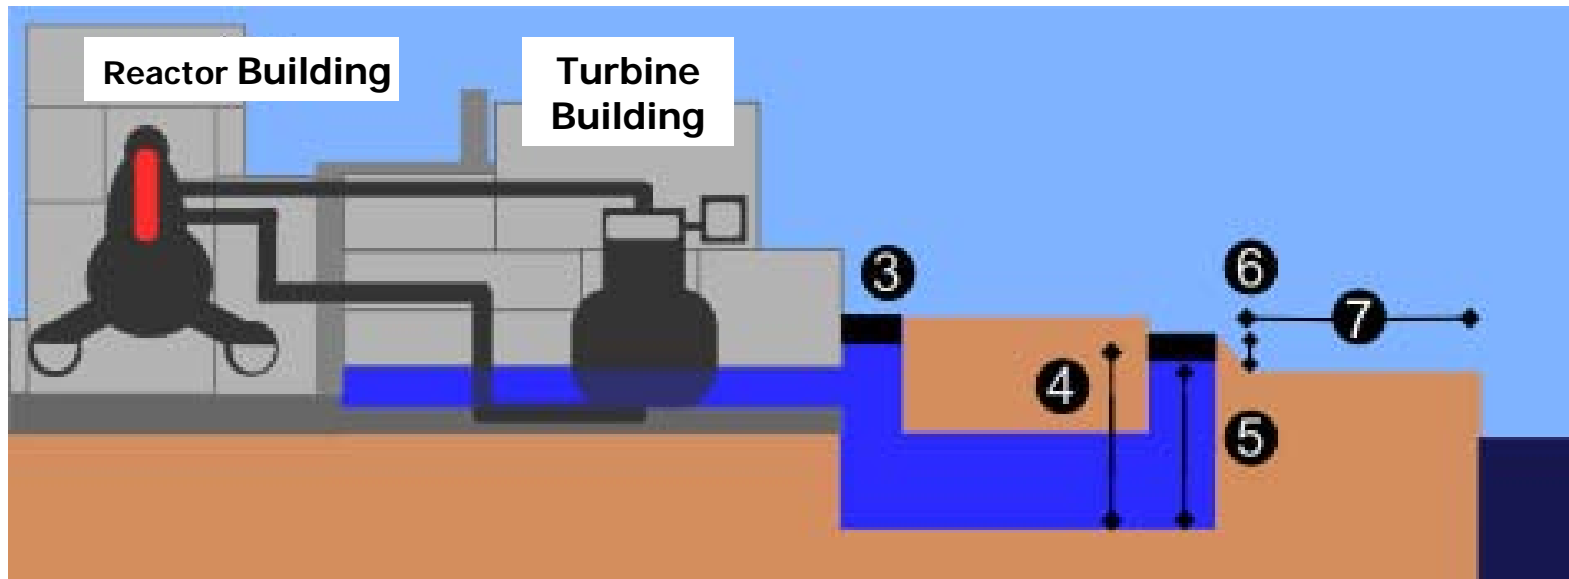
Water leakage in trenches

- Highly radioactive water was found in trenches at Units 1, 2 and 3

The Units 2 and 3 trenches were 1 m below the level at which they would overflow into the sea. On the other hand, the unit 1 trench was 10 cm from overflowing. (As of March. 30th)
