Investigation and Retrofitting Proposal for a Panbo Type House in Sisimiut, Greenland

Jing Qu^{1*}, Petra Vladyková², Arne Villumsen¹

¹ The Arctic Technology Centre, Department of Civil Engineering, Technical University of Denmark. DK-2800 Lyngby, Denmark

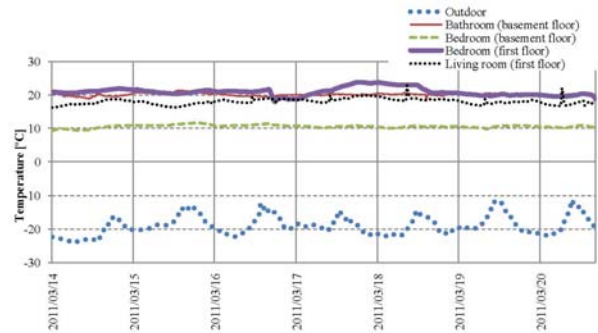
Figure 8: Measured temperature in the coldest week of 2011

The figures show that in the summer the house does not have a problem of overheating. In the winter the bedroom in the basement is probably not used because the temperature of the bedroom is around 10°C. But in the warmest week of 2011 the measure relative humidity often reaches 100% and it might show a malfunction of the sensors. In addition, there are also some problems with where the sensors are placed. The sensors are placed too close to the floor. However ideal position should be between 1m and 2m on the wall. Therefore the results of the TinyTags measurement could be taken for reference but in the future the sensors should be replaced and more precise results would be used to analyze the indoor climate.

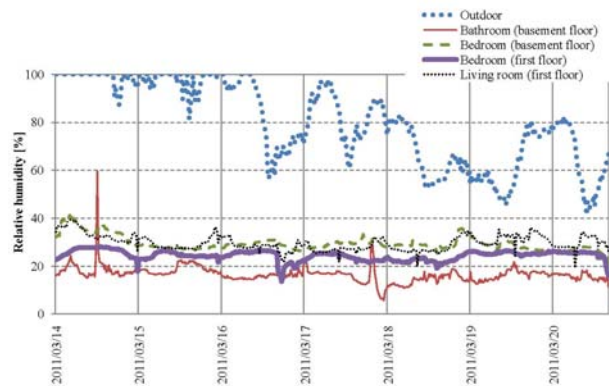
Figure 9: Measured relative humidity in the coldest week of 2011

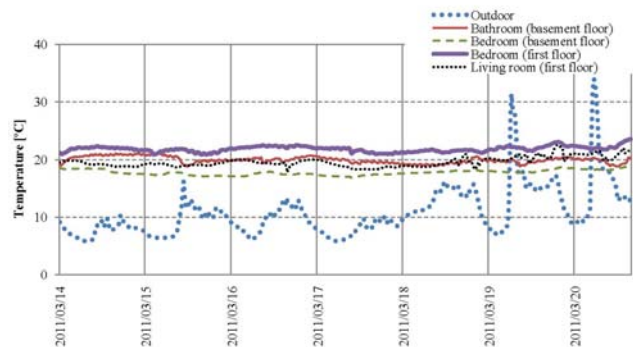
Figure 10: Measured temperature in the warmest week of 2011

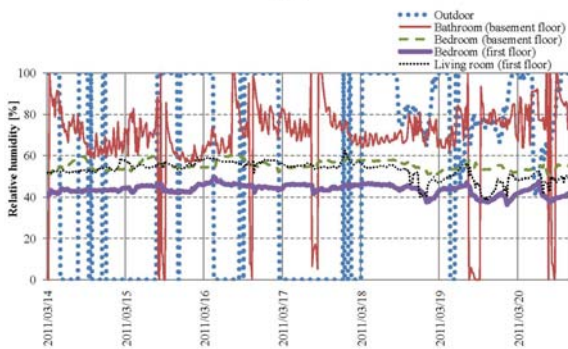
Figure 11: Measured relative humidity in the warmest week of 2011

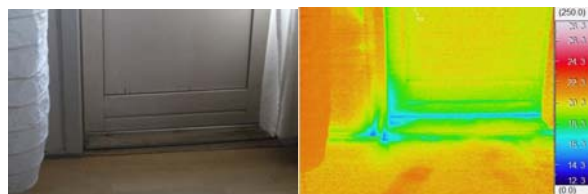
The thermography tests show that there are some problems with the building envelope, such as leaky windows, doors and building component joints. Some pictures are taken as examples to see the problems. (Figure 12, 13 and 14)

Figure 12: The leaking balcony door in the living room

From the thermography tests it can be seen that although the building envelope of the blue house is rather tight, the house has many weak points. Except for the problematic windows, doors, natural vents and some joints between building components, the heat loss through the building envelope of the ground floor (wood) differs from heat lost through the envelope of the basement (concrete). The result of the testing reveals that heat loss through the thermally weak parts could be quite high. It means in the retrofitting, improvement of the wind barrier and continualization of the whole building envelope must be considered.

According to the result of the investigation, the retrofitting work mainly consists of applying extra paper insulation layer and new climate shield, replacement of windows and doors, levelling up the living room floor and installation of mechanical ventilation system.

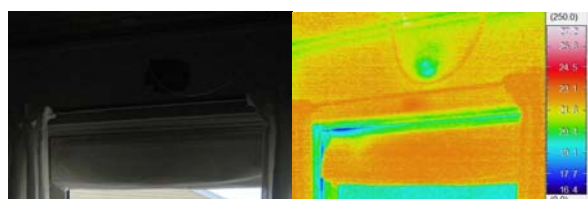
Figure 13: Untight window, natural vent and joints between the wall and the ceiling
