Fatigue damage propagation in unidirectional glass fibre reinforced composites

Published in:
ECCM15 - 15th European Conference On Composite Materials

FATIGUE DAMAGE PROPAGATION IN UNIDIRECTIONAL GLASS FIBRE REINFORCED COMPOSITES

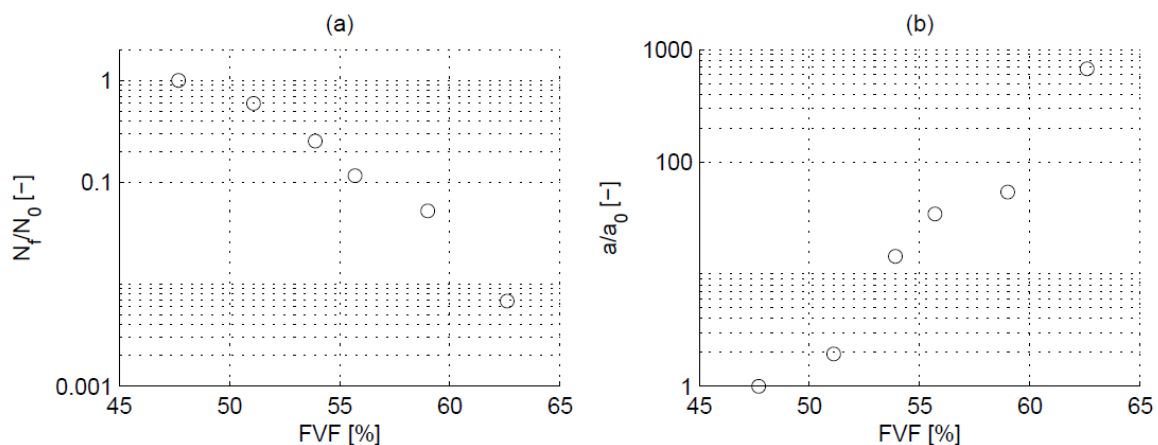
Figure 3. Result of fatigue experiments of GFRP's with different FVF's. Each circle presents the mean value of at least three experiments, and the results are normalised with the value from the experiment with the lowest FVF. (a) Number of cycles to failure. (b) Stiffness degradation rate, Eq. (1).

It is observed that there is a strong influence of the FVF on the fatigue life-time and the damage propagation rate.

From Fig. 3(a) it is evident that the fatigue life is highly dependent on the composite microstructure reflected in terms of the FVF. Furthermore, the stiffness degradation rate, Fig. 3(b), is substantially larger for increasing FVF meaning that fatigue damage propagates faster for larger FVF's. It is recalled that all experiments are carried out for the same maximum initial strain level, which means that the specimens with the larger FVF experience a larger stress due to the increased stiffness. However, this increase in stress cannot explain the lower fatigue lifetime. For the present range of FVF's, there does not seem to be a plateau for an optimum fatigue performance. However, there seem to be a power law dependency on both the number of cycles to failure, Fig. 3(a), and the stiffness degradation rate, Fig. 3(b), as a function of the FVF. Even though the stiffness degradation rates are different for each FVF, the overall shape of the curves is similar (not shown, comparable to Fig. 1(b)). This indicates that the damage process is identical for all samples, but the magnitude of the propagation is different. In a given application it is essential to be aware of the material behaviour reported in Fig. 3 since local variations in the FVF within the material can cause different resistance to fatigue.

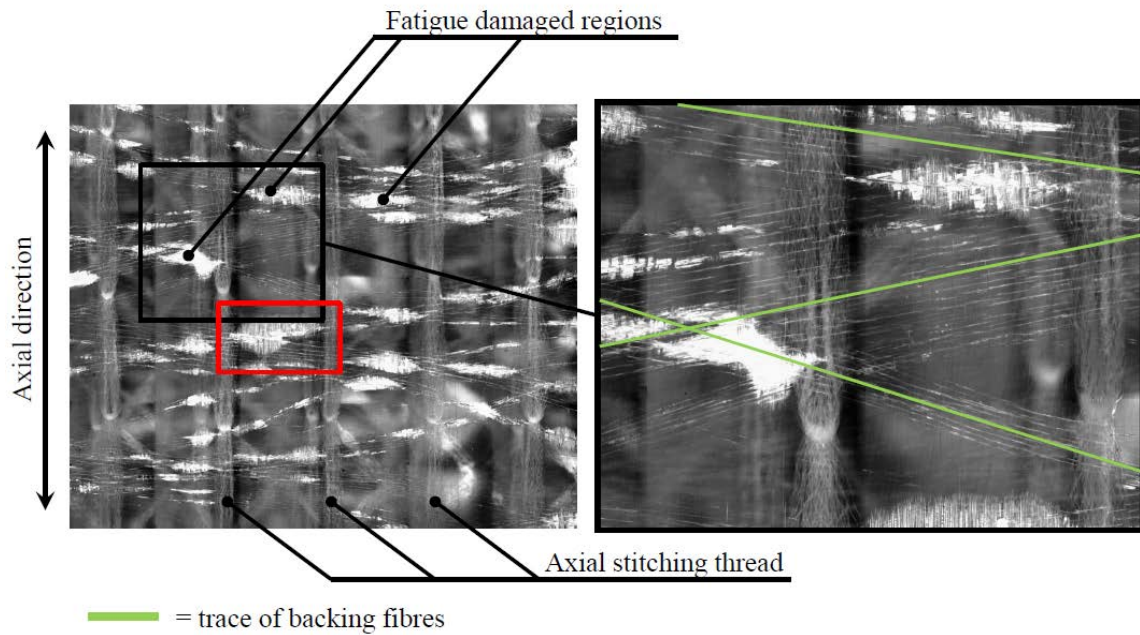
In order to detect the stiffness degradation mechanisms in phase II, see Fig. 1(b), the fatigue damaged specimens are analysed. Prior to burning the resin, polarised microscopy is used to inspect for changes in the strain field within the interior of the specimen. A typical micrograph showing the interior fatigue damage is presented in Fig. 4. There is a considerable amount of damage due to fatigue, and a closer examination reveals that the damage is concentrated in regions where the backing fibres are crossing each other, see magnification in Fig. 4. From the magnification in Fig. 4, it is also observed that there is a kind of delamination (transverse cracks) in the direction along the backing fibres. Beneath the crossing points of the backing, an extensive amount of fibre debonding is observed in the axial load-carrying fibre bundles, which is shown in Fig. 5. Matrix cracks are apparently not present within the samples. The observations in Fig. 4 and 5 are found in all specimens independent of the FVF.

Figure 4. Fatigue damage in a unidirectional GFRP. The red box is magnified in Fig. 5.

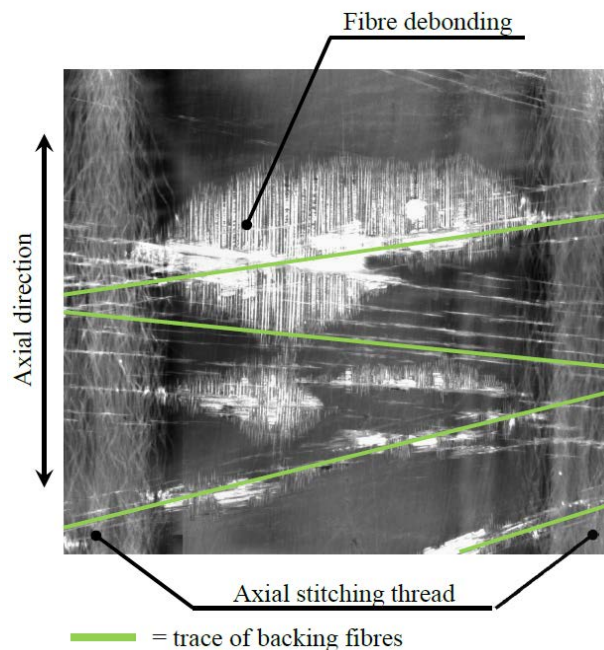
Figure 5. Magnification of the red box in Fig. 4 showing fibre debonding in the axial fibres beneath the backing layer.

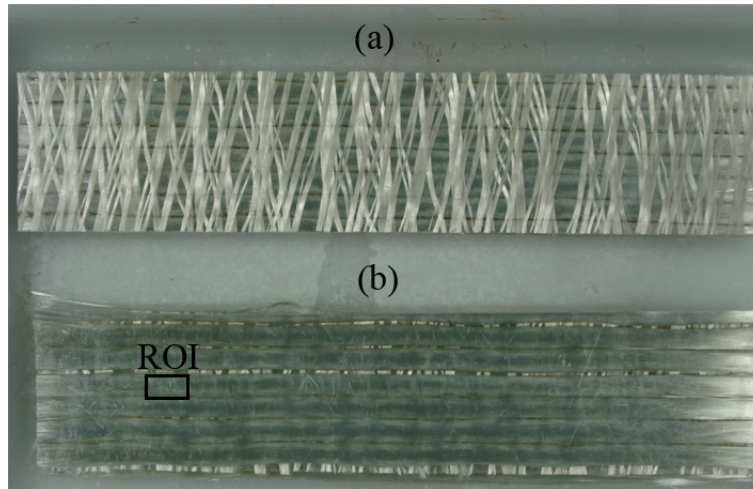
The resin is burned away, and potentially broken fibres are investigated in the axial bundles in the regions of contact to the backing fibres. A typical specimen after burning the resin is shown in Fig. 6. Note that the stitching thread is also removed during the burning process since it is made of polyester. From Fig. 6(b) it is evident that the method of burning the resin can also be used to estimate the in-plane waviness of the axial bundles. However, this is outside the scope of the present study and has been left out.

Figure 6. Specimen after removal of the resin. Axial fibre direction is horizontal. (a) With backing fibres. (b) Without backing fibres. ROI = Region Of Interest.

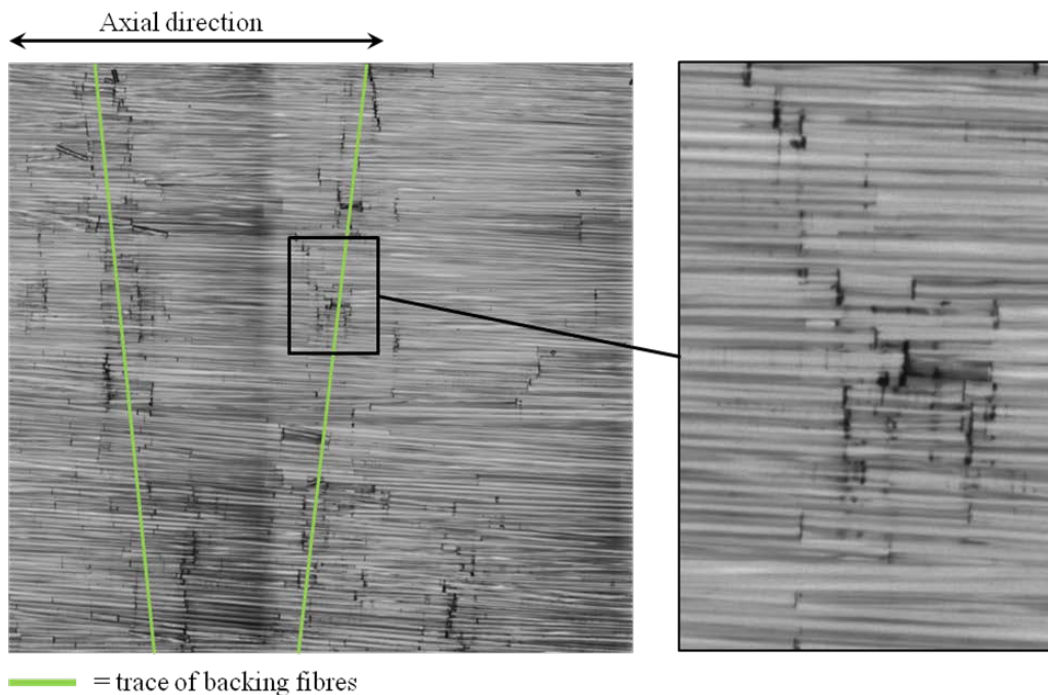
Upon microscopic inspection in the region of interest, Fig. 6(b), it is found that there is a severe concentration of broken axial fibres underneath the backing and the stitching thread. A typical image is presented in Fig. 7 where a severe concentration of broken fibres is found beneath the backing (only backing side is shown with backing fibres removed).

Figure 7. Micrograph of broken fibres underneath the backing for the region shown in Fig. 6. Note the extensive amount of fibre breaks beneath the location of the backing layer.

Phase II: Lasting most of the life-time with a somewhat constant stiffness degradation rate, damage consists of sliding friction (fretting, rubbing) between the backing layer (as well as the stitching thread) and the axial fibres. As the cyclic load is applied, the fretting causes fibre breaks in the axial fibres. Due to the stress transfer at the broken fibre ends in the load-carrying bundles, fibre debonding occurs and propagates along the axial direction. Fibre fracture and debonding continues throughout the phase and cause both a loss of stiffness and an increase in material damping. Interfacial fibre/matrix properties are considered crucial.

- (i) optimise the fibre arrangement of the backing,
- (ii) change the backing fibres to a more compliant material (e.g. polyester) to reduce the interfacial stresses and stiffness mismatch between the layers,
- (iii) apply a soft and thin interleaf (tackifier) between the axial bundles and the backing (see e.g. Tsotsis [11], or Hillermeier & Seferis [12]),
- (iv) develop new stitching patterns that can stabilise and support the fabric so backing can be avoided.
