Analysis and diagnosis of timber structures in Porto historical centre

T. Ilharco, J.M. Guedes & A. Arêde

Faculty of Engineering, University of Porto, Porto, Portugal

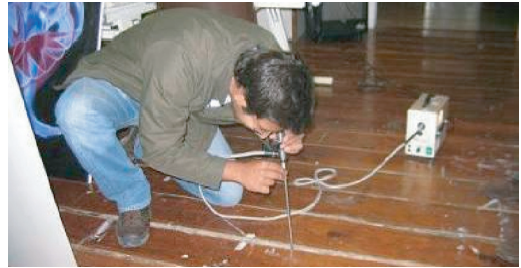
Figure 8. Use of the videoscope for the visualization of a timber floor. Belomonte Palace, XVIII century, Porto.

The Videoscope is an instrument that allows the observation of hidden areas or of difficult access, Figure 8. This instrument allows us to observe timber floor structures through small holes or gaps. For instance, in Belomonte Palace, an imposing XVIII century building that needed urgent rehabilitation measures, the Videoscope was a precious help, enabling the observation of some floor frameworks and the detection of metallic reinforcements and the presence of biotic attacks without the need to remove the floorboard. With this visualization it was possible to conclude, without any damage for the structure, that it wasn't necessary to reinforce the beams, but only to provide a curative treatment against insects.

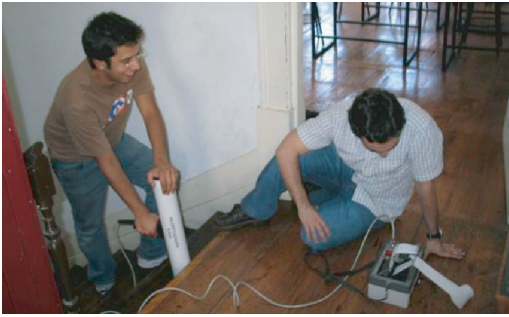
Figure 9. Use of the resistograph on wood stairs. São Domingos building. XIX century (1856), Porto.

As a result of its use, it was possible, for instance, to verify that the timber floors and stairs of a XIX century (1856) building, located in São Domingos square, were in excellent state of conservation, therefore not demanding reinforcement measures. On other hand, in the timber roof of Belmonte Palace, a building around 300 years old, some interior voids were discovered in the supports of tie beams (diameter of 0,30 m) with around half of its cross-section. The extension of the degradation along the elements was evaluated, allowing estimating the length of a future prosthesis to install (Faria, 2002). In Figure 10 illustrates the results given by the Resistograph, where a quite long void on the radial profile of one of the tested elements was

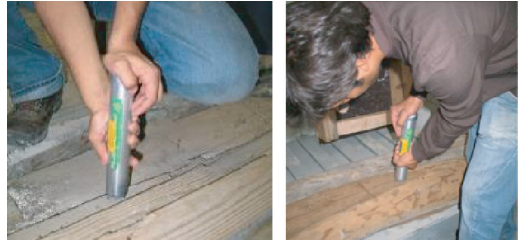
Figure 11. Pilodyn used in a timber floor. António Carneiro building, XX century (1916), Porto.

In the surveyed structures, the Pilodyn allowed finding wood defects through the reduction of the wood resistance to the penetration of the needle.

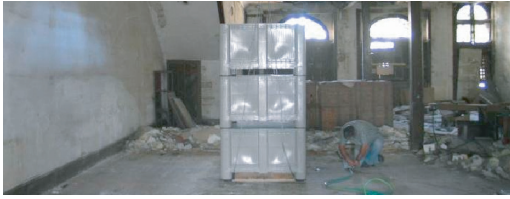
Figure 13. Load test on a timber floor. António Carneiro building, XX century (1916), Porto.

The strength capacity and the stiffness of the floors are strongly affected by factors such as the moisture content and the malfunctioning or degradation of its structural elements, beams and transversal bars, and of the floorboard. The load test was carried with the main purpose of evaluating the structural behaviour of the floor and the contribution of its single elements to its global resistance and stiffness, Figure 13. In order to better understand and to be more conclusive about the floors behaviour, the test was done on a 3,5 m wide strip (corresponding to an assembly of 7 beams) that was isolated from the rest of the floor. It was chosen a well preserved floor area (beams, transversal bars and floorboard).

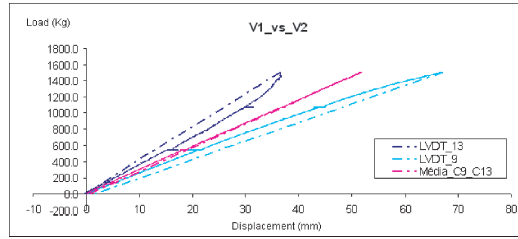
The analysis of the results, in particular of the load-displacement diagrams, and for the applied load range, shows a linear behaviour, Figure 14. From the results obtained it was possible to estimate the wood modulus of elasticity (around 12 GPa), verify the increase of

Figure 14. Load-displacement diagram for two isolated beams loaded simultaneously (the load refers to the total load applied).

the floor stiffness conferred by the floorboard and the poor effectiveness of the transverse bars to distribute the applied loads when compared to the floorboard. Other conclusions and analyses from the test will be published in the future.

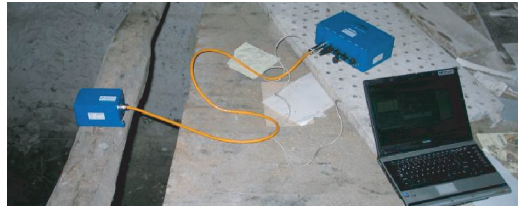
Figure 15. Seismograph used in single beam.

The data from the seismographs were particularly helpful in the evaluation of the relative importance of floor elements. In particular, several readings were made. Firstly, the floor with the original width was analyzed (30,0 m); Secondly, the measurements were repeated after the cut that isolated the 3,5 m strip from the rest of the floor, (final area of $6,0 \times 3,5 \text{ m}^2$). Afterwards, measurements were done without the transversal bars and, finally, on an isolated beam, Figure 15. The comparison between the results of these four situations, with the main natural frequency changing from 7,0 Hz to 10,0 Hz, allowed evaluating the importance of the floorboard, transversal bars and beams, to the floor structural behaviour and, simultaneously, estimating the medium values of the wood modulus of elasticity. It was also verified that the values of the natural frequencies measured in-situ were within the range of theoretical values calculated according to EC5 (1998).

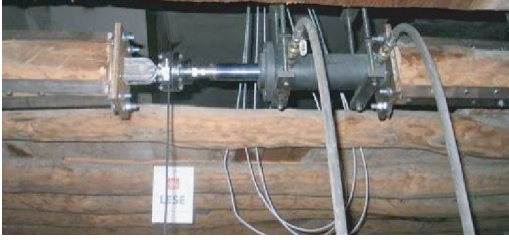
Figure 16. Beam wall friction test using a hydraulic actuator.

To evaluate the resistance of the friction connections between the timber beams and the masonry walls, a destructive test was carried out. A segment of beam was cut of to install a hydraulic actuator that would act along the beam axis. In order to maintain the two segments of the tested beam in the original position, it was conceived a metallic structure with pulleys to support it (not allowing vertical movements but free horizontal displacements), Figure 16. To set the actuator on the beam, metallic corner cupboards fastened by M12 bolts were used. The test consisted on applying pull out and in movements of the beam in relation to the wall. Displacement transducers were installed at the extremities of the beam to evaluate the load-displacement diagram of the beam-wall connection. With the purpose of verifying any possible horizontal movement of the wall during the test, transducers were installed on the walls. The results permitted to conclude about the limited efficacy of the connection between the two elements, traduced by a friction force of about 2,0 kN.
