Strengthening of Structures Damaged by the Azores Earthquake of 1988

Aníbal COSTA
Associate Professor
FEUP
Porto

António Arêde
Assistant Professor
FEUP
Porto

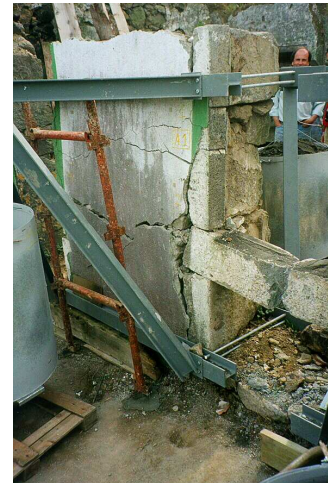
Fig. 9 – Collapse of panel A1

The non-strengthened panel (A1) wall was the only one that collapsed when subject to a load much lower than those applied to walls A2 and A3. In fact, after the load of 5.40 kN was reached, pronounced oscillation of panel A1 started occurring as a consequence of the bucket forced oscillating movement. This oscillation was followed by the panel wall collapse as shown in fig. 9.

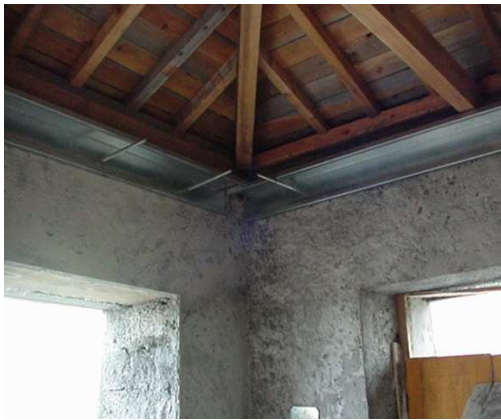
Fig. 14 – Angle plate supporting the roof braces in the semi-rural house

This last strengthening option is shown in the picture of fig. 14, corresponding to the structural intervention on the semi-rural house under study. There can be seen the angle plate supporting the roof braces, that simultaneously helps on confining the top ends of the building walls; note how the plate is fastened to the wall using threaded rods crossing the total wall thickness. Fig. 15 shows the same house partially plastered, in which almost all the referred techniques were applied, and where can be seen the connectors adopted for fixing the steel mesh.

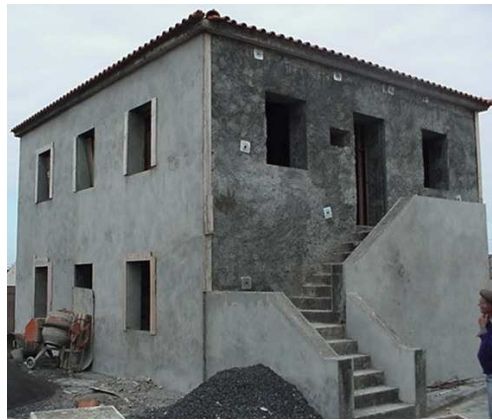
Fig. 15 – Semi-rural house strengthened and partially plastered
