# Journal of Applied Geophysics

# A case study of the use of GPR for rehabilitation of a classified Art Deco building: The InovaDomus house

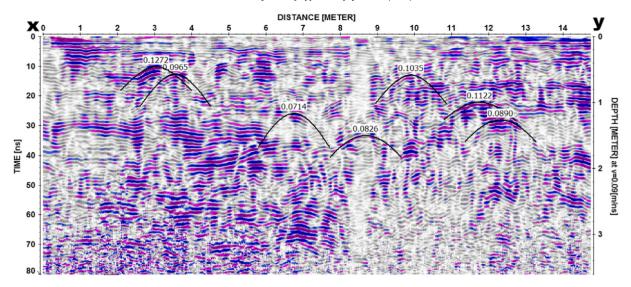
Fig. 2. Radargram acquired outside the building (500 MHz): the radargram fitted hyperbolae give velocity values ranging from 0.0714 m/ns to 0.1272 m/ns. This variation is due to the heterogeneity of the area that suffered extensive anthropic intervention.

The GPR survey performed on the concrete pavement outside the building shows hyperbola with different velocities (Fig. 2). Hyperbola adjustment produced velocity estimations ranging from 0.0714 to

0.1272 m/ns, thus revealing the heterogeneity of the ground, which makes data migration more difficult. Nevertheless data were migrated using a mean velocity value of 0.09 m/ns, hence introducing a relative, yet controlled, marginal error in the migrated radargrams. The data depicted in Fig. 6 show three clear horizons (thus four "layers"):

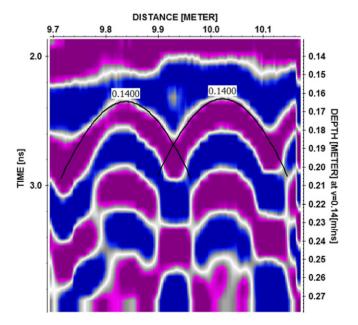
**Fig. 3.** Radargram section obtained over a concrete slab in the building: the estimated velocity is 0.14 m/ns.

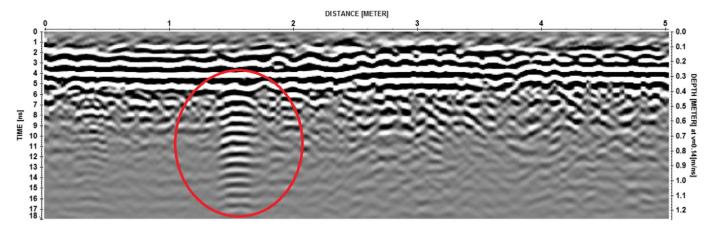
**Fig. 4.** Radargram showing the hyperbola and ringing effect (red) originated from the metallic rod on the opposite face of a wall. In this case, it was possible to estimate a velocity value of 0.14 m/ns (from hyperbola fitting) and a wall thickness of 0.34 m. Furthermore, the area of interest of the radargram corresponds to two way time values less than 4.945 ns.

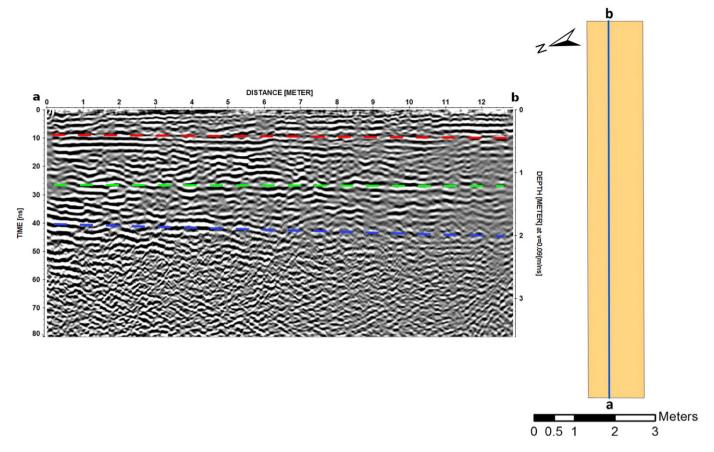
- The first layer, above the dashed red line, could be interpreted as the concrete pavement.
- Immediately below, between the red and the green lines, the radargram shows cross bedding signatures likely to correspond to anthropic fillings.
- Between the dashed green and blue lines the cross bedding is less visible but still present.
- The dashed blue line must correspond to the phreatic level, as interpreted depths are coherent with local phreatic measurements.

Below the dashed blue line, the signal is uncharacteristic and depicts visible attenuation. Local geology indicates the presence of clayey layers.

Fig. 6. On left: GPR image, on the right: location of the GPR image on the corresponding acquisition area (E1).

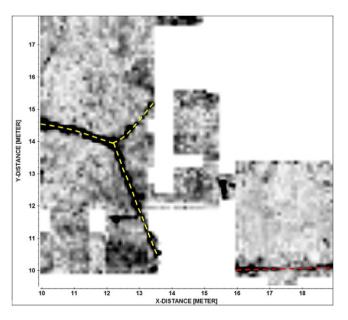
**Fig. 7.** Time Slice 3026 ns (-0.17 m) in area A1 (electrical cabling in dashed yellow; plumbing in dashed red).

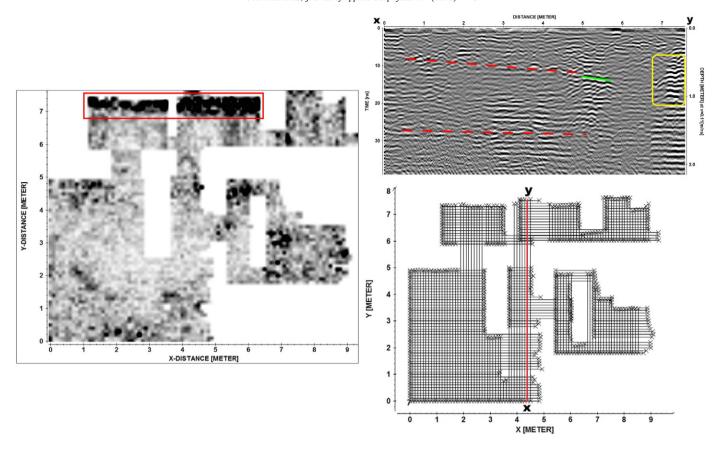
The top right side of Fig. 8 shows a radargram, carried out along the red line (XY) on the layout presented below the radargram. The yellow rectangle shows a clear hyperbola and some ringing of the signal, thus indicating the presence of a structure, probably metallic. This event corresponds to the red alignment on the time slice, shown on the left of Fig. 8.

The radargram, top right side of Fig. 8, also depicts two reflectors (marked in dashed red) that correspond to the two bottom layers (green and blue) revealed in the radargrams of Fig. 6. The interpreted interfaces positioning in Fig. 6 (data acquired with a 500 MHz antenna)

Finally, the green line on the radargram of Fig. 8, corresponds to the foundations of a wall.

Fig. 8. GPR time slice 11.63 ns (-0.64 m), GPR image and grid of measurements in Area A2: bottom right, grid GPR measurements grid in Area A2; top right, radargram corresponding to the YX acquisition line; left, 11.63 ns time slice for the whole A2 Area.

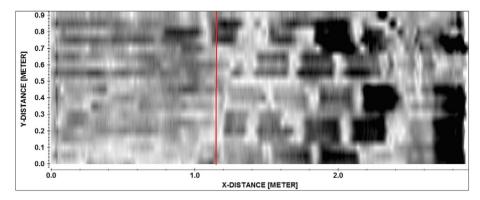
**Fig. 10.** Time slice 1038 ns (-0.06 m) in Area P3. (Two types of masonry separated by the red line; on the right a pillar).

On the other hand, the apparent individual signature of each brick in Figs. 10 and 12 has also been previously observed in laboratory experiments (Hermozilha et al., 2009). This phenomenon can be explained as adobe bricks are made individually and it is not possible to obtain a set of adobe bricks with exactly the same composition. Consequently, properties are likely to vary from adobe brick to adobe brick. Regarding the behavior of modern bricks, it has also been observed that a set of bricks does not show two identical specimens. They vary in color and in texture as production was almost artisanal decades ago.

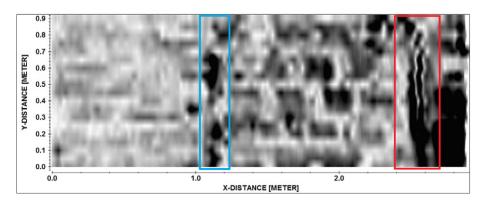
Fig. 11. Time slice 1.828 ns (-0.10 m) in Area P3. Blue rectangle corresponds to a perpendicular wall joint; the red rectangle corresponds to an embedded pillar.

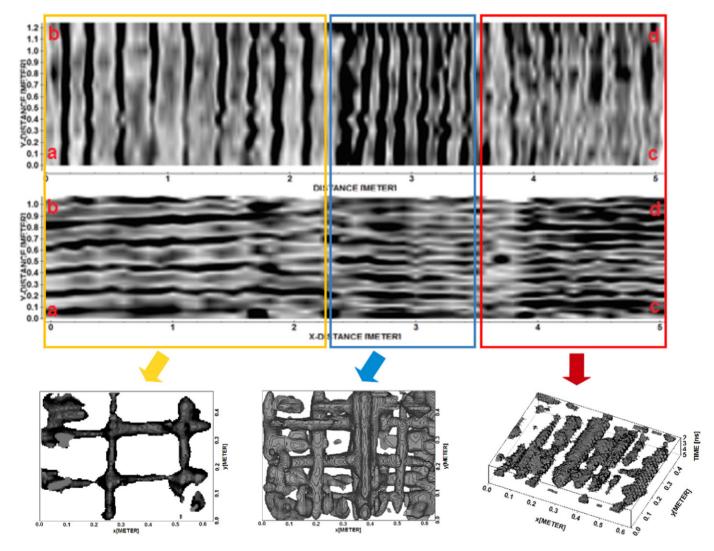
Fig. 13. GPR data over the balcony: on top time slices, 3.026 ns (-0.21 m) acquired using an 800 MHz antenna, on the bottom the amplitude isosurface data (1.6 GHz).

Both top rows of Fig. 13 evidence three different areas:

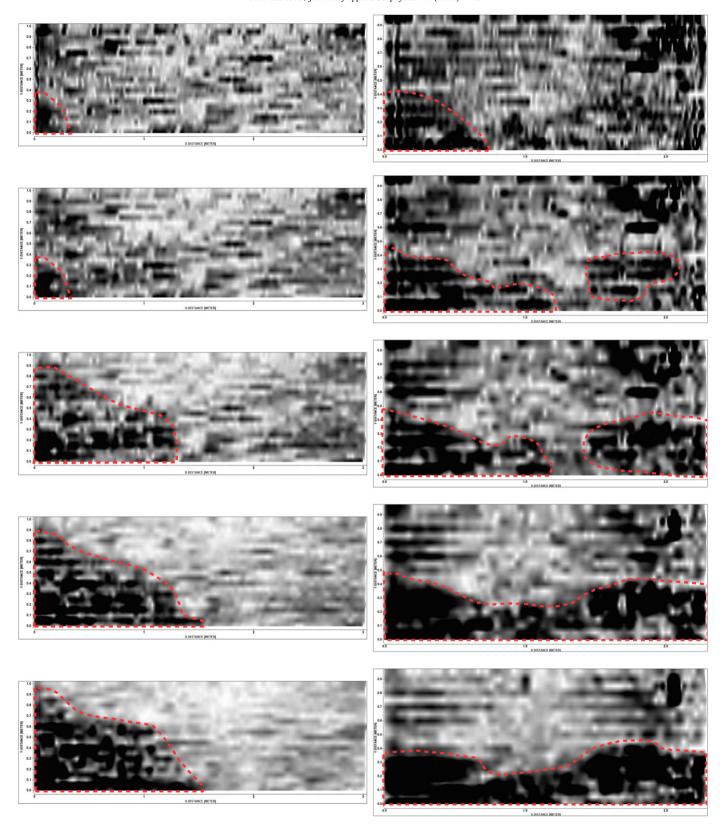
During GPR vertical data acquisition on a wall a darker area, that is more reflective zone, was recorded, as seen on the time slice sequence, left side of Fig. 15: this feature develops inside the wall and seems to occupy larger areas at greater depths, as depicted by the dashed red line. At the time no explanation was available for this signature. However a similar anomaly was later registered on a wall showing a surface damp stain (right side of Fig. 15). On the upper right time slice of Fig. 15 the red dashed line delimits the area where the superficial damp stain was observed. The deeper time slices also shown a widening

of the high reflectivity area in a similar to that observed on the left side of Fig. 15.

The anomaly on the left must have been caused by damp infiltration, although invisible on the surface of the wall, as it is suggested by the evolution of the red dashed line drawn on the time slices.

Fig. 15. Time slices revealing the effect of damp in two different walls: on the left, in a wall showing no surface evidence of the damp infiltration; on the right, in a wall showing superficial damp accumulation. The time slices on the right also reveal the extension of the damp inside the wall (red dashed line). (From top to bottom, time slices of: 0.5929 ns, 0.9387 ns, 1.334 ns, 1.729 ns and 2.125 ns).

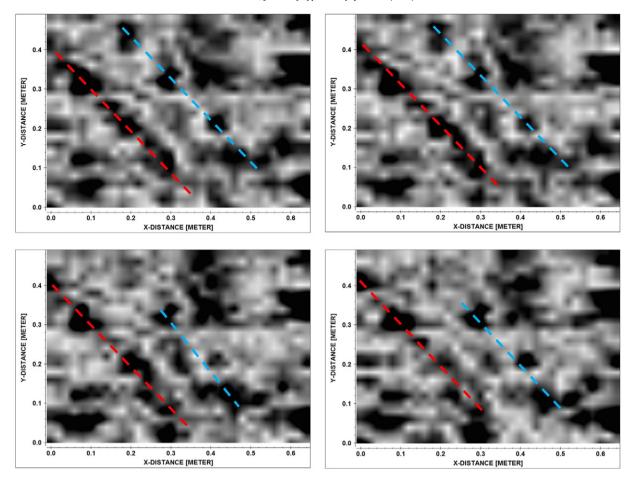
Several walls on the first floor of the building show fracturing related with the removal of structurally relevant walls on the ground floor. In a particular case, there is a major unrepaired fracture parallel to another fracture (already repaired with plaster filling).

A detailed GPR survey was carried out on this wall using a 1.6 GHz antenna. Data were acquired with 0.02 m distance between profiles and 0.002 m spacing between readings (Figs. 16 and 17). The time slices in Fig. 16 show high reflectivity alignments, marked by the red and blue dashed lines. The signature corresponding to the repaired fracture is not continuous, which must reflect the imperfect and coarse filling as it can be seen locally.

Thus the repairing plaster must have left open voids, evidenced by the highest contrast areas on the picture. This higher contrast is shown by the black, non-continuous anomalies along the dashed blue line. On the other hand, the open fracture shows a continuous higher reflectivity behavior represented by the dashed red line.

Fig. 16. Time slices showing the effects of two fractures: on the left the original time slices, on the right the interpretation: red dashed line depicts an open fracture; the blue dashed line depicts a repaired fracture. (Top left: time slice 0.1246 ns (-0.006 m), top right: time slice 0.3738 ns (-0.019 m), bottom left: time slice 0.6230 ns (-0.031 m) and bottom right time slice 1.121 ns (-0.056 m)).
