A Nightmare Revisited: The Resotation of the Canadian War Museum's 8.8 cm Flak Gun

The Restoration of the Canadian War Museum's 8.8 cm Flak Gun

Michael H. Miller

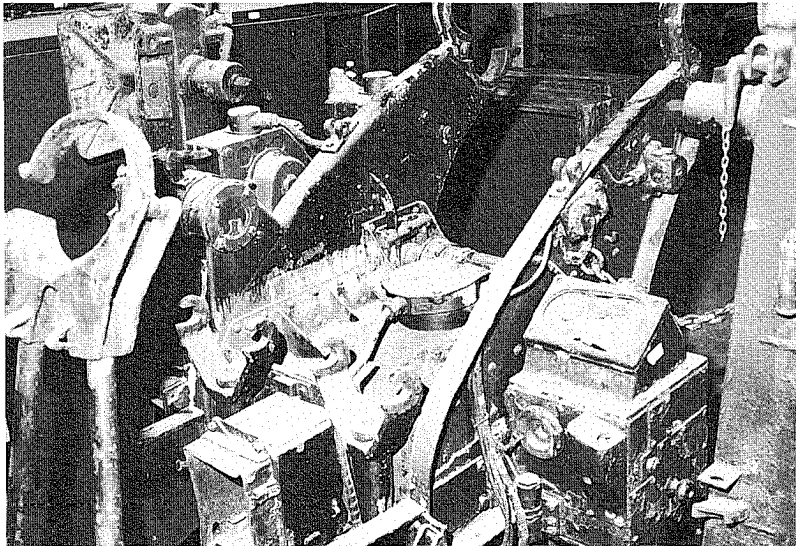
Components of the Canadian War Museum 88 prior to restoration: **Above left:** The pedestal assembly - virtually every moving component was firmly rusted and seized. **Above right:** The breech mechanism of the gun. **Opposite:** The barrel assembly. (Photos courtesy of author)

The pedestal assembly was next. Before work could commence, a large tent of polyethylene had to be constructed around it. This precaution was necessary to contain the dust and residue that would be created by the abrasive stripping procedure. Any components that could be removed from the pedestal assembly were taken to another work area. Other parts and critical areas were covered and protected from abrasive materials and dust. Unfortunately, the folding legs of the pedestal assembly were rusted and seized in the upright position. With enough penetrating oil and downward pressure the legs were eventually lowered.

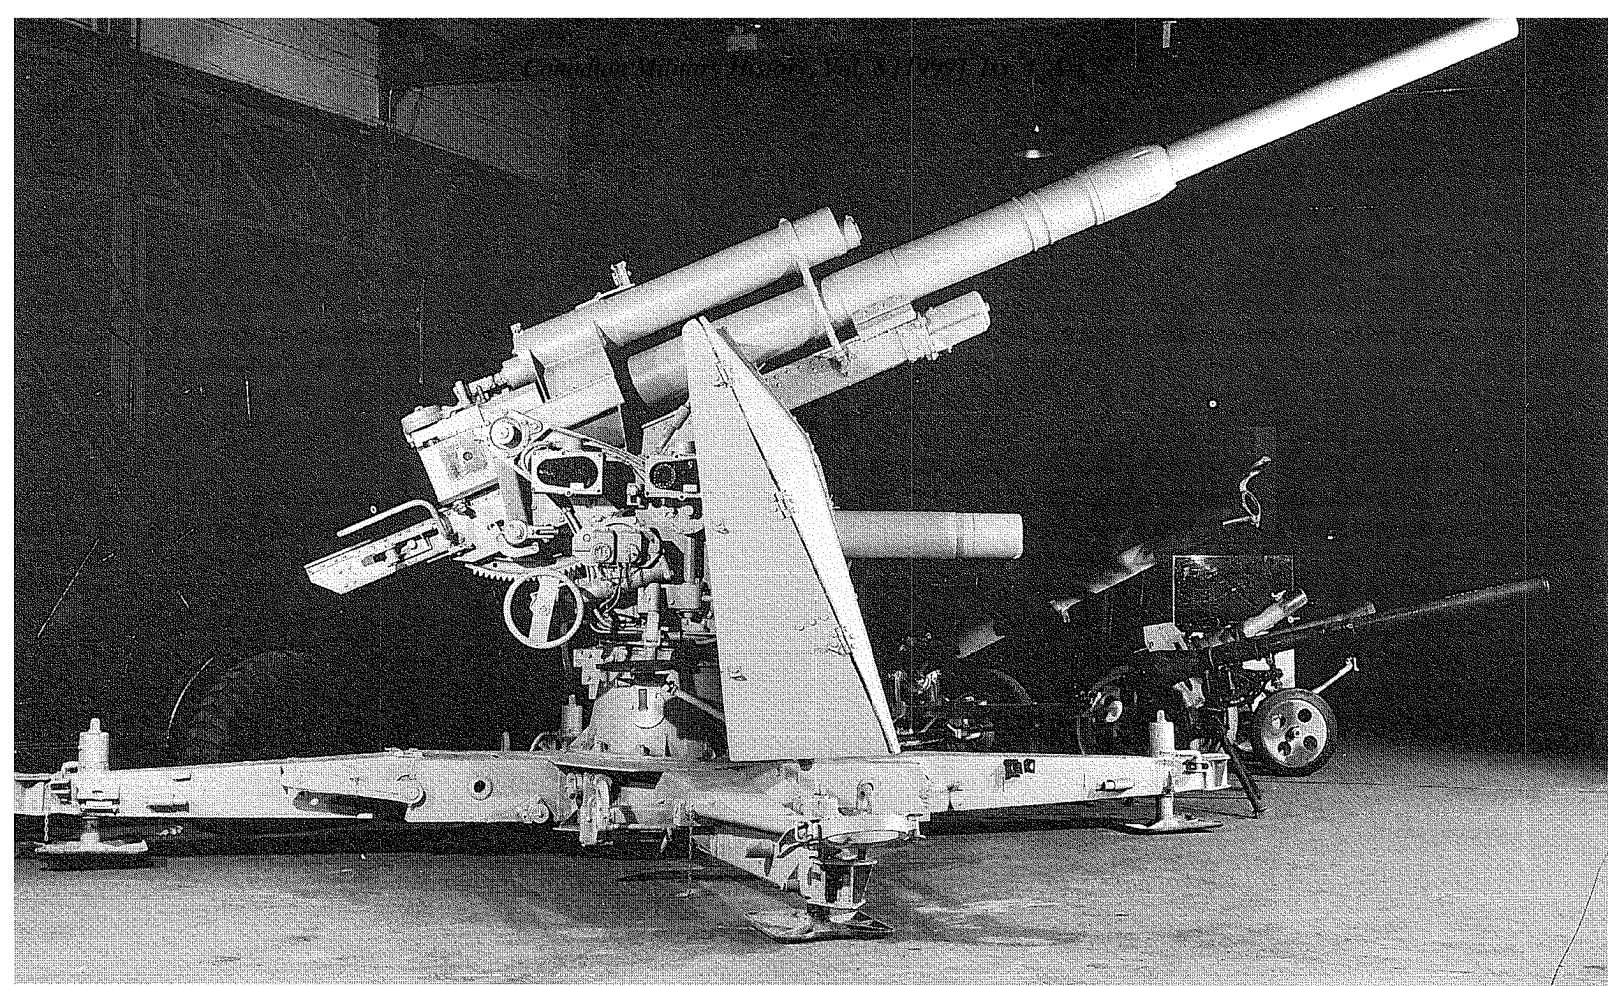
The restored 8.8 cm Flak 37 on display at the Canadian War Museum.
