<b>Geologia Croatica</b>	55/1	93 - 100	8 Figs.		ZAGREB 2002
--------------------------	------	----------	---------	--	-------------

## Water Reservoir Within the Karst Field Overburden: Gusić Polje, Croatia

**Key words:** Surface water reservoir, Karst, Water losses, Geophysical investigation, Gusić polje, Croatia.

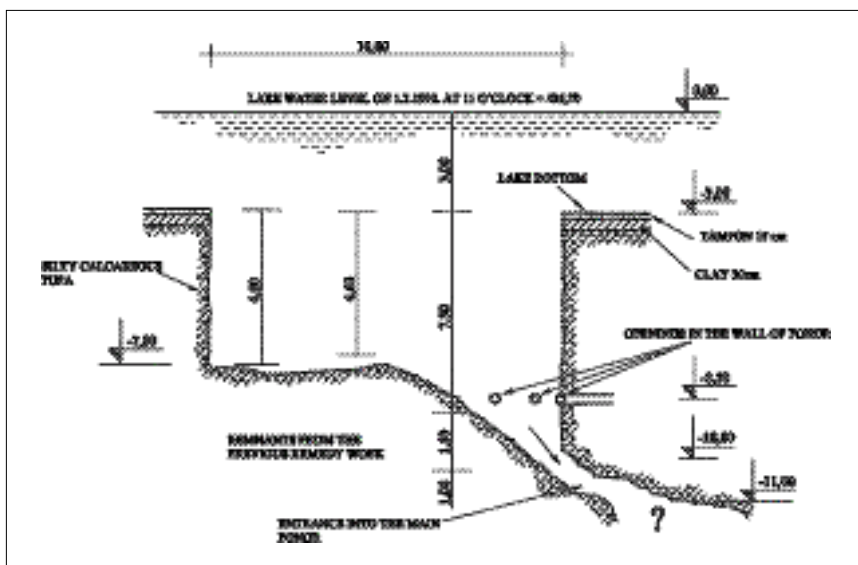
At sudden changes of groundwater level the conditions for appearance of pressure and under pressure exist. They have probably greater values after the clay carpet was made, because natural ventilation conditions were changed. Washing out of clay and travertine silt on the contact with the palaeorelief increased as well as the genesis of holes that lead to caves in ponors (Fig. 2).

Fig. 2 Ponor within the Gusić Polje reservoir.

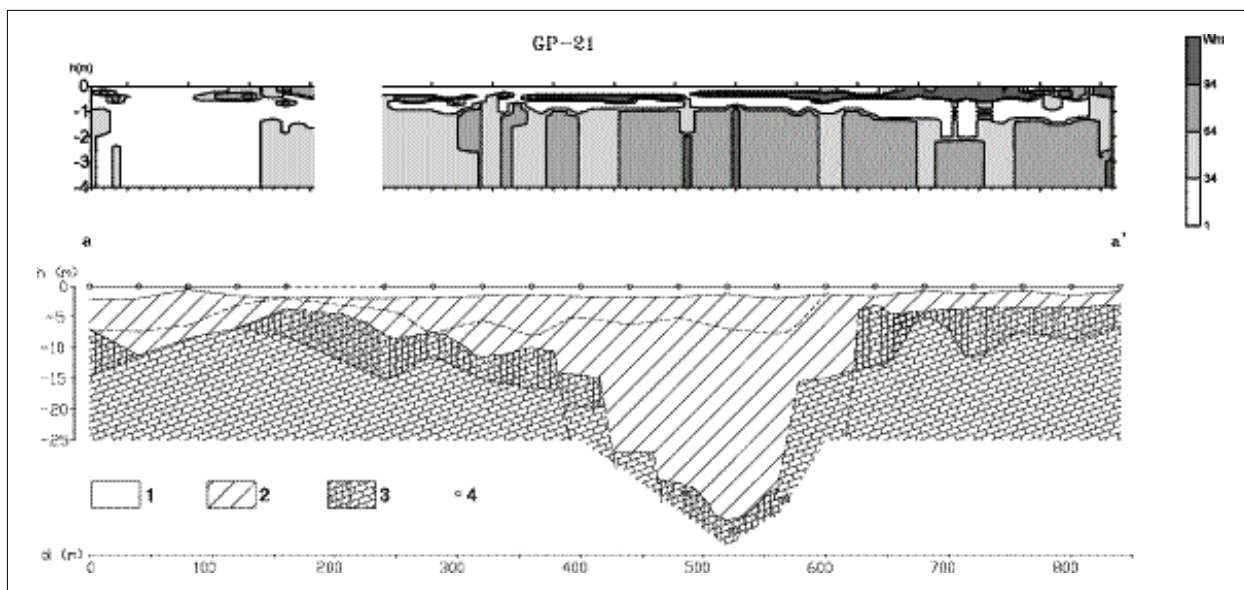
Figure 3 shows the characteristic geoelectrical cross-section GP-21. The results of sounding confirmed the existence of distinguished palaeodepression in carbonate bedrock and determined its strike. According to

Fig. 3 The characteristic geoelectric profile (GP-21) with results of geoelectric profiling (upper part) and vertical electrical sounding (bottom). Legend: 1) 20-1400 m, surface layer; 2) 25-70 m, quaternary deposits; 3) 65-420 m, limestones; 4) fault determined by geological and geophysical investigations.

these results, ponors are connected to the drainage net from the time of palaeodepression, which is at present time the basis for groundwater outflow from Gusić polje. However, smaller ponors (suffosions) appear on the surface outside the deepest parts of the palaeodepression, but they are connected with ponors inside the palaeodepression.

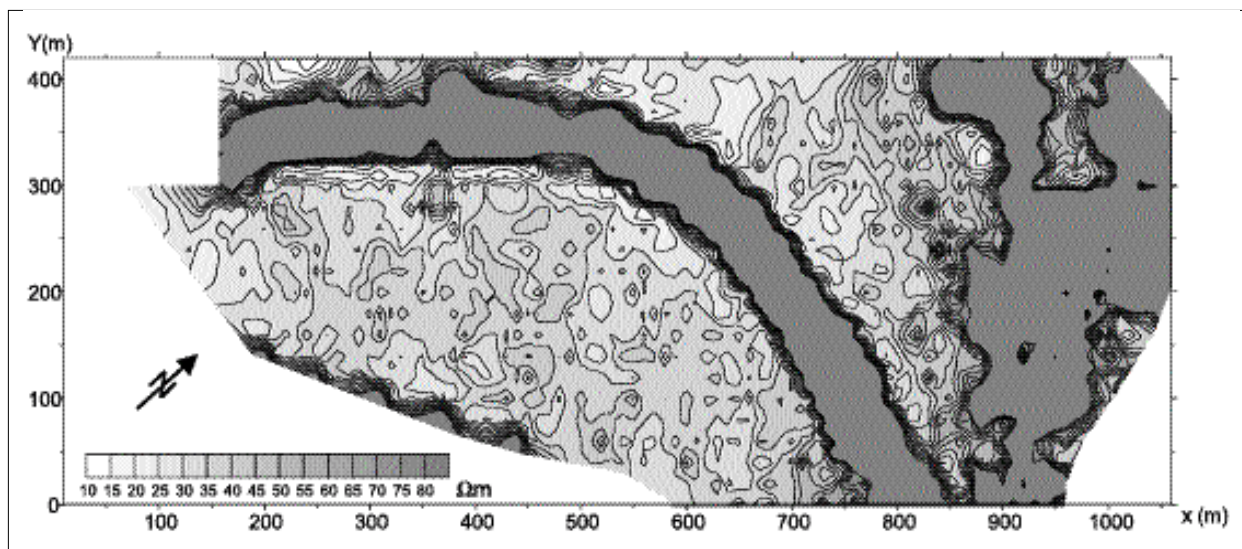
The measuring results were supposed to isolate zones of damage in rock and clay layers with tendency to form a ponor. However, the results suggested that the cause of water loss was not damage, but an incomplete protective carpet on the bottom of the basin and along the central embankments. According to the measuring results (Fig. 4) in the northeast part of basin, low values of resistivity, which correspond to the clay carpet were not recorded. Measured high values were not from protective rock aggregate, but from indigenous travertine cover below the humus layer. As this part of the basin is on higher spot heights than the rest, and as it is not always under water, the ponors do not emerge here, but water probably seeps through travertine not allowing further filling of the basin.

Similarly along the base of the inner embankments, resistivities that correspond to the protective clay carpet were not recorded. This is in accordance with the facts that the majority of new ponors appeared along the base of the inner embankments, and that those embankments were built before the clay carpet was placed on the bottom of the basin. The above mentioned conclusions should be verified through direct investigations.

Fig. 4 The results of geoelectrical tomography for depth level of 0.5 m. The dark tone represents sector with high electrical resistivity, and therefore it belongs to the zone where clayey carpet is damaged or missing.

In the areas inside the basin, where geophysical investigations determined the possibility of water loss or discontinuity of a clay carpet, a new clay carpet or the strengthening of the existing one is foreseen. The

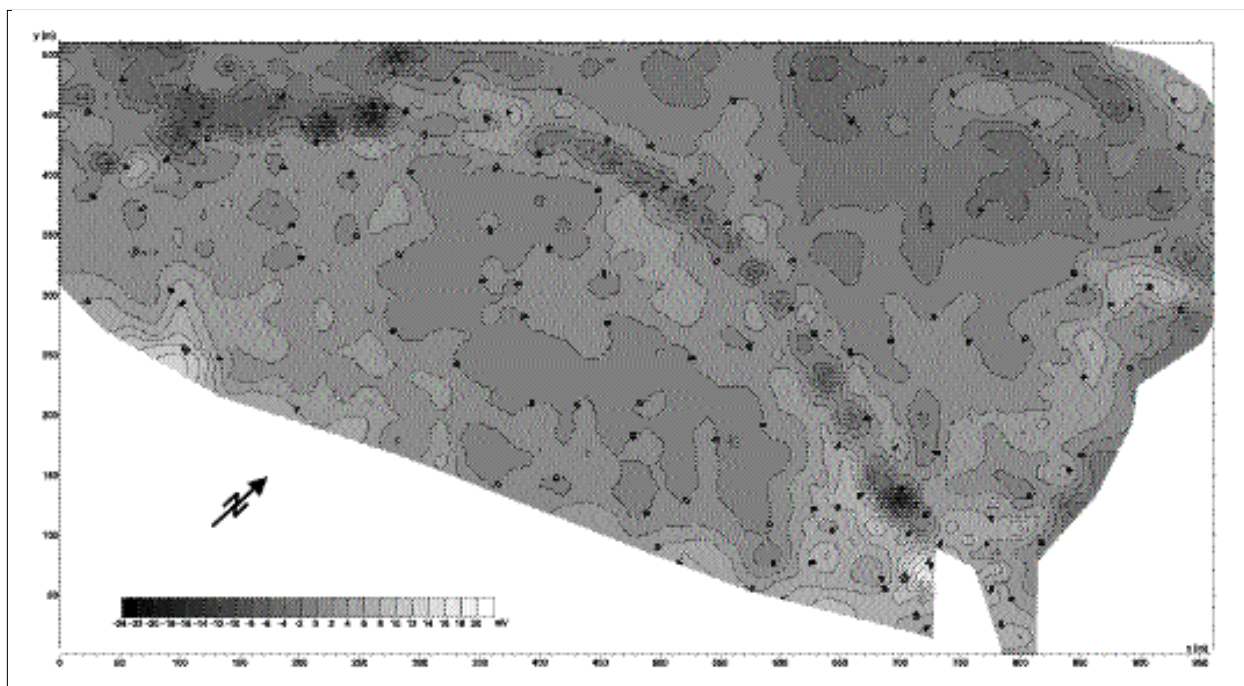
areas. Because the water is above the ground in this case, the areas with minimum values of potential would be the places of sinking of water into the ground. Anomalies of especially low values of potential do not have to mean that the sinking is proportionally expressed at those locations. In contrast, it is interesting to notice that mainly greater values of potential are recorded on the accompanying embankments in regard to other areas. This indicates seepage of water from the surrounding areas towards the embankments. The same is valid for the outer embankments toward which the values of potential increase. Besides, on the areas of additional basins (north and south) there are no anomalies in potential values, but the recorded values are uniform leading to the conclusion that no new ponors have emerged in those areas.

If we compare the results of geoelectrical profiling and self potential, we can conclude that the area of increased resistivity (dark) follows the area of increased potential fairly well, especially along the north edge of the basin. There, the zone of low resistivity, extending like a narrow band, is identical to the local minimum of self potential. Consequently, the locations of high resistivity are the zones towards which the groundwater flows, probably through the surface layer. This confirms the presumption that the clay carpet was not constructed on that location.

Fig. 5 The spontaneous potential map. Supposed groundwater flow is from dark toward white areas.

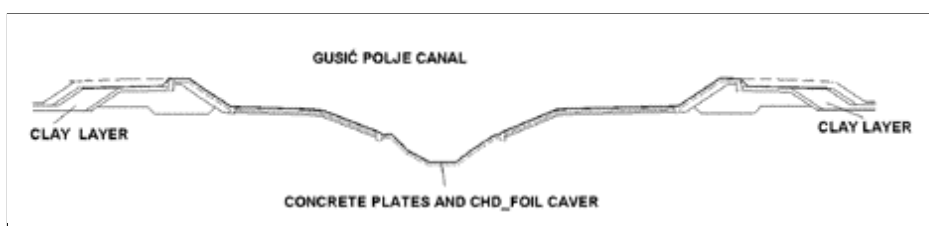
Fig. 6 Gusić polje canal cross-section.

Based on the investigation results, it is determined that the highest seepages are in the area of the canal, which

is covered with concrete plates under which a protective clay layer was not constructed. Due to the fact that investigations inside the basin are possible only during the annual one month reparation of the plant, the solution was chosen for remediation of the canal area, which can be performed in phases over several years. The economic-technical comparison of various possible solutions led to the choice of a method, that includes construction of a protective impermeable cover of the canal, made of foil which is laid on a geotextile layer with a density of 300 g/m<sup>2</sup> over the existing concrete plates of canal (Fig. 6). The foil is anchored in the canal bottom and on the slopes of accompanying embankments, where the connection between foil and clay carpet, in the form of a 5 m wide overlap is made.

The foil of CHD type is chosen (modified PHD - polyethylene high density foil used for potable water) due to ecological requirements, because water from the basin is also used for the public water supply.
