INVESTIGATION OF CAUSES OF SCRAP OCCURRENCE IN THREAD CUTTING ON STEEL SLEEVES FOR MOTORCAR INDUSTRY

Received - Primljeno: 2006-03-08
Accepted - Prihvaćeno: 2006-09-25
Professional Paper - Strukovni rad

V. Marušić, I. Budić, T. Šarić, Faculty of Mechanical Engineering University of Osijek, Slavonski Brod, Croatia

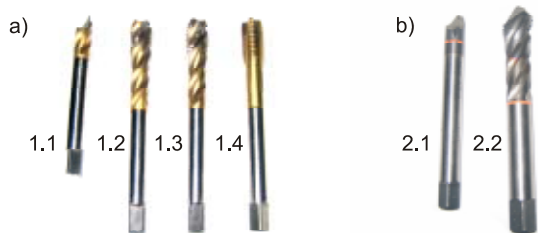
Several different cutters were examined for the purpose of control of the present damages. Besides their geometry, the cutters differ also by composition of their surface protective coating on base material (HSS steel). This protective coating is with some cutters titan nitride (TiN) and with other titan carbide (TiC). The appearance of damaged cutters is shown on photo in Figure 5.

Figure 5. The appearance of damaged cutters prior to thread cutting in the sleeve: a) thread cutters with protective coating TiN; b) thread cutters with TiC protective coating

Based upon the inspection of delivered cutters (Figure 3.a and 3.b) it can be seen they broke (cutters 1.1; 2.1; 2.2), while the others displayed only signs of "wear" (cutters 1.2; 1.3; 1.4). Discoloration of some of the cutters caused ("turned blue"), by the overheating during thread cutting. The following can be concluded:

- because 3D control established satisfactory perpendicularity of symmetry lines of the sleeve, it is not to be expected that damaging of cutters came as result of deviation of coaxial hole;
- due to fact that cutters with surface coating TiN and TiC on HSS steel display breakage and material wear, coating itself does not affect essentially to cutter breakage.

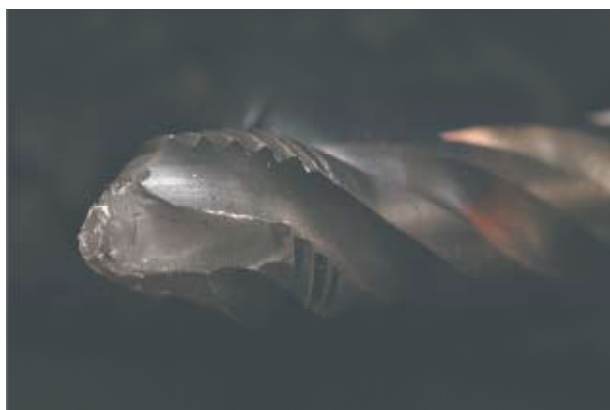
The detailed control of cracked surfaces of the broken cutters showed that:

- the cutters broke under an angle of 45°,
- local wrinkling of base material due to stresses over boundary of base metal tensile strength occurred,
- some cutters changed color (“turned blue”) due to overheating prior to breakage.

Figure 6. Appearance of the cracked surfaces of the thread cutter (macro record)

Cutter wear is in partly consequence of grind "drainage", but real cause of breakage with those sleeves which had smaller internal diameter than minimally allowed lies prevalently in overstress (stress above tensile strength of material), because the cutter not only enters the sleeve by cutting, it also shapes it by process of "rolling".

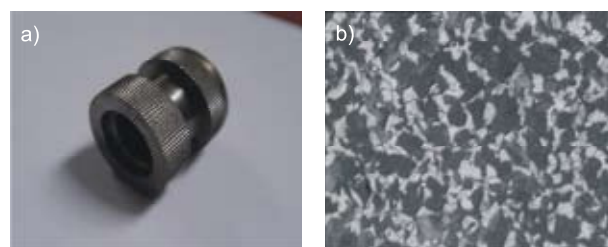
Out of results of dimensional control it can be observed that after short time “annealing” three out of five clamp sleeves showed a reduction of the internal diameter, while the other two displayed an increase (measured differences range up to maximum 0,008 mm). It must be pointed out that these are values within measured cylindricity of the bores. Only slight decrease of hardness value has been observed, from 260 - 270 HB to ~ 230 - 260 HB. However it must be pointed out that with one of the sleeves (No. 5) bore diameter in *as delivered* status was lesser than minimally allowed.

The analysis of microstructure of cross section of *as delivered* sleeves was performed, after the simulated annealing treatment. In both cases characteristic for the ferrite - pearlite microstructure could be observed the relatively small grain size and a significant difference between marginal areas and the central cross section area could not be noticed. The microstructure of these sleeves is shown in Figure 7.b.

Figure 7. Clamp sleeve: a) appearance in *as delivered* condition; b) characteristic microstructure of the cross section. Magnification 220x, Nital etching
