ENGINEERING-GEOLOGICAL CHARACTERISTICS OF THE LANDSLIDE MLIJA AND THEIR IMPACT ON ENGINEERING STRUCTURES (OMIŠ, SOUTHERN CROATIA)

Slobodan ŠESTANOVIĆ¹⁾ & Duško BARČOT²⁾

¹⁾Faculty of Civil Engineering, University of Split, Matice hrvatske 15, HR-21000 Split, Croatia

²⁾Civil Engineering Institute of Croatia, Business Centre Split, Matice hrvatske 15, HR-21000 Split, Croatia

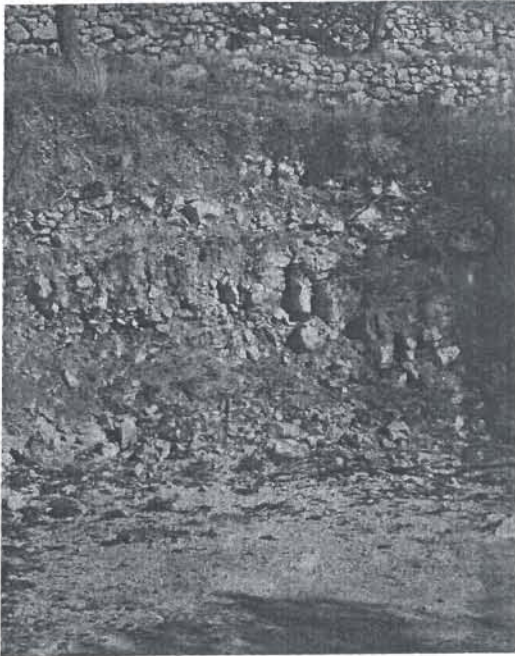
Fig. 2. Deluvial sediments in the cut of the slope

Deluvial sediments (Q_d) are the result of the weathering of carbonate and flysch beddings in the hinterland which were transported to a short distance mostly by gravitation (Fig. 2) to the foot of the slope and accumulated over older beddings. They consist of silty clay of low to intermediate plasticity and compactness with small percentage of angular limestone fragments. According to the results of exploration, thickness of deluvial deposits in the area of Mlija ranges between 2 and max. 8 m (mostly 2 to 5 m).

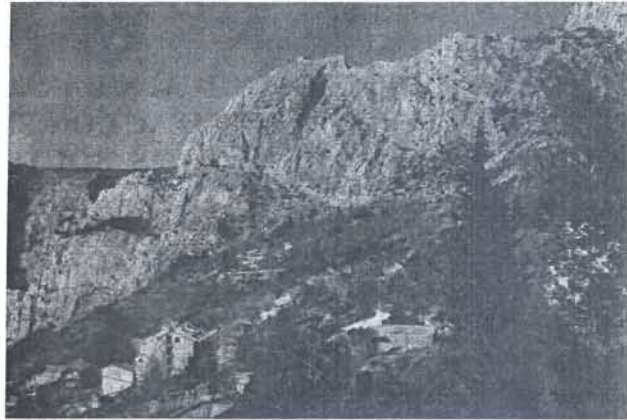
A tectonic activity locally breaks physical-mechanical features of the rock mass. However, general condition of autochthonous beddings of the Mlija slope point at a simple structure without pronounced deformations. Locally more pronounced decomposition and crushing of the flysch sediments is due to faulting and thrusting of Senonian limestones of Omiška Dinara over flysch beddings (Fig. 3).

Fig. 3. Thrust Omiška Dinara above the landslide

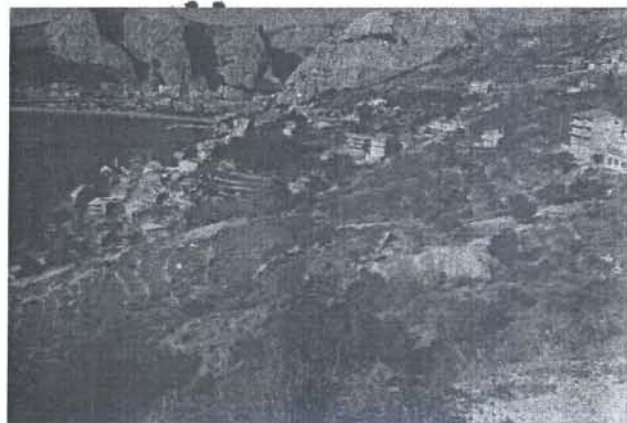
Morphologically speaking explored location is a slope cascadedly shaped by small stone walls. General direction of dip is southwest and the observed dip angle 20° , locally to 35° (Fig. 4). Slope is covered with deluvial sediments (Q_d). A rocky steep carbonate massif of Omiška Dinara, of height 565 m above sea level, rises above the slope.

Fig. 4. Landslide Mlija

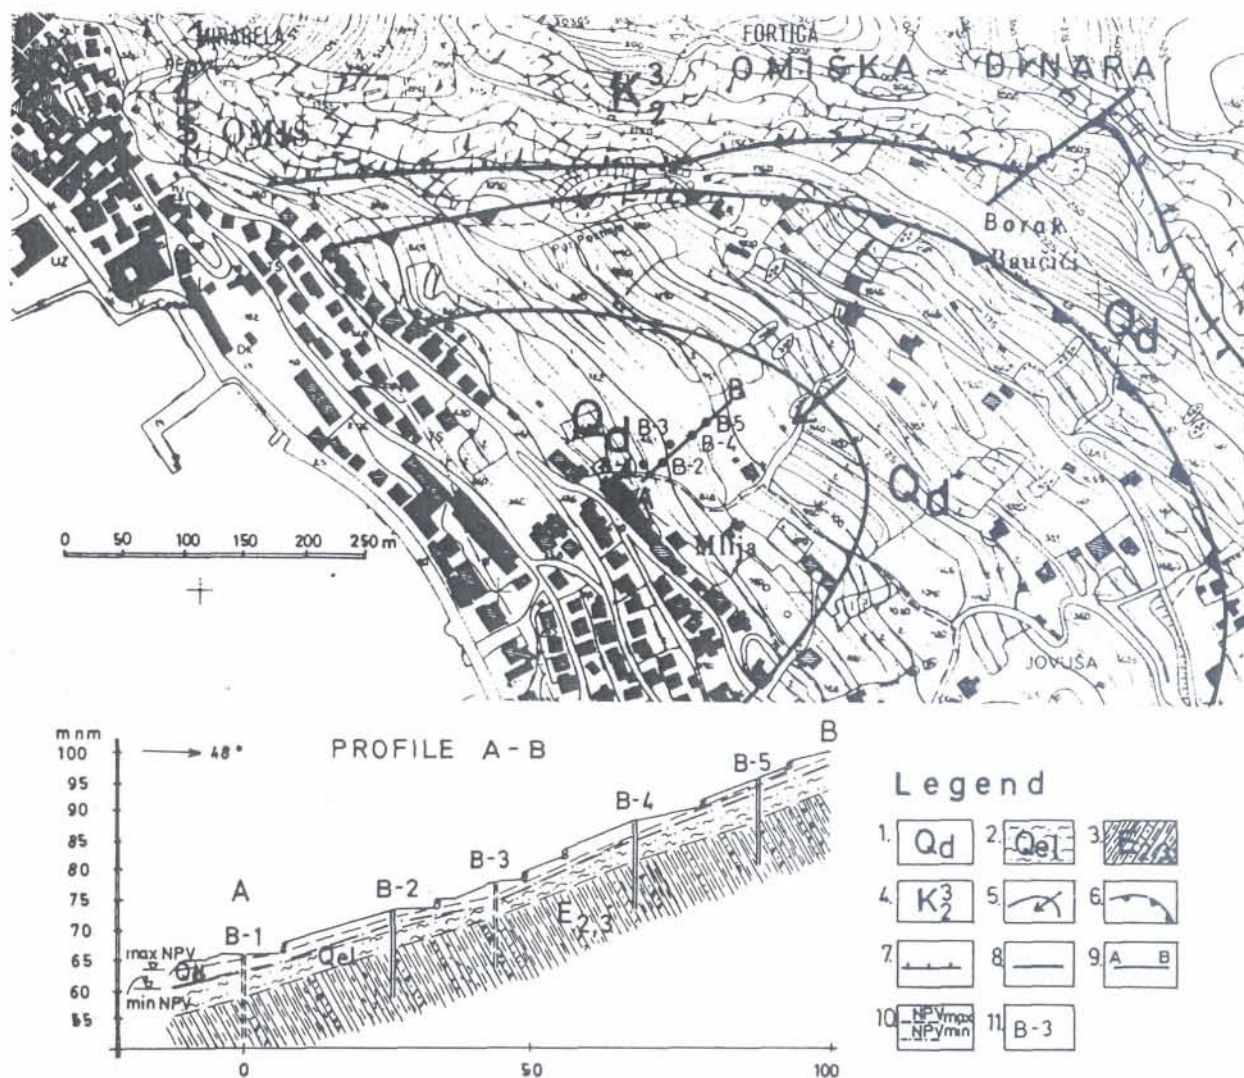
Fig. 5. Engineering-geological map and profile.

Ground water level was monitored during three winter months of 1986 and minimal levels in five boreholes, from -1.80 m to -4.10 m from the ground surface, were measured as shown in Fig. 5. Maximal water levels ranged from -2.70 m to -0.65 m. In a well situated near the upper part of the landslide ground water level of -1.60 from the ground surface was measured.

Engineering-geological map and characteristic profile obtain by boring is shown in Fig. 5. The surface area is formed from deluvial deposits (I) which is covering degraded flysch-Eluvium (II) and the base rock mass - flysch (III).

There are two boundary planes between mentioned elements. One of them is at the contact of deluvium and eluvium and it should be considered as potential slope failure plane. Another negative factor is the ground water level mainly in the contact zone.

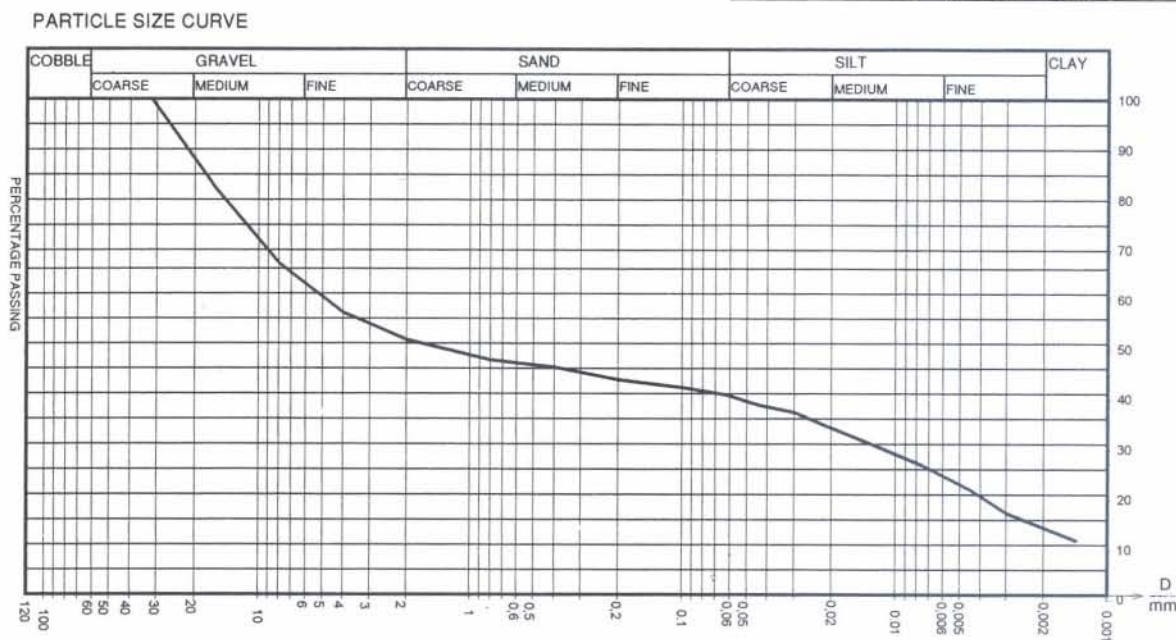
LOCATION:	MLIJA	BORING No:	B-3
DEPTH:	2.7-3.0 m

Fig. 6. Particle size distribution curve of the deluvium from the boring B-3

Characteristic grain size distribution curve of the deluvial material from the boring B-3 is shown in Fig. 6 while the subsurface exploration log of the boring B-3 is shown in Fig. 7. Standard penetration test (SPT) using the cone and cutter shoe obtained results between 13 and 21 blow for the same material shown in grain size distribution diagram

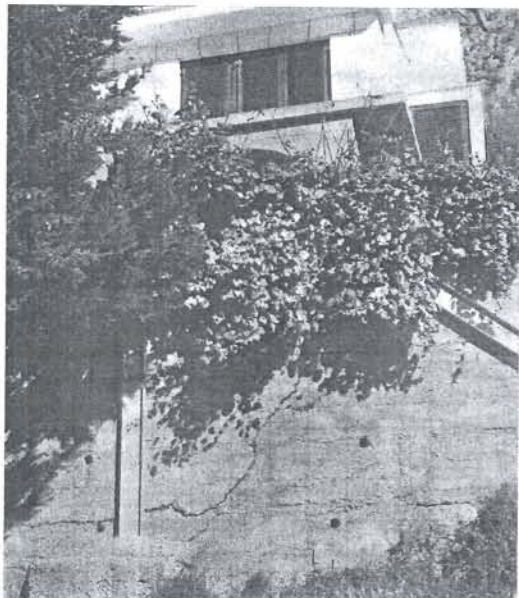
In the area of Borak the following can be observed: deformations of new stone walls (Fig. 8), creeping of blocks and deluvial breccias (Fig. 9) and cracks in asphalt pavement (Fig. 10). The most vivid example of inadequate foundations on the Mlija slope, as can be observed in Fig. 11 and Fig. 12, is a family house overturned during the construction. The structure was situated on the top of the slope (south from the local road) and had shallow foundations in deluvium which was the mass that moved.

Fig. 8. Crack in the retaining wall of the family house in the area of Borak

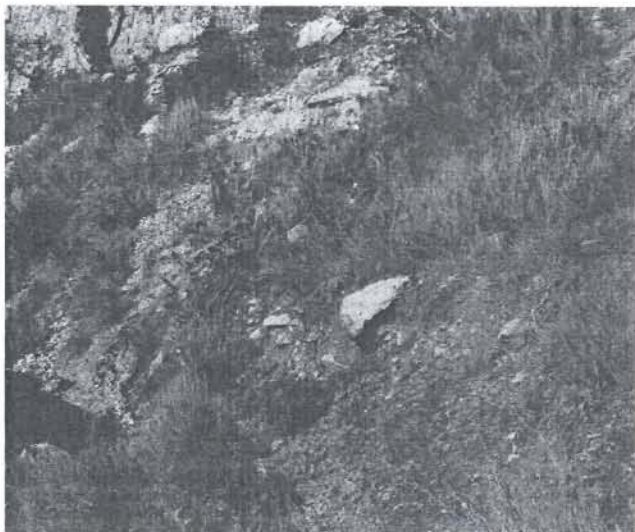
Fig. 9. Creeping of blocks and deluvial breccias in the slope

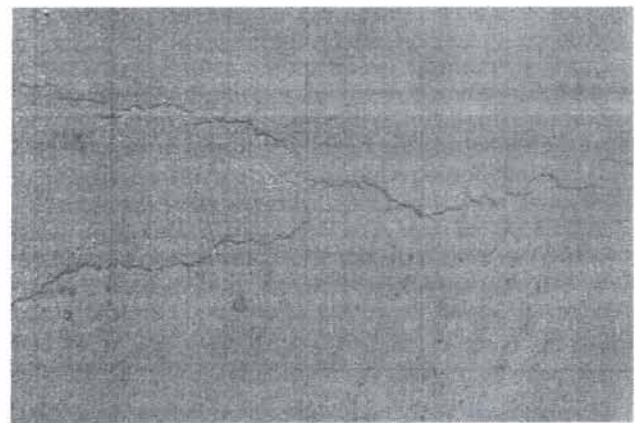
Fig. 10. Cracks in the asphalt pavement of the local road Mlija-Borak

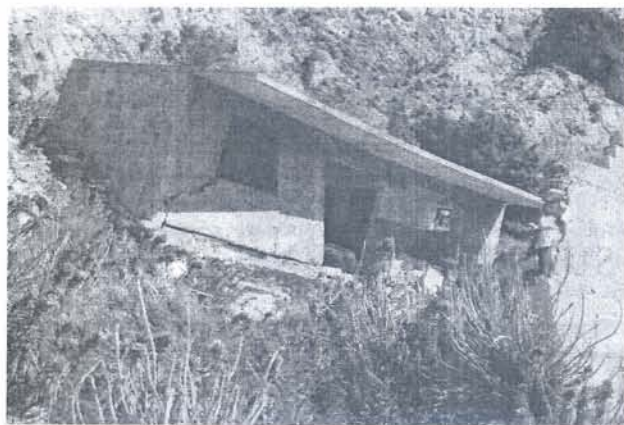
Based on obtained information, a conclusion can be drawn that the slope is in the state of constant creeping due to the hydrodynamic pressure, with sporadic failures of local character while each intervention as the slope cutting causes landslide and inadequate foundations overturning of houses.

Fig. 11. Overturned house due to the slope movement

Foundations should be constructed in non-degraded flysch beddings, with deeper strictly controlled excavation if flysch is found on depths less than 3 m. Pilots should be used when non-degraded flysch is found on greater depths. If intervention and construction costs are too high construction should be avoided. Therefore, any action in this slope should be strictly programmed, and preparatory works designed and undertaken before any other activity.

Preparatory works should consist of drainage of ground water and intake of surface water out of the construction site. Drainage should cover the permeable

surface area to depth of approx. 4.0 m from the ground surface.

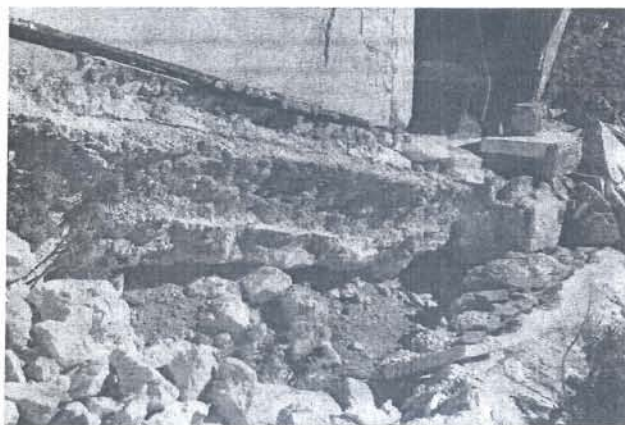
Fig. 12. Shallow foundations in deluvium mass which moved as a cause of overturning
