## CRACKS IN A ROLLER-BEARING

Received – Prispjelo: 2006-12-19  
Accepted – Prihvaćeno: 2007-04-10  
Professional paper – Strukovni rad

Bearings are among the most important components of electromotors, pumps, compressors and other processing equipment. After 30 years of work some non-destructive and metallographic examinations were carried out on a single-row cylindrical roller-bearing. A non-destructive liquid-penetrant testing revealed crack indications on an inner ring groove. When a sample of the roller-bearing outer ring was cut out for metallographic examination, new cracks were discovered that were not detected by the non-destructive testing. However, with the examination of the non-failed bearing it is possible to obtain useful information that can help us to decide how much of the remaining population of bearings with the same geometry and loading should be examined.

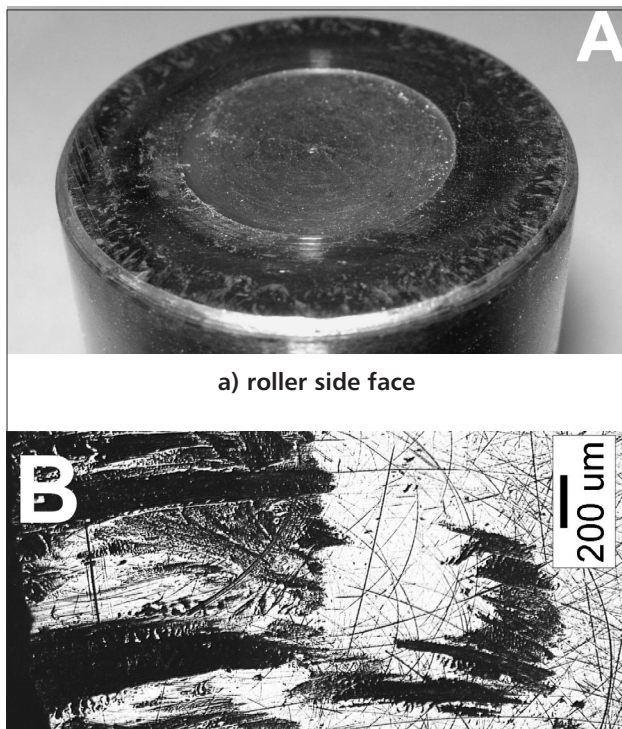
Figure 1. Roller side face surface

On each of the side faces of the rollers traces of spalling were found. Figure 1a shows the side face of one roller, and Figure 1b shows the same surface at a magnification of 50 $\times$ .

b) spalling and scuffing magnified 50

On the side faces of all the cylindrical rollers traces of spalling were detected. This is due to a lack of lubricant between the side face of the roller and the ribs of the inner and outer rings or retainer. The spalling shown in Figure 1b is minimal and in its initial stage. The contrast of the indications in Figure 2 is very poor because:

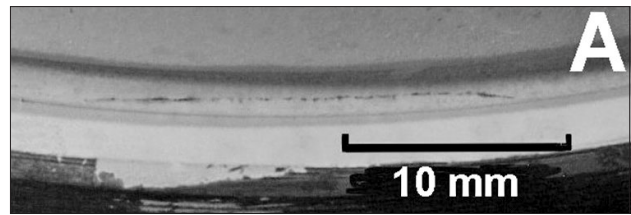
Figure 2. Indications of an inner-ring crack no. 1

All the surfaces of the inner and outer rings were examined with a red-dye liquid penetrant. On the outer ring no indications of defects were found. Three linear indications of cracks were found in the groove between the side rib and the raceway (location C in Figure 6). Figure 2 shows indication no. 1 with length of 22 mm. The lengths of indications no. 2 and no. 3 were of 25 mm and 60 mm, respectively.

- of the very narrow crack opening, which is on the very limit of detection for the liquid-penetrant system applied,
- the lubricant penetrated into the crack during roller-bearing operation and was impossible to remove it with the applied cleaning and degreasing procedure.

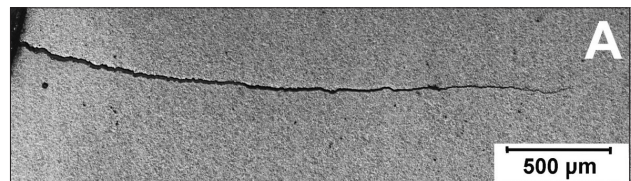
Figure 3. Crack no. 1

On the inner ring cross-section samples were cut out on the crack indications no. 1 and no. 2. Figure 3 shows cross-section of the crack indicated in Figure 2.

The depth of crack no. 1 is approximately 3 mm. Also, a sample cross-section was cut out at random from the outer ring. Rather unexpectedly, crack no. 4 (spot A in Figure 6) was discovered. The crack opening in Figure 4 is so narrow that the applied liquid-penetrant technique was not sufficiently sensitive to detect the crack.

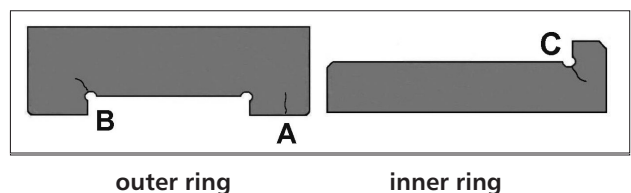
Figure 6. Ring cross-sections with discovered cracks

The positions of the detected cracks on the inner and outer rings are shown in Figure 6.

Cracks no. 1, 2, 3 and 5 are positioned on the low stress area of the roller-bearing. Taking into consideration the morphology of the cracks it is very difficult to estimate and evaluate their nature. Figure 9 shows the end of crack no. 2, with a splitting end and an intergranular path, which is characteristic of a quenching crack.

A visual examination of the roller-bearing's surfaces did not reveal any signs of a damage. The cracks were detected with non-destructive and destructive examinations. The purpose of the inspection was to determine the overall condition of the roller-bearing. Because of the detected cracks, the frequency and the extent of the inspections on the roller-bearings with a similar geometry and loading were increased.

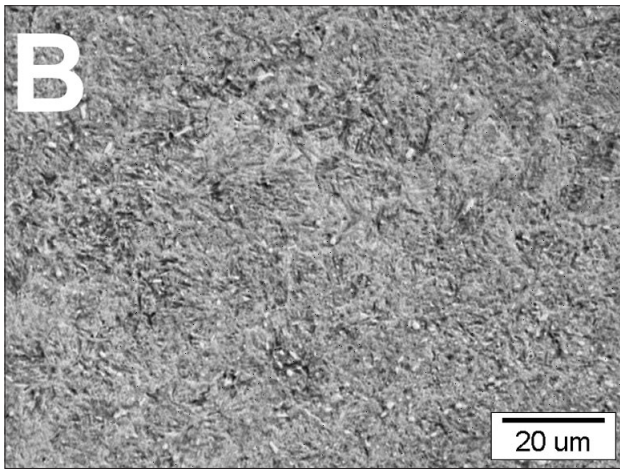
Figure 7. Microstructure of outer ring

The microstructure of the outer ring is shown in Figure 7. The microstructure consists of tempered martensite with an even distribution of small globular carbide particles.

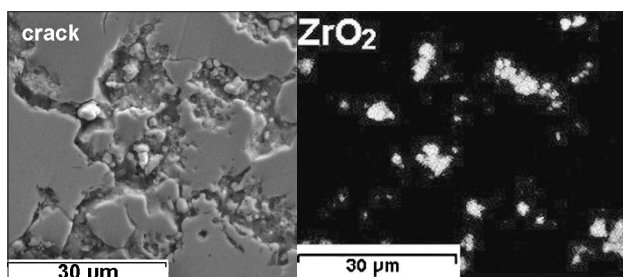
Figure 8. Crack no. 4 with the distribution of the  $ZrO_2$

An EDS analysis on crack no. 4 was carried out, and the presence of zirconium oxide ( $ZrO_2$ ) was detected. Figure 8 shows a picture of the crack with the distribution of  $ZrO_2$ .

Crack no. 4 was probably formed at the outer ring forging due to the crashing of hard non-metallic inclusions [5]. It appears that the crack itself did not propagate during the operation of the roller-bearing. The zirconium oxide inclusion probably originates from the steel casting process as a fragment of the pouring ladle, for which  $ZrO_2$  is often used. In the other cracks there were no deposits found (scale, sulphide, oxide); only in the area near the crack opening were the remains of a lubricant detected.
