AMMONIA FACTORY GIANT COMPRESSOR CRACKED 3rd STAGE CYLINDER FAILURE ANALYSIS

Tibor Köves, Szabolcs Szávai, Gyöngyvér B. Lenkey

Original scientific paper

Failure analysis of a giant compressor cracked cylinder has been performed using complex numerical and experimental methods. Further operating parameters for expected lifetime (with regard to the crack propagation) at reduced pressure are given based on the results of the investigations.

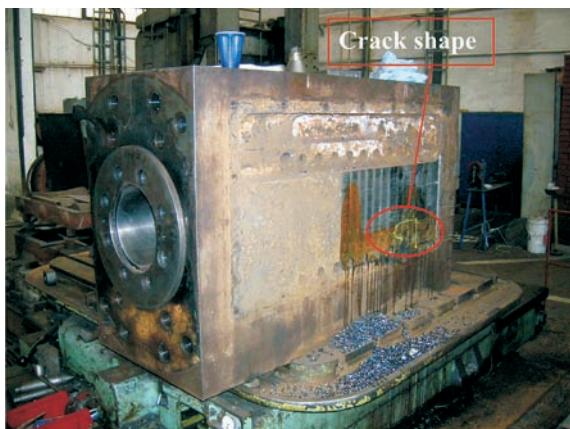
A crack was found between one of the inlet valve seats and cooling pipe row (Fig. 1-2) of a giant gas compressor. The crack face was situated almost in the symmetry plane.

Figure 1 The 3rd stage cylinder and crack shape measured by ultra-sound
Slika 1 Trostupanjski cilindar i oblik pukotine izmjerena ultrazvukom

The crack was dangerous, because it reached the cooling pipe and in this case H₂ might get into the cooling system, where it could be exploded. The customer did not have another cylinder to replace it, and the manufacturing of a new one would take about one month. Stopping the production process would be very expensive. These were the reasons, why the customer wanted to know, how the cracked cylinder could be operated safely until it was replaced by a new one. The Hydrogen leakage had been stopped by closing the two nearest cooling pipes by fastened through-wall bolts.

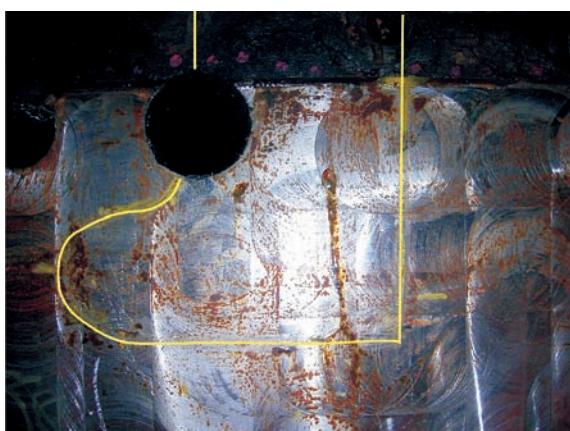
Figure 2 Crack shape on cylinder surface measured by ultra-sound
Slika 2 Oblik pukotine na površini cilindra izmjerena ultrazvukom

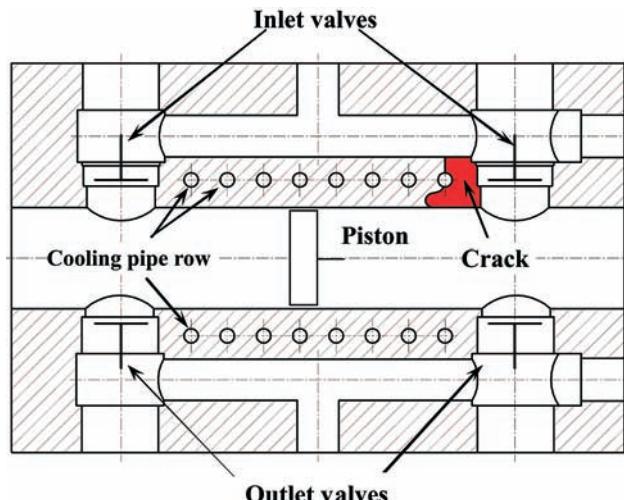
Figure 3 Cross-section of cylinder with crack
Slika 3 Poprečni presjek cilindra s puktinom

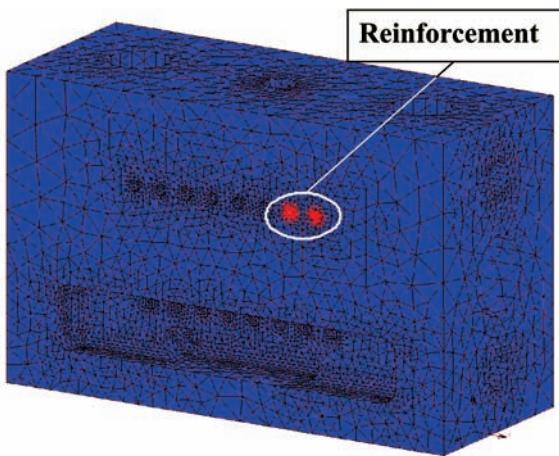
Figure 4 FEM mesh and the reinforcement
Slika 4 MKE mreža i ojačanje

The reinforcement bolts were modeled by springs and links (Fig. 4). Fig. 5 shows the crack face loaded by outlet pressure, and the surfaces also loaded by outlet pressure. The light surfaces in Fig. 5 were loaded by inlet pressure. The crack face was situated 20 mm from the plane of symmetry. The constraints were on the bottom plane of the body.

The customer recommended repairing the cracked part by screw reinforcing. The over cracked and the adjacent cooling pipe (in Fig. 5) has been enclosed, rebored, threaded, and the structure reinforced by M33 bolts to detain the crack propagation.

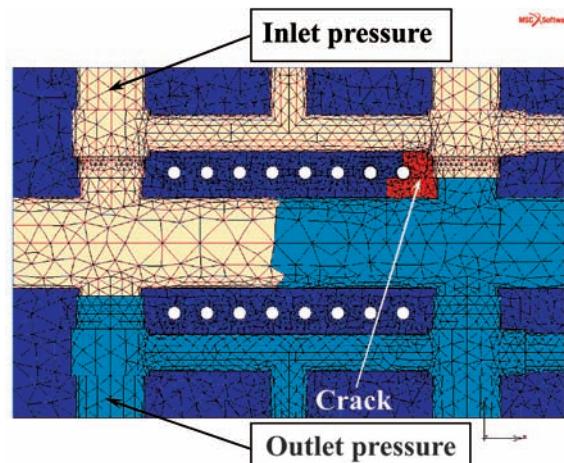
Figure 5 Cross-section of cylinder with crack for stress calculation
Slika 5 Poprečni presjek cilindra s pukotinom za računanje naprezanja

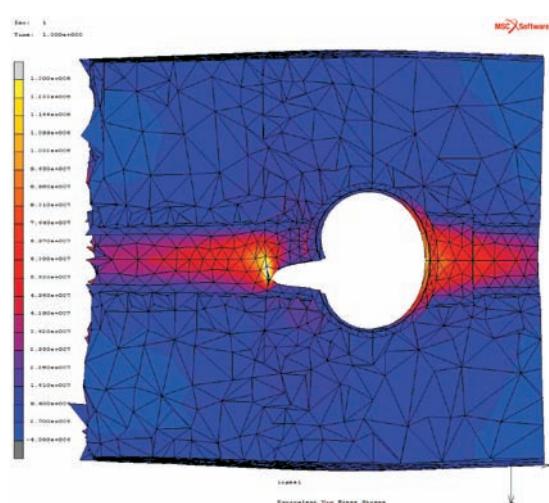
At first the calculation was carried out without taking into consideration the effect of the bolts. The results in Fig. 6-9 were calculated with normal operational pressures. The stresses at normal operational pressure were lower than the yield stress, therefore plastic deformation could not cause the damage of the structure. Only a small plastic zone could be found around the crack front.

Figure 6 Equivalent von Mises stress result around the crack without reinforcement (strains in 600× magnification)
Slika 6 Rezultat ekvivalentnog von Mises-ovog naprezanja oko pukotine bez ojačanja (deformacija - povećana 600×)

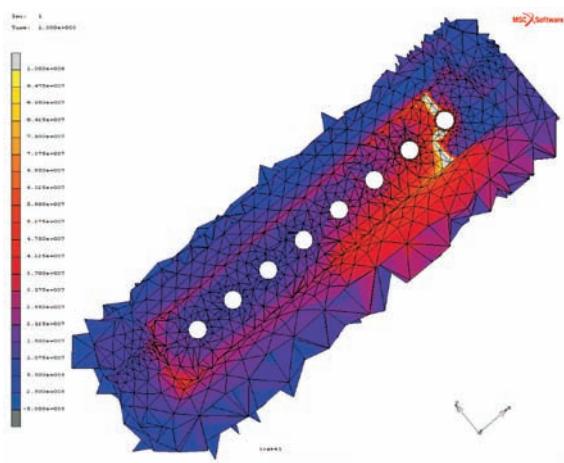
Figure 7 Equivalent von Mises stress result around the cooling pipe row with crack without reinforcement
Slika 7 Rezultat ekvivalentnog von Mises-ovog naprezanja oko reda cijevi za hlađenje sa pukotinom bez ojačanja

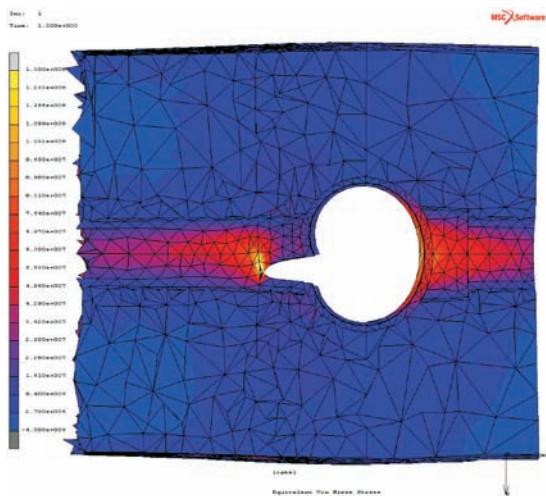
Figure 8 Equivalent von Mises stress result around the crack with reinforcement (strains in 600x magnification)
Slika 8 Rezultat ekvivalentnog von Mises-ovog naprezanja oko pukotine s ojačanjem (deformacija - povećana 600x)

The reinforcements have been taken into consideration for the next calculation. Comparing the stresses in Fig. 6 and in Fig. 8 it can be shown that the stresses decreased by about 6-8 % near to the crack due to the reinforcement but it is not enough to close the crack so further crack propagation can take place.

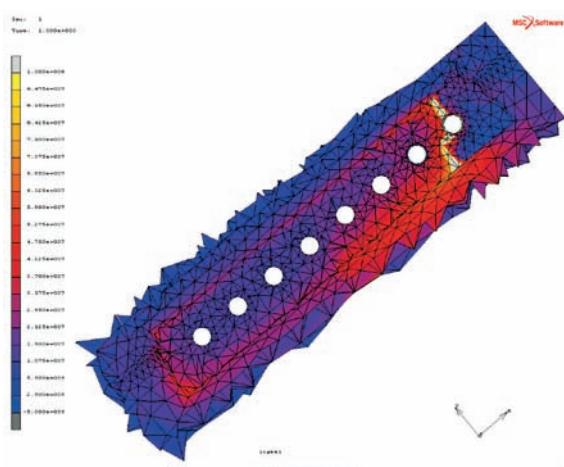
Figure 9 Equivalent von Mises stress result around the cooling pipe row with crack and reinforcement
Slika 9 Rezultat ekvivalentnog von Mises-ovog naprezanja oko reda cijevi za hlađenje sa pukotinom i ojačanjem

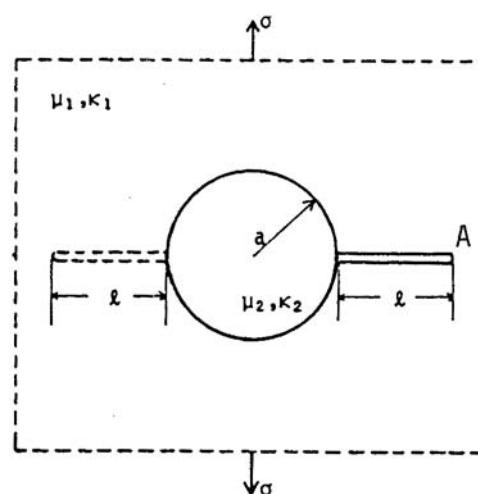
Fracture mechanical analyses were performed for brittle fracture and crack propagation calculation. Simplified plane-strain model as shown in Fig. 10 has been applied for the analytical fracture mechanical analysis. The model has been verified by FEM calculation.

Figure 10 Simplified model of the crack
Slika 10 Pojednostavljen model pukotine

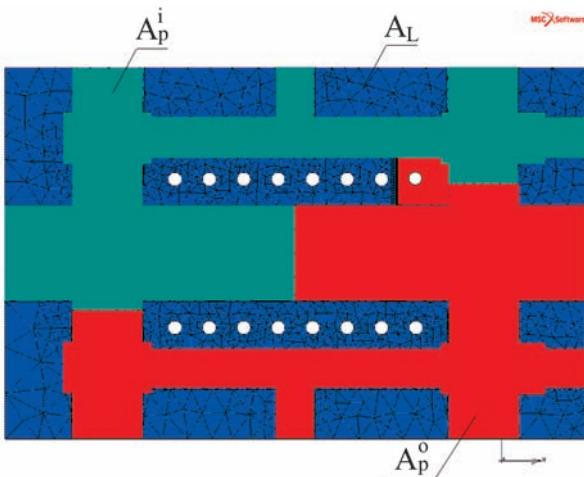
Figure 11 Cross-section of cylinder with crack, for J-integral calculation
Slika 11 Poprečni presjek cilindra s pukotinom, za računanje J-integrала

The nominal stress was calculated based on the ratio of the inlet and outlet pressure loaded area to the ligament section (Fig. 11) as follows:

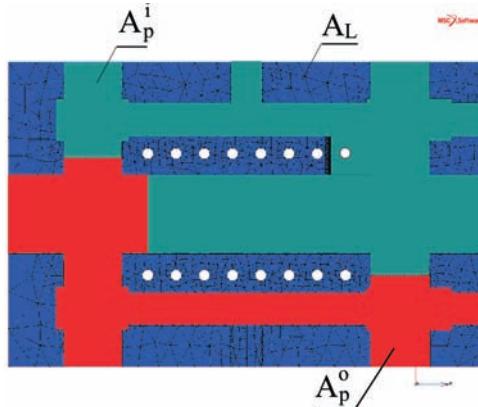
Figure 12 Minimum load for the cross section
Slika 12 Minimalno opterećenje za poprečni presjek

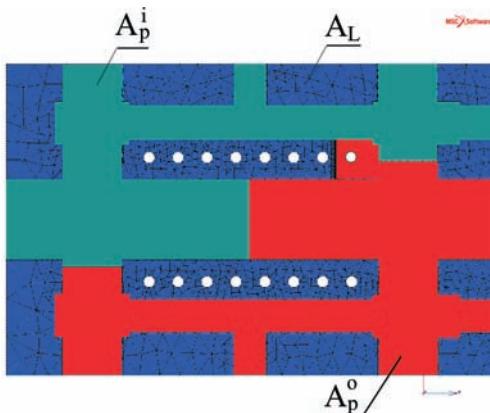
Figure 13 Maximum load for the cross section
Slika 13 Maksimalno opterećenje za poprečni presjek
