An Evaluation into the Cause of Corrosive Failure in Autophoretic Coated Material

ABSTRACT

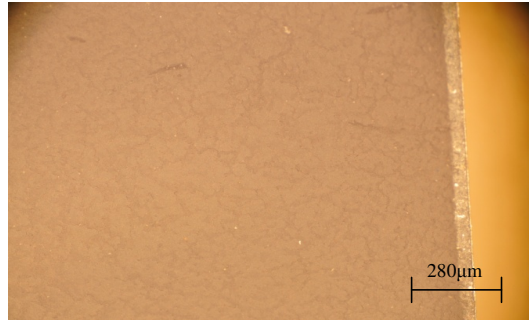
Under close inspection the voids expose a significant amount of substrate surface area and are present in all PVDC AP samples. Figure 5a below shows the surface of a non-corroded AP specimen as referenced, while Figure 5b shows the same image with the voids highlighted for comparison. It should be noted that even under ten times magnification, the highlighted voids are difficult to detect.

Figure 5a: Non-corroded AP Sample (10x mag).

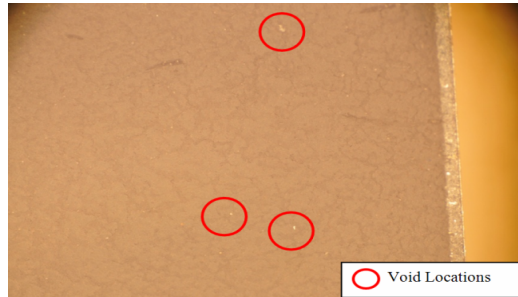
Figure 5b: NC-AP Sample Showing Voids (10x mag).

Figures 5a and 5b are meant to show that product could meet visual quality inspections while not properly coating product. Therefore it is plausible that manufacturers are releasing product which would not meet the productive needs of their consumers.

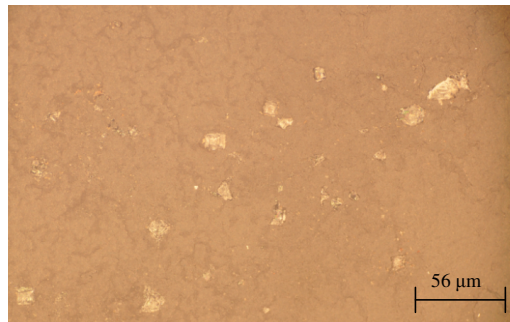
Some non-corroded specimens had an abundance of surface voids in isolated locations. Figure 6 below illustrates such an occasion where multiple voids are grouped together. This example also shows visible base metallic substrate and therefore has the potential for corrosion. The voids in Figure 6 have not been subjected to any corrosive cycles.

Figure 6: NC-AP Sample Showing Voids (50x mag).

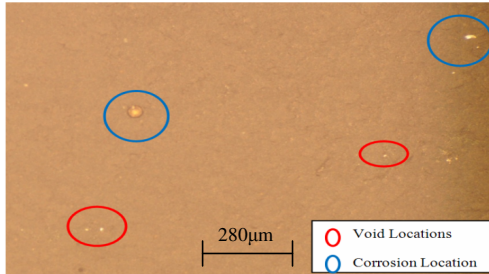
Once discovered it became evident that these locations were the first sites of corrosion formation. Figure 7 below shows an AP sample that has been subjected to 10 corrosive cycles. The presence of corrosion, highlighted in blue, is visible inside several larger void locations.

Figure 7: Corroded AP Sample (10x mag).

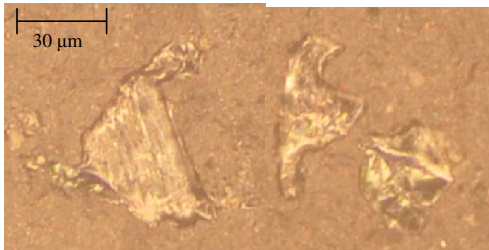
Using a side by side comparison (Figures 8 through 11) of the voids under 100x magnification it became evident that void locations begin to corrode around their periphery. Once the locations have filled in with corrosion they begin to flake the coating away. Figure 8a and 8b show void locations from AP coatings not subjected to the SAE-J2334 corrosion test. In these examples you can see the irregularity of the voids as well as the underlying non-corroded substrate.

Figure 8: NC-AP Sample Showing Voids (a right, b left).

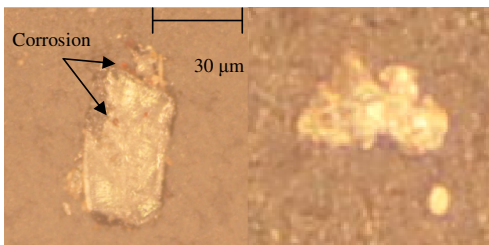
Figure 9a and 9b show specimens subjected to 10 corrosion cycles. In both examples corrosion is visually evident. Figure 9a shows corrosion points beginning to form both in the interior as well as a light amount around the periphery. Figure 9b shows a void location with its perimeter fully encircled by corrosion.

Figure 9: AP Sample Voids w/ 10 cycles (a right, b left).

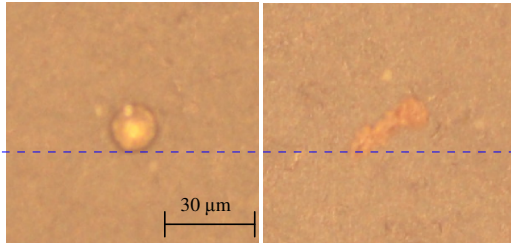
Figure 10 illustrates AP voids which have been subjected to 20 corrosion cycles. With 20 cycles, visual rust becomes evident without microscopy and can be described as “Fly Spotting” hence the original porosity hypothesis. The majority of voids examined with 20 cycles are generally +50% filled with corrosion as seen in Figure 11b. Some voids were observed to also have begun to lift and further compromise the coating around the void periphery, as shown in 11a, without being fully corroded.

Figure 10: AP Sample Voids w/ 20 cycles (a right, b left).

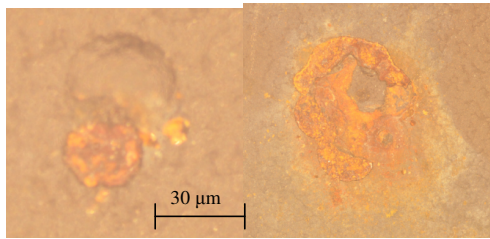
Finally, Figure 11 shows void locations subjected to 30 corrosion cycles. All voids have been fully filled in by corrosion and have begun to fully compromise the coating. In most cases the sample’s coating has begun to delaminate around the void. Figure 11a shows a void which fully corroded and has breached adjacent coating. Figure 11b shows a similar void once the breached coating has flaked.

Figure 11: AP Sample Voids w/ 30 cycles (a right, b left).

Large visible rust spots and coating failure can be seen on specimens subjected to 30 cycles. In some isolated cases the corroded areas can reach as large as 0.25 inches in diameter.

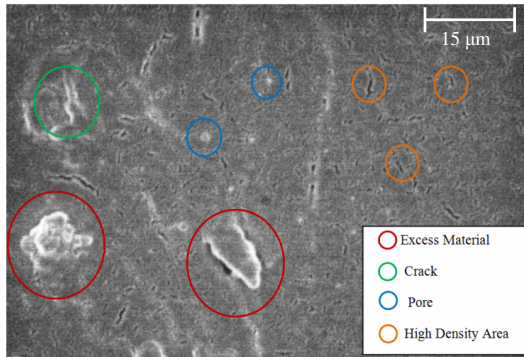
The FE-SEM study confirmed that micro-porosity was not present in the AP coated specimens. Figure 13 shows an AP coated specimen at 5,000 μm resolution (100,000x). At this magnification several defects are present; specifically surface cracks from curing stress or degassing, micro-pores, as well as areas of dense or overlapping material.

Figure 13: Non Corroded AP Surface under FE-SEM.

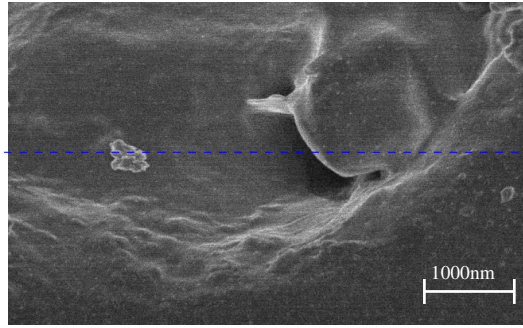
These defects were studied under higher magnification to determine their origin and severity. Figure 13 shows one of the pore locations (highlighted in blue) in Figure 14. Under inspection it becomes evident that this pore does not penetrate the surface of the coating.

Figure 14: Surface Pore in AP Coating Sample.

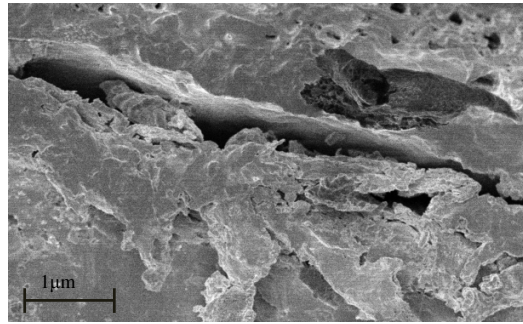
Figure 15 is a higher magnification observation of a surface crack detected in Figure 13 (highlighted in green). As mentioned before this crack appears to have been caused either due to stress of the curing process or by off-gassing. Although it is indeterminate whether this crack fully penetrates the surface of the coating it should be noted that this crack is as fine as a human hair. Therefore the likelihood of this crack resulting in accelerated corrosion, greater than the void location, is very small.

Figure 15: Surface Micro-Crack in AP Coating Surface.

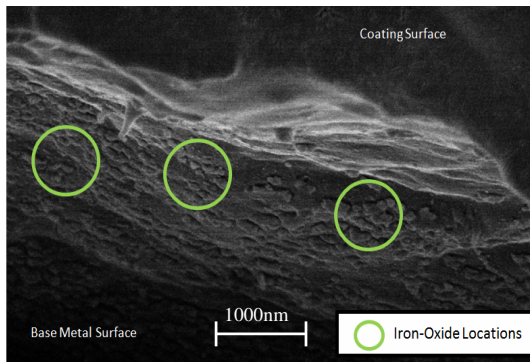
To better understand the void areas the perimeter of one such void was also inspected under FE-SEM. Figure 16 depicts the boundary of a void. The top surface of the coating is denoted in the upper right corner while the base metal, although out of sight, would be located in the lower left corner. Review of the void around the periphery showed formation of microscopic iron oxide deposits (highlighted in green). It should be noted that this specimen was not subjected to any corrosion tests.

Figure 16: Surface Void Periphery Boundary.

Oil residue is known to cause similar surface voids on a macroscopic scale. It is possible that the voids are the result of microscopic oil particles which were improperly cleaned from the surface of the substrate. Additional testing should be conducted to determine if advanced cleaning techniques could reduce or eliminate this phenomenon

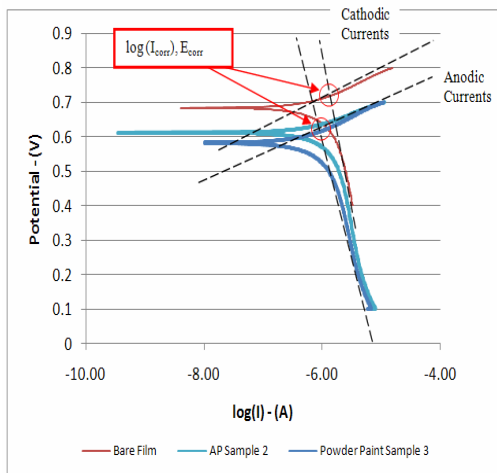
Figure 17: Tafel Plot

The results obtained from the Tafel plots indicate AP coatings have a higher corrosion current density than powder paint coatings, which insinuates a higher corrosion rate. Consistent Tafel plots for each sample were obtained, and anodic/cathodic currents could be extrapolated to find the corrosion current. Figures 17 and 18 below show a comparison of bare, AP and powder paint coated sample Tafel plots and corrosion current, respectively. It should be noted that Figure 18 shows a distinctive difference in current density between powder paint and AP. However, it was also determined that the AP samples had a higher corrosion density than that of the bare metal control sample which was used. This phenomenon may have been caused due to breaches in the coating which expedite corrosion.
