ISSN 0543-5846  
METABK 49(4) 357-360 (2010)  
UDC – UDK 669.14.018.298:669.18=111

## CRACKING OF AN AIRCRAFT WHEEL RIM MADE FROM AL-ALLOY 2014-T6

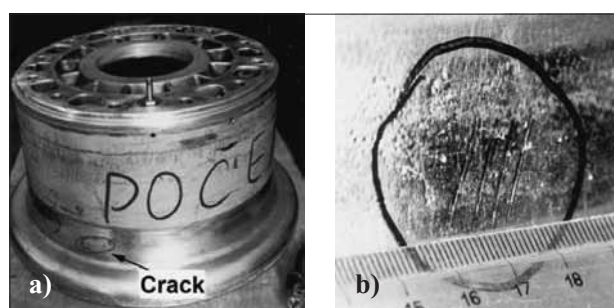
The crack (Figure 1) was revealed in a regular check up by the method of eddy currents. The crack was approximately 38 mm long and had propagated through the rim wall. Small pits over the entire rim/tire contact surface were revealed. A small number of corrosion pits were also observed by the naked eye. In the manufacture of tires a strong textile fabric net is incorporated. In worn-out tires the net is in direct contact with the rim surface. Therefore, high pressures result in pits on the rim surface.

**Figure 1** An investigated aircraft wheel with a crack (a), and the detail of crack in the rim (b).

It was determined that the crack of the rim investigated was a typical fatigue crack [16]. The crack was branched, and its size was lower than the critical which could cause immediate failure. It was not possible to determine the site of crack initiation. The presence of carbon and sulphur in the crack represents strong evidence that the crack was a fatigue crack. Carbon and sulphur deposited on the surfaces of the crack and the surroundings. Probably during landing and slowing down when the temperature of wheel rim and tire was sharply increased, resulting in partial dissociation of the tire.

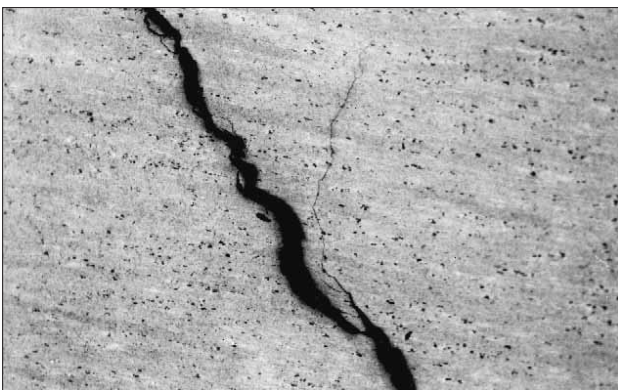
Figure 4 Parallel cracks (OM); magnification 100x.

First of all the ends of cracks were examined. Parallel cracks were also found in one of the metallographic samples investigated, as seen in Figure 4.
