R. TALAR, A. STOIĆ

ISSN 0543-5846
METABK 52(3) 383-386 (2013)
UDC – UDK 539.377:621.833:661.55=111

LOAD CAPACITY OF HARDENED GEAR WHEELS MACHINED WITH CUBIC BORON NITRIDE (CBN) WEDGES

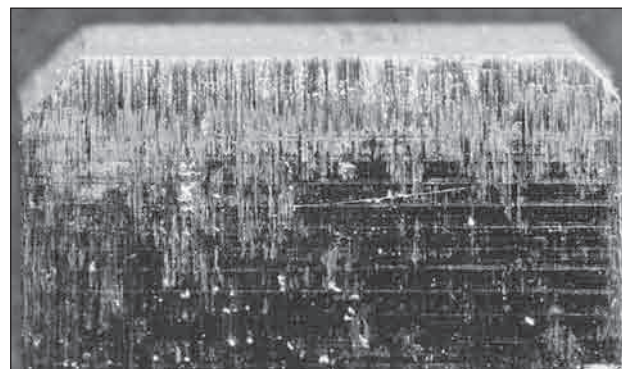
In the conditions of transmission load resulting in nominal pressure of 1 300 MPa, only small symptoms of abrasive wear have been found. Scratches of direction in conformance with the sliding direction of the pinion and wheel side surfaces has been observed in contact when the pressure was increased up to 1 550 MPa (Figure 2). The wear symptoms shown in Figure 2 prove activation of the processes of adhesion wear [5]. Occurrence of scratches and accretions has been found on the teeth of pinions and wheels. They have significantly spoiled the primary structure of the tooth surfaces in the region of their vertices. In the regions of the vertices, the relative speed of the surfaces moving in relation to each other has reached the highest values.

Figure 2 Adhesion wear of the pinion tooth vertex

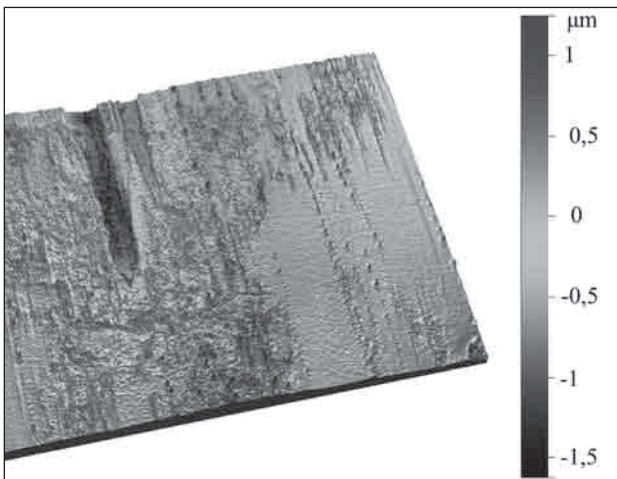
The significant quantities of heat generated as result of friction in those areas have activated the process of adhesion wear. Due to the high hardness of the gear wheel surfaces, the depth of scratches did not exceed $2 \mu\text{m}$ (Figure 3).

Figure 3 Topography of a tooth surface damaged as result of adhesion processes

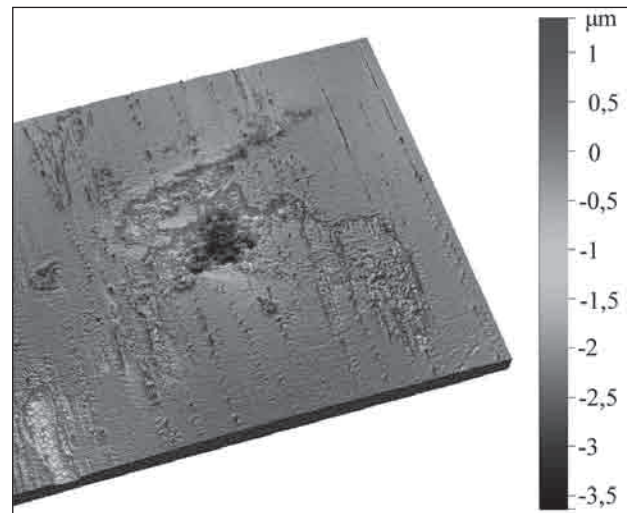
An image of an adhesion pinhole surrounded by plastically deformed area can be seen in Figure 5. In the vicinity of the base diameter, an area with the surface destroyed by the processes of fatigue wear. Single fatigue pinholes have been found.

Figure 5 Topography of a tooth surface with an adhesion crater

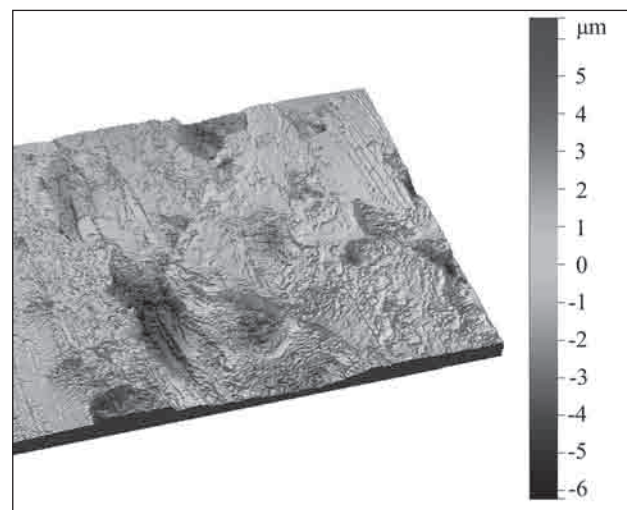
Uniform wear on the whole width of the tooth proves good contact. None of the tested wheels has worked with an edge contact. Fatigue pinholes in the vicinity of the base diameter have created hollows resulting from unbinding of flat flakes, number one in figure six. The depth of the fatigue pinholes has reached the value of up to 8 μm from the level of the average roughness height. It is visible in the roughness profile through a fatigue pinhole (Figure 6). Around a pinhole, the surface irreg-

Figure 6 Topography of a tooth surface with fatigue pinholes

ularities exceed the height of 3 μm ; this proves strong deformation of the whole area in the vicinity of the base diameter.

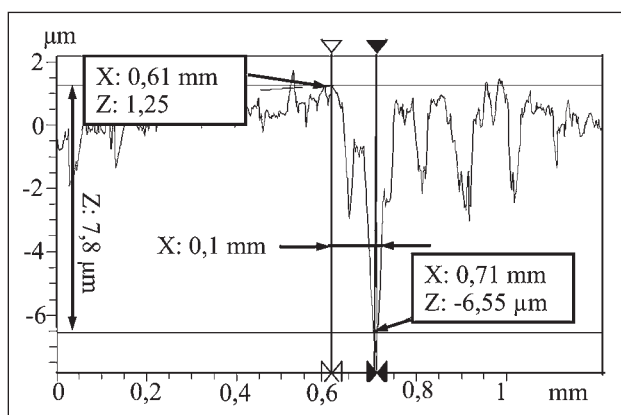
Prior to the exploitation test, the value of the roughness parameter, R_a , of the surface did not exceed 0,4 μm . After the exploitation test, the roughness parameter for the profile shown in Figure 7 was as high as 1,95 μm .

Figure 7 Surface roughness profile through the fatigue pinholes
