The 2015 Nepal Gorkha Earthquake: An overview of the damage, lessons learned and challenges

H. Hazarika¹, N.P. Bhandary², Y. Kajita³, K. Kasama⁴, K. Tsukahara⁵ and R.K. Pokharel⁶

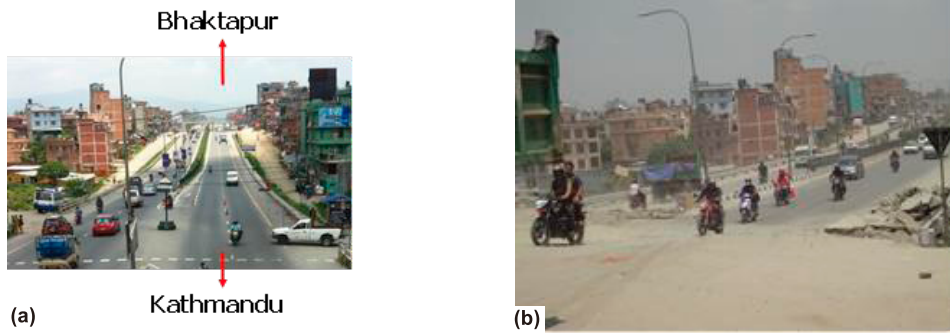
Our survey focused only on the damage of the road located near the Lokanthali area (Fig. 3), covering a length of about 400 m. The state of the road before and after the earthquake (Fig. 4) is shown in NPC (2015a) Post disaster needs assessment, **A: Key findings**. Kathmandu, Nepal: Government of Nepal, National Planning Commission.

Fig. 4. State of the road (a) before the earthquake and (b) after the earthquake.

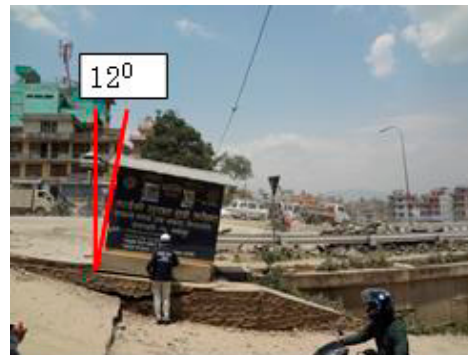
Slope failure in location 3 is shown in Fig. 6. As seen in the figure the traffic police box was tilted by about 12 degree due to slope failures and settlement of the road. In the Bhaktapur side (location no. 7) subsidence of the main road was observed (Fig. 7a). Also, slope failure took place in the access road (Fig. 7b). In location 5,

Fig. 6. Slope failure in the Kathmandu side.

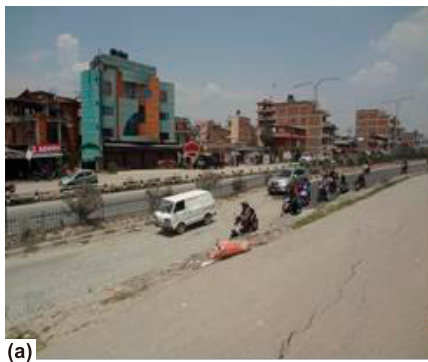
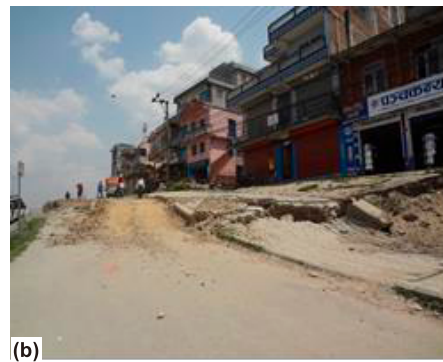
Fig. 7. Slope failure and subsidence (Bhaktapur side) (a) main road and (b) access road.

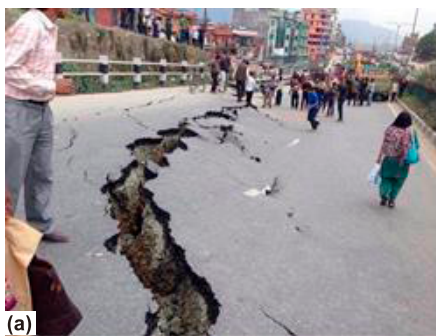
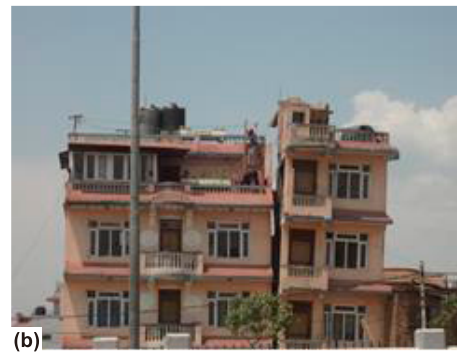
huge settlement of the access road in the Kathmandu side was observed (Fig. 8a). An apartment building close to this sinking road was found to be settled and tilted as seen in Fig. 8(b).

Fig. 8. Slope failure and subsidence (Bhaktapur side) (a) subsidence of the access road and (b) tilted apartment building.

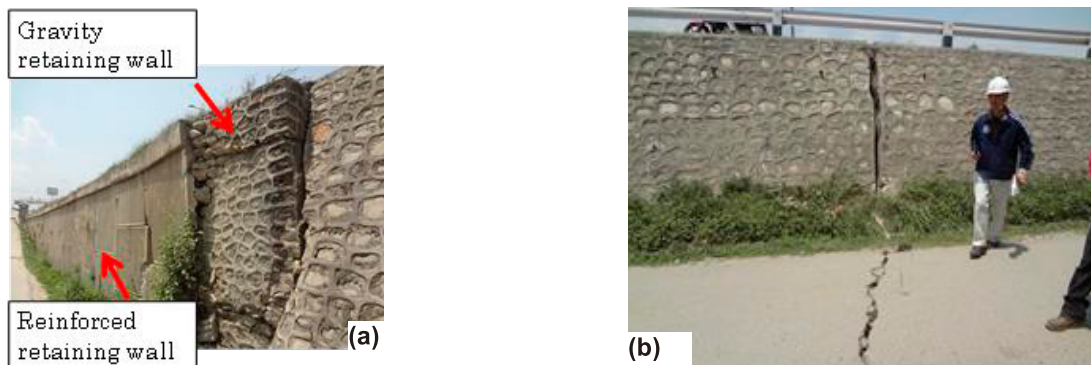
In location 4, two types of retaining walls exist: One is the reinforced retaining wall and the other is the gravity retaining wall. As seen from Fig. 9(a), in the joint between the two walls, damage was observed. Also, in some parts of the gravity retaining wall, cracks were observed along the same line in which ground fissuring of the access road was observed Fig. 9(b). Ground fissuring extended up to the residential areas along the road. Two residential buildings located along this fissure were found to be heavily damaged (Fig. 10). According to the owner the building with exposed brick structure, whom the authors happened to meet, the building settled by about more than 1 m towards the road and tilted. Many ground fissuring were also observed in the surrounding of the two buildings.

Fig. 9. Retaining wall damage and ground fissuring (a) damage to retaining walls and (b) ground cracks.

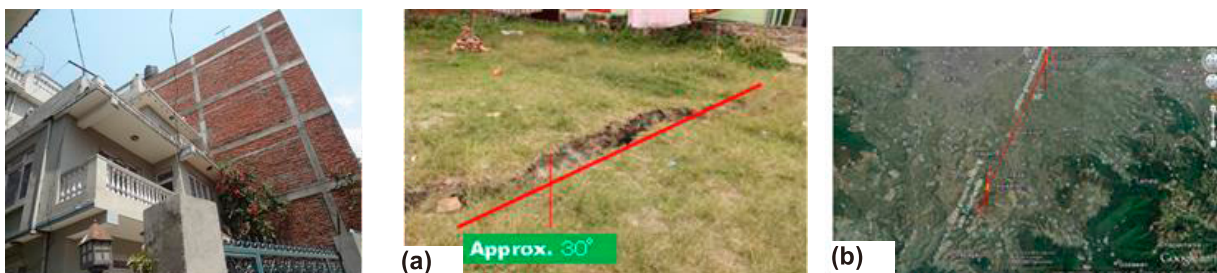
Fig. 10. Settlement and tilting of buildings resulting from ground fissuring.

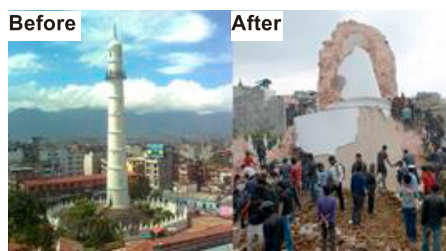
Several pagodas on Kathmandu Durbar Square, a UNESCO World Heritage Site, collapsed. The Dharahara tower in that square, built in 1832, completely collapsed leading to death of at least 180 people including

honeymoon couples. **Fig. 14** shows the states of the tower before and after the earthquake.

Fig. 14. State of damage of Dharahara tower.

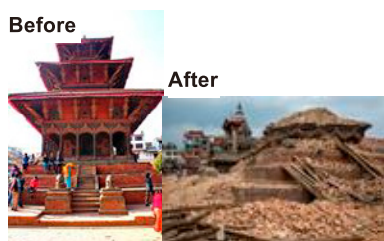
Figure 15 is a 2010 photo of the intact temples. Several of the tiered temples appear to have collapsed. **Fig. 16** shows the Harishankar temple, built in 1706 and one of the most outstanding temples in Patan before and after the earthquake.

Fig. 16. Harishankar temple before and after the earthquake.

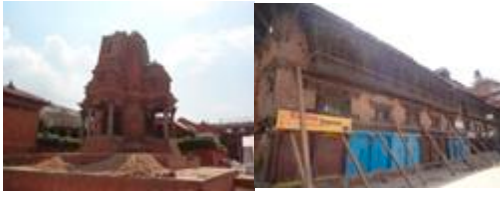
Fig. 19. States of other temples and buildings in Bhaktapur square.

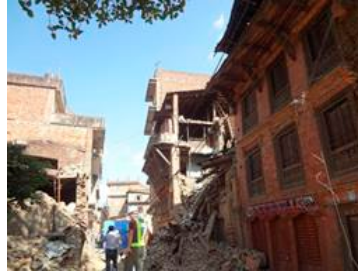
Figure 26 shows the view of the buildings in the town before the earthquake. **Figure 27** shows the state of the same buildings after the earthquake. Total collapse of many structures in the city were observed here and there (**Fig. 28**).

Fig. 27. View of the spot in Fig. 15 after the earthquake.

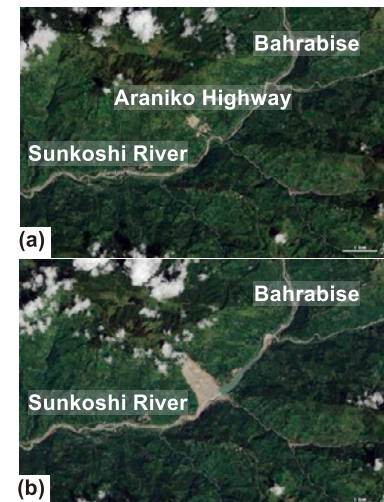
Fig. 32. Landslide in Jure (a) before the landslide and (b) after the landslide (Courtesy: NASA).

The massive landslide blocked Sunkoshi River creating a high dam across the river (**Fig. 32**). A river gauging station of the Department of Hydrology and Meteorology (DHM) at Pachuwarghat downstream of the landslide dam showed a rapid decline in water flow three hours after the landslide, after which the flow of water completely stopped for approximately 12 hours. An inflow of about 160 m³/sec of water quickly created a large lake behind the dam. Within 13 hours the newly formed lake, which rapidly grew to a volume of an estimated 7 million cubic meters, extended about 3 km upstream, completely submerging the 2.6 MW Sanima hydropower station (**Fig. 33**).

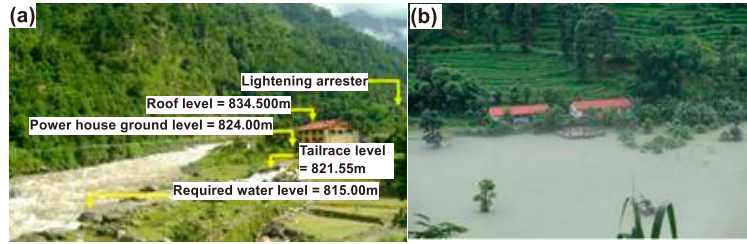
The landslide at Jure has swept away two gates of the Sunkoshi power house headworks. The power house was also submerged after damage to the project's penstock. The powerhouse and the camp house lied at the sediment deposition zone. The lake inundated most of the equipment/materials in powerhouse and camp house. **Figures 34 (a)-(b)** show the state of the damage before and after the landslide.

Fig. 34. State of the power station (a) before the landslide and (b) after the landslide (Courtesy: Sanima Hydropower Ltd., Kathmandu).

Private development firm (Sanima Hydropower Plant) undertook the repair and reconstruction works of the dam and it was ready for commissioning on May 1, 2015.

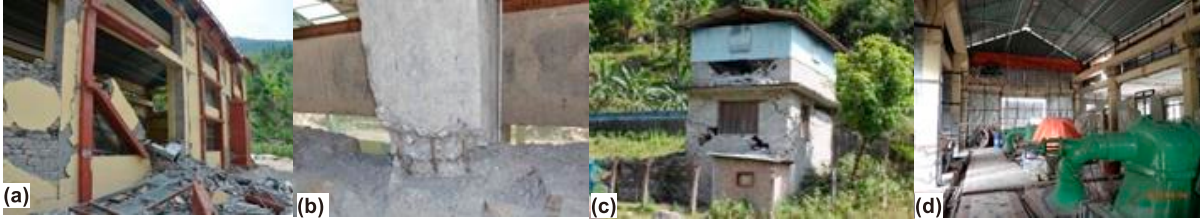
However, there is big blow to the works by the earthquake of April 25, 2015. The power house was damaged at various places by the earthquake as seen in **Figs. 35 (a-d)**. The earthquake also induced shallow landslides on the upstream and right bank of the power station as shown in **Figs. 36 (a and b)**.

The landslide related loss to the power plant amounts to 148 million Nepali Rupees. The earthquake damage was estimated to be 34 million Nepali Rupees. Total damages from this compound disaster stand at 203 million Rupees.

Fig. 35. Earthquake induced damage to the power station (a) wall collapse on riverside (b) rupture of reinforcement bar (c) operator's camp at headworks and (d) machine floor.

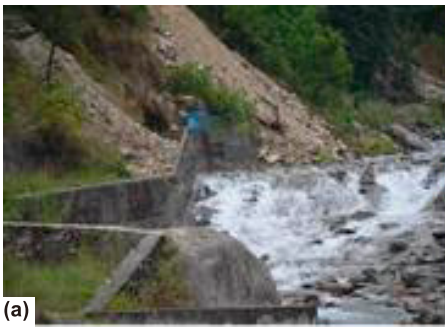
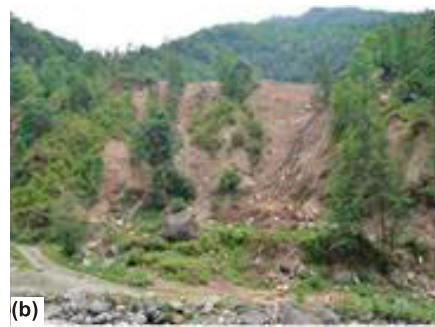
Fig. 36. Earthquake induced landslide (a) landslide in the upstream of intake and (b) landslide in the right bank of headworks.
