Liu, G., Cantó, J., Winwood, S., Rhodes, K. & Biroasca, S. (2018). The effects of microstructure and microtexture generated during solidification on deformation micromechanism in IN713C nickel-based superalloy. *Acta Materialia* <http://dx.doi.org/10.1016/j.actamat.2018.01.062>

The Effects of Microstructure and Microtexture Generated during Solidification on Deformation Micromechanism in IN713C Nickel-Based Superalloy

G. Liu¹, J. Salvat Cantó¹, S. Winwood², K. Rhodes², S. Biroasca¹

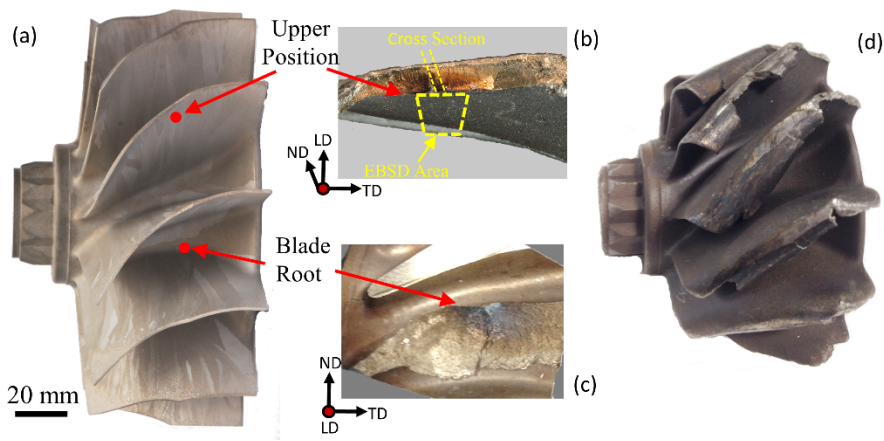
For LCF cases, the failure occurred on the blade root, see Fig. 1c. The predominant features in LCF failed samples are (1) dendrite structure as indicated in Figs. 4a and 4b, and (2) secondary cracks as

Fig. 1 Turbine wheel blade prior (a) and post (d) testing at 600°C, typical failure location during HCF (b) and LCF (c) tests.

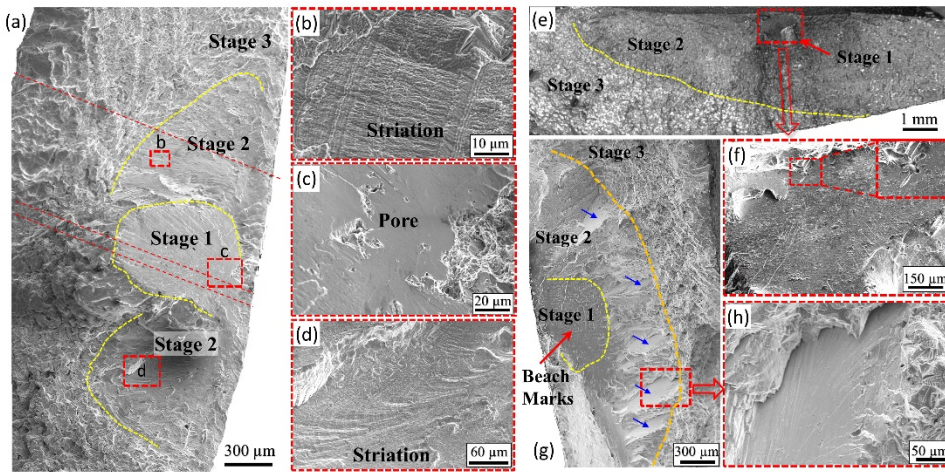
In the current study fractography, *i.e.*, fracture surface study, was used to identify the main difference between LCF and HCF fracture surface features. Fig. 3 and Fig. 4 both give three representative examples of fractographies of HCF and LCF samples after failure, respectively. Macroscopically, nearly all HCF failures occurred in the upper position of blades, see Fig. 1b and it appears that the fatigue failure occurred following three stages, as indicated in Fig. 3a and magnified in Fig. 3b-d, *i.e.*, Stage 1: crack initiation on a specific grain plane, see Fig. 3c; Stage 2: relatively flat and large crack propagation area with characteristic of striations, see Fig. 3b and d; and Stage 3: tensile overload area which suffers catastrophic mechanical failure with ductile fracture features (dimples). The other two examples are shown in Fig. 3e-f and g-h, respectively, showing the same three failure stages as in Fig. 3a-d. Although the same faceting phenomenon had occurred in stage 1 in all the specimens, the crack initiation sites were differed. The crack sometimes was initiated in the vicinity of casting defects such as porosity (Fig. 3c) or inclusions (Fig. 3e, f), or from the sample surface as shown in Fig. 3g. In Fig. 3g, another characteristic of fatigue, beach marks, can also be clearly seen on the facet plane.

Fig. 3 Typical fractography of HCF test specimen. Three failed specimens are shown here. (a-d) Specimen 1, (e, f) Specimen 2, and (g, h) Specimen 3. ((b,c,d) are magnified image in red rectangular areas in (a). (f) and (h) are magnified images in red rectangular areas in (e) and (g), respectively. Three stages of crack initiation and propagation are indicated.

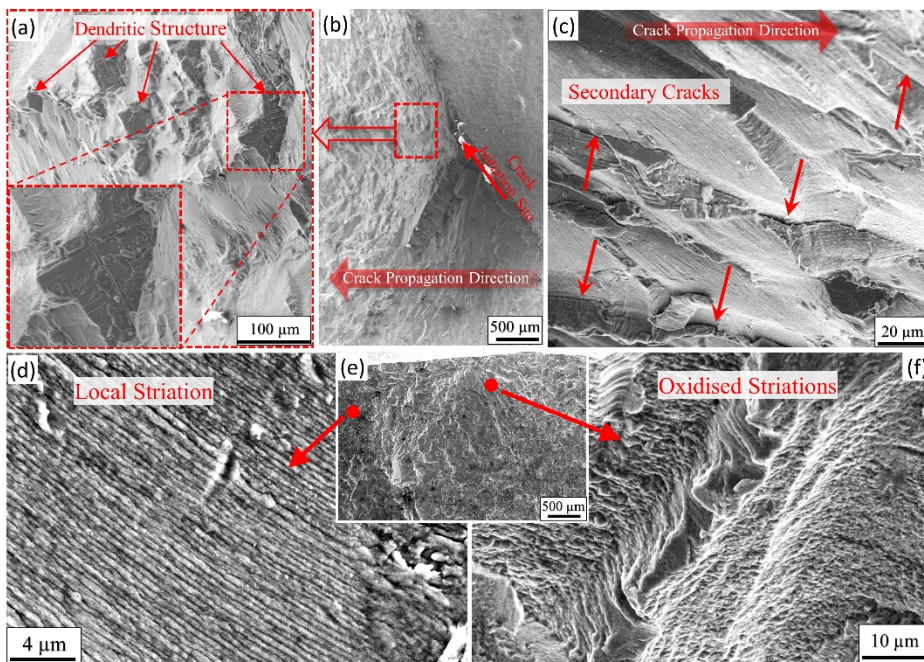
indicated in Fig. 4c, both of which are close to initiation sites, indicating that the dendrite structure play an important role in crack propagation, as once the crack initiated during LCF, it can propagate in other directions depending on the dendrite morphology and structure. Moreover, the microstructurally crack propagation areas were not clear on the fracture surface, see Fig. 4e. In other words, there was no clear transition between crack propagation area and tensile overload area as was observed for HCF. This might indicate a faster crack propagation during LCF than in HCF. Microscopically, in HCF samples, long continuous striations, which are the most eminent features of fatigue can be found in the propagation areas, especially at the end of crack propagation areas, see Figs. 3b and 3d, and this is in agreement with most striations observations [29]. Although no such long and continuous striations was found in LCF samples, many local striations with different directions can be clearly observed in the propagation area, see Fig. 4d. Moreover, oxidised striations were also observed near crack initiation site, see Fig. 4f. It appears that the most contrasting difference between HCF and LCF is that the initiation sites in HCF is highly orientation dependent. Although most of cracks in HCF samples initiated directly from casting defects such as pores (Fig. 3c) and inclusions (inset of Fig. 3f) which are stress concentration locations, they are all located in grain planes with specific orientations. These planes on the surface of which feature with cleavage fractures are generally known as ‘facet’, are not unusual to be observed in HCF failed specimens. It is generally believed that the facet planes possess a specific angle with loading direction that favourable for slipping during external loading. As shown in Fig. 3g, not only did the crack start from a facet, but the propagation of crack also depended on specific oriented planes (indicated by blue arrows in Fig. 3g with one of area enlarged in Fig. 3h). Further microanalyses show that the dendritic structure and secondary cracks are found close to crack initiation site in LCF failed specimen, see Fig. 4b, which is rare case in HCF sample and this aspect will be further investigated in the next section.

Fig. 4 Fractography of 3 LCF test specimens. (a, b) Specimen 1, (c) Specimen 2, and (d-f) Specimen 3. (a) Magnified image of the red rectangular area in (b) showing dendritic structure close to initiation site. (b) Crack initiation site and propagation area in Specimen 1. (c) secondary cracks close to initiation site in Specimen 2. (d) local striations in propagation area in the Specimen 3 (e), (f) oxidised striations close to initiation site in (e).

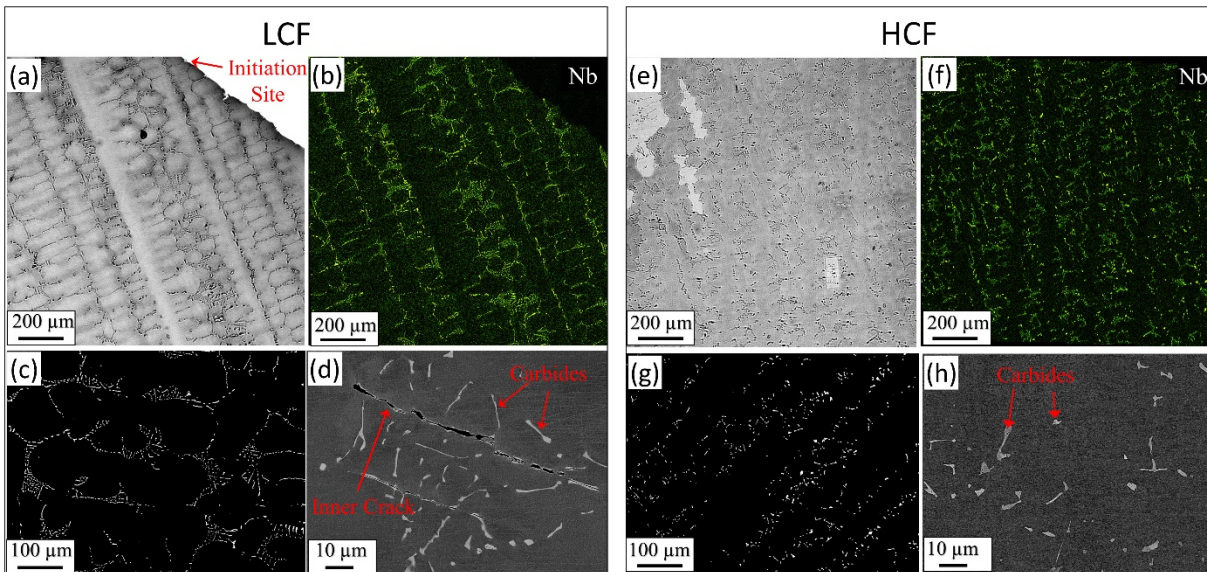
In general, the carbides chemical composition and their trapping in interdendrite channel were the same in the locations where LCF and HCF took place. It is clear from Figs. 5c and 5g that the carbides show Chinese script and cluster morphology in the area where LCF failure occurred. Whilst the carbides show more uniform and granular shape in the area where HCF failure occurred. Although it is difficult to quantitatively analyse carbides size and their distribution due to the connectivity in 3D of some carbides (particularly in LCF sample), it is obvious that carbides in LCF specimen are much

larger in size than that in the HCF specimen, with 5~40 μm in the former and 1~10 μm in the latter. Despite the obvious difference in MC carbide size and shape, the total volume fraction of carbides in two locations are almost the same with 1.8%, which seems less affected by cooling conditions. The effects of cooling parameters on microstructure including carbides and dendrite in casting superalloys have been widely studied. The shape and size of carbides in IN713C was reported depend on solidification parameters such as thermal gradient, growth rate and local cooling rate where a higher cooling rate leads to finer carbides size [30]. It is worth noting here that besides the disparity in carbides size and morphology, the connectivity of carbides clusters in LCF specimen as mentioned earlier, see Fig. 5c, might affect the low cycle fatigue property, which will be discussed in Section 4.2.

Fig. 5 SEM images of Dendritic structure (a, e), optical micrographs of carbide network (c, g) and carbides size and morphology (d, h) in LCF and HCF failed specimens. Nb EDX maps for the area in (a, e), shown in (b, f), to signify the Nb element partition in dendritic structure.

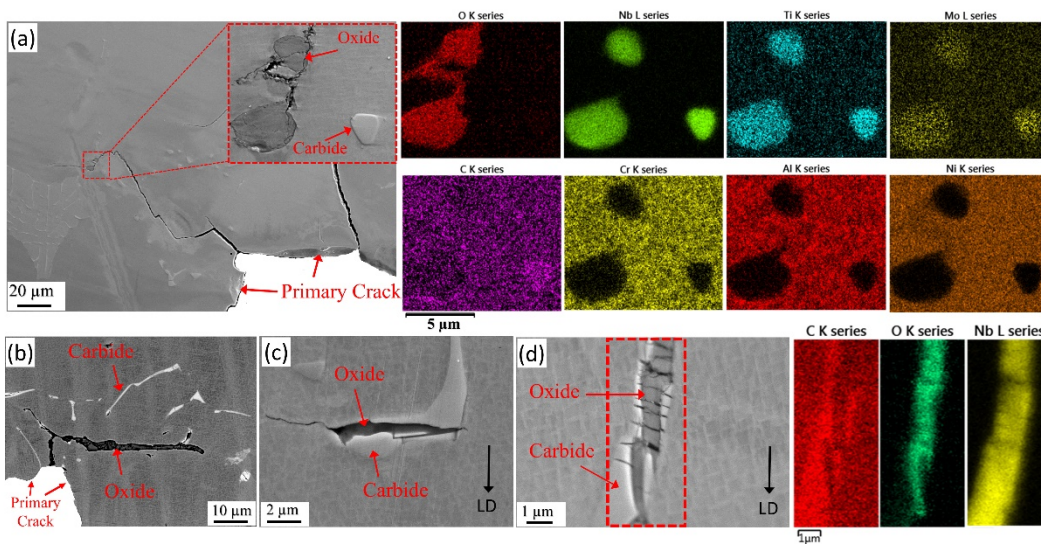
Detailed microstructure observations revealed a prevailing oxidation phenomenon of carbides close to fracture surface in LCF failed specimen as shown in Fig. 6. The EDS mapping of carbides and oxides in the inset of Fig. 6a clearly identify that some $(\text{Nb}_{0.7}\text{Ti}_{0.2}\text{Mo}_{0.1})\text{C}$ carbides in the vicinity of specimen surface had been oxidised. The oxides share a similar stoichiometric composition with carbides as $(\text{Nb}_{0.7}\text{Ti}_{0.2}\text{Mo}_{0.1})\text{O}$. Furthermore, semi-oxidised carbides were also found near the failed sample surface, see Fig. 6c, d. It is evident that the oxidation process initially started from the centre of carbide precipitates, see the same EDS maps for Fig. 6d. Fig. 6 clearly demonstrates that oxidised carbides can play a vital role in secondary cracks formation and its behaviour, causing secondary crack deviation and undulation, Fig. 6a; forming new secondary cracks, Fig. 6b; initiating short (inner) cracks within γ matrix, Figs. 6c and 6d. It should be noted that in addition to the stress assisted intergranular oxidation [10], these types of near-surface carbide oxidation and their effects on fatigue property received scientific attention recently in single as well as polycrystalline superalloys that

contain high content of Nb during high temperature exposure [11-13]. It is suggested the tensile stress resulted from volume expansion of carbides oxidation leads to the short crack initiation [11]. However, as clearly shown in Figs. 6c and 6d, all the small initiated cracks are perpendicular to the loading direction, indicating the stress assisted effects on short cracks initiation within the oxidised carbides. From current investigation, it is established that carbides are brittle precipitates and can act as preferable sites of crack initiation. However, they are less susceptible to cracks than the oxidised carbides.

Fig. 6 Typical oxides and semi-transformation of oxides from carbides in LCF failed specimen. (a) oxides change the second crack propagation direction and EDS maps show the chemical composition of red dashed rectangular area in the left; (b) second crack initiated from oxides; (c) inner short crack initiated from oxide and (d) semi-transformation of oxides from carbides with EDS maps for the red dashed rectangular area in (d).

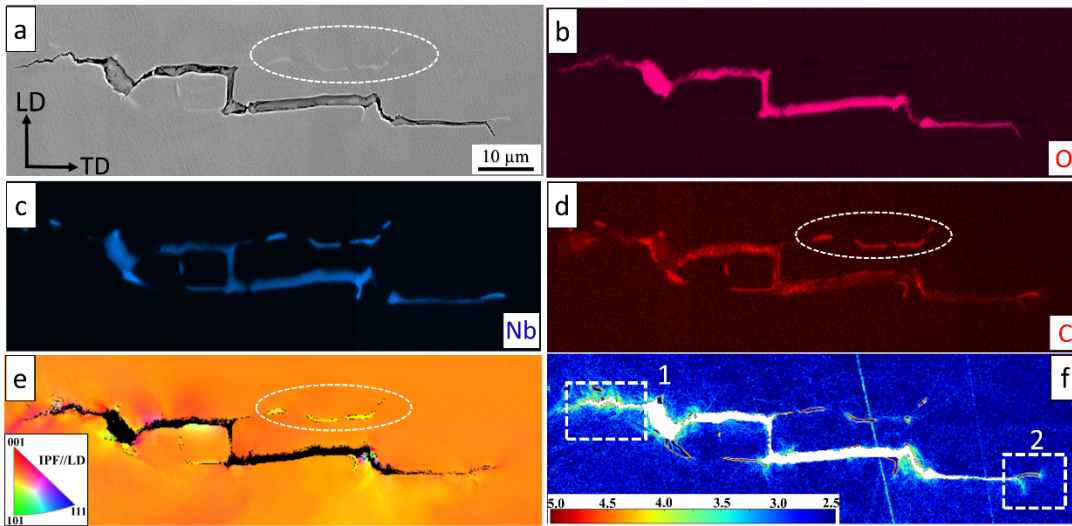
Fig. 7 shows continuous carbide and oxide along a short crack. It is clear from EDS maps (O, C, Nb, Fig. 7b-d) that only the carbides within the opened crack were oxidised, see the non-oxidised carbide away from the crack in the white dashed ellipse shape on Fig. 7a and 7d. It shows that the short cracks initiated at the tip of oxidised carbides and perpendicular to the loading direction. Figs. 7e and 7f show EBSD-derived IPF//LD map and GND map, respectively. From the IPF map the carbides as well as oxidised carbides along the crack are all within one big grain. From the same figures, it appears that the carbides have slightly different orientation from the γ matrix, see the white dashed ellipse in Fig. 7e. It appears that carbides have an FCC crystal structure and similar lattice parameters to γ matrix. This is in good agreement with the Transmission Electron Microscope (TEM) observation in [1]. Looking at the GND density distribution around the oxidised carbides in Fig. 7f, it is not surprising to find higher GND density around oxidised carbides. This is due to different deformation behaviour, hardness and volume expansion coefficient between carbides and the γ matrix that cause strain heterogeneity and GND accumulation. However, it is clear that the GND density at the end of oxides (where small cracks initiate) and ahead of the cracks (see the rectangular areas 1, 2 in Fig. 7f) are much higher (about two orders of magnitude) than those in the γ matrix. It seems the GND accumulation along crack direction or perpendicular to the loading direction. Moreover, it is safe to assume that high GND density ahead of the small cracks can promote further propagation.

Fig. 7 Near surface oxidised carbides in LCF failed specimen. (a) SE image of carbides and oxidized carbides; (b-d) selected EDS mapping for elements C, O and Nb in area (a); (e) EBSD-derived IPF//LD map of area (a); (f) GND (Geometrically Necessary Dislocation) map with step size of 200 nm.

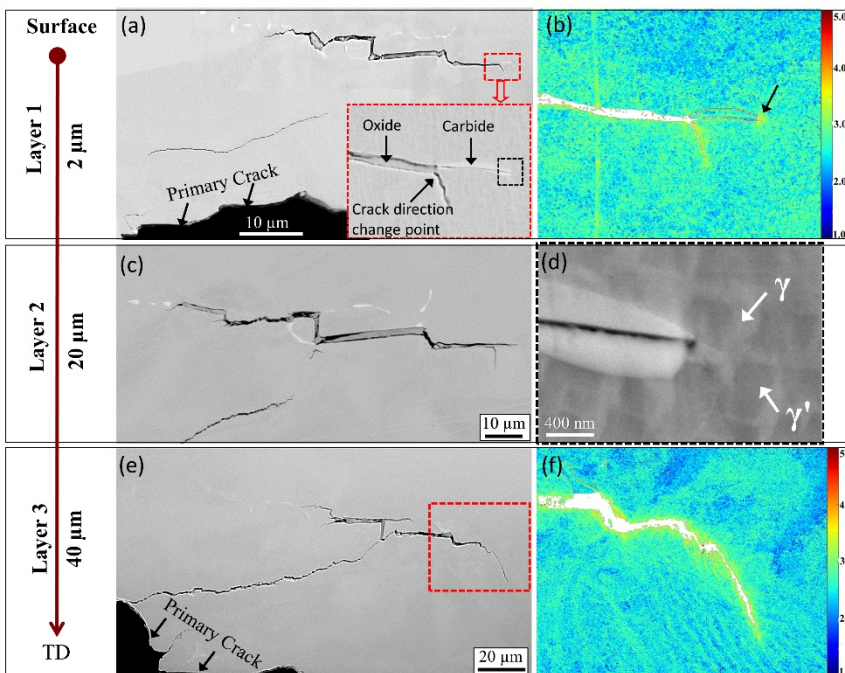
polishing method. Fig. 8 shows only 3 sections of the 3D observation: LD-TD plane surface in Fig. 8a which is the same plane surface in Fig. 7a, 20 and 40 microns away from the surface in Fig. 8c and 8e, respectively. The micro-crack in Fig. 8a appear as an isolated crack within the bulk sample, however, looking at other sections in Fig. 8c and 8e, it is evident that the crack was connected to the primary surface crack. This 3D connection provided sufficient oxygen amount to be diffused from the sample surface to deep inside the material in order to oxidise the carbides during 600°C fatigue test. Moreover, it is evident that the small crack shown in the inset of Fig. 8a grew along the oxide/carbide boundary with the carbide been continually oxidised along the crack. This is because the oxide/carbide was directly bordered by a γ' , see the black dashed rectangular area in Fig. 8a and enlarged in Fig. 8d, and the crack was finally arrested when it encountered by γ' , however, after leaving a large GND accumulation at the tip of the crack which indicates strong γ' resistance to crack propagation, see Fig. 8b.

Fig. 8 Three layer of the same area GND density maps in LCF failed specimen. (a), (c) and (e) are SE or BSE images; (b) and (f) are high-resolution GND maps with step size of 60 nm in the red

rectangular area in (a) and (e), respectively; (d) is the GND density map for (c); the inset of (b) is the same area of black rectangular area in (a), showing the γ' impeding carbide.

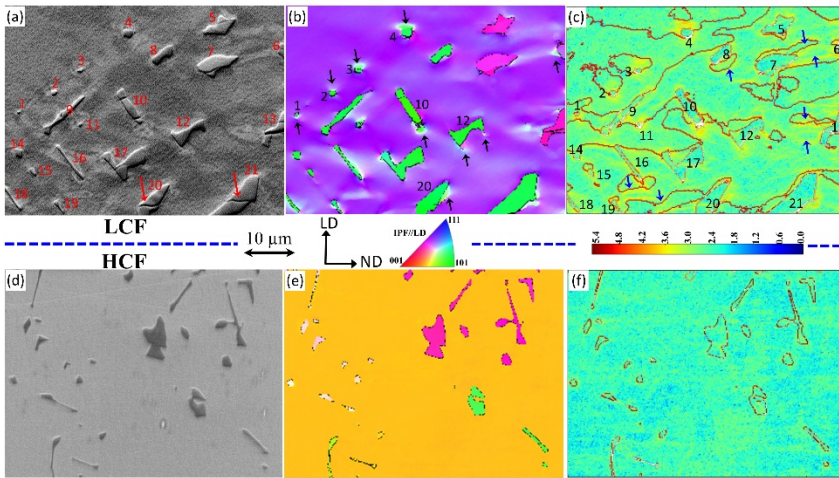
GND density in the carbide was slightly less than the average GND density of γ matrix, which indicates in the hard and brittle nature of carbides. The reduced ductility of carbide lead to inhomogeneous deformation and less strain accumulation, hence less dislocation generation during LCF loading. It should be emphasized here, that during HCF loading, the GND density within the carbides seems to be rather uniform with the rest of matrix, see Fig. 9f. This is mainly due to overall lower GND density of γ matrix in HCF failed sample which were exposed to less straining during HCF loading. However, in general in both LCF and HCF cases, the carbide contained much less GND density than the matrix.

distribution of GNDs around carbides in all directions is demonstrated in Section 3.3 and shown in Fig. 9c. This phenomenon is also reported in [17], where sharper corners tend to possess higher density of GNDs than the curved corners. In order to study the inhomogeneous distribution of effective strain and GNDs around non-metallic inclusion, an elastic finite element (FE) model has been generated and suggested that geometry of inclusion is responsible for the stress/strain conditions and hence GNDs accumulation in different directions [17].

Fig. 9 GND density and their local distribution of carbides near crack initiation sites in LCF (a-c) and HCF (d-f) failed specimens. (a,d) SEM image; (b, e) EBSD-derived IPF//LD; (d,f) GND density maps using step size of 200 nm.

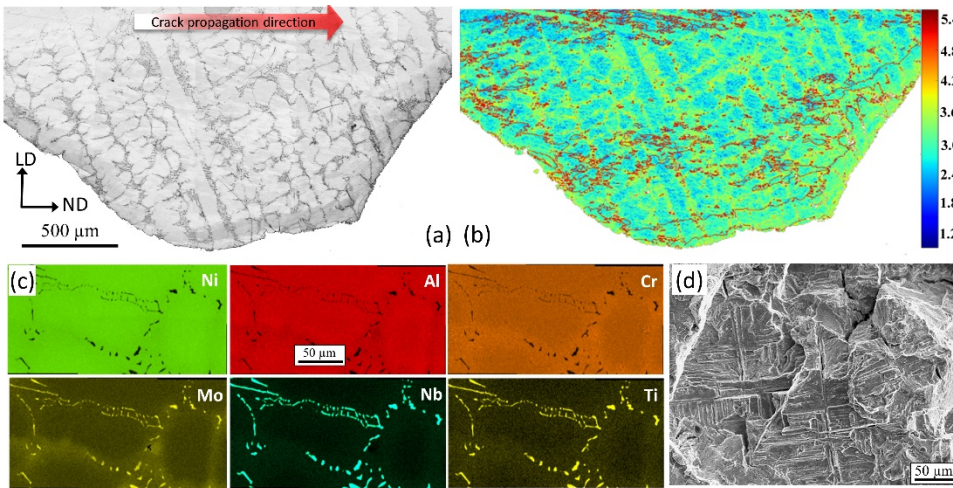
Further GND measurement was conducted to investigate the GND density and their distribution in the dendrite structure within large area of the blade. Fig. 10a-b show the GND density in a large area for the same LCF failed specimen as in Fig. 9a-c. The plane area of interest in both Figs. 9a and 10a was parallel to LD-ND plane, which was parallel to main crack propagation direction of the primary crack, see also Fig. 1c. It is obvious from Fig. 10a-b that the dendritic structure has a great effect on the GND density distribution in LCF. The figure shows much higher GND density in interdendrite area (averagely $10^{3.7} \mu\text{m}^{-2}$) than in dendritic area ($\sim 10^{2.3} \mu\text{m}^{-2}$). This GND density disparity imply the heterogeneous strain accommodation caused by the dendrite structure during plastic deformation. These dendrite structures are generated during the investment casting solidification process. However, essentially, they are the consequence of microsegregation of the alloying elements at the solidification front. Fig. 10c shows the EDS mapping of six major elements in the material in local dendrite/interdendrite structure. It is clear from the images that Ni and Al enriched and partitioned in dendrite area while Cr, Mo, Nb and Ti enriched in interdendrite areas. Moreover, among the latter four elements, only Cr uniformly distributed across the entire interdendrite area and did not diffuse or segregate into the carbide precipitates, see Cr EDS map. Whilst large quantity of Nb, Ti and Mo are merely partitioned and segregated into MC-type carbides. However, Mo shows a slightly wider diffused area in the EDS map compared with Nb and Ti segregation in carbide. The segregation ratios, defined as the maximum concentration in interdendritic areas over minimum concentration in

dendrite core for each element, are determined and shown in Table 2. Fig. 10d shows a typical example of dendritic structure in the crack propagation area in the LCF failed sample. Moreover, secondary cracks can also be found along the dendritic structure. These prevailing dendritic structure along primary cracks and secondary cracks along dendritic structure clearly signify the weakening effect on LCF properties and this effect closely related with the heterogeneous strain distribution that identified by GND measurements.

Fig. 10 GND density distribution in dendritic structure in LCF failed specimen. (a) Band contrast image of large area of interest; (b) GND density map for the same area in (a) with step size of 0.5 μ m; (c) fracture surface in crack propagation area revealing sharp and square shape dendritic structure and (d) EDS chemical elements maps for a selected area in (a).

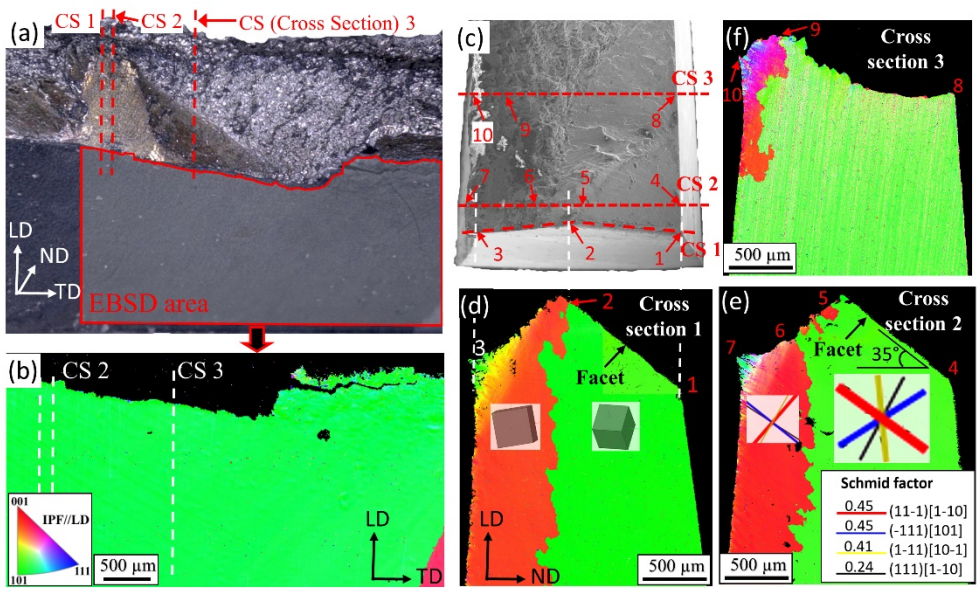
ND and 1~3 mm along LD. In the first example, the crack initiated and facet formed in the Goss grain ($\langle 110 \rangle // LD$), and the facet ended at the grain boundary, see points 3 and 2 in Fig. 11c, d. The same situation applies to the second example, where facet also formed in a Goss grain, which is roughly circled by points D-E-I-M-L, see Fig. 12a, b. The facet also ended at the encountering grain boundary, see points I and E in Fig. 12a, e, f. The results clearly show that facet area correspond well with the grain size.

As shown in Fig. 11e and Fig. 12d, the (111) slip traces are superimposed on IPFs, and Schmid factors for each slip systems in facet grain (Goss grain) are also calculated and presented. These figures show that facet plane is parallel to the slip plane with highest Schmid factor among all slip systems available, *i.e.* (11-1) [1-10] in the first sample and (1-11) [10-1] in the second sample, see the slip trace line in red in Fig. 11e and Fig. 12d, respectively. It should be noted here that the highest Schmid factor in the faceted grain in Fig. 11, although already high with 0.45, is slightly lower than the one in Fig. 12 (0.49). Since the first facet initiated from a pore while the second one started from surface, it is reasonable to deduce that the stress concentration induced by porosity might reduce the critical shear stress needed for slip system activation. In other words, when Schmid factor is high enough, the slip of that plane can occur without an assistant of the presence of defects such as porosity or inclusions. The angle between the facet and horizontal plane (TD-ND plane) are around 35° in both cases. The degree of deviation of faceted grain away from ideal Goss orientation are determined using ODF (Orientation Distribution Function), and shows $\sim 7^\circ$ away from ideal Goss in the both cases, representatively shown in Fig. 12e. For crack propagation stage in the first HCF fracture surface, where featured as visible striations, propagation area was found within the same Goss grain, although changed into different lattice planes after faceting, see Fig. 11. Whilst for the second fracture surface, after faceting in Goss grain 'H-I', fatigue crack further propagates in adjacent grain 'I-J, E-F'. In this fractured specimen, Schmid factors of two other surrounding-faceted grains have also been calculated and listed in Fig. 12f. It shows that neither the highest nor average values of Schmid factor for the two grains are lower than that in the faceted grain, especially in Brass grain (grain 3), in which two

Fig. 11 EBSD-derived IPF//LD across facet after serial sectioning on a HCF failed fracture surface. Sectioning position are indicated in dashed lines in (a,b,c), and are the same position indicated in red dashed lines in Fig. 3a. (d,e,f) are IPFs map //LD of cross section 1-3, respectively, parallel to LD-ND plane, and (b) is IPF//LD of LD-TD plane indicated as red line enclosed area in (a). {111} Slip traces and 3D-view of crystal are superimposed on IPF maps in (e) and (d). Schmid factor values for each slip system in facet grain are listed in the inset of (e).

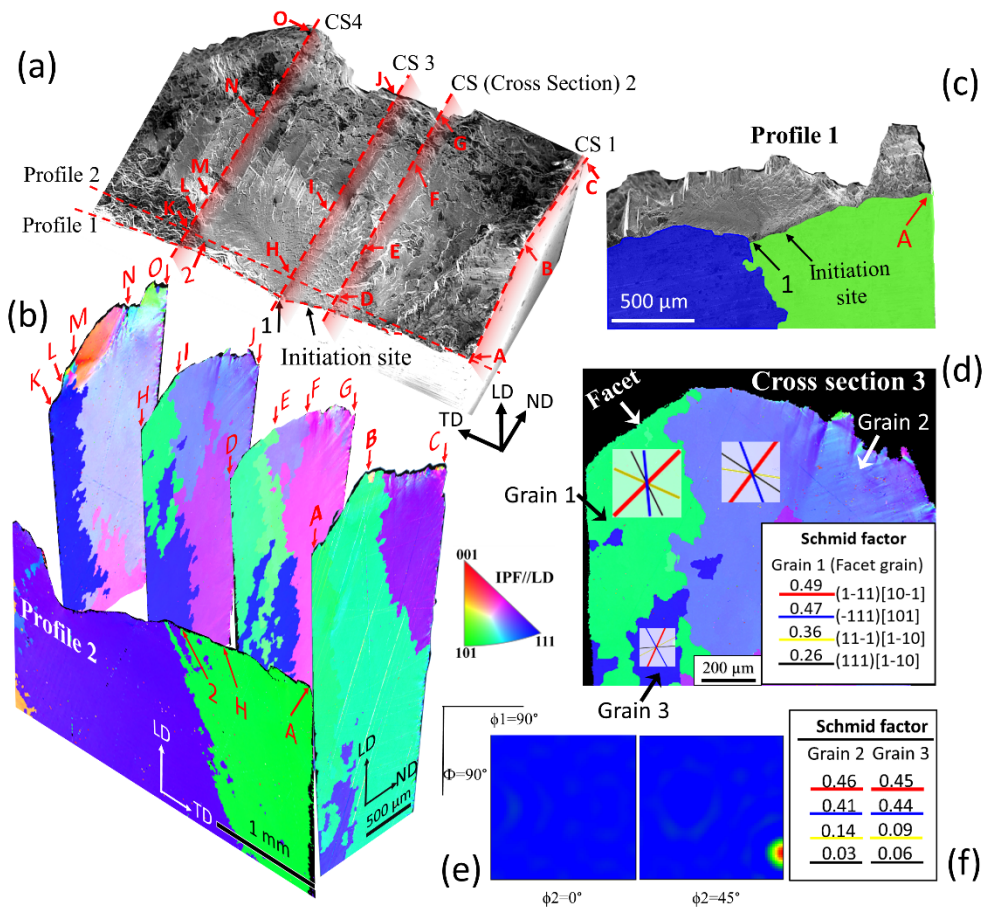
It was evident from the current study, that the crack initiated in a grain that possesses highest average Schmid Factor value among surrounding grains. Comparing three observed grains in Fig. 12d, *i.e.*, Grain 1, Grain 2, Grain 3, it appears that in addition to the higher value of Schmid factor of favorable activated slip system in faceted grain (0.49 in Grain 1) compared to the Grain 2 and Grain 3 (0.46 and 0.45 in Grain 2 and Grain 3, respectively), the Schmid factor of other available not-activated slip systems in Grain 1 (0.47, 0.36 and 0.26) are much greater than in Grain 2 and Grain 3 (0.41, 0.14, 0.03 in Grain 2 and 0.44, 0.09, 0.06 in Grain 3). Moreover, within the faceted grain, the crack occurred on a $\{111\}\langle 1-10\rangle$ octahedral slip with a highest Schmid factor value among all the available slip system. Here, in Grain 1, the Schmid factor of 2nd rank favorable slip system (0.47) is slightly smaller than the 1st rank activated slip system (0.49). It should be noted that the Schmid factor calculation here is based on the validity of the external uniaxial stress state within individual grains without considering additional local stresses. Although it has been reported that the effective Schmid factors might be affected by local stress states which maybe generated by a present of precipitates such as carbides, adjacent grains or residual stress [37]. However, as discussed previously, the carbides in HCF failed areas were relatively small and homogeneously distributed. Moreover, it should be noted that the microstructure of the failed HCF specimens consist of very large size grains (order of mm), where the entire fracture surface consists of only two and three grains along ND direction as shown in Fig. 11 and Fig. 12, respectively. Furthermore, in the current study, most of the Schmid factor calculations matched well with the effective slip plane (faceted plane). Therefore, the local stress effect is likely to be negligible in this study. It has also been reported [38] that at relatively small

Fig. 12 3-D view of the microstructure, grain orientations around a facet for a HCF failed specimen. (a) SE-SEM image of the fracture surface; the section direction along ND (CS) and TD (profile) are indicated in red dashed lines.; (b) selected EBSD-derived IPF of Cross Sections (CS) on and near facet plane. (c) IPF//LD of the section plane parallel to LD-TD plane (profile 1), IPF//LD of profile 2 are shown in (b); (d) part of IPF//LD of cross section 3 on facet grain. Slip trace maps for three grains (Grain 1-3) are superimposed on the IPF. (e) ODF (Orientation Distribution Function) of facet grain (Grain 1); Schmid factor values are for three grains listed in (d) and (f).

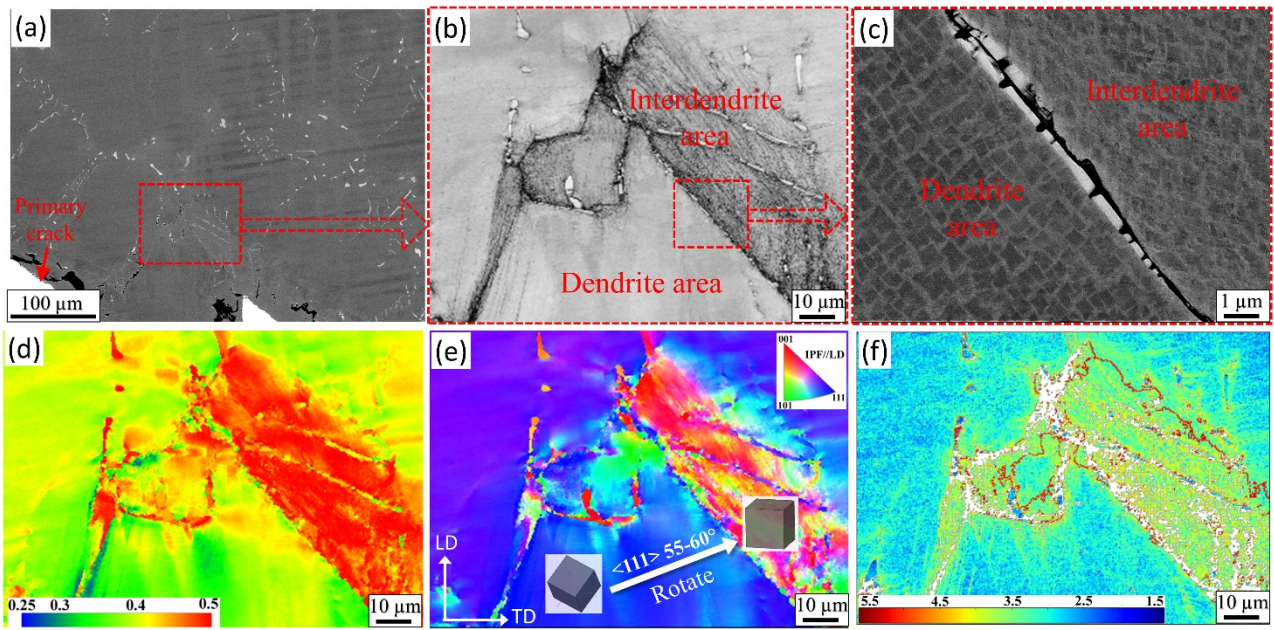
The interaction between individual carbides/oxidised carbides and small cracks discussed in previous section underline the damage mechanism at microscopic scale at the early stage of crack initiation and propagation. Macroscopically, however, these damage accumulations lead to the weakening of large interdendrite areas where accommodate most of carbides and might accelerates crack propagation afterwards. Fig. 13 illustrates such weakening of interdendrite and its effects on failure mechanics. The dendrite structure is shown in Fig. 13a with area of interest been indicated by red rectangular inset and higher magnification of the area of interest are shown in Fig. 13b and 13c. The dark contrast of interdendrtrite area in the EBSD band contrast images, see Fig. 13b, indicate lattice distortion and high local misorientation in that area. IPF in Fig. 13e shows that the original grain has a Brass orientation ($\langle 111 \rangle // \text{Loading Direction (LD)}$) while the interdendrite shows Cube orientation ($\langle 100 \rangle // \text{LD}$). In general, Brass oriented grains are regarded as hard grains with low Schmid factors and hence the slip system is difficult to be activated. Therefore, grain rotation is necessary in order to accommodate further external strain. Clearly a lattice rotation indeed happened in the area studied, but instead of the rotation of whole Brass grain, only weakened interdendrite rotated, specifically, about 55° along $\langle 110 \rangle$ axis from Brass to near Cube orientation, see Fig. 13e. In other words, at this stage of crack propagation, during loading of hard Brass grains, only the interdendrite area was rotated toward a soft orientation, *i.e.*, Cube with higher Schmid factor (Fig. 13d) so that can facilitate an easy slip system activation and hence crack propagation. This type of local lattice rotation would eventually lead to grain fragmentation and fracture of the blade in this area. This is further demonstrated in Fig. 13c, where a crack formed at the dendrite-inderdendritic boundary. This is analogous to dislocation motion theory which replace the whole bulk shear during plastic deformation of alloys. The high GND density in Fig. 13f and severe deformed γ' in the interdendritic area shown in Fig. 13c as well as long cracks along dendrtite/interdendrite interface are the result from the lattice distortion and hard Brass grain fragmentation.

Fig. 13 Illustration of dendritic weakening during LCF failure. (a) Low magnification image shows the dendritic structure, (b) Band Contrast (BC) map of the red rectangular area in (a); (c) SE image of the red rectangular area in (b) showing the γ' structure in dendrite and interdendrite areas; (d) Schmid factor map, (e) EBSD-derived IPF//LD and (f) calculated GND density map of area in (b) with step size of 300 nm.
