BIODETERIORATION OF THE WOODEN ROOF OF THE PHNOM PENH NATIONAL MUSEUM

Bartolomeo Megna*, **Giovanni Liotta**

Laboratory of Materials for Restoration and Conservation, Dipartimento di Ingegneria Civile, Ambientale, Aerospaziale, dei Materiali, Università di Palermo, Italy

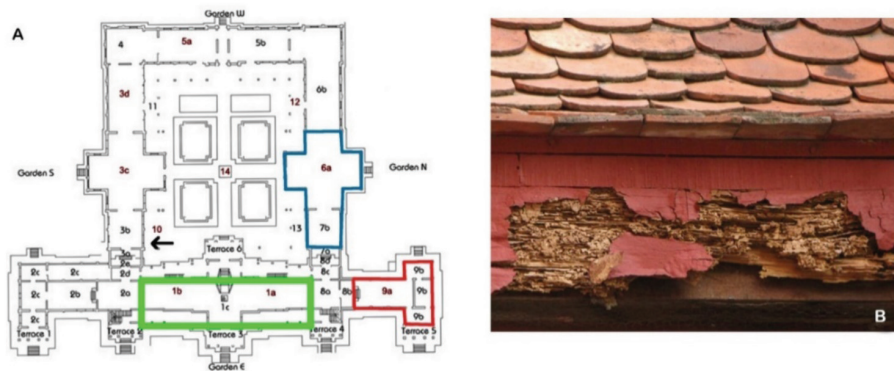
In the framework of an international training program organized by the University of Palermo in Siem Reap, Kingdom of Cambodia, during a visit to the National Museum in Phnom Penh, the Authors noted signs of termite attack on the external wooden beams of the southern portico of the inner garden (see Figure 1).

Figure 1. A) Floor plan of the museum; the black arrow indicates the place where signs of termite infestation were noted; the blue frame indicates fungi infestation; the red frame indicates termite infestation; the green area indicates the observed concrete structure. B) The external wooden element damaged by termites.

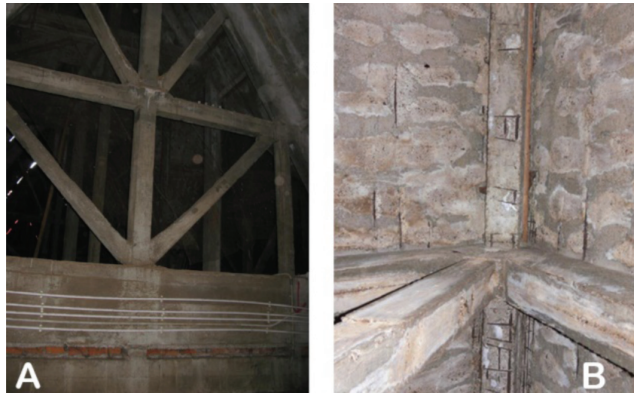
nor corrosion was detected at the top of the roof, despite the structure being 40 years old (see Figure 2). The presence of corrosion was probably caused by water condensation occurring at the top of the roof.

Figure 2. Concrete structure of the roof: A) base of the concrete structure with no visible corrosion of reinforcing steel bars; B) top of the structure with clear signs of corrosion.

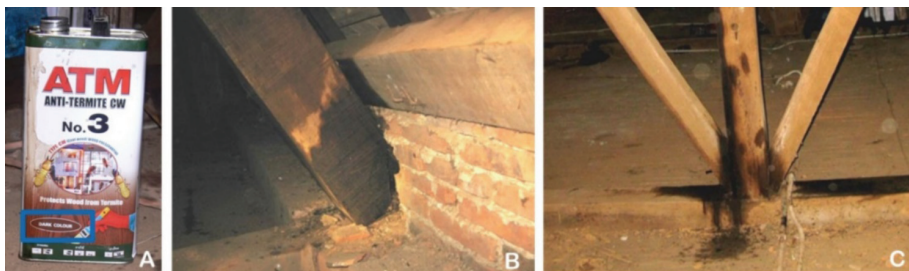
The intervention consisted in the substitution of the decayed wooden beams, considered unfit to bear the required load, with brand new ones. The latter underwent insecticide treatment performed by brush application of a liquid insecticide, mostly in the end grain or in the joints of the beams (see Figure 2). Signs of this treatment could be easily noted due to the visible brown stain of the product used.

At first sight, the previous insecticide treatment was easily individuated as the wood appeared darker where the insecticide had been applied, as shown in Figure 3; moreover, signs of the termites' walkways were identified both on the original wooden beams and on the new ones (Figure 4 A and B), highlighting that termite infestation was active after the restoration and had spread to the recently introduced wooden beams. The presence of the ghost trace of a termite walkway (probably removed in the past intervention) beside the new walkways, highlights the ineffectiveness of the insecticide treatment.

Figure 3. A) Insecticide used in the previous restoration intervention; B) treated end grain of an old rafter; C) sign of insecticide treatment on new beams of the roof.

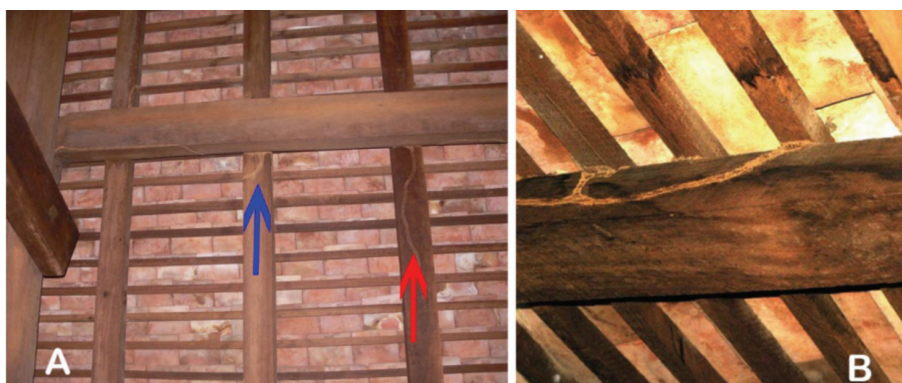
It could be noted that most of the original wooden elements were not substituted in spite of the presence of termite walkways on the surfaces, probably assuming that massive use of the insecticide could stop the ongoing infestation. Unfortunately this assumption is valid only in the case of drywood termites; the pathways were not considered as being used only to move from one feeding place to another, while most of the termite population lived safely within the nest, where it cannot be reached by any treatment performed from the surface. Moreover, this approach would only be effective for drywood termites, as the colony lives in the feeding place, but totally ineffective for subterranean termites, as the colony mostly lives far from the feeding place inside the nest, that could be located dozens of meters away from the roof.

Figure 4. A) The blue arrow indicates a termite walkway on an old rafter, the red one indicates ghost traces of the walkway removed during the previous intervention; B) termite walkways on newly installed rafter.

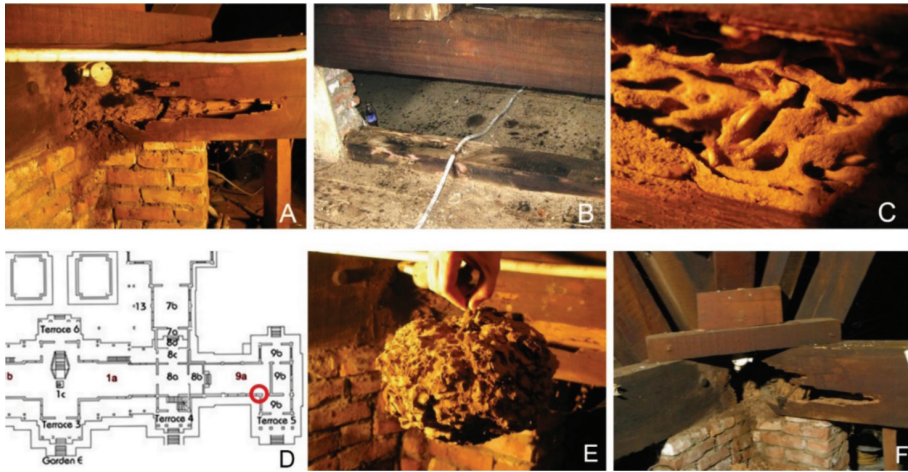
As the bearing structures of the roof are installed over large tie beams going from one wall to the opposite one, forming the base of the A shape structural truss element bearing the whole roof, particular attention was paid to these elements. Some of the large tie beams resting on the brick walls showed severe deterioration of the end grain, induced by termites, while the remaining part of the beams appeared to be in good condition (Figure 5B); unfortunately, even though the external wooden surface appears sound, termites can act inside the wood. In particular, when the wood was hammered, the resulting sound clearly indicated the presence of large voids within: widespread termite galleries could be observed by removing the thin wooden film on the surface along the whole beam (Figure 5C). The decay appears to be quite severe as the galleries pass over the support area indicating a clear risk of failure (Figure 5F).

On closer examination, it was possible to observe that the termites had hollowed out the wood, severely reducing the section and consequently its mechanical properties. In the north-east corner of the roof structure (Figure 5D), there was some evident danger, as the wooden bearing tie beam was filled with recently constructed termite cells (Figure 5E); moreover, several termites were noted, indicating an ongoing active infestation (Figure 5C).

Continuing further with removal of the termites' nest, it was possible to observe that no wood was left in the beam head (Figure 5F). In these conditions, the whole roof was clearly in danger of collapsing.

Figure 5. A) End grain of a tie beam decayed by termites; B) apparently sound tie beam, C) after removal of the thin wood surface layer; D) the red circle indicates the position of the structural corner element in the Museum floor plan; E) termite gallery extracted from the end grain; F) hollowed out wood in the end grain of the corner tie beam.

Suitable measures have to be taken to maintain good air circulation in the Museum garret in order to reduce or avoid the settling of new termite infestation. The first step of the recovery will be the disinfection of all the termite infested beams in the roof and in the colonnade, by means of Cypermethrin (Cyano-(3-phenoxyphenyl) methyl]3-(2,2-dichloroethenyl)-2,2-dimethylcyclopropane-1-carboxylate) base product. The second step will be the removal of all elements showing signs of termite attack. All the removed wood must be burnt. The insecticide has to be applied by pressure injection, an awkward operation that has to be performed by specialized operators. The beams severely attacked by fungi have to be removed too and all the surrounding wooden elements have to be treated with a 10% solution of Benzalkonium chloride, also known as alkyldimethylbenzylammonium chloride (ADBAC), applied by brushing.

The last step in the recovery intervention will be the sanitization of the soil all around the Museum against the species, *Coptotermes gestroi*. To achieve this result, a product such as hexaflumuron should be used which is able to affect the growing process of the termites and lead to the destruction of the entire nest [19-21].

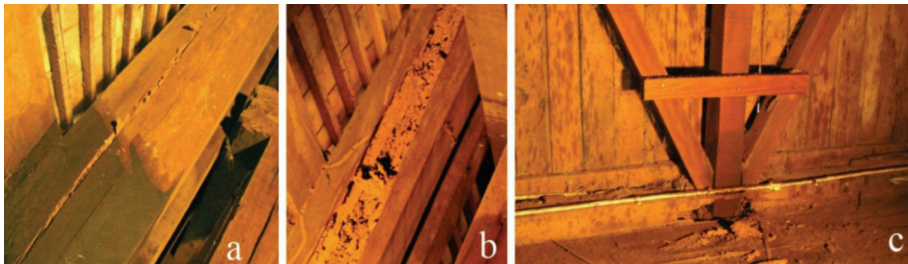
In addition, some of the roof prop beams showed clear signs of termite attack. One of the prop beams in particular was found to be broken in the middle as a result of the weight of the vertical poles connected to it, with no residual mechanical function, which indicated the presence of a large number of termite galleries within (Figure 6c).

Figure 6. a) Termite pathways on a roof bearing beam; b) the same beam after the removal of the wood surface; c) collapsed horizontal prop beam, caused by termite infestation.

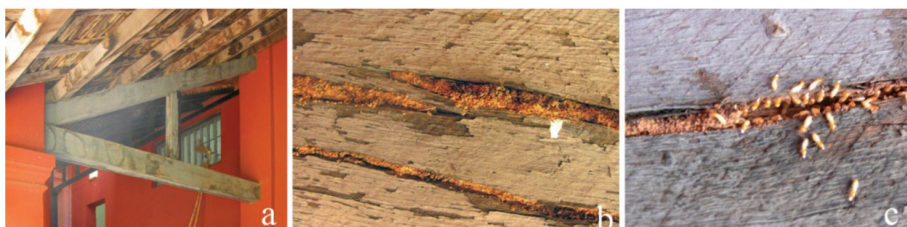
Finally, the pitches of the lateral colonnade of the inner garden were slightly sloped; according to this geometrical consideration, it would be possible for water to reach the wooden structures under the roof in the case of heavy rain and strong winds. These wooden beams in effect showed clear signs of fungi infestation, due to high water content, even if transient (Figure 7a).

presence of termites in the tie beams of the trusses of the colonnade roof was investigated. It was possible to note that all the shrinkage cracks were filled with a granular material (Figure 7b). Sampling and direct observation of this material were performed and identified as termite faeces, commonly used by termites to build their tunnels or walkways. In general, these walkways or tunnels have to be perfectly sealed as termites are scared by light. The termite population was large and active (Figure 7c), as clearly observed when the walkways along the whole beam were broken; in all investigated points, a large number of living insects were seen to spread out from the wood. This observation confirmed that termite presence was widespread and abundant.

Figure 7. Colonnade beam: a) fungi signs; b) termite pathways; c) living termites.

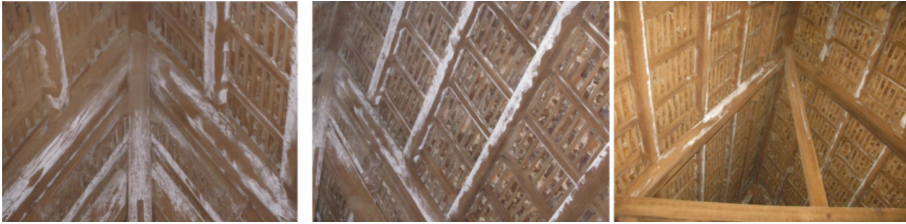
The investigation was also extended to the west wing of the roof. In this part of the structure there was no sign of termites, but a large fungi infestation was clearly present and active (Figure 9). Visual investigation and knocking on the wood beams indicated that the decay was affecting only the surface of all the wooden elements. It should be highlighted that fungi infestation is mostly present at the top of the roof, indicating that the main cause of the high humidity is the condensation occurring when hot humid air reaches the cool top of the roof. Nevertheless, the restoration intervention on the roof must be designed to reduce the relative humidity in the garret ensuring good air circulation throughout the entire roof.

Figure 9. Detail of the fungi infestation found in the west wing of the Museum roof.

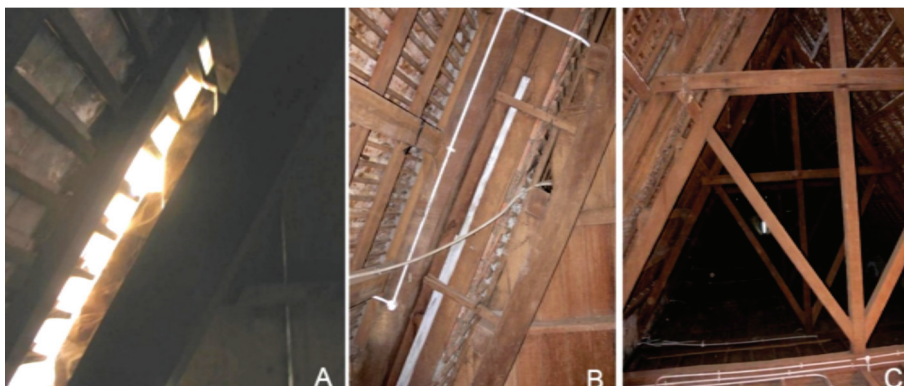
Figure 10. Roof structure: A) open gap between the folds of the roof; B) open gap between the folds sealed with tape; C) open gap between the folds sealed with mortar.

All the new beams should be treated with the same products previously used for the old parts. The heads of the new beams should not be put in direct contact with the walls, in order to facilitate moisture exchange with the air and avoid the settling and development of new termite infestation or fungi infection. It is essential to create in all the garrets, a good system of air circulation in order to avoid condensation phenomena and prevent new settling of biodeterioration agents. It should be sufficient to ensure the presence of open gaps between the beams as shown in Figure 10A, in all parts of the roof. It is also necessary to avoid the mistakes highlighted in Figure 10B and 10C, where the gaps are sealed with tape or mortar, respectively. In order to increase air circulation and prevent a high level of humidity in the garret, a 50 x 50 cm window has to be created at the top of each gable in the roof. These windows will be designed properly to prevent rain water from entering.
