ベルリン東洋美術館所蔵花鳥螺鈿食籠 [修理報告]

著者	山下 好彦
図書名	在外日本古美術品修復協力事業 : 修理報告書 : 工芸品 / 絵画 [平成12年度実施事業] : Project for Conservation of Works of Japanese Art in Foreign Collections
開始ページ	105-106
終了ページ	109-134
URL	http://id.nii.ac.jp/1440/00005436/

品名：花鳥螺鈿食籠
 所蔵：ベルリン東洋美術館 ドイツ
 品質構造：木製、乾漆製、黒漆塗り、螺鈿、
 所蔵番号：ID.25922-a

請負者 目白漆芸文化財研究所
 修理担当者 山下 好彦
 原稿執筆 山下 好彦

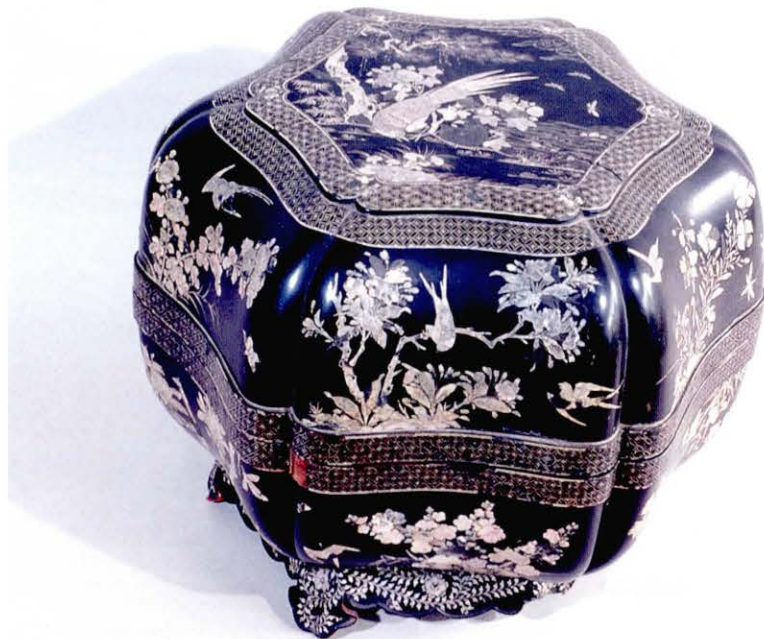
図59 「花鳥螺鈿食籠」一合 ベルリン東洋美術館所蔵 (修理前)
“Kacho Raden Jikiro” before restoration

現資料は黒漆螺鈿の大型の食籠で、第二次世界大戦後、旧ソビエト軍によってレニングラード（現在のサンクトペテルブルグ）に持ち去られた。東西ドイツ統合以前にいったん旧東ドイツ・ライプティヒに返還、その後、ベルリン東洋美術館に所蔵されるようになった経歴がある。損傷が著しく、足が欠損し自立することが出来ない。この事は、現在の所蔵館に返還される以前の保存環境の悪さを物語っているものと考えられる。

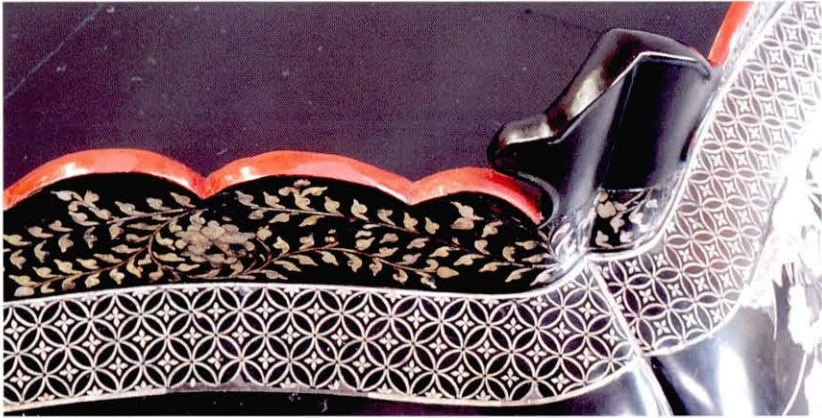
図60 高台、刎足の状態 (修理後)
Kodai and kuriashi after restoration

高台が崩れ、折れ曲がっていた部分は麻糸数本で繋がっているにしかすぎないことから、いったんこの部分を取り外した。つぎに露出した素地や下地を補強するため、麦漆を薄く希釈し含浸した。亀裂によって変形した高台を修正するため、他の高台部分をCraftResin WR-200A・Bと錫金貝で型取りした。破損した高台は内側の麻布間での剥離を接着すると同時に亀裂部分に麦漆を含浸した後、この型を使って高台の形状を修正し、クランプを使って圧着した。折れ曲がっていた部分も他と同様に作業を進め、断面に麦漆を付け、クランプと木杵とヒゴを用いて元の形状に戻した。

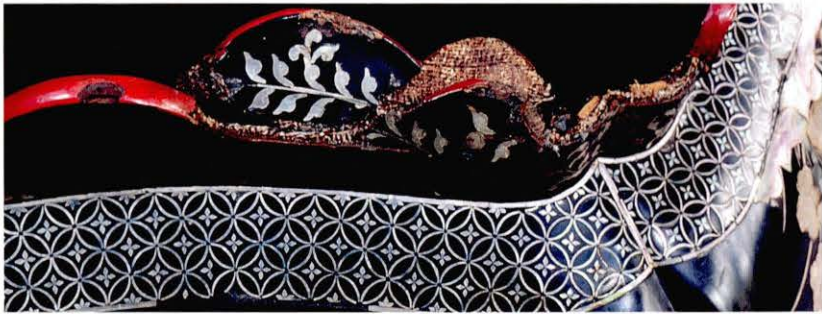
図61 高台、刎足の状態 (修理前)
Kodai and kuriashi before restoration

- ⑦ 6本の刳足のうち4本が破損、欠失し、自立出来ない状態だった。また、刳足内側の木地が一部欠失していた。
- ⑧ 身の合口部分、立ち上がりの一部が2箇所欠損し、木地が露出していた。
- ⑨ 高台の一部が大きく崩れ、非常に危険な状態にあった。
- ⑩ 各所に打損や擦り傷が認められた。
- ⑪ 各所に後世修理がすでに施されていた。刳足の一部に合成樹脂による接着跡があった。螺鈿は広い面積が合成樹脂によって再接着され、周囲を下地で埋めていた。また、塗膜剥落部分に朱漆、透漆が塗り込まれていた。
- ⑫ 身立ち上がりの木地が露出した部分に朱色の補彩があった。
- ⑬ 一部に西洋塗料や朱漆の付着がみられた。

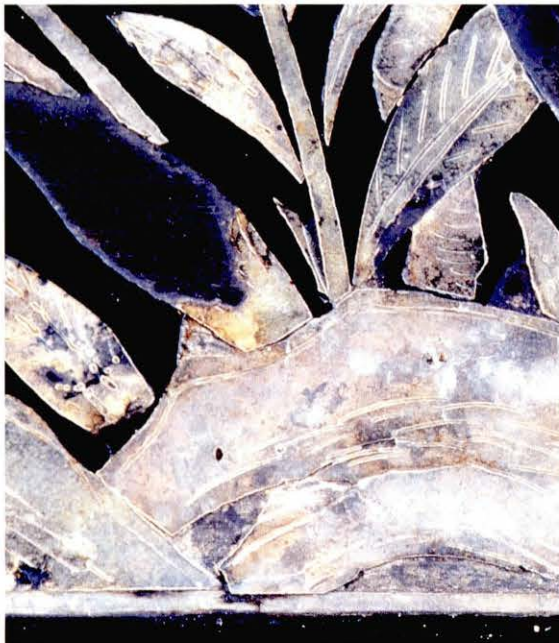
図62 螺鈿の剝離 (修理後)
Exfoliation of raden (after restoration)

螺鈿の剥離箇所に粒膠を含浸、木杵（しんばり台）と竹製や木製のヒゴ（しんばり棒）を用いて圧着した。膠はサンオリエント化学社製のパール膠大王20パーセント溶液を使用した。膠には表面張力があり、含浸しにくいことから、8時間超音波発生装置で分子の鎖を切り、さらに少量のエタノールを混入した。また、膠の含浸によって貝の下に薄く塗られた胡粉が流れやすく、灰色の下地が露出することで貝の表情を変化させやすいため、膠に少量の胡粉を混ぜ含浸させた。胡粉は数種類ある胡粉のうち、最も色合いがあうものを選び、さらに、彩度をおとすため表具の修復に使用する灰汁を微量に混ぜて使用した。膠は筆を使って含浸し、余分な膠を拭き取った後、剥離した部分に合わせてビニールシートやゴムを置き、細く抑えた。螺鈿の剥落止めと同時に雁皮紙の養生を除去した。

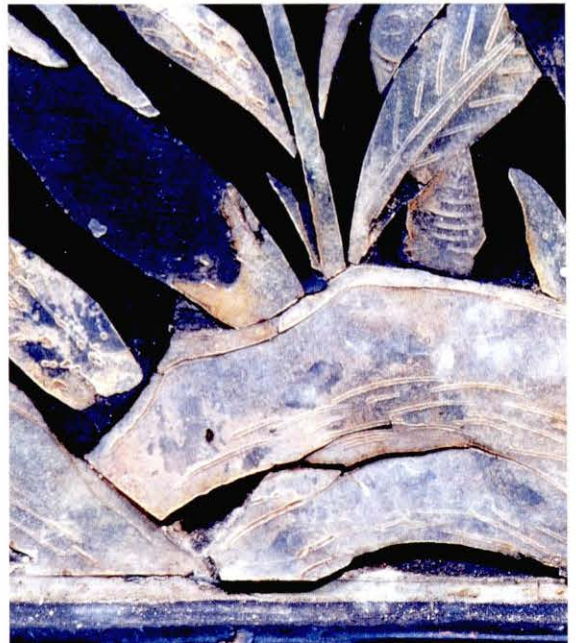
図63 螺鈿の剝離 (修理前)
Exfoliation of raden (before restoration)

- ①悪い条件下で外箱もなく保管されていたと考えられ、器胎表面の一部に水が流れた跡があった。
- ②紫外線による漆塗膜の劣化が表面塗膜にみられ、細かい断文が入っていた。
- ③劣化することで本来の漆の艶が失われていた。
- ④経年変化や木地の収縮によって各素地の接合部からの割れが著しく、蓋甲板では矧ぎ目部分に歪みが生じ、素地面にずれが生じていた。
- ⑤亀裂や断文の周辺では漆塗膜が各所で剥離し、一部で塗膜の剥落があった。蓋の内側朱漆塗膜面に剥離があり、底裏の漆塗膜剥落箇所では木地が露出していた。
- ⑥素地の収縮や打損等により螺鈿のほとんどが剥離していた。また、貝素材の劣化によって貝が崩れやすくなり、真珠層間の剥離が進行することで貝の色が白色化していた。また、多くの貝がすでに欠失

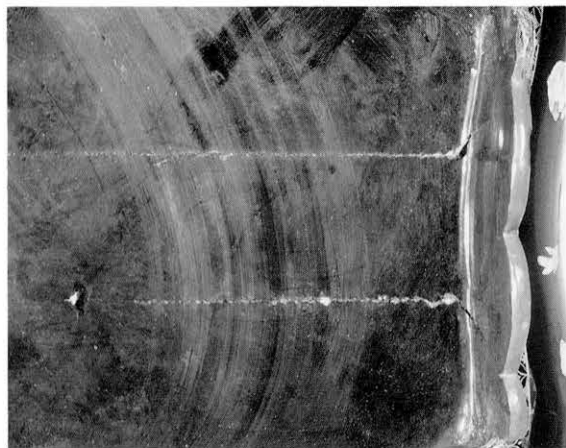
図72 底板の状態
Condition of the bottom board

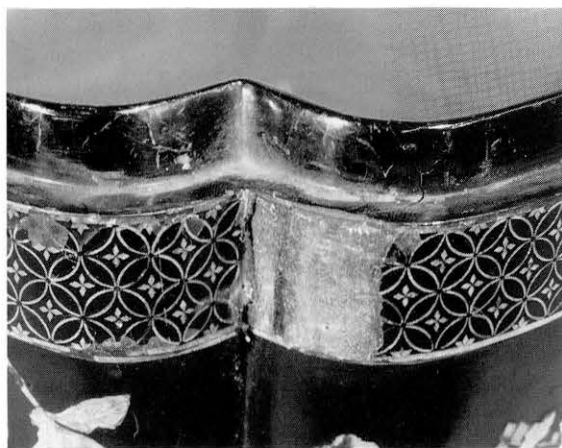
図73 身口縁部の剥落
Lifting of the coating film on the rim of the body

漆塗膜の剥離箇所に接着用に調整した麦漆を希釈、含浸し、ビニールシートをあて、木杵とヒゴを用いて圧着した。このとき、漆が貝の下に流れ込まないように注意した。

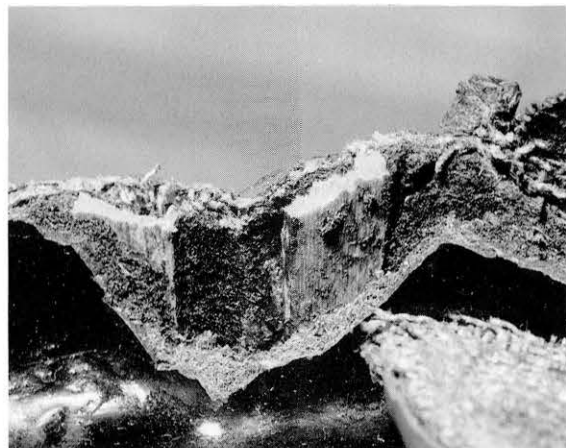
図74 刎足破損部の状態
Condition of damage of the *kuriashi*

- (7) Four of the six *kuriashi* had been damaged and lost so that the object could not stand on its own. Also, a part of the inner side of one of the remaining *kuriashi* was missing.

4本の刳足を現存する2本の足と同様の技法で復元した。刳足は外側を麻布を4枚貼り重ねた乾漆で作成し、足の内側に竹（笹）と檜の薄板で補強、さらに刻苧で形を整えている。復元では、つぎの工程に沿って作業を行った。

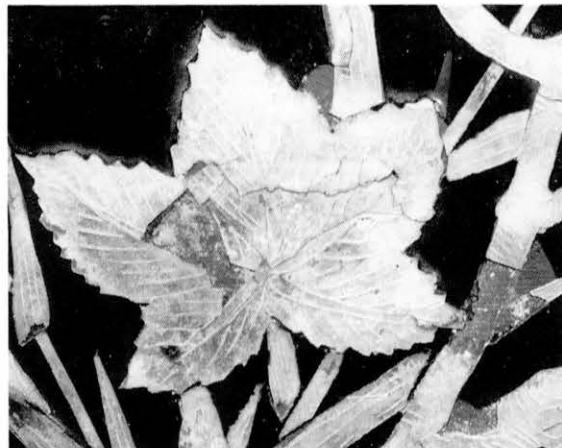
図75 螺鈿の剥離と剥落、後補の毛彫
Lifted and fallen off *raden*, later engraving

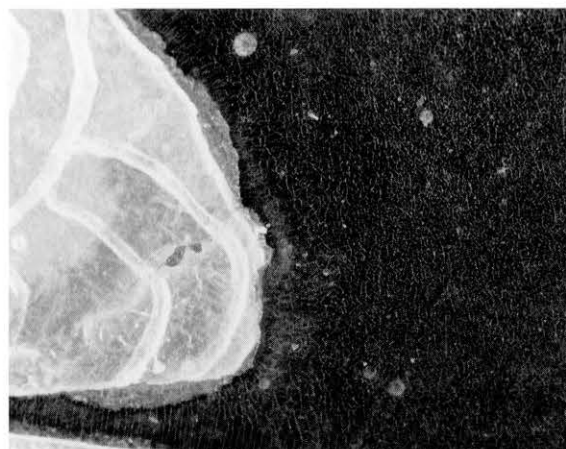
図76 螺鈿の毛彫りとマイクロクラック
Engravings on the *raden* and minute cracks

劣化した漆塗膜を補強するため、漆固めを行った。漆塗膜に出来た細かい断文にクリーンソル（石油系の溶剤）で希釈した漆を螺鈿部分をよけて筆で含ませ、表面に残った漆は完全に拭き取った。漆は本地呂漆と生正味漆を混合し、使用した。

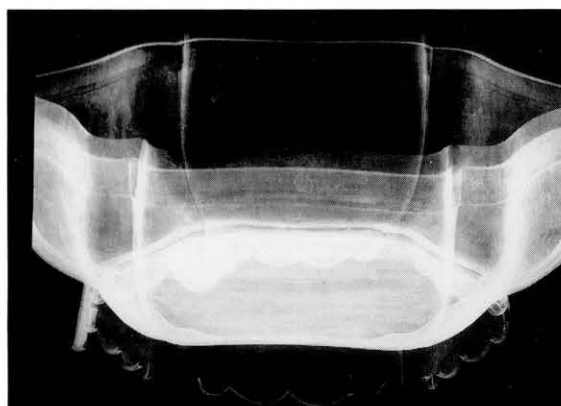
X線透過写真をから、次のことが分かった。蓋甲板と身底板は、針葉樹の柾目板二枚を剥ぎあわせ、素地が狂わないように中央に垂直方向に同種の板を抜けないように差し込む。側板は六弁各面ごとに乾漆で作り、六枚を寄せて接着する。蓋身とも口縁部は柾目針葉樹の曲物作りで、内外両側から薄い板を寄せ、木釘で止める。高台と刳足は乾漆造り、刳足内側から三本の薄板で補強する。

図101 X線透過写真
X-ray radiography

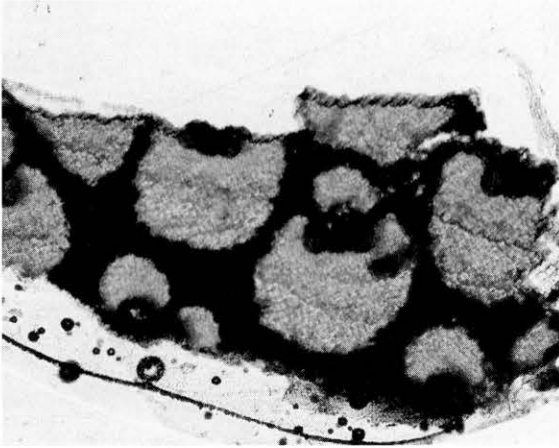
図102 刳足裏側補強材のクロスセクション—竹または笹
Cross section of the reinforcing material on the inner side of the *kuroshitsu* - bamboo or wild bamboo

Prepared specimen of the cross section of wood was observed with an optical microscope. As a result, it was found that the material at the center of the *kuriashi* is bamboo or wild bamboo and that the substrate to the left and right are straight-grained cypress.

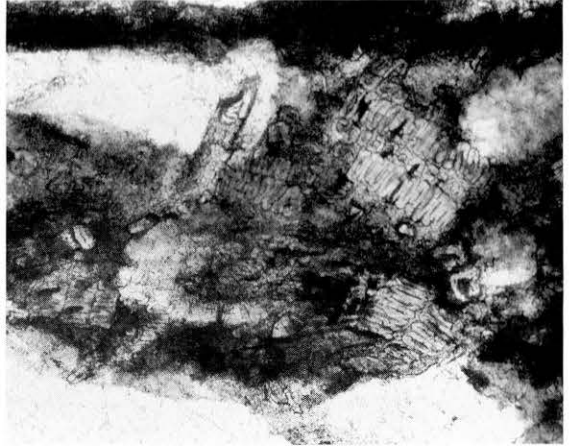
図103 刻苧のクロスセクション
Cross section of *kokuso*

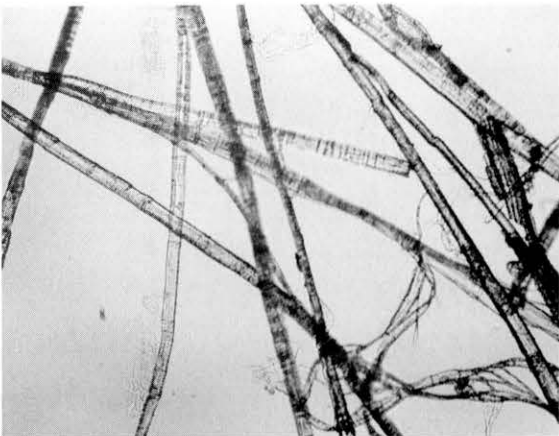
図104 乾漆布繊維—大麻 (大川昭典氏撮影)
Fiber of *kanshitsu* cloth - Indian hemp
(photo by Okawa Akinori)

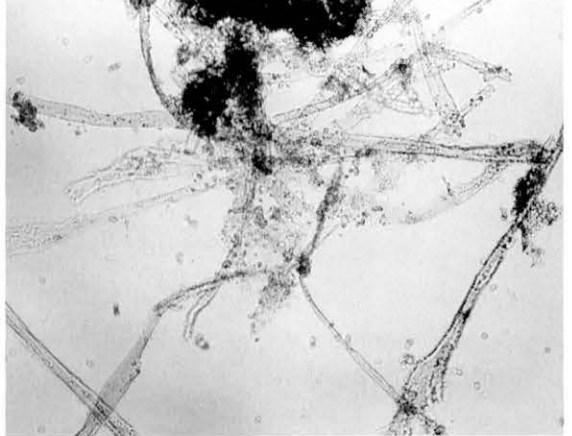
図105 乾漆の紙繊維—間似合紙または笥打ち紙 (大川昭典氏撮影)
Fiber of paper used for *kanshitsu* - *maniai* paper or *hakuuchi* paper (photo by Okawa Akinori)

Through optical microscopic analysis it was discovered that paper fiber from the surface of the *kanshitsu* was mainly *gampi* with some *mitsumata* mixed. *Hakudo* was seen around the fiber and it was found that *maniai* paper or *haku'uchi* paper, which are still produced at Najio in Hyogo Prefecture, had been used. Fiber from the cloth was identified to be Indian hemp, which is an annual herbaceous plant that grows in South and Central Asia that was introduced to Japan from ancient times and grown in fields.

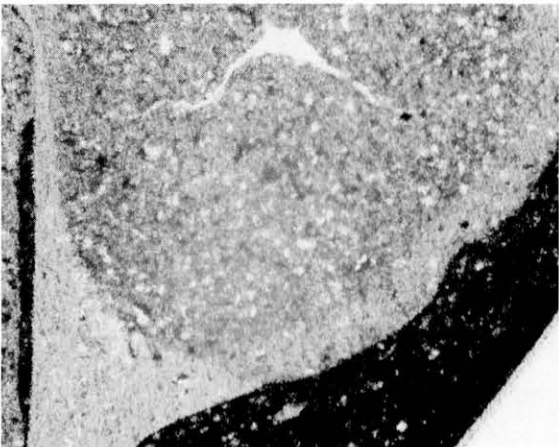
図106 身高台玉縁のクロスセクション
Cross section of the edge of the *kodai*

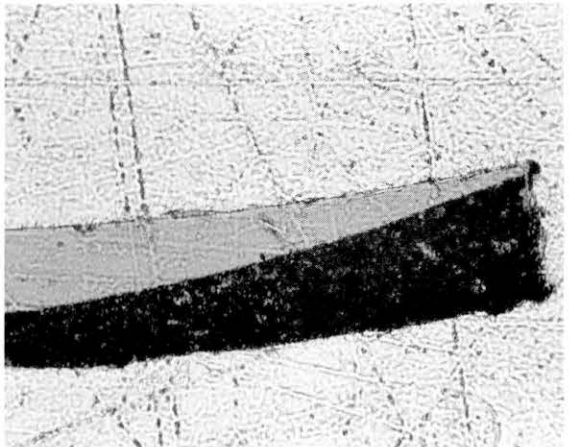
剥落片を対象にエポキシ系の樹脂で封入し、耐水ペーパーで薄くした後、光学顕微鏡で下地構造を観察した。漆塗膜は2層で、黒色の顔料を混入した漆で下塗りし、透き漆で上塗りしている。下地は漆下地で、濃茶色の荒い下地を3層、濃い灰色の細かい下地を1層施す。高台の玉縁部分は、茶色の下地を型で引き、こい灰色の荒い下地と細かい下地を2層付けて表面を整えている。刻苧は木粉と漆、さらに少量の下地を混入したものと判明した。

図107 中塗・上塗漆のクロスセクション
Cross section of the middle coating and final coating
