ENVIRONMENTAL IMPACT PRODUCED BY ECOLOGICAL ACCIDENT FROM THE TAILING POND OF NOVĂȚ STREAM (BAIA BORȘA ZONE – NW ROMANIA)

DENUT, I. (Department of Geology and Environmental Engineering, North University, Baia Mare, Romania) & **BOLCHIȘ, R.** (Environmental Protection Agency, Baia Mare, Romania)

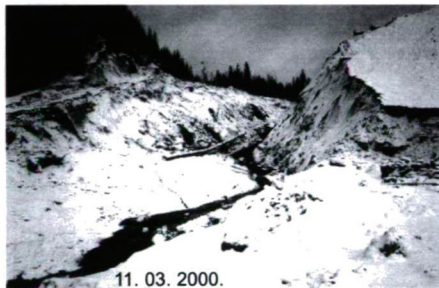
In spite of all the preventive measures of E.M. Baia Borșa S.A. (the stop of Processing Plant, 09.03.2000, 11:00 am), on 10.03.2000, 10:30 am, the dam downstream of the pond was broken. Polluted water and tailings were let out through this breach contaminating the rivers Novăț, Vaser, Vișeu and Tisa with heavy metals. The size of the breach rapidly increased to 40 m in length and 18 m in height. The entire mass of overflowed material was 70 000 m³ of water and 40 000 m³ of gangue (but approximately 20 000 m³ were hold back by the downstream dams).

After the accident – until 15.03.2000, 06:00 pm – the next actions were undertaken: Sampling and analysis of the water from the rivers Vaser, Vișeu and Tisa; cleaning of snow and mud (of landslides) from access routes to the tailing pond; restoration of the pumping station; pumping clean water from Novăț Pond temporarily to Colbu Pond; controlled evacuation of the water through pipes leading to tumbling bay; construction of a supplementary dam to stop the breach advance; reconstruction of the dam upstream of the eroded zone.
