ASIA TURBOMACHINERY & PUMP SYMPOSIUM
SINGAPORE | 22 - 25 FEBRUARY 2016
M A R I N A B A Y S A N D S

Dry gas seal failure and trouble shooting

Manikandan, A

Moorthy Subramanian

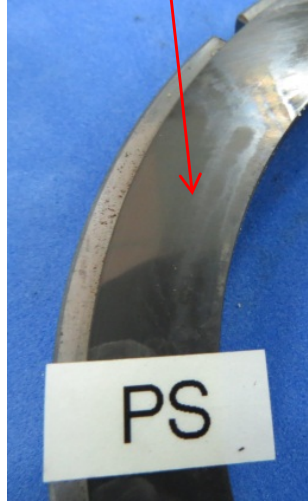
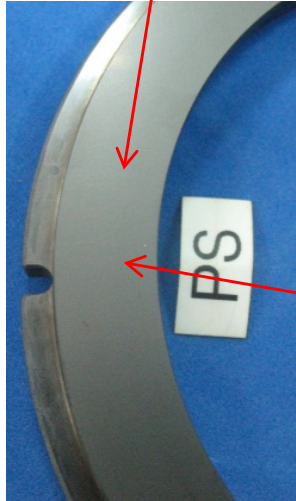
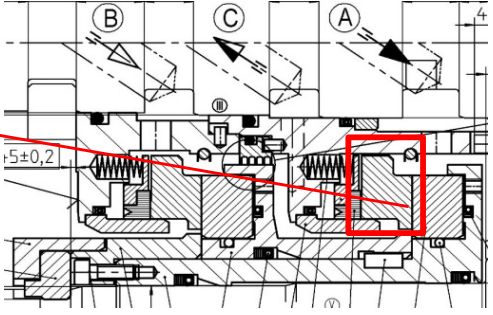
<p>PS Seal face Pos-2: Traces of black sticky liquid observed on the sliding surface. Seal face found to be in re-usable condition after cleaning.</p>

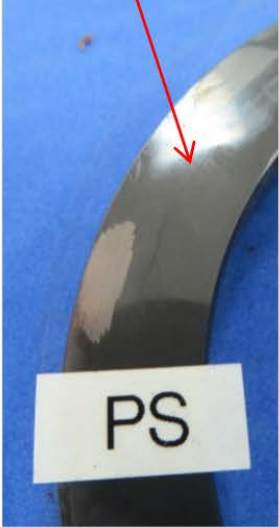
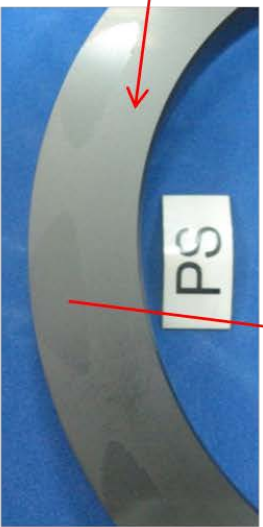
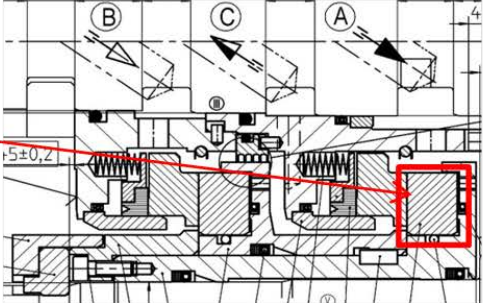
<p>PS Seat Pos-1.1: Traces of black sticky liquid observed on the sliding surface. Seat found to be in re-usable condition after cleaning.</p>

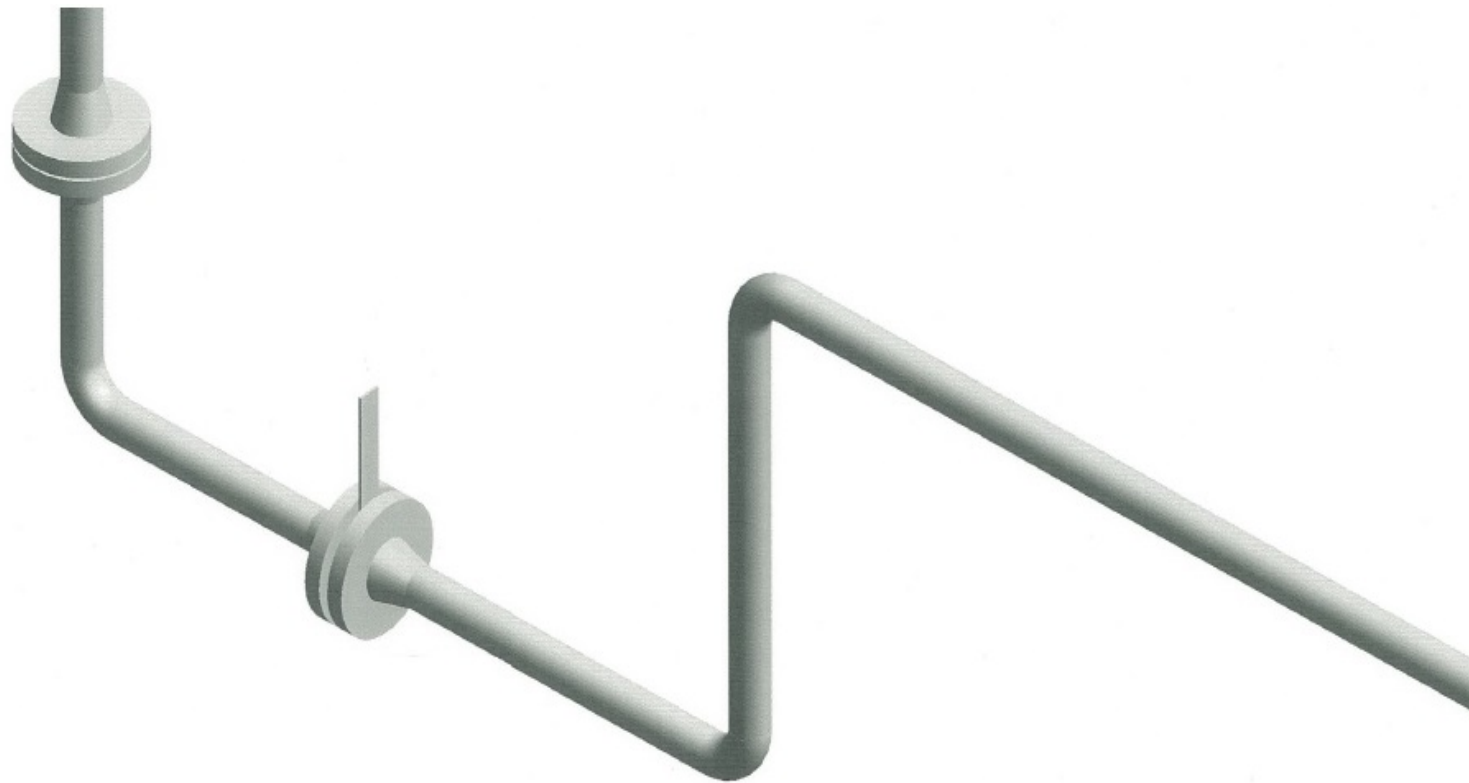
Original as per design

The orifice plate installed at the NDE primary vent line was lower than the center line of the compressor. It makes the primary vent gases turn to liquid at the orifice plate due to pressure drop. The condensates started accumulating over the period of time in the loop and blocked the orifice plate hole for further escape of the gases which leads to back pressure in the line. But the DE primary vent orifice was found already at the height of 1.5m as per the design from ground level.
