44<sup>TH</sup> **TURBOMACHINERY** & 31<sup>ST</sup> **PUMP SYMPOSIA**  
HOUSTON, TEXAS | SEPTEMBER 14 – 17 2015  
GEORGE R. BROWN CONVENTION CENTER

# FCCU PRT Compressor Blade Failure Case Study

Austin Anderson, CITGO

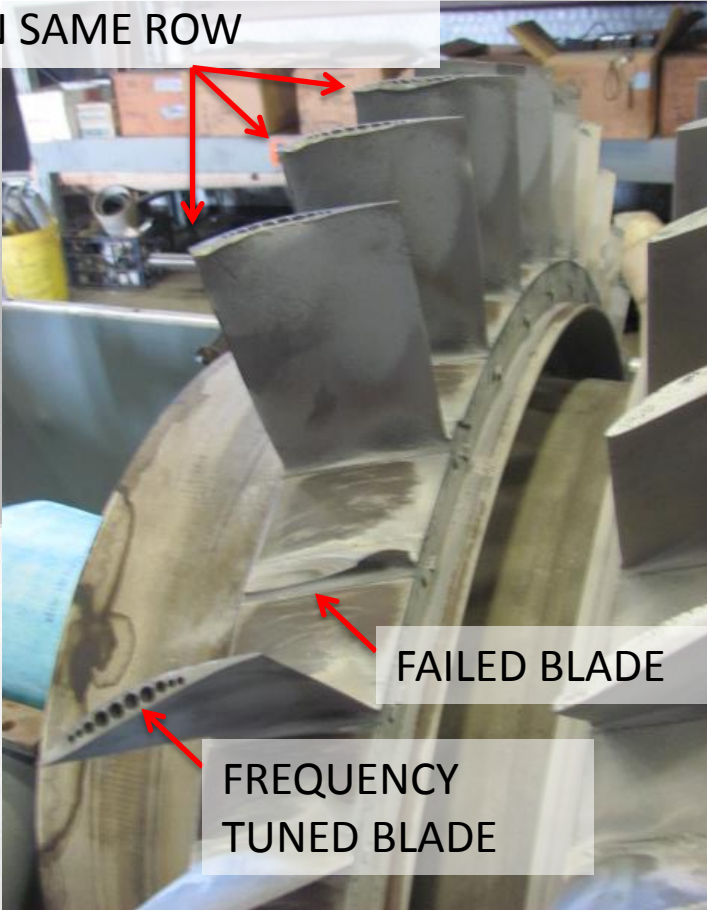
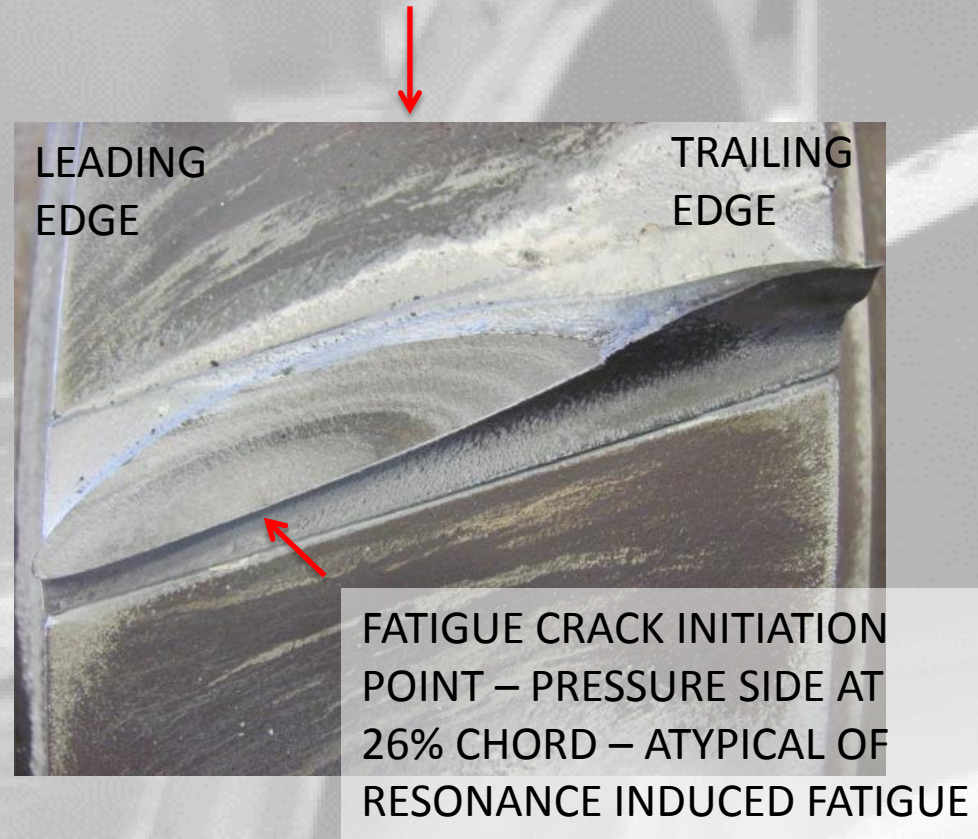
- One first stage blade separated near blade attachment at fillet runout onto airfoil.
- Only the failed blade had a fatigue indication.
- Trailing edges of all Inlet Guide Vanes (upstream of 1<sup>st</sup> stage blade) severely damaged.
- Other downstream airfoils had minor, sporadic impact damage from contact with failed blade.
- Foreign material found in compressor.
- Tip rub noted on casing above first stage blade.

ADVANCING BLADES  
IN SAME ROW

WHEEL ROTATION

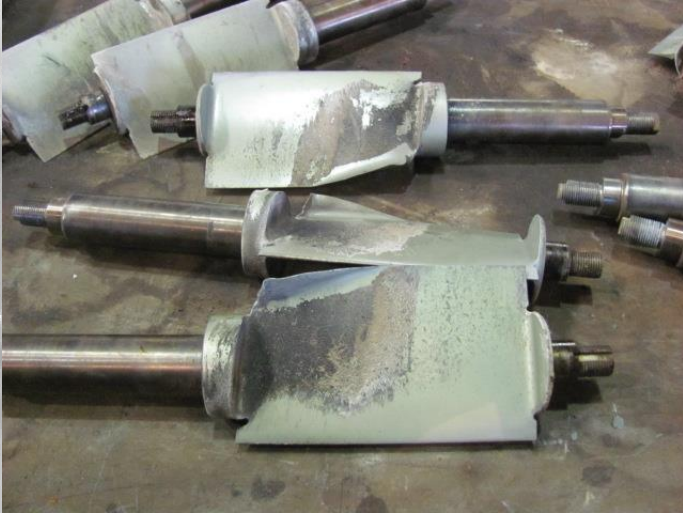
REMOVED IGV's WITH BENT TRAILING EDGES FROM CONTACT WITH "BATTED" FAILED BLADE

SEPARATED BLADE COATING REDEPOSITED ON CASING SURFACE

SMEARED MATERIAL FROM TIP RUB

RUB HEAVIEST DEPOSIT SAMPLE LOCATION

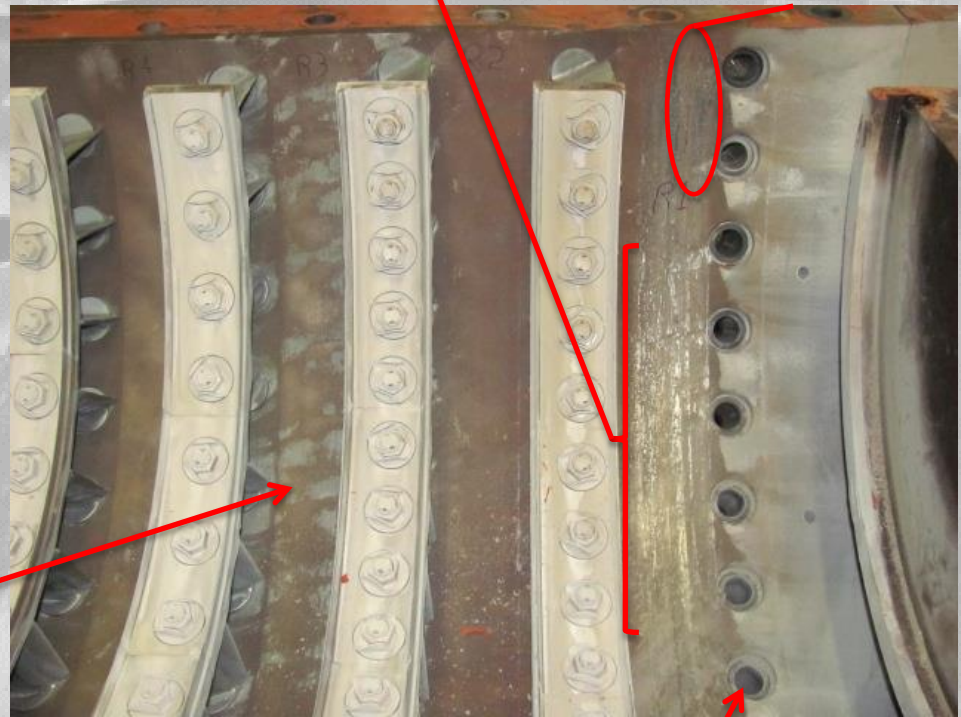
IGV'S REMOVED

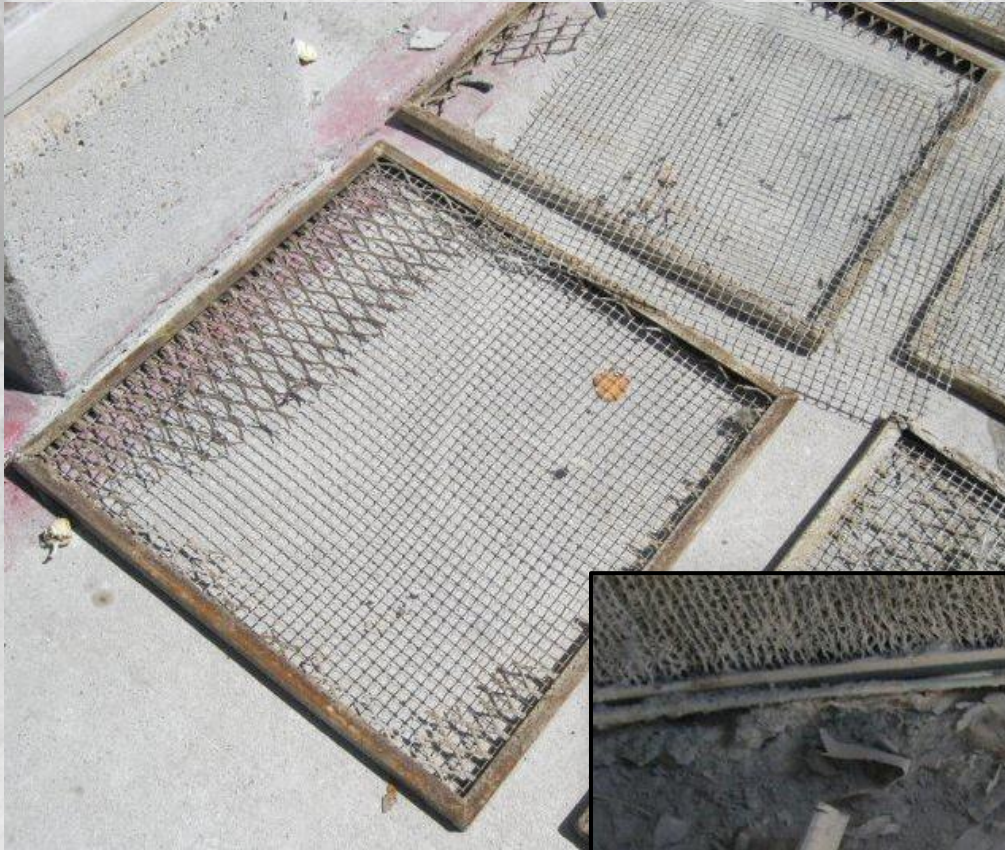
EXPANDED METAL AND  
SCREENS FOUND MISSING -  
INGESTED BY COMPRESSOR

- Inlet system inspection and maintenance should be a planned, high priority activity during turnarounds.
- Maintain adequate flow path spare components.
- Sudden, sustained, unexplainable flow capacity changes should be investigated at earliest opportunity.
- Include inlet system instrumentation to for  $\Delta P$  changes
- Provide provisions for manway & borescope access
- Include visual inspection for both the inlet system and the front end of the compressor. Also to perform preventive maintenance on the inlet housing implosion door trip monitors during shutdowns

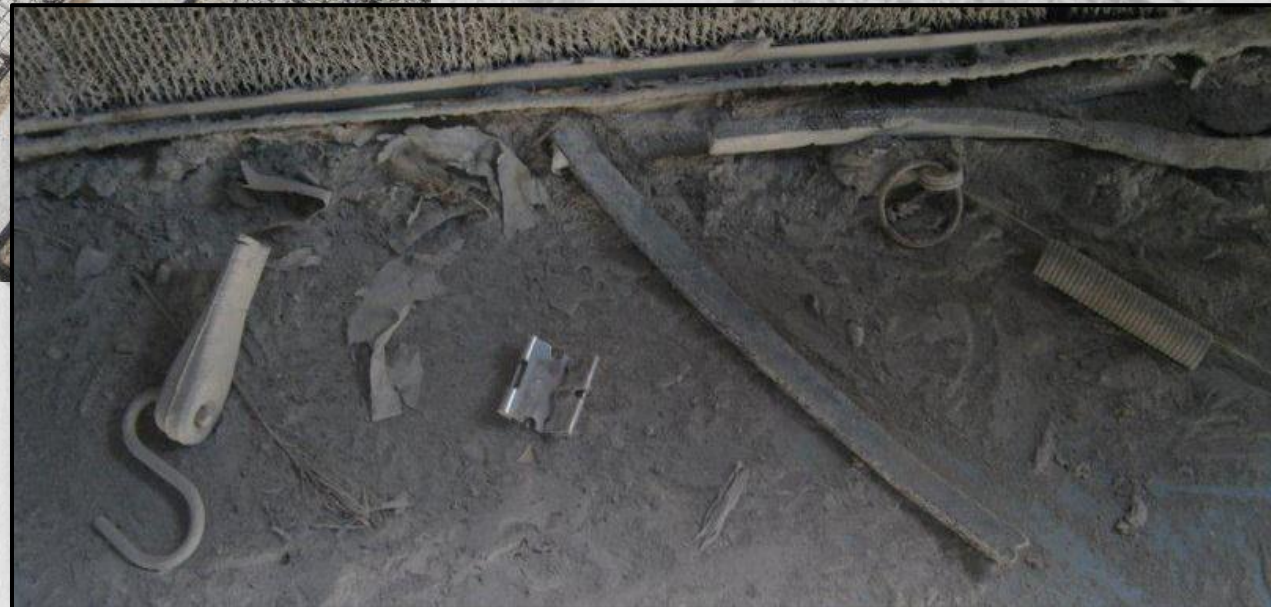
DEBRIS ON FLOOR  
OF FILTER HOUSE

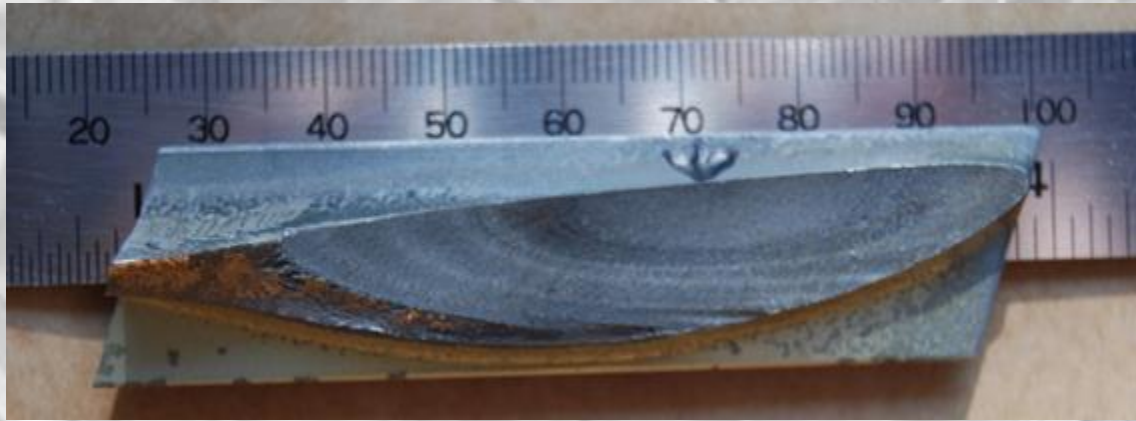
- Blade failure initiated due to high cycle fatigue.

- Blade microstructure and mechanical properties within typical values; no manufacturing anomalies.

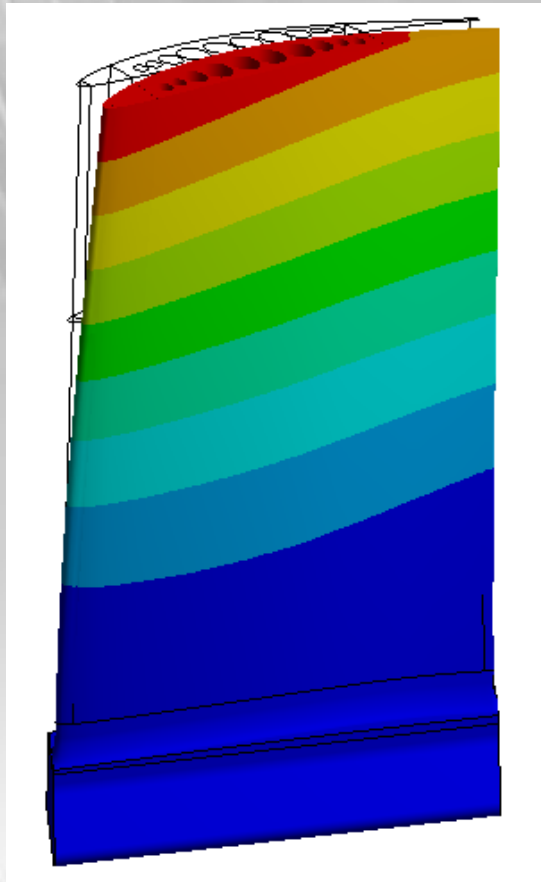
Mode 1 – 1<sup>st</sup> Flex Bending

- Train operates at constant speed well away from stall or choke regions.
- Location of fatigue initiation site **inconsistent** with peak stress areas of first three vibration modes.
- Location of fatigue initiation site **consistent** with observed tip rub loading and forced excitation of first mode deflection.

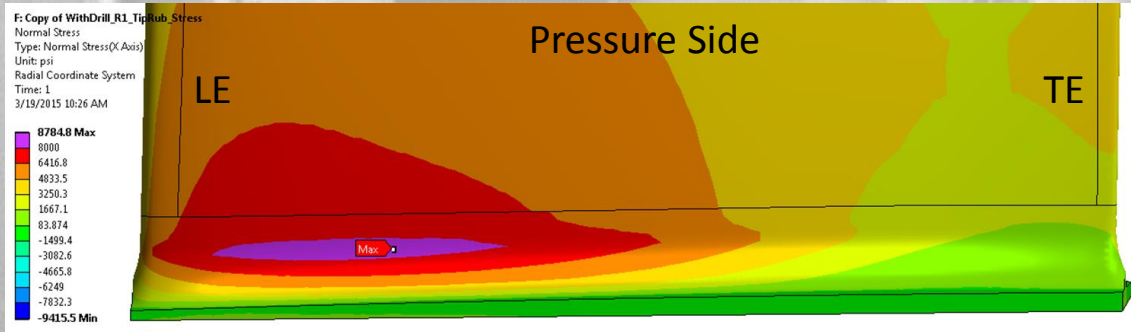
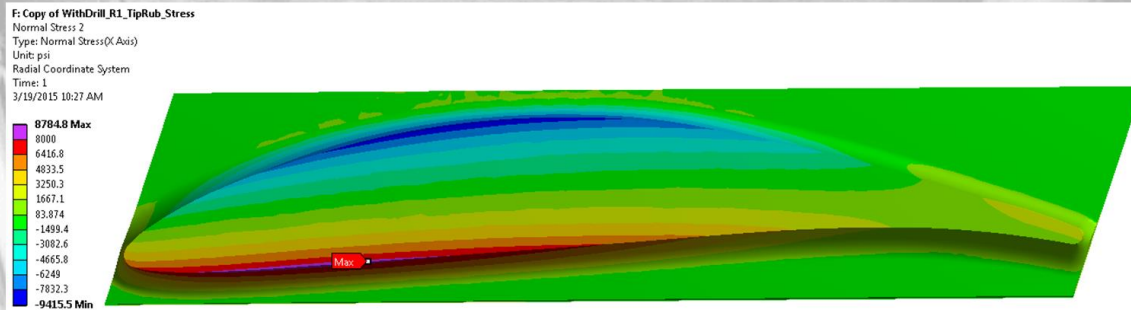
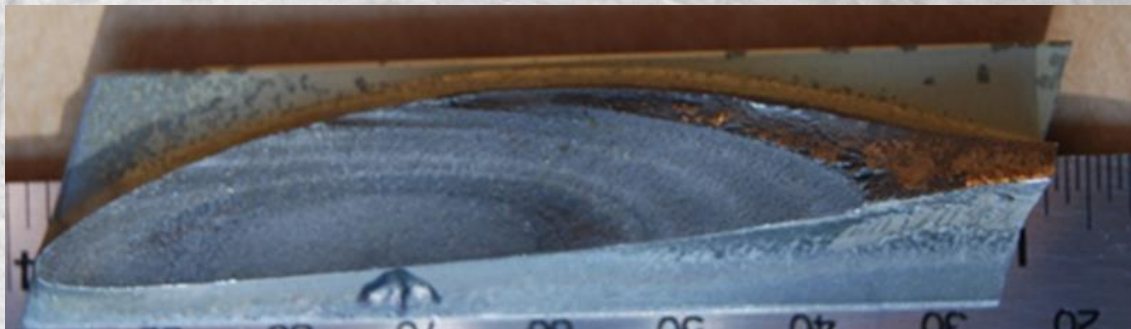
- Stage 1 Blade Tip Rub Peak Stress

- Root cause was fatigue crack initiation due to cyclic loading from a tip rub.
- Material from the inlet screen became trapped between the casing and “longest” blade causing tip forcing function
- Shutdown & inspection decision was the “right decision” avoiding additional consequential flow path damage, and train structural damage from elevated vibration.

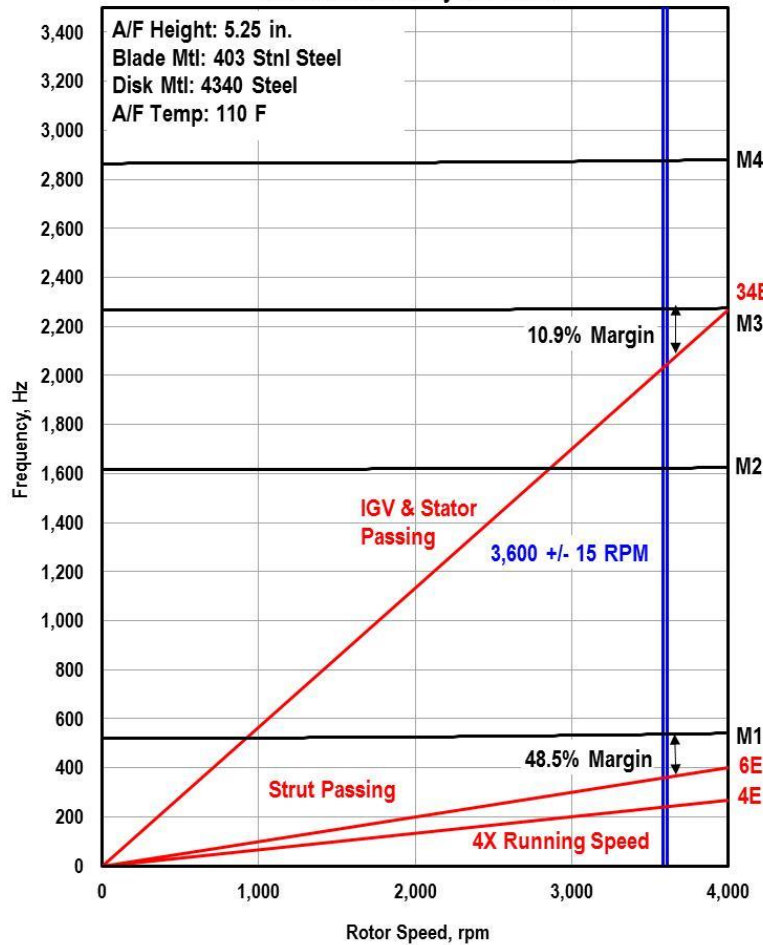
Citgo Axial Compressor Rotor  
 CIT3611 - Stage 1 Rotor Blade  
 Blade with Tip Drilling  
 With Disk Boundary Conditions

- Blade design suitable for purpose based on structural analysis and operating history
  - previous blades operated for 13 years
  - previous blades retired at overhaul.
- Blade design has adequate frequency margin.
  - satisfactory Campbell Diagram
  - frequency response verified by impact testing
  - all remaining 1<sup>st</sup> stage blades frequency tested to verify consistency of manufacturing.
