Piping Load Effect on Shaft Vibration in a Multi-Stage Barrel Type Boiler Feed Pump

American Electric Power (AEP) – Welsh 1 Power Plant in Pittsburg, TX
Base load: 1500 MW Coal Fired Power Plant (Welsh 1, 2, and 3 combined)

Type: 4 stage Double Case with Twin Suction and 2nd stage bleed-off
Rotation: CCW Viewed from the Driver
Speed: 4,000 rpm to 4,860 rpm (66.7 Hz to 81 Hz)
Capacity: 9126 GPM
Suction Pressure: 216 psig
Discharge P.: 3016 psig
Total Dynamic H: 7,370 ft
Temperature: 375 °F
Specific Gravity: 0.877
BHP: 17,530 HP (steam turbine)

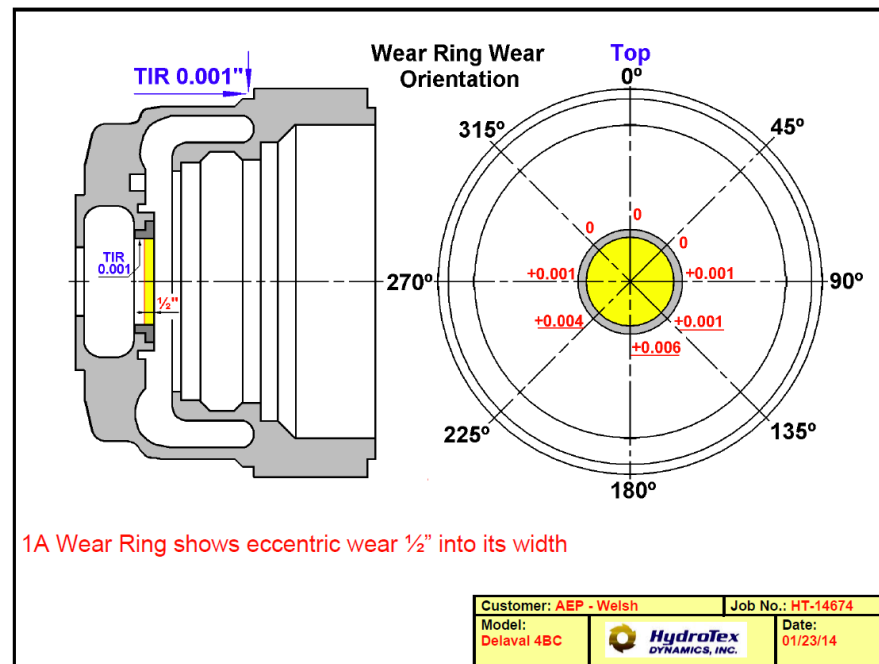
Welsh 1A Ring
Suction Diaphragm TIR
3.0 mils wear
at the top of the wear ring

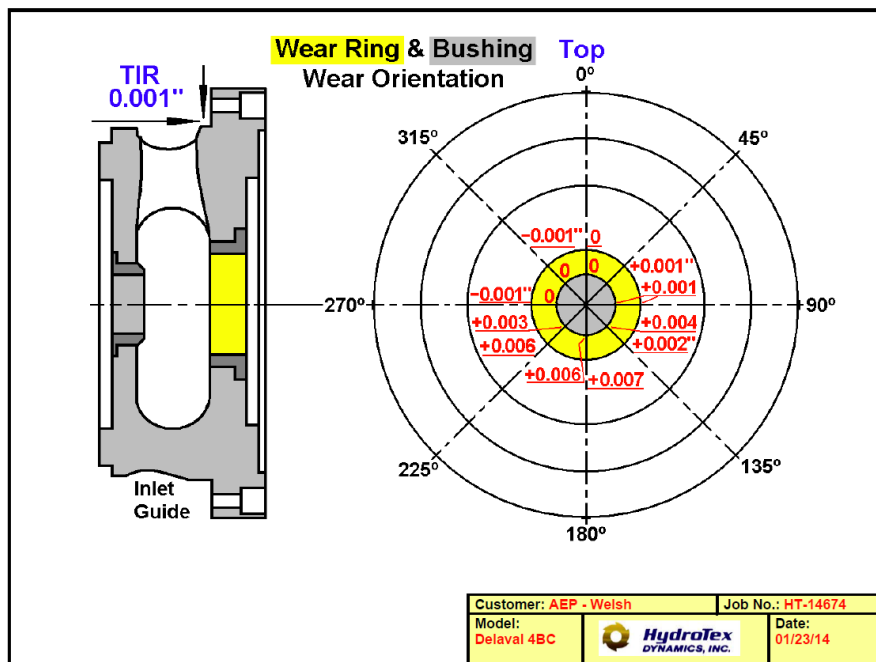
1A Wear Ring shows eccentric wear 1/2" into its width

Welsh 1B Ring
Inlet Guide TIR 3.5 mils wear
at the top of the wear ring

2. Distortion of the pump casing was taking place. “Egged” shape of the wear ring from previous element confirmed that the casing was distorted at high load operation (i.e. high temperature).

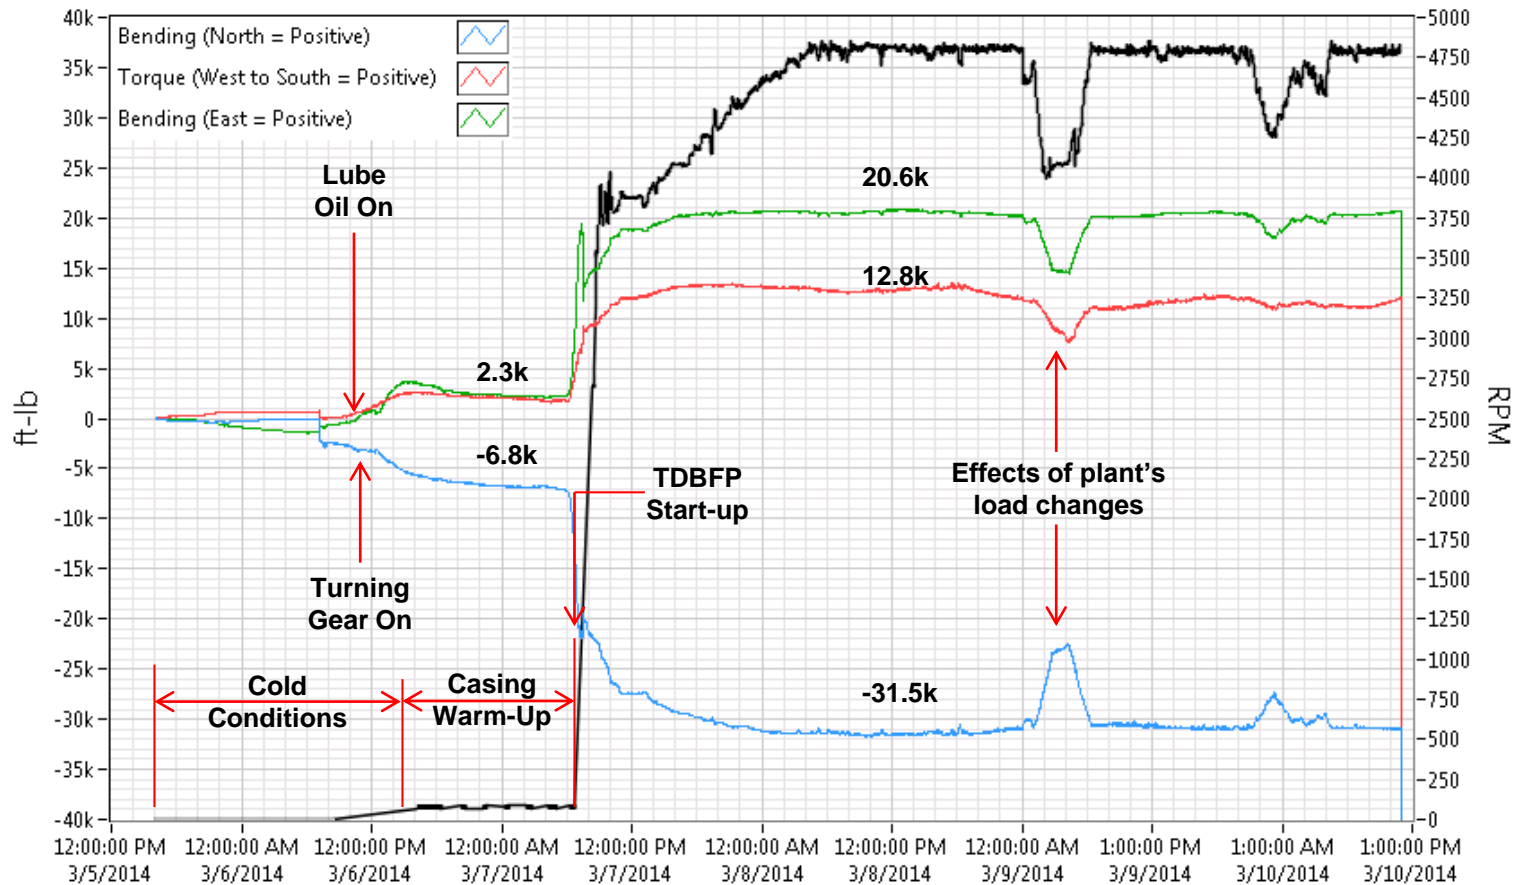
Suction Pipe Bending & Torque Trend

During warm-up, suction pipe is twisting from south to east and bending towards south-east. At full load (525 MW) maximum piping load was reached in the same direction. Plant load plays a role in changing the suction bending and especially the torque.

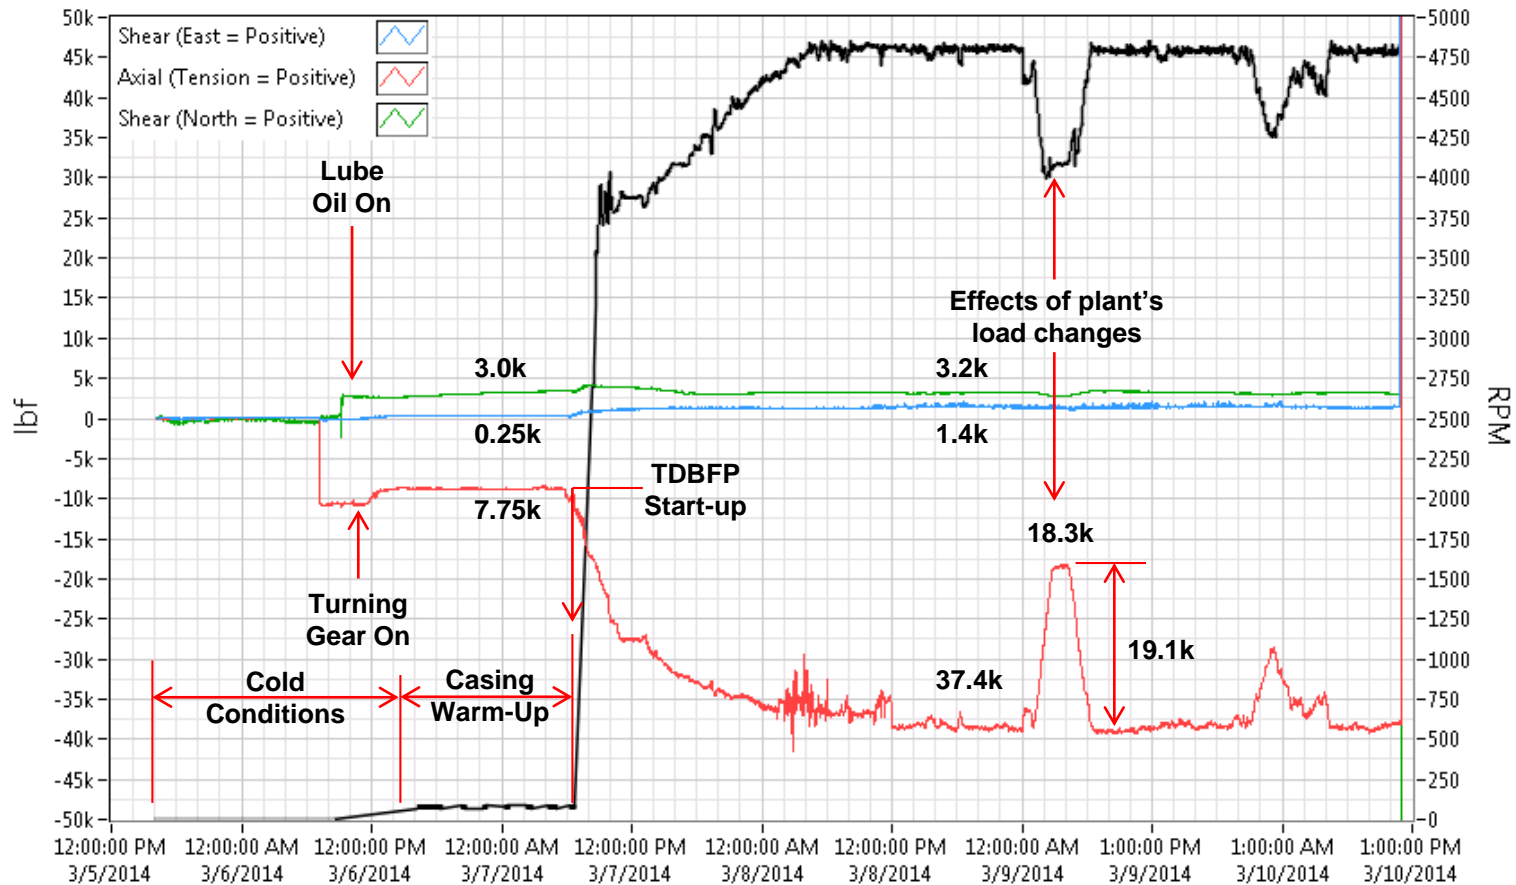
Suction Pipe Shear & Axial Trend Plot

During warm-up, suction pipe is in compression and lightly shearing towards north-east. At full load (525 MW) maximum piping load was reached, especially in the axial direction. The MW load of the plant applies significant downwards axial load to the pump casing.

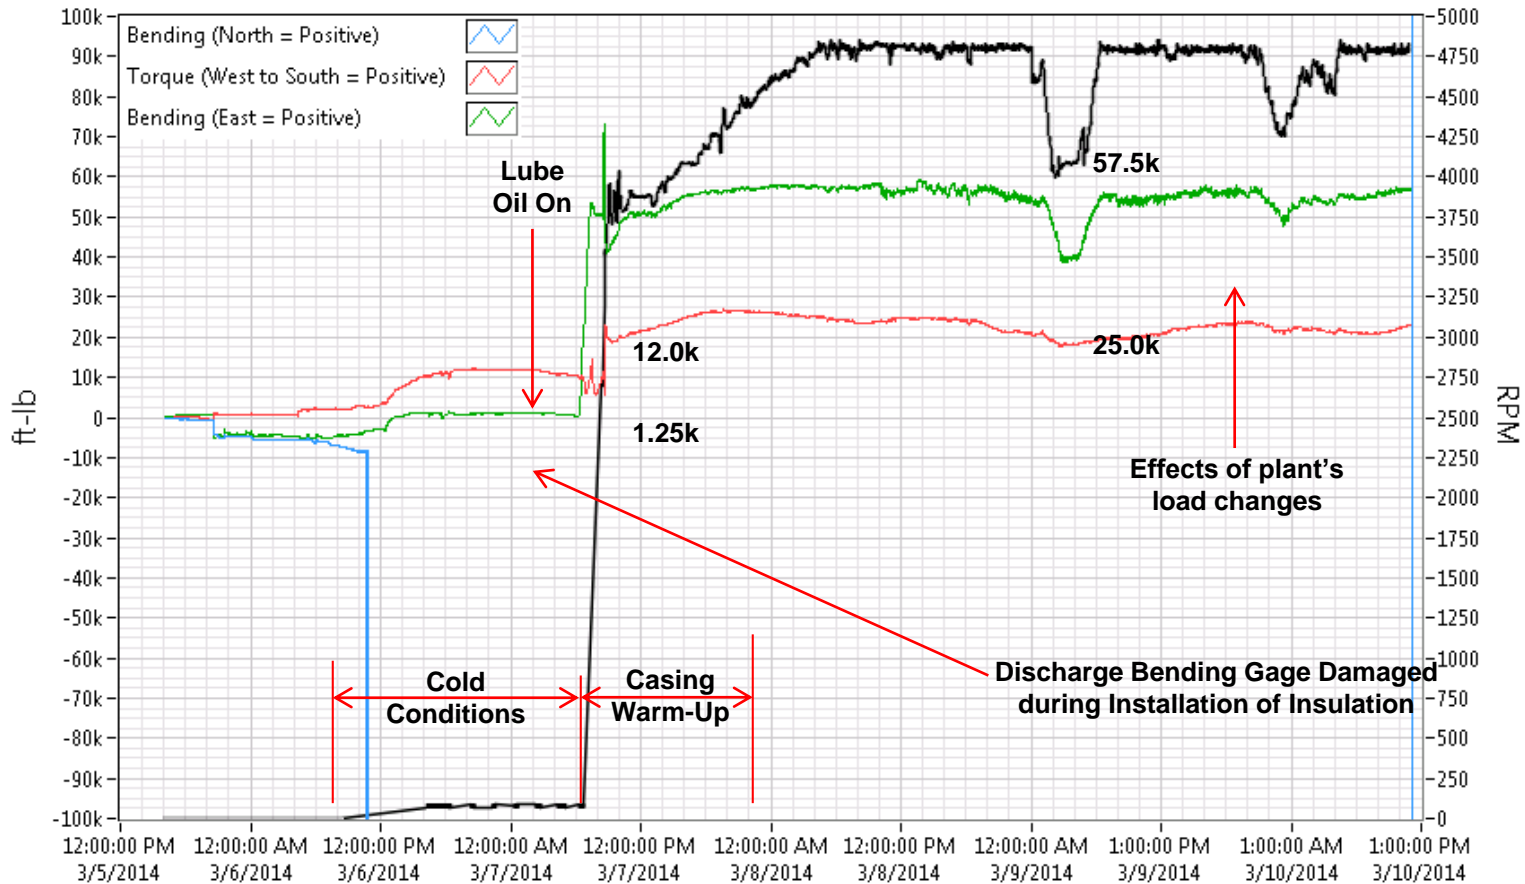
Discharge Pipe Bending & Torque Trend

During warm-up, discharge pipe is twisting from south to east and bending towards east (north-south bending gage lost prior warm-up). At full load (525 MW) maximum piping load was reached in the same direction. Plant load plays a role in changing the discharge torque and especially the bending load.

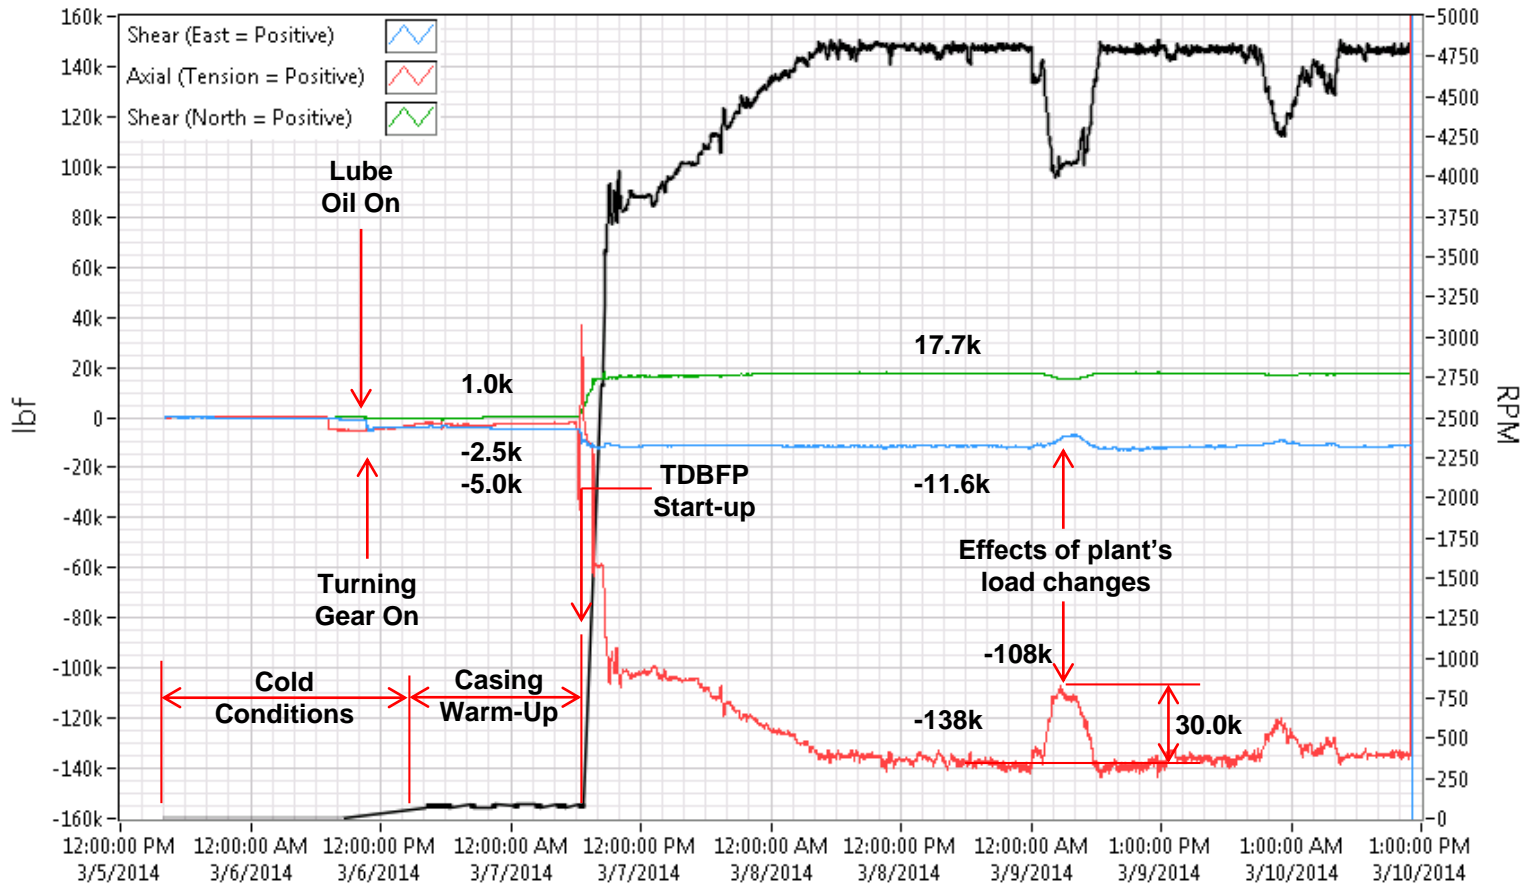
Discharge Pipe Shear & Axial Trend Plot

During warm-up, discharge pipe is lightly loaded (compared with full load operation). At full load (525 MW) maximum piping load was reached, especially in the axial direction (compression). The MW load of the plant applies significant downwards axial load to the pump casing. The discharge pipe is under shear in the north-west direction.

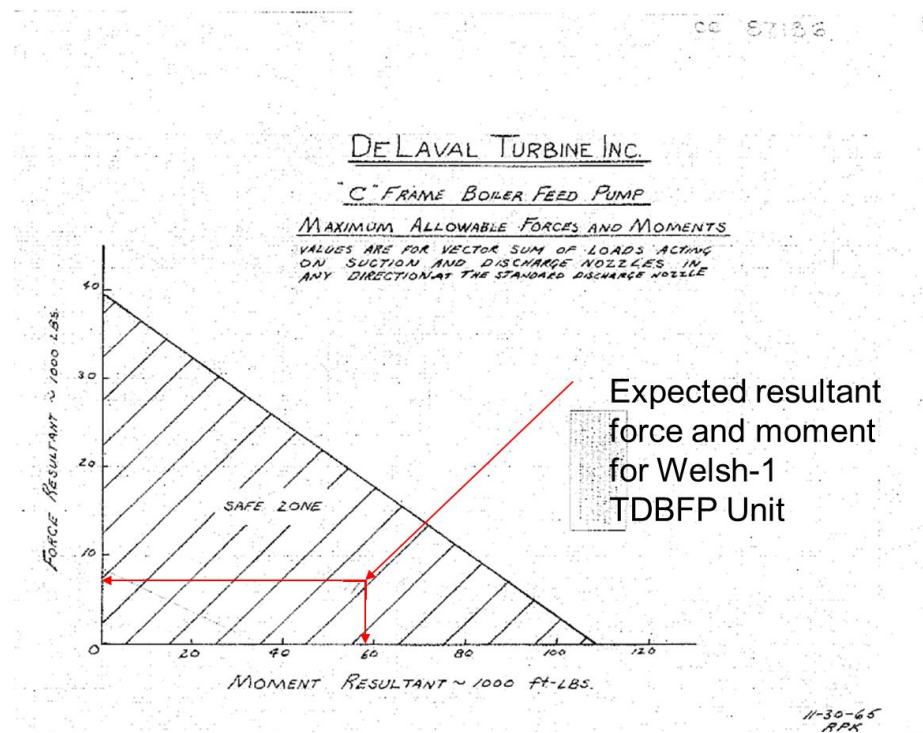
Welsh 1 TDBFP Pipe Strain

**Resultant force exceeds
 25 times De Laval Calculations**

**Resultant moment exceeds
 3.2 times De Laval Calculations**

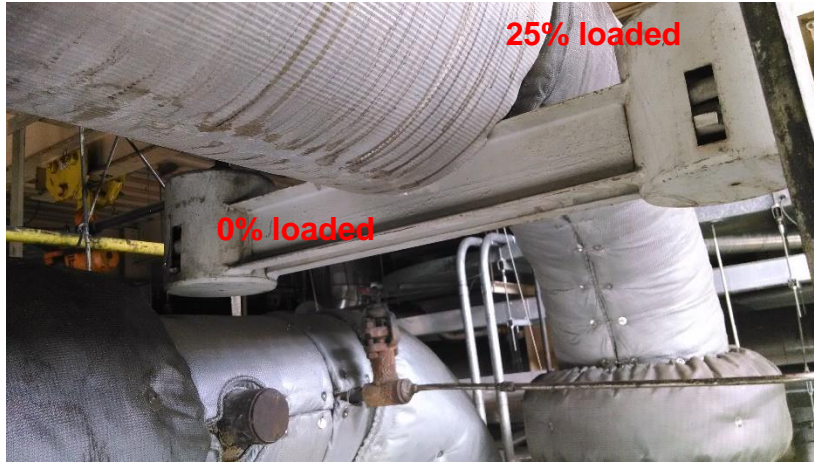
Suction Pipe

3. The closest hanger to the pump on the suction piping (double hanger) was lightly or barely loaded (0% to 25% loaded) with the load indicators at the bottom end of the scale.

1. The loads of the hangers for the suction and discharge piping must be corrected. The hangers must be set in their straight vertical condition. The excessive vertical load was considered the main contributor for the casing deformation and therefore, pre-loading of the IB bearing of the pump.
2. The loads for each hanger should be corrected at cold conditions, taking into account the longitudinal thermal growth of the piping. Once these issues are corrected, the new baseline alignment approach should be conducted.
3. Conduct a hot alignment for verification purposes.

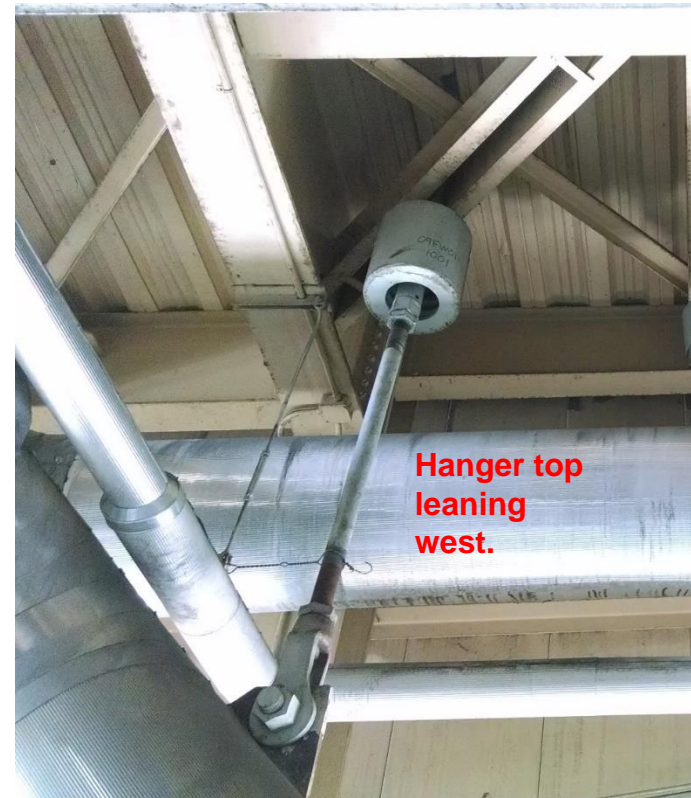
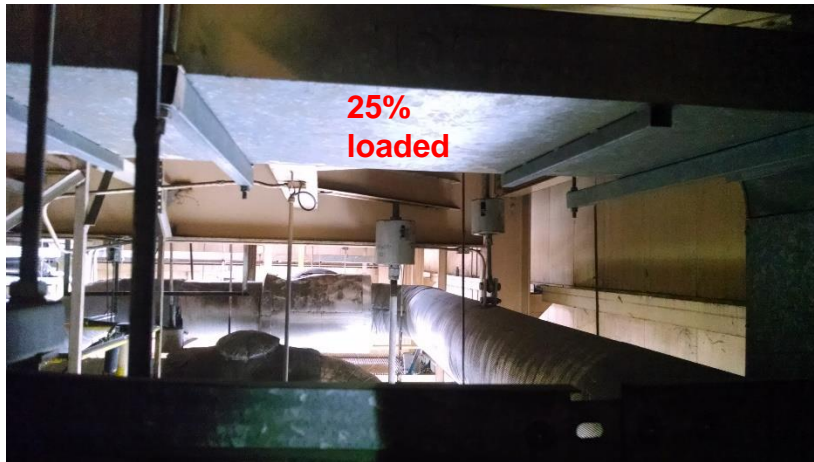
4. The closest hanger to the pump on the discharge piping was detected to be lightly loaded (only 25% loaded) and the upper end leaned towards west direction.

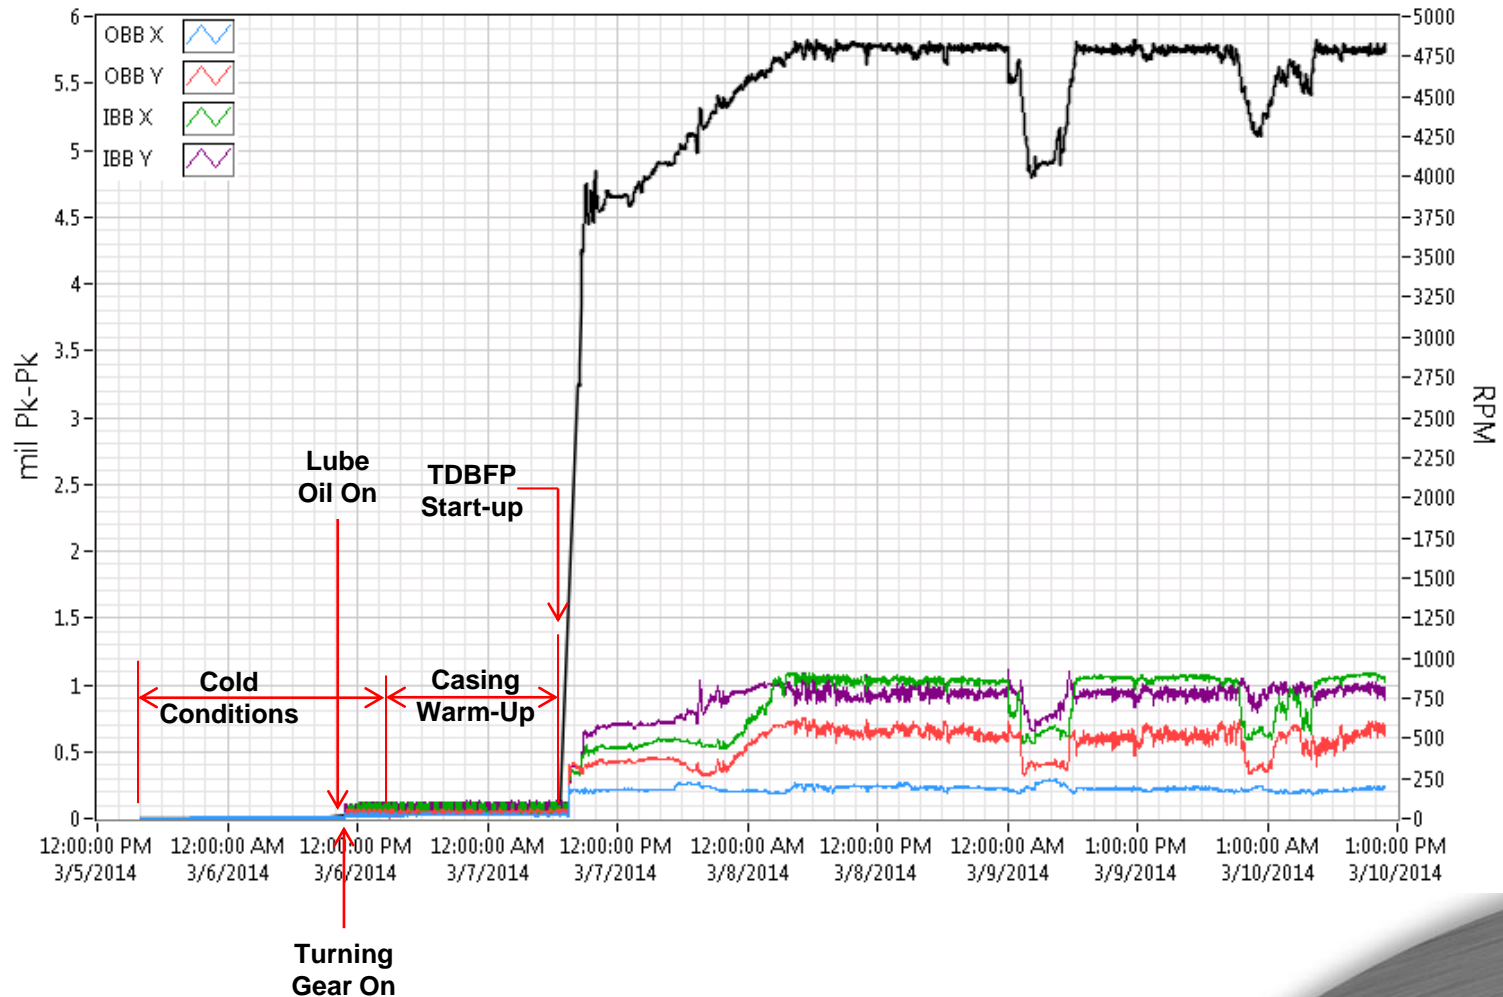
Turbine Shaft Overall Vibration Trend Plot

Turbine rotor overall vibration was measured to be low and acceptable (~1.0 mil pk-pk) for the entire start-up evolution of the test.

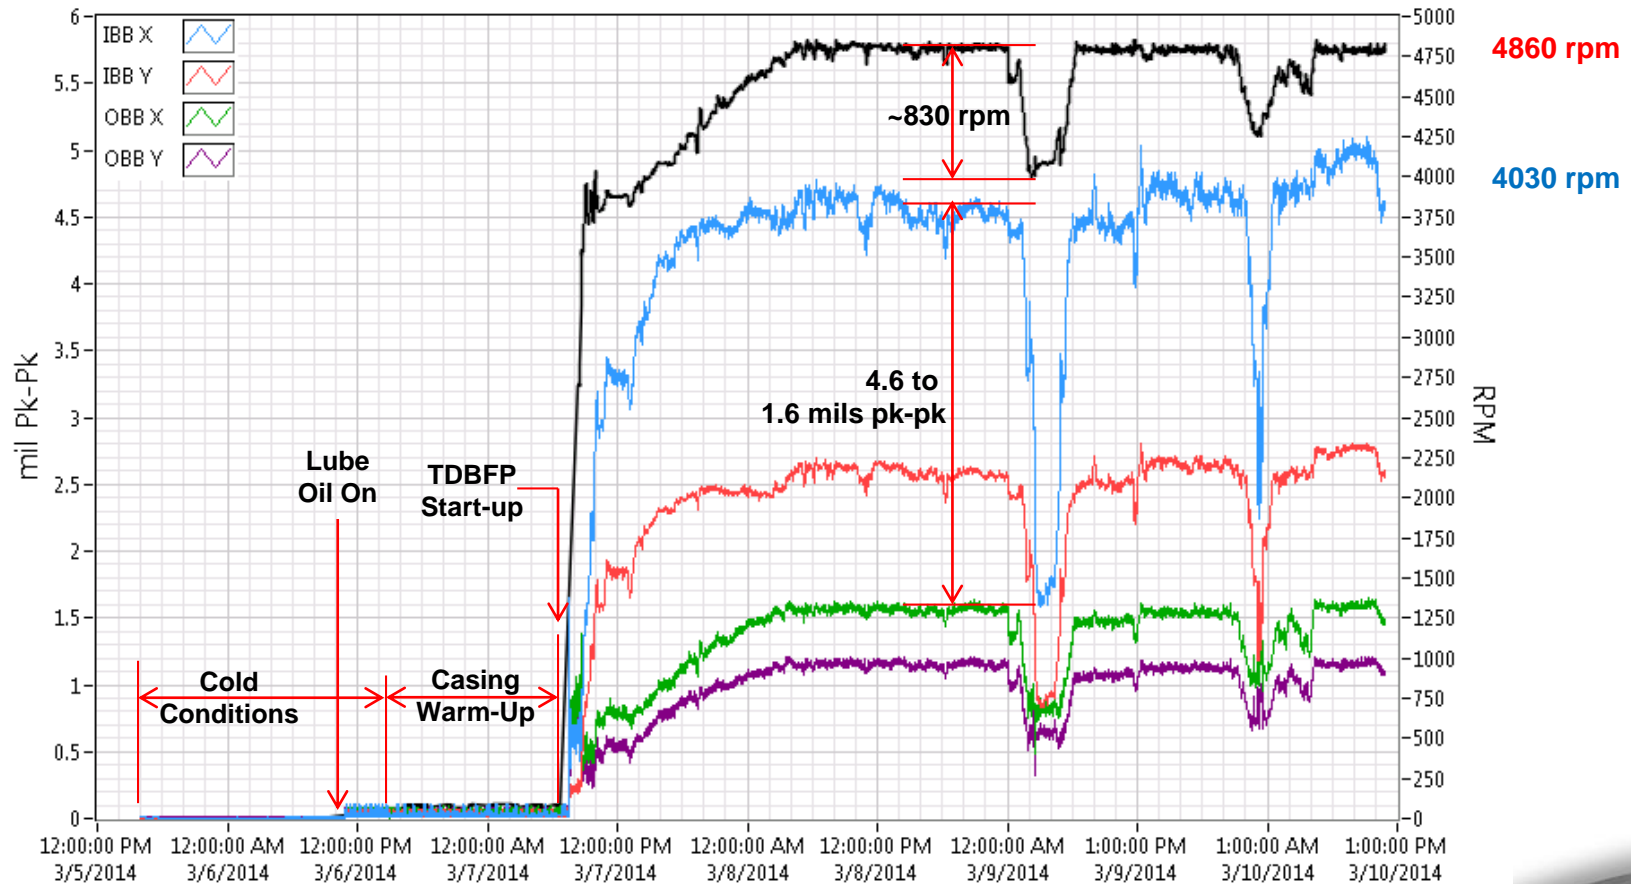
Pump Shaft Overall Vibration Trend Plot

Pump rotor overall vibration at the IBB was measured to be elevated (~5.0 mil pk-pk) at full load operation (525 MW). Strong vibration change versus speed effect is observed in this trend plot. ~830 rpm reduction, the vibration at IBB-X was reduced from 4.6 to 1.6 mils pk-pk.

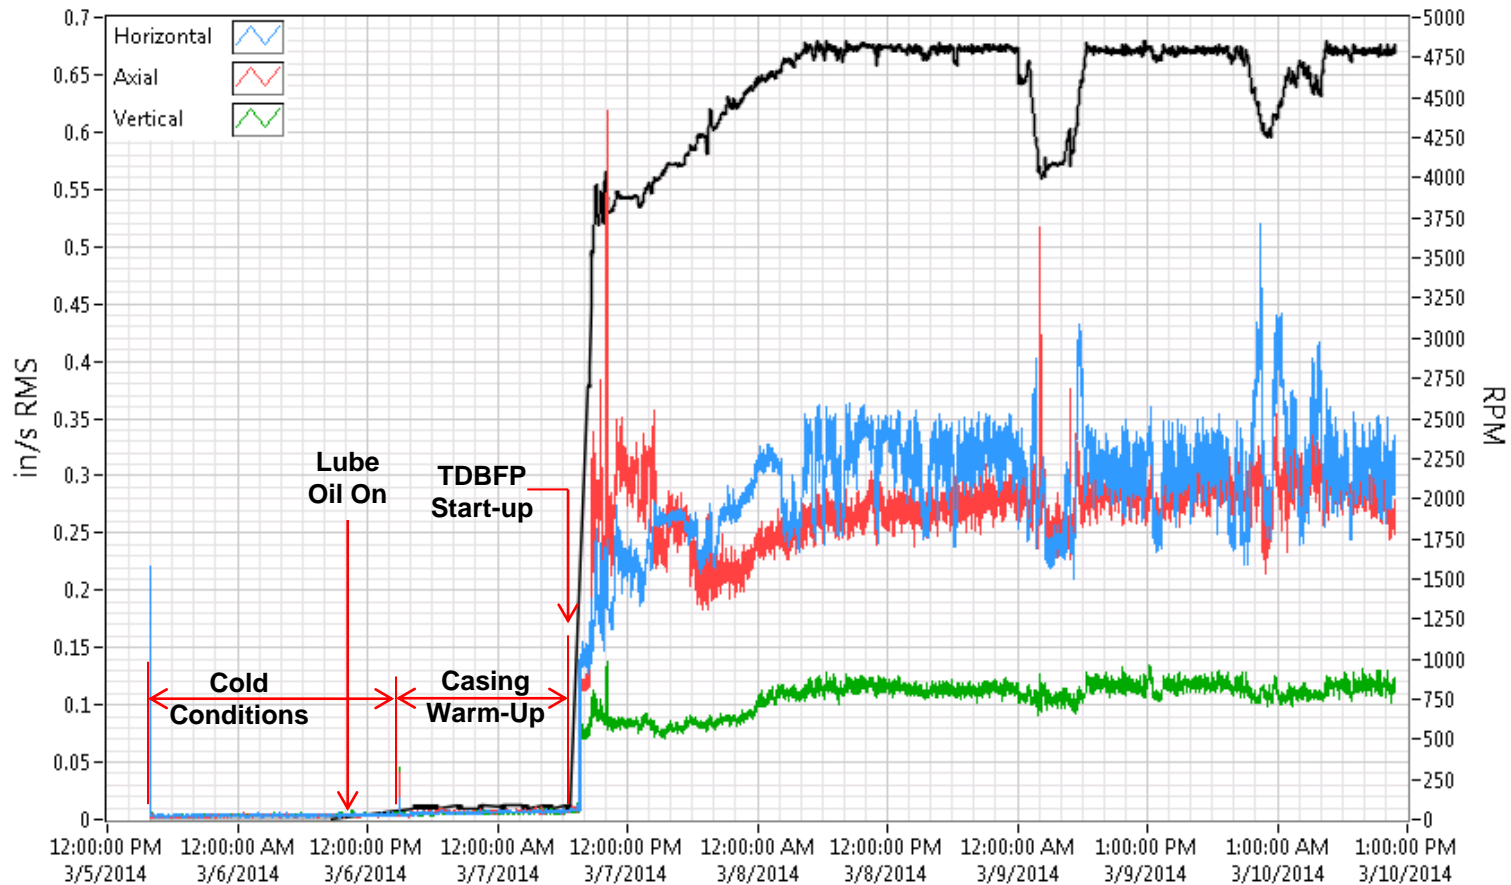
Pump Inboard Bearing Vibration

Pump IBB housing overall vibration was measured to be elevated mild (~0.35 in/s RMS in the horizontal direction) at full load operation.

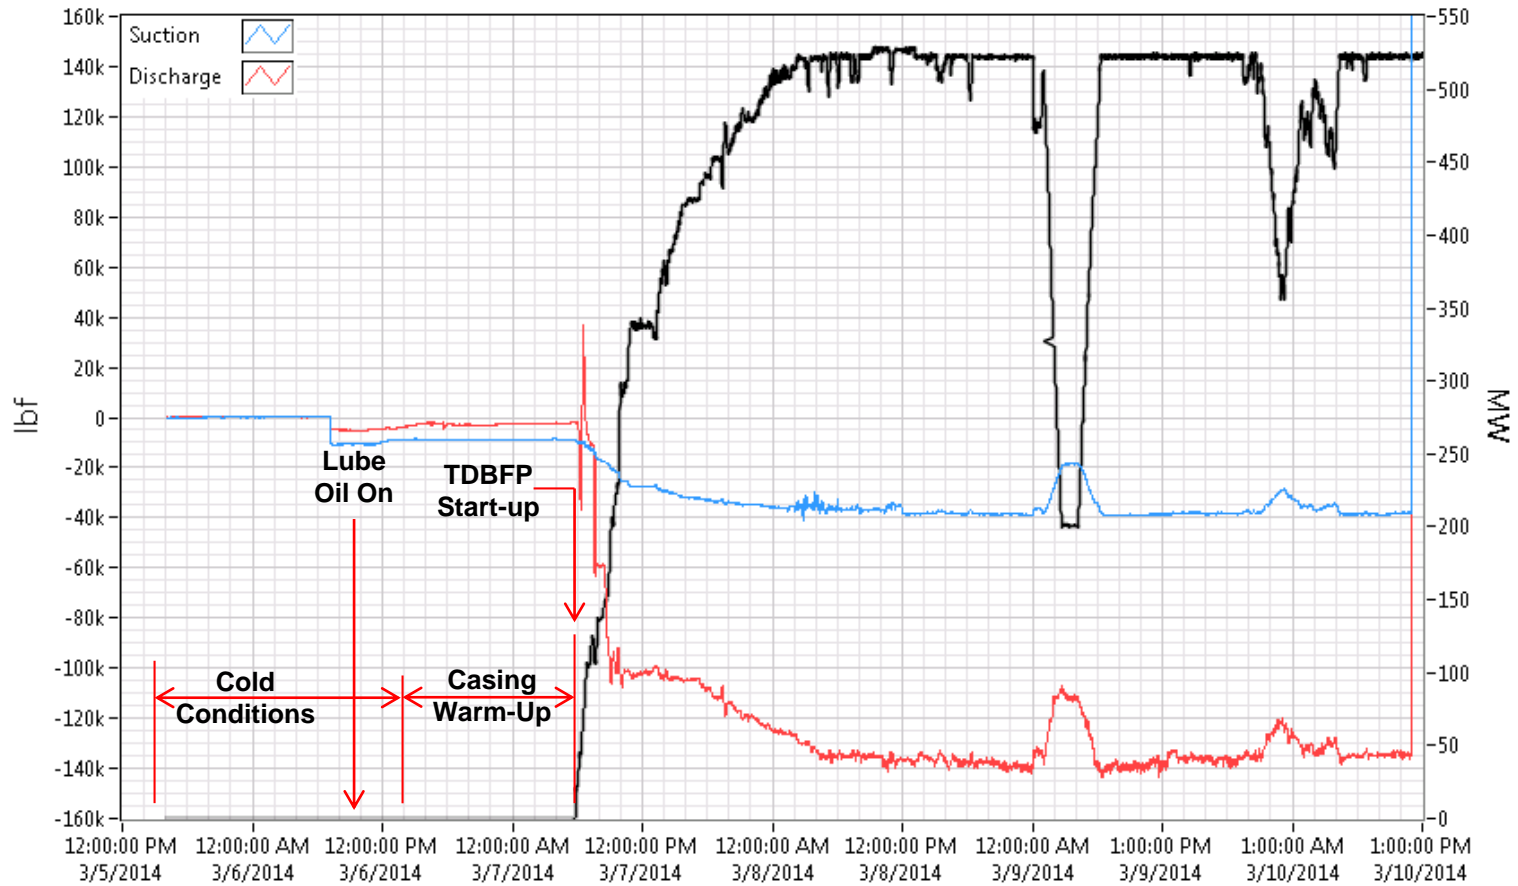
Pipe Axial Load and Power

As the plant load was increasing the axial load of the piping against the casing was also increasing (compression load). The change in temperature of the condensate water was playing a significant change in load on the pump casing due to thermal expansion effect.

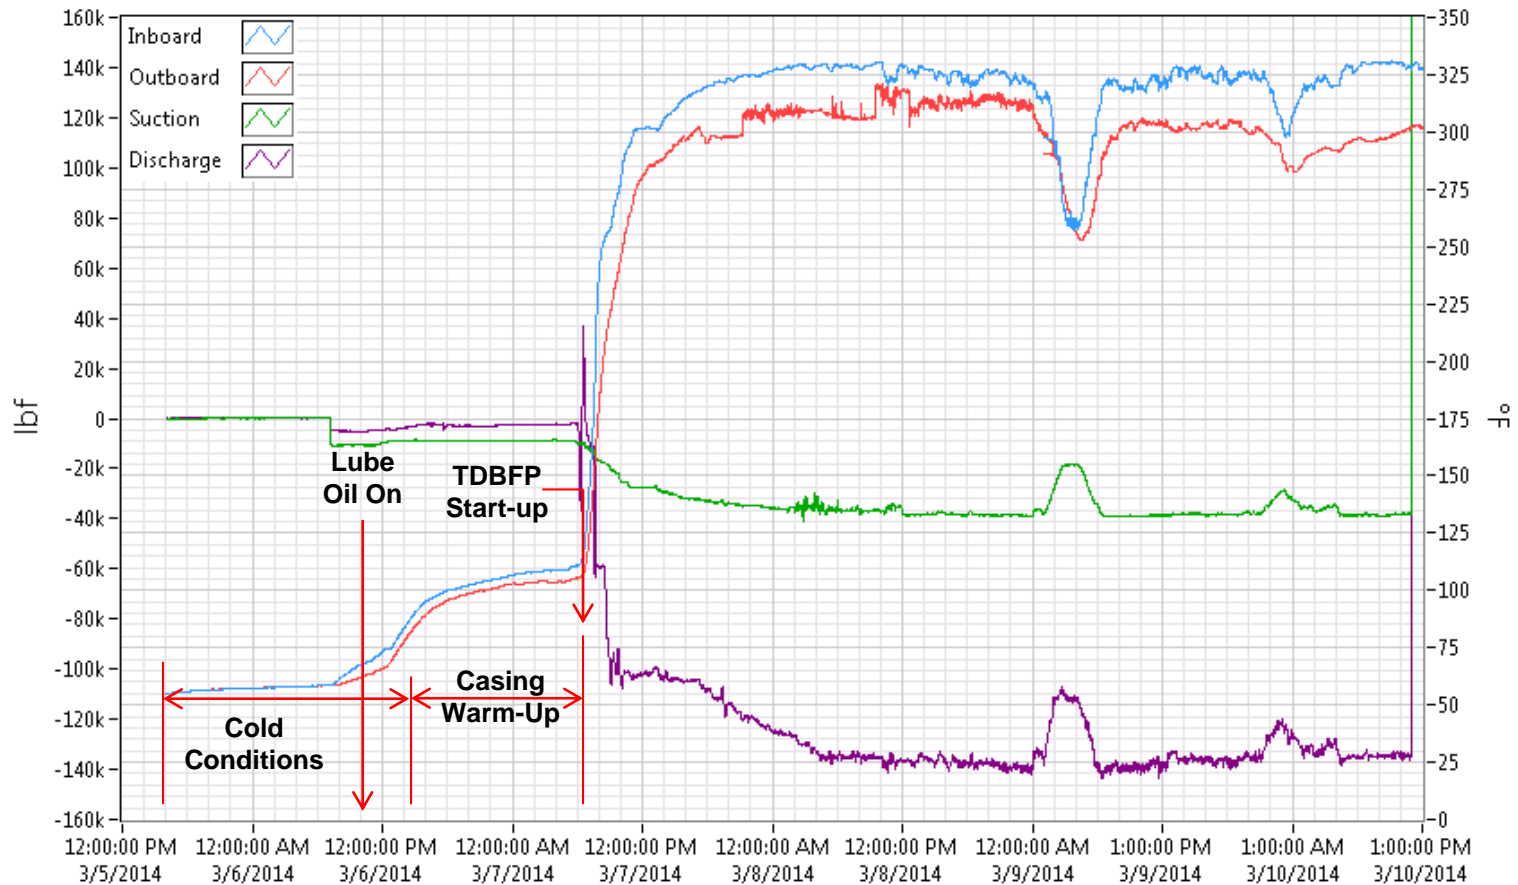
Temperature and Pipe Axial Load

As the plant load was increasing the axial load of the piping against the casing was also increasing (compression load). The change in temperature of the condensate water was playing a significant change in load on the pump casing due to thermal expansion effect.

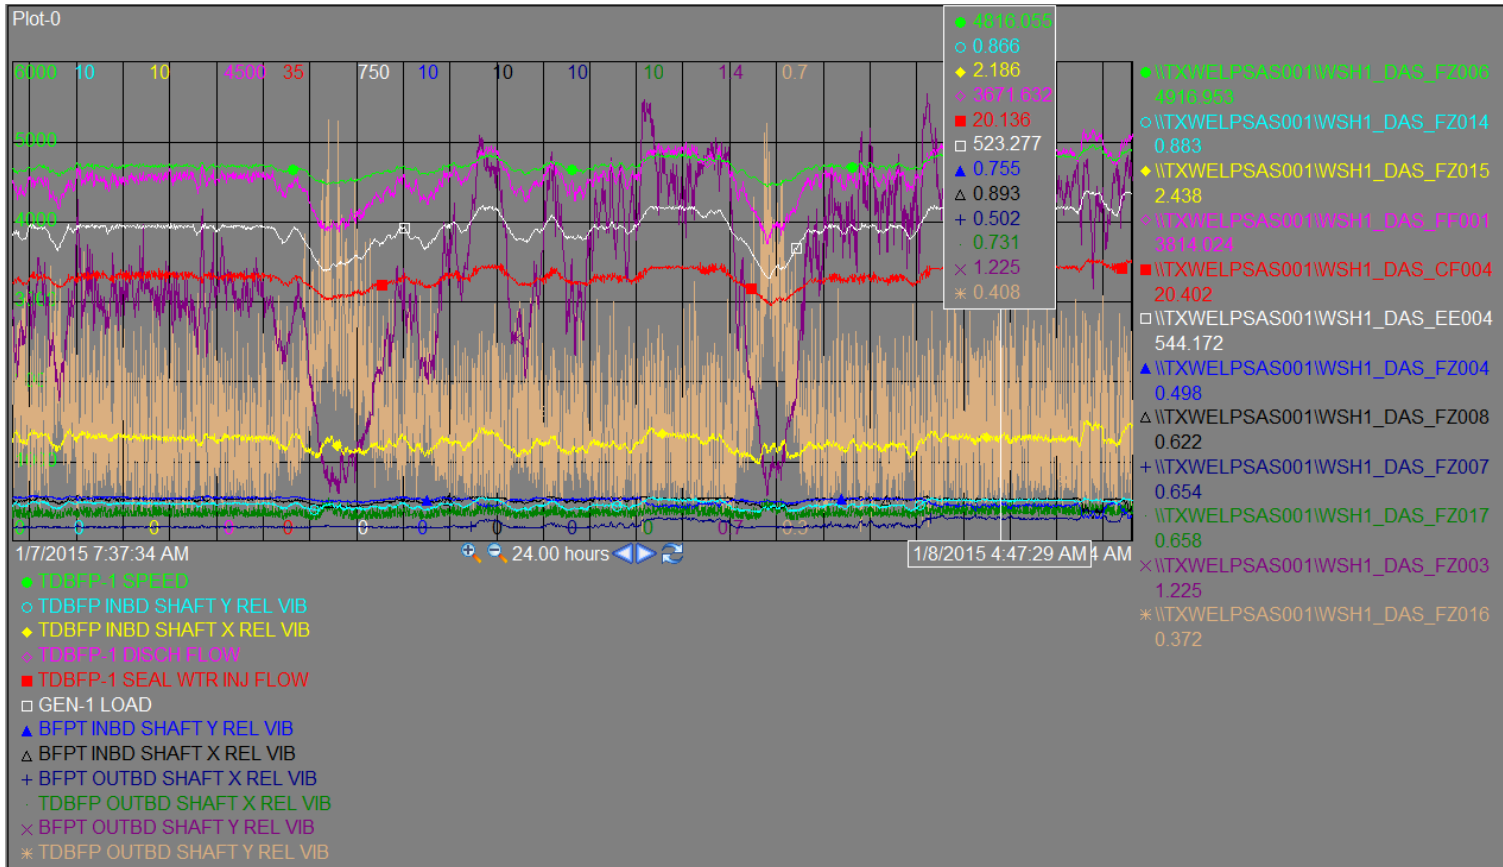
Follow- Up Vibration Data After Correcting Pipe Hangers

Pump Speed: 4816 rpm
Load: 523 MW
Pump IBB-X: 2.2 mils pk-pk
Pump IBB-Y: 0.9 mils pk-pk
